# INSPECTING SERVICE RESERVOIRS FOR WATER QUALITY NOW!

*10<sup>th</sup> Annual WIOA  
NSW Water Industry Operations Conference and Exhibition  
Newcastle Jockey Club,  
6 to 7 April, 2016*

**David Barry**, *Director*, Aqualift Project Delivery Pty Ltd

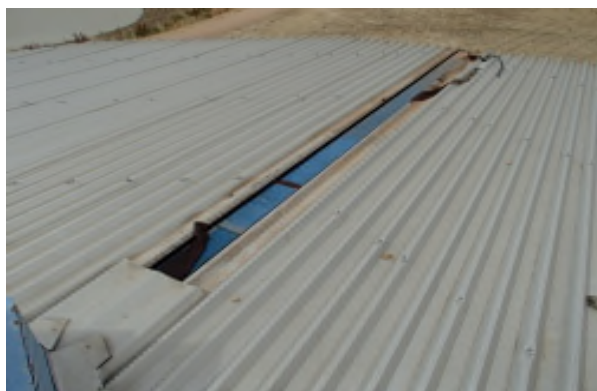
**Figure 1:** *Roof Ridge Cap Missing*

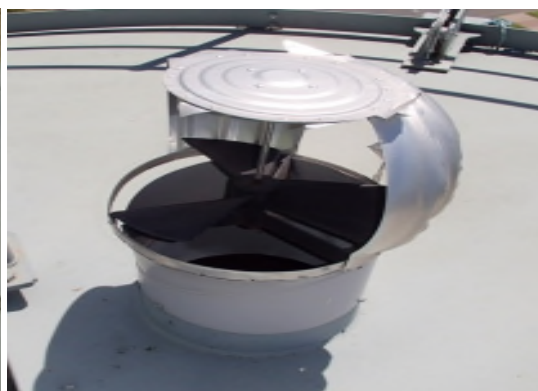
**Figure 2:** *Faulty Rotating Vent*

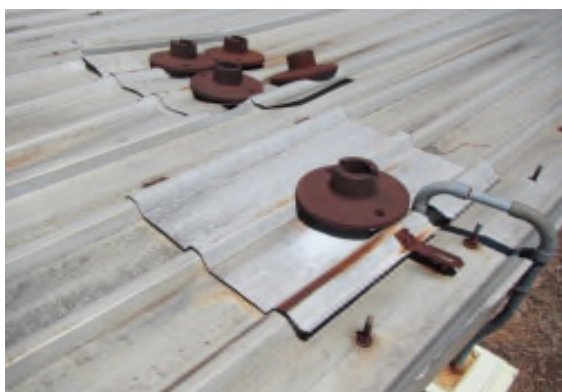
**Figure 3:** *Unsecured Entry Hatch*

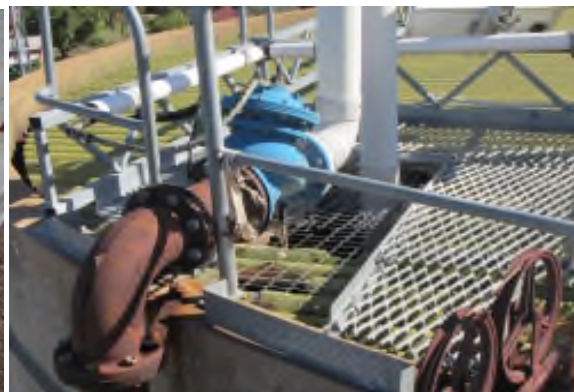
**Figure 4:** *Open Roof Areas Allowing Drainage and Vermin Entry*

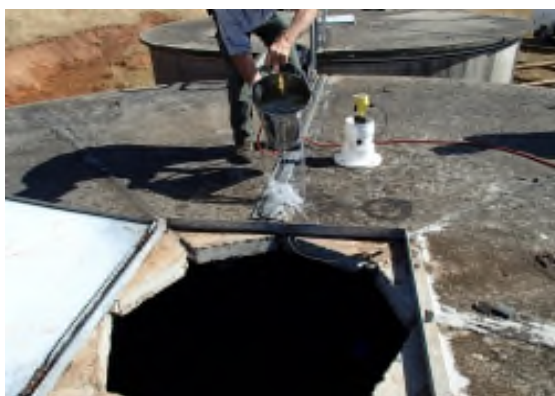
While most defective areas are obvious, some of the worst contamination entry points are also the hardest to identify. This is where experience comes into play, based on recognising the available evidence such as bird activity around the roof area, staining and debris on platforms from ponded water residues, hatches that leak when the bucket of water test (BoW) is applied, and feathers or nesting material on the internal water line areas.

**Figure 5:** *Bucket of Water Test*

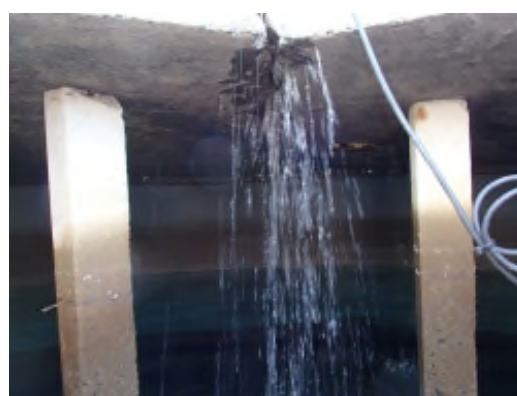
**Figure 6:** *Internal Evidence of BoW Test Failure*

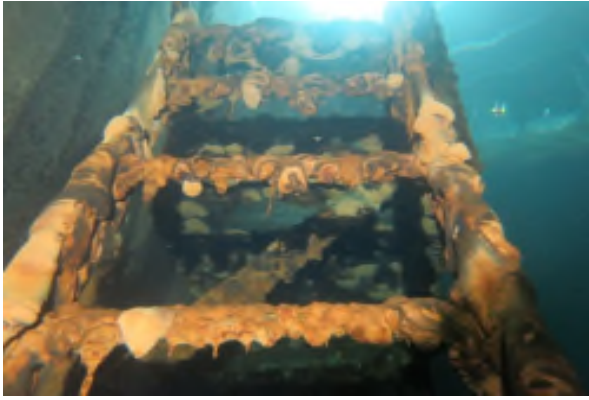
The Barrier 2 items can mostly be identified and recorded without entering the water, but there are other areas within a service reservoir that may be affecting water quality, such as corroded internal ladder systems (Figure 7), pipework and posts.

**Figure 7:** *Corroded Ladder*

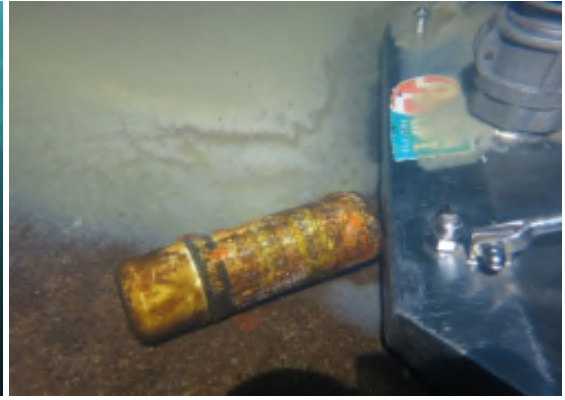
**Figure 8:** *Excessive Sediment and Debris*

Along with excessive sediment loadings, poorly designed inlet and outlet pipework and debris (Figure 8) that has entered the tank, it is important to identify issues that will be impacting disinfection residuals within the storage (Barrier 3).

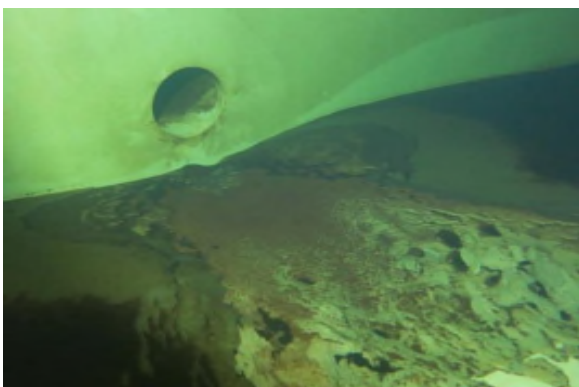
**Figure 11:** *Inlet Flow Disturbing Sediments*

If incoming water is stirring up existing sediments (figure 11) or outlets have no effective raised edge barriers in place to stop debris from entering reticulation system, then the inspection process is not complete (see figure 12 for an effective barrier).

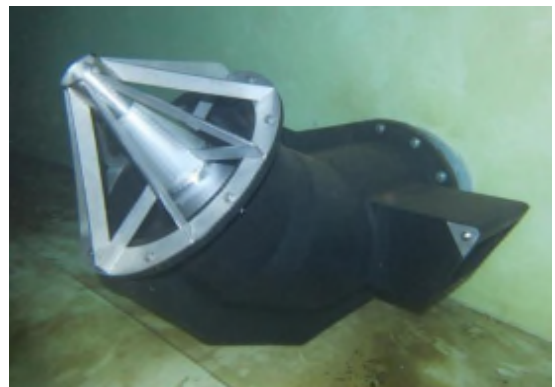
**Figure 12:** *An Inlet Nozzle Directing Water Flow Up Off the Floor Area*
