# CLEAR WATER TANK CAPERS: AN OPERATOR'S VIEWPOINT

**Travis Hutton, Process Operator Trainee,**

Tamworth Regional Council

*10<sup>th</sup> Annual WIOA  
NSW Water Industry Operations Conference and Exhibition  
Newcastle Jockey Club,  
6 to 7 April, 2016*

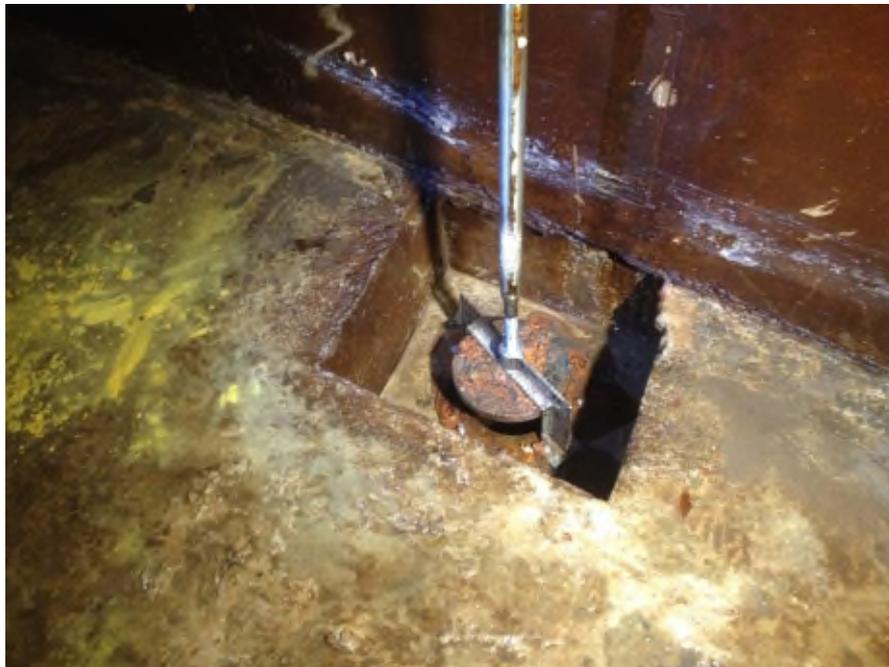
**Figure 3:** *Clear Water Tank Scouring Valve*

Scouring of the Clear Water Tank was initiated, but it was soon discovered that the scouring pipe was blocked. (Later we found that tree roots had almost completely blocked the 200mm diameter pipe.)

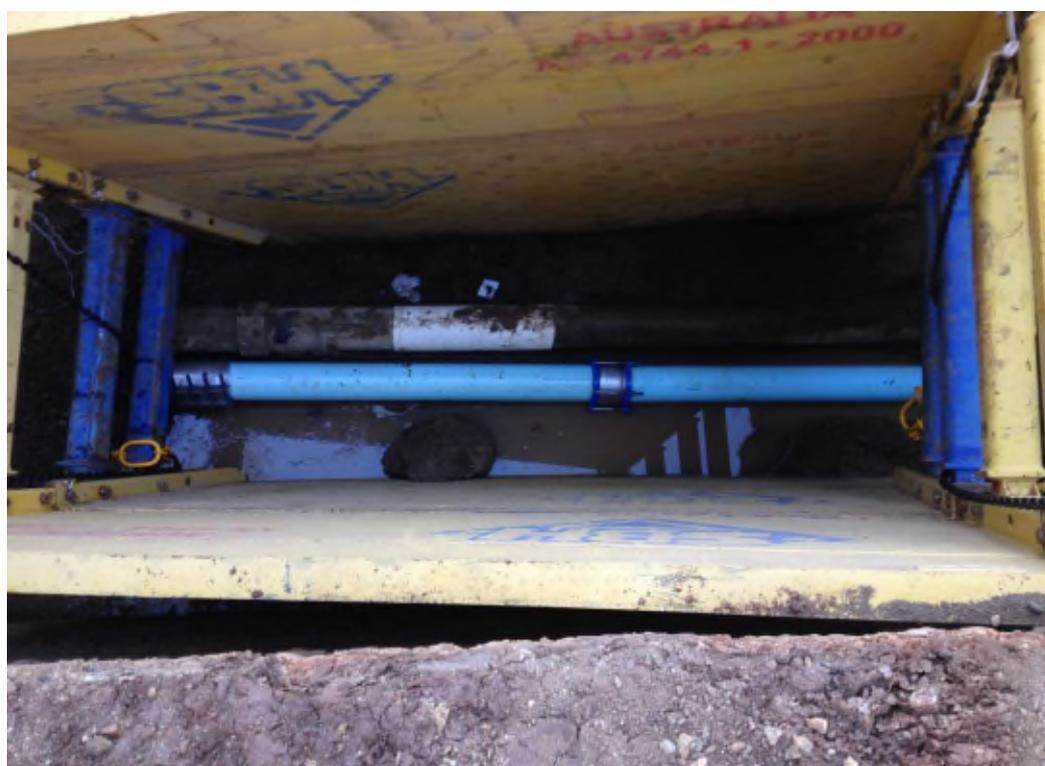
**Figure 4:** *Repaired Clear Water Tank Scouring Pipe*

Firstly, the Clear Water Tank needed draining, but the scouring drainpipe was blocked and required repair. We used an inspection robot with a tethered controller to find out what the blockage was in the pipe. There was a large clump of tree roots near a damaged section of the pipe. This was only a few meters away from the Clear Water Tank.

The excavation began of the blocked and damaged pipe. Digging was fast with the 30 tonne excavator. When the pipe was located, they lowered the shoring into place then the workers climbed down to start the repair.

The pipe contained asbestos, this needed removing safely and in the correct manner. We contracted a local plumber who would follow industry best practice in removal of the asbestos.

Now it was time to lower into place the new section of pipe along with two gibaults. Once the repair was finished we opened the scouring valve to test for leaks. The repair was successful.

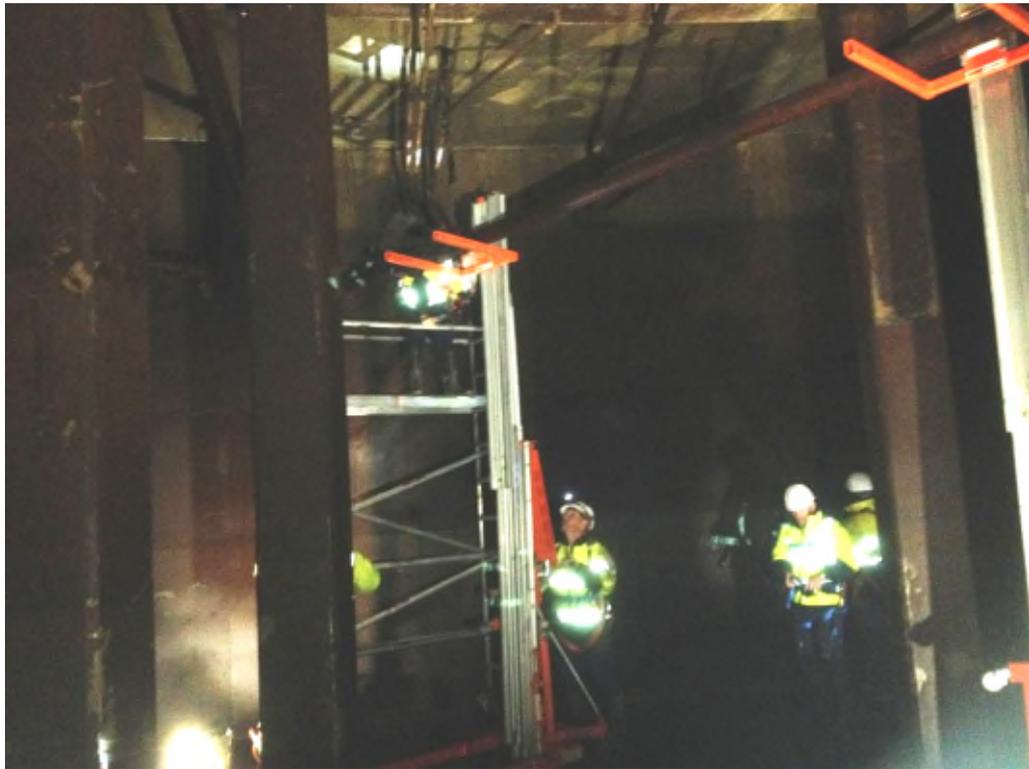
**Figure 5:**     *Repairing Pipe inside Clear Water Tank*

In my opinion this major problem was ultimately caused by a design flaw. Placing a clarifier on top of a Clear Water Tank with the benefit of hindsight is clearly a bad idea. Another problem was that the original sludge pipe had insufficient support to carry the weight of the pipe.

After the Clear Water Tank scouring pipe was repaired, the tank needed draining. There were many other challenges that had to be overcome, being below ground level yet working at a height of 6 metres, all repair tools (laser level, low voltage lighting, Genie lifters and scaffolding) and materials had to be lowered into one small opening.

Significant consideration and planning was required to ensure efficient and safe work in a confined space. Chlorine and carbon monoxide monitors also needed to be in place. Another major consideration was the limited time we had to complete the works, due to Tamworth's limited water storage capacity. Following the correct plant isolation protocols would ensure the safety of all workers. If any other major problems were discovered, they had contingency plans in place.
