LANDERS SHUTE WTP RAW WATER MAIN DRAIN DOWN, REPAIR & REFILL

Alysha Di Martino, *Operations Process Engineer*, Seqwater
(Co-authors if any) Chris Brown, *Operator Supply*, Seqwater
ABSTRACT

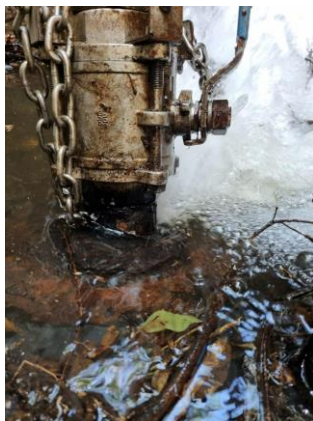
In April 2024 it was discovered that there was a leak on the pre lime connection point on the raw water main. When the leak was discovered, Seqwater engaged a contractor to assess the damage and to conduct repair work. The contractor was only able to complete a temporary repair and advised that the main would need to be de-pressurised to conduct a permanent repair.

Figure 1 Leak at injection point

After the main had been drained and the isolations were in place, the repair work began on the main. The section of the main was removed where the pipe had thinned and failed. A reinforcing pad was welded on which contained the injection point for pre lime. Refer to Figure 8 showing the repair work and Figure 9 showing the finished repair.

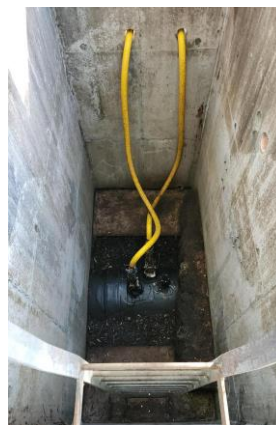
Figure 2 Pre lime dosing pit

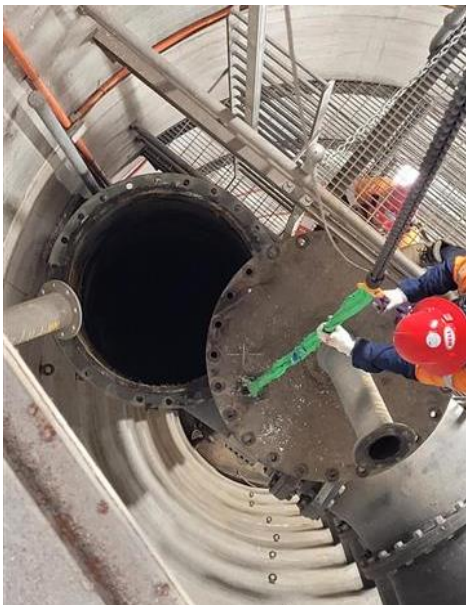
For the drain down of the raw water main, we identified a very high risk of a vacuum being created in the raw water main leading to pipe failure. This was due to inadequate venting. To control for this risk, we decided to remove a DN900 blanking plate at the intake tower. Scaffolding was set up at the intake tower prior to the day of the works to improve access, see Figure 5 below showing the blanking plate removal.

Figure 5 Blanking plate at intake tower

Installing a larger air valve at the intake tower would enable drain down at higher flows without having to remove the blanking plate. The larger air valve could be installed when the dam level is below the blanking plate level to minimise impact on the WTP.

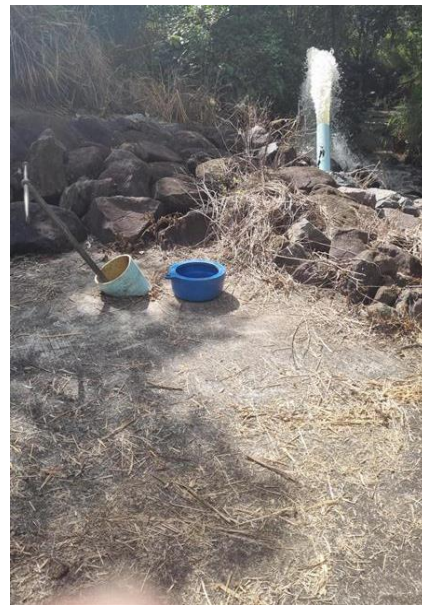
Figure 6 Raw water scour

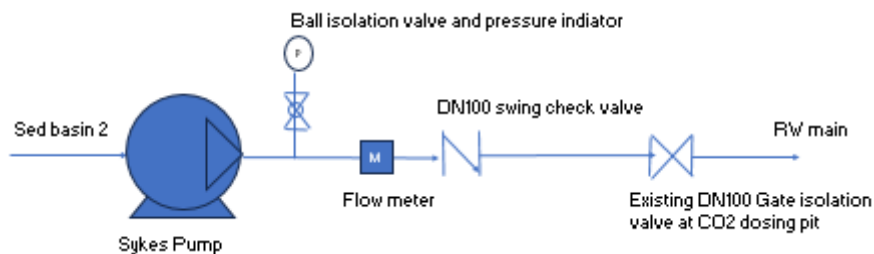
Figure 7 Sykes pump arrangement sketch

Seqwater sourced two Sykes pump (one as a backup) from other sites and had them transported to the WTP. We included an irrigation totaliser flow meter and a pressure indicator on the discharge line of the Sykes pump. The Sykes pump was connected to discharge into an existing DN100 tee in the CO2 dosing pit. Filling from the lowest point

on the main allowed for the air to rise and be released through the vent at the intake tower. Figure 7 shows the Sykes pump arrangement.

Regarding the refill, there were extra pressure losses in lay flat hose used for the Sykes pump that were not considered which meant the pump flow rate was lower than expected. The losses could be minimised by using sections of rigid hosing at both the Sykes pump end and the connection point at the main.

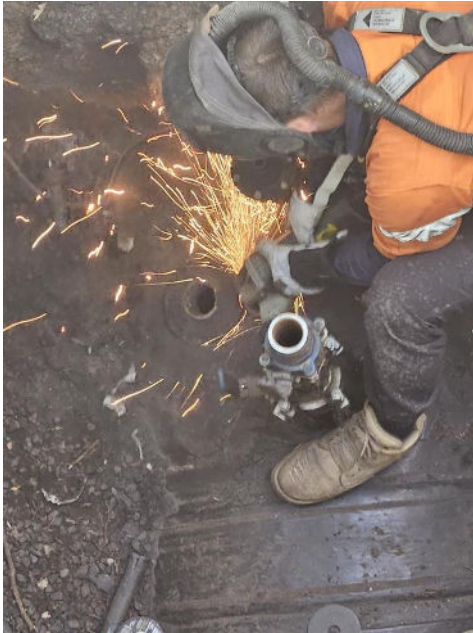
Figure 8 Works in the pre lime pit

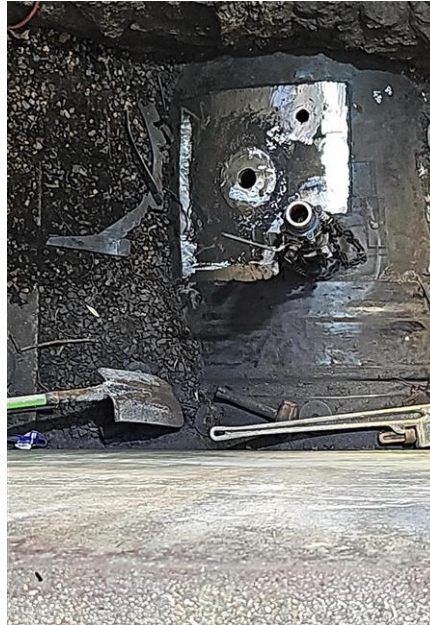
Figure 9 Complete repair work

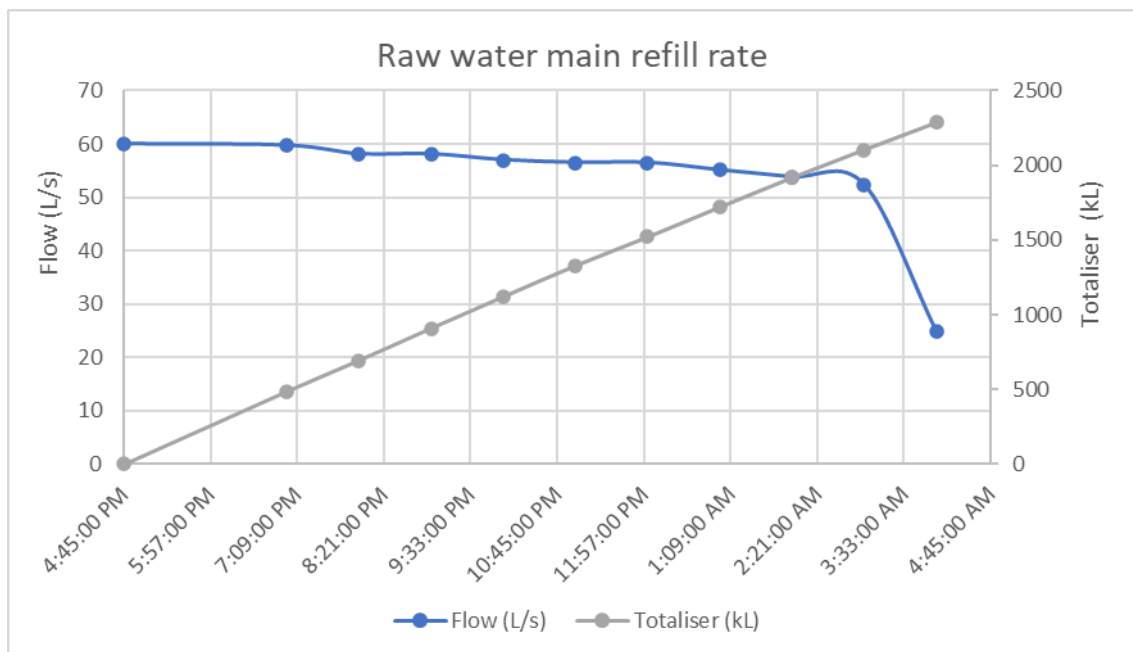
Refilling of the main began at 4:30pm and continued until 4am the next morning. We monitored the progress of the refilling by checking the flow meter totaliser and the pressure in the raw water main hourly. The chart below shows the data collected during the refill. The steep decline in flow at the end is due to the rapid rise in elevation at the intake tower. Upon completion of the raw water main refill, the WTP was deisolated and restarted. The project was a great success and we finished a few hours ahead of schedule.

Figure 10 Chart showing raw water main refill rate
