THERESA CREEK DAM; “DAM SAFETY AND MANAGEMENT PLAN”

Tahir Khan, Technical Officer Dams, *Isaac Regional Council, Qld*

Stephen Wagener, Manager Operation & Maintenance, Water and Wastewater, *Isaac Regional Council, Qld*

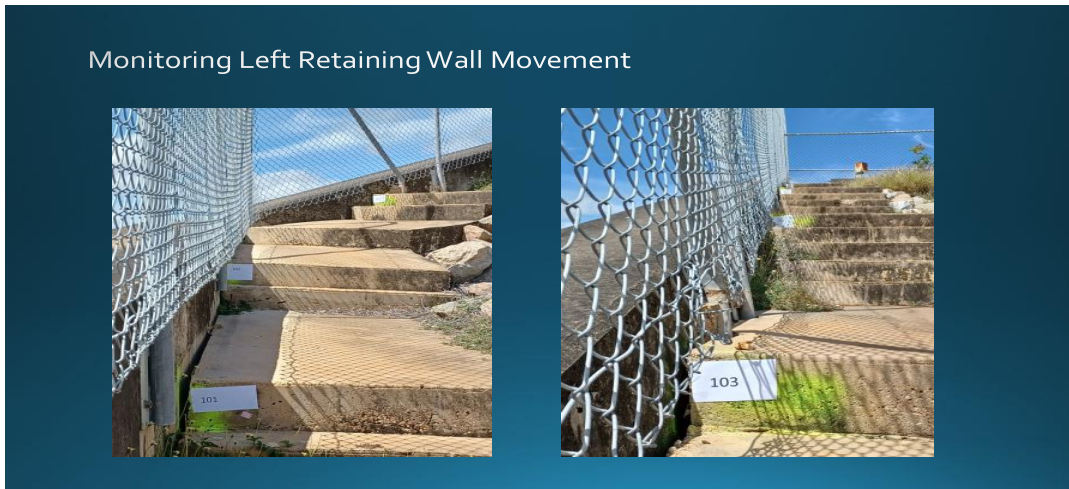
In the last Comprehensive Inspection report (2022), the consulting engineers showed their concerns about the variable gap between the left retaining wall and the staircase on the left embankment of the Theresa Creek dam. The consulting engineer was concerned about possible movement of the structure over time, which could lead to dam failure. Similarly, significant cracks in the dam apron on both sides of the spillway were identified which could also trigger structural instability and subsequent dam failure. In response to these findings, a comprehensive dam safety plan for Theresa Creek Dam was developed which include twice a week dam inspection, seepage data collection, monthly measurement of cracks identified in the dam apron and measuring variable gap between the retaining wall and staircase. Similarly downstream erosion data is also collected after major flood incident in the area. Besides this Theresa Creek Dam has an active ‘Emergency Action Plan’ (EAP) and “Standard Operating Procedures”.

Figure 1 shows gap between dam retaining wall and staircase. The data presented in Graph 1 does not show any significant movement of the structure over the period that data has been collected. However, such data is more conclusive when collected for a longer duration. This graph 1 shows data collected for little over one year. Potential ground movement is most likely to occur in the wet season, when the water level in the dam changes significantly on a regular basis due to rain and floods, resulting in an increased and variable hydraulic pressure. This creates enormous stress on the dam structure; therefore, it is necessary to collect data over a longer period before making any conclusive predictions about any possible movement of the retaining wall. The data collection is ongoing. However, last summer was comparatively dry with only one incidents of spillway overflow in December 2023 without raising any alert as per EAP.

Figure 1: Gap between the Dam Left Retaining Wall and Staircase of Left Embankment

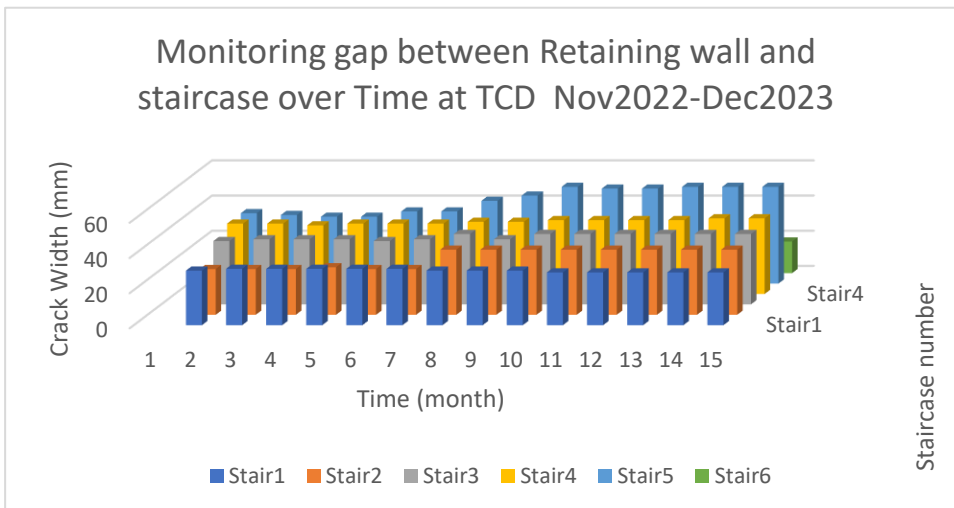
Graph 1: Monitoring gap between Dam Retaining Wall and Staircase of Left Embankment.

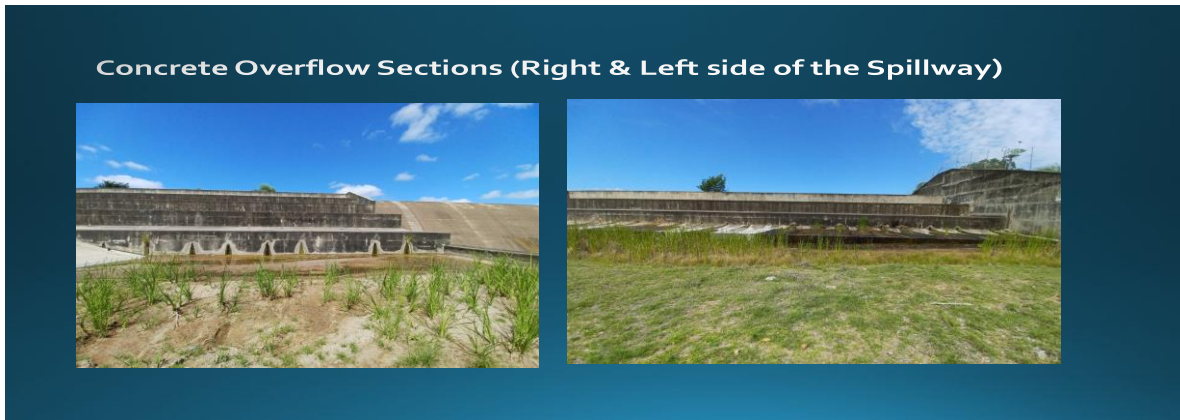
In the Concrete Terraces sections, on both the left and right sides of the dam spillway (Figure 2), pressure relief drains are built into the structure through which water is constantly seeping out in various locations. To measure the seepage volume, V-Notch Weirs have been installed below the Concrete Terrace Sections on both the left and right sides of the dam spillway. Graph 2 A & B shows the pattern of water seepage from these concrete terrace sections recorded that is being measured at both V Notch Weirs.

Figure 2 Concrete Overflow Sections of Theresa Creek Dam (TCD)

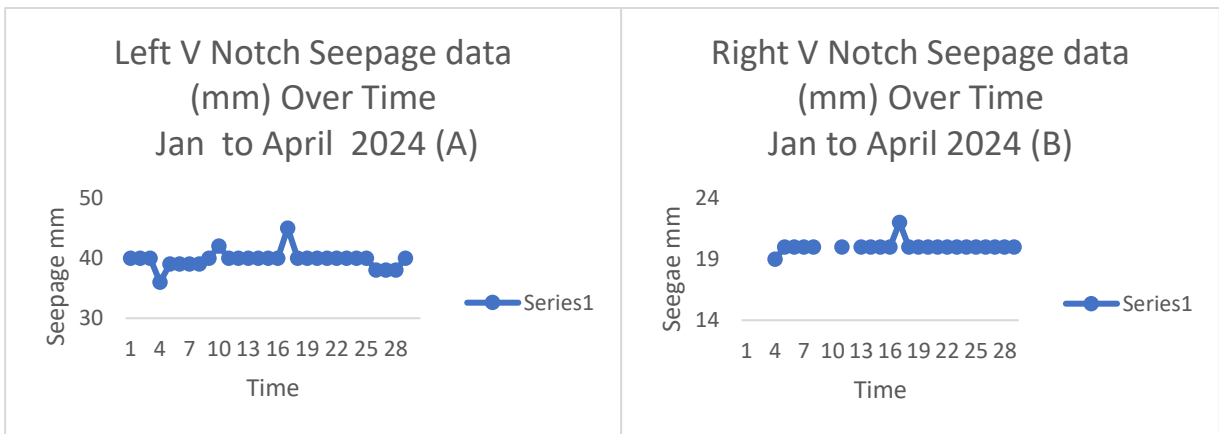
The data (Graph 2 A&B) for both V-Notch Weirs show a constant pattern with a few spikes and missing data points in the right V-Notch Weir. The constant pattern of seepage volume indicates that there is no potential variation of hydraulic pressure in these sections and a constant flow rate of seepage through these pressure relief drains is maintained. This is very reassuring in terms of dam safety. A change in seepage volume will indicate variable hydraulic pressure and changing stress on the Concrete Terrace sections of the dam. The spikes in the graph show an extra volume of water passing through V-notch weirs after rain or flood events, which is added surface inflow from adjacent areas. The missing data on the right V-Notch Weir shows the inaccessibility of staff to the right side of the spillway after flooding, particularly when the area downstream of the dam is inundated with water.

Graph 2: V-Notch Seepage data over time (mm) Left side (A) and Right Side (B) of the dam spillway of Theresa Creek Dam.

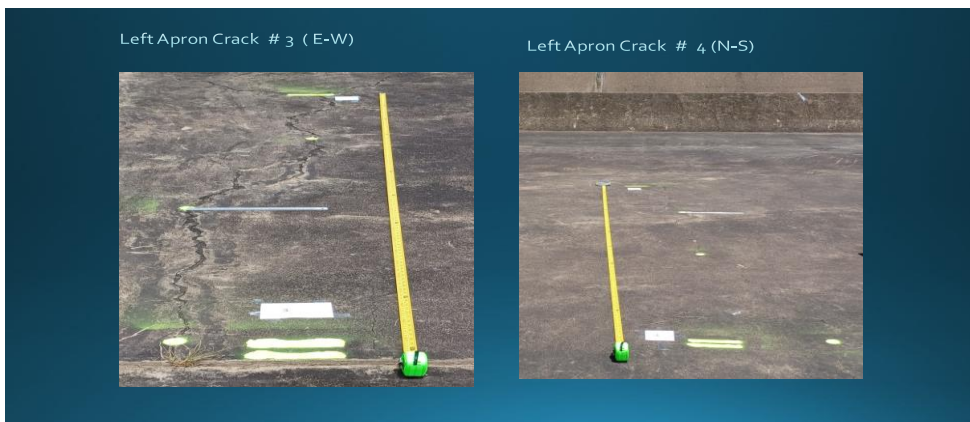
Downstream Monolith 13 to 15 seven (7) visible cracks in the apron slabs were selected. For uniformity of results 300 centimeters length of the crack was selected and crack width was measured at 100 centimeters, 200 centimeters and 300 centimeters. The width of these cracks at same locations are measured monthly to note any differences. Results of one of such cracks #4 is presented below in Graph 3.

Figure 3: Monthly Cracks width measurement of Apron Slab Cracks at TCD

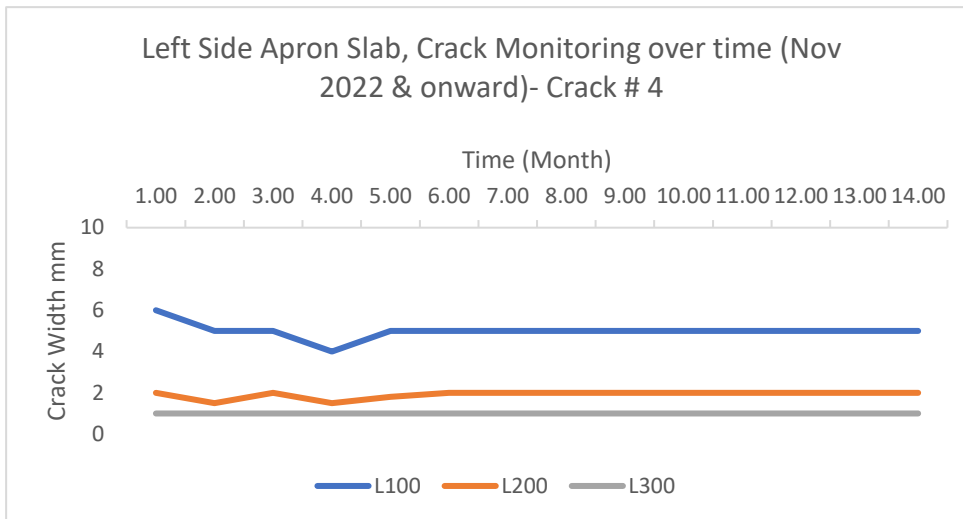
Graph 3: Apron Slab Crack monitoring over time at TCD

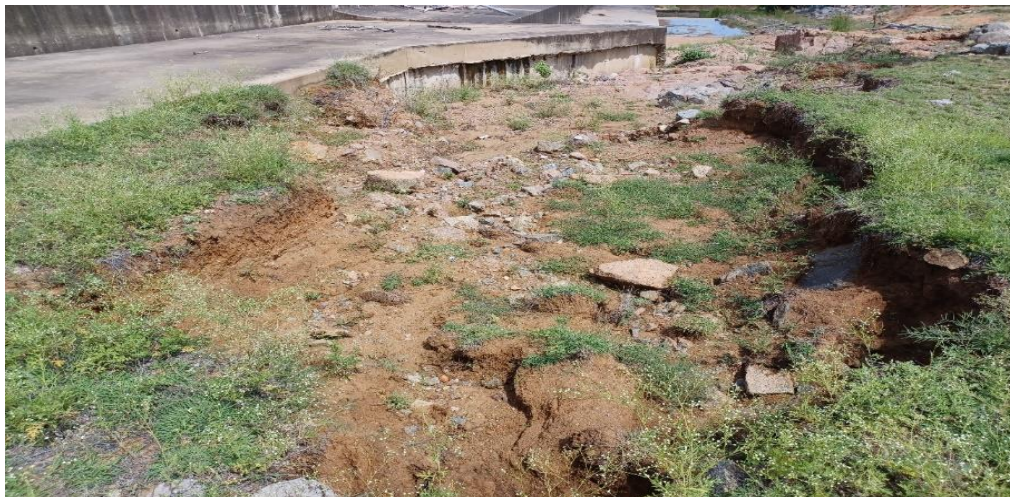
Downstream of the right Concrete Terrace section of the dam, there is significant water erosion which occurred in a flood event during February 2021 (Figure 4). The water inflows from adjacent hills and paddocks during heavy rains and it is believed to have exacerbated this erosion. A rehabilitation project is being scoped and is waiting for budget allocation. There is no immediate risk to the dam structure, currently, but a monitoring program has been placed to study the gully development after storms or flood events in the area. The data (Graph 4 A&B) shows that at the top of the gully (W1), the depth of the gully increases with successive storms, whereas towards the end of the gully (W3) the depth is decreasing. The increase in depth at the top of the gully signifies the soil erosion due to water dissipating energy at location W1, whereas the reduction in depth at location 3 suggests the transportation and deposition of debris. However, the width of the gully keeps increasing under the hydraulic forces, especially at W3 (Figure 4 B).

Figure 4 Gully area below the right concrete terrace of the dam being monitored.

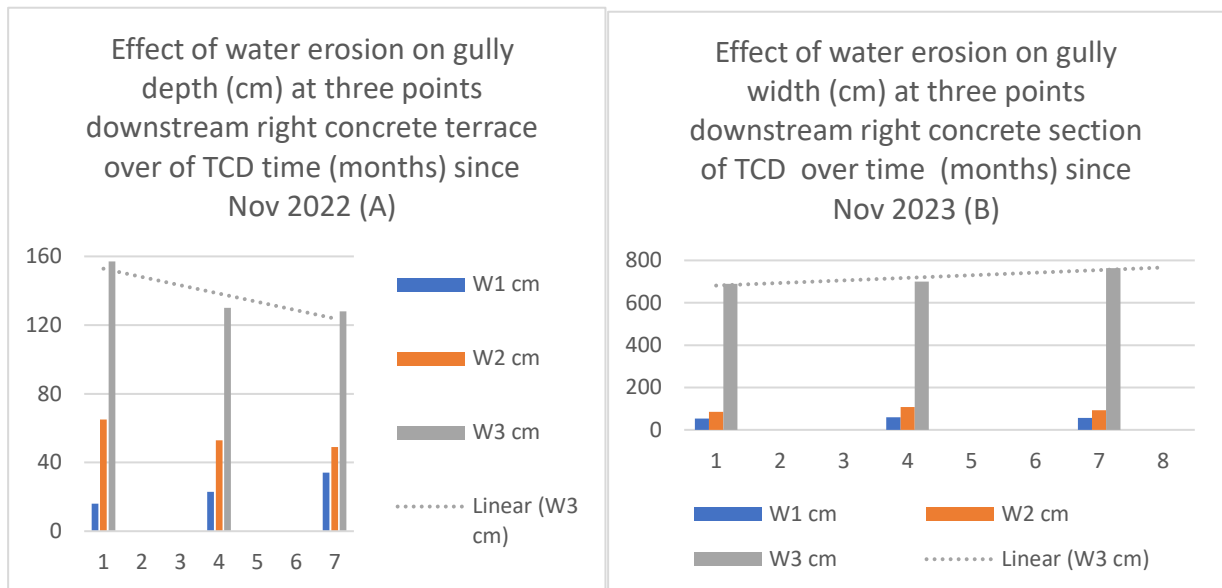
Graph 4: Data showing effect of water erosion on Gully width (A) and gully depth (B) the Right Concrete Terrace of TCD
