BYPASSING A CRITICAL SEWER PUMP STATION FOR MAJOR UPGRADES: CHALLENGES AND LEARNINGS

Curtis Biggs, *Operations Maintenance Officer*, North East Water

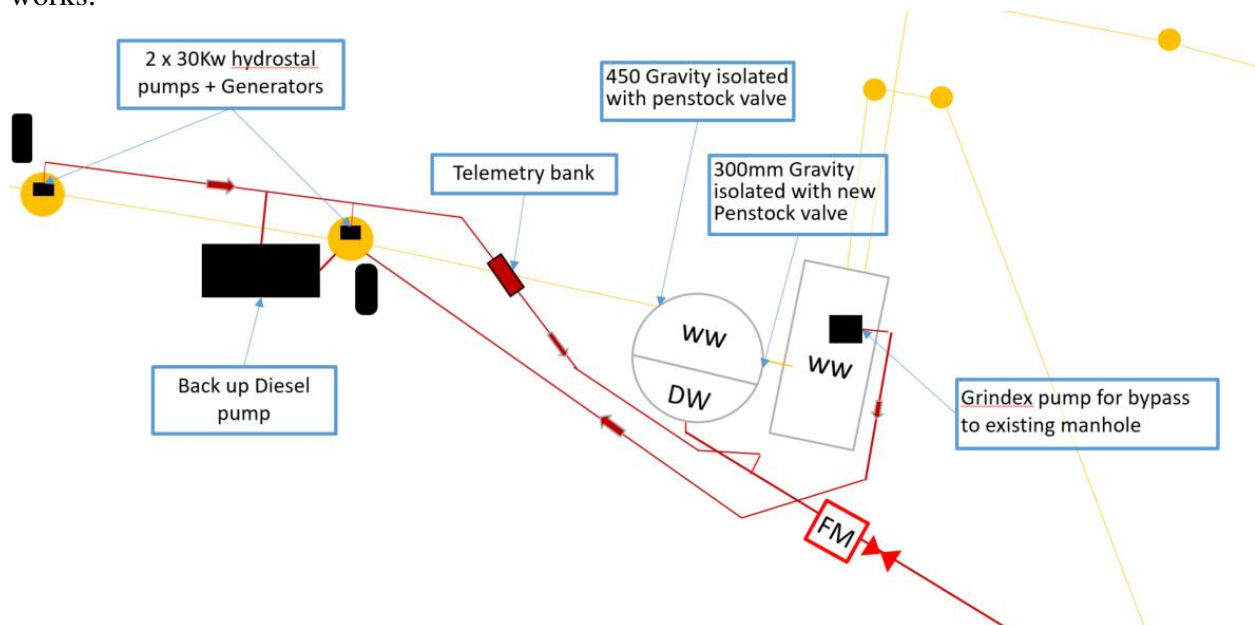
Figure 2: Overview of bypass setup

The bypass system consisted of three primary electric pumps located in different parts of the reticulation system. A backup diesel pump was situated in the main inflow point on the 450mm main in case of failure of the electric pumps. The system used two 30kW Hydrostal submersible pumps in individual standard manholes on the 450mm gravity main. A Grindex Sandy 5.6kW submersible pump was placed in the internal well, which pumped around the station into the primary catchment side and discharged through the Hydrostal's. Fortunately, a 150mm bypass point was already installed into the 300mm discharge rising main that had previously been utilised for a high-level backup pump from previous years. The system included a full telemetry dashboard, which provided alarms and up-to-date monitoring of flows, pressures and levels. The bypass telemetry provided an almost exact replication of North East Water's telemetry system and provided a significant level of comfort with the capability and reliability of the system. Due to the complexity of the bypass system, NPE was engaged to man the bypass for the duration of the works.
