Iron and Manganese Issues in the Mundubbera Water Supply

By Tim Merrett, Water and Wastewater Treatment Operator, North Burnett Regional Council

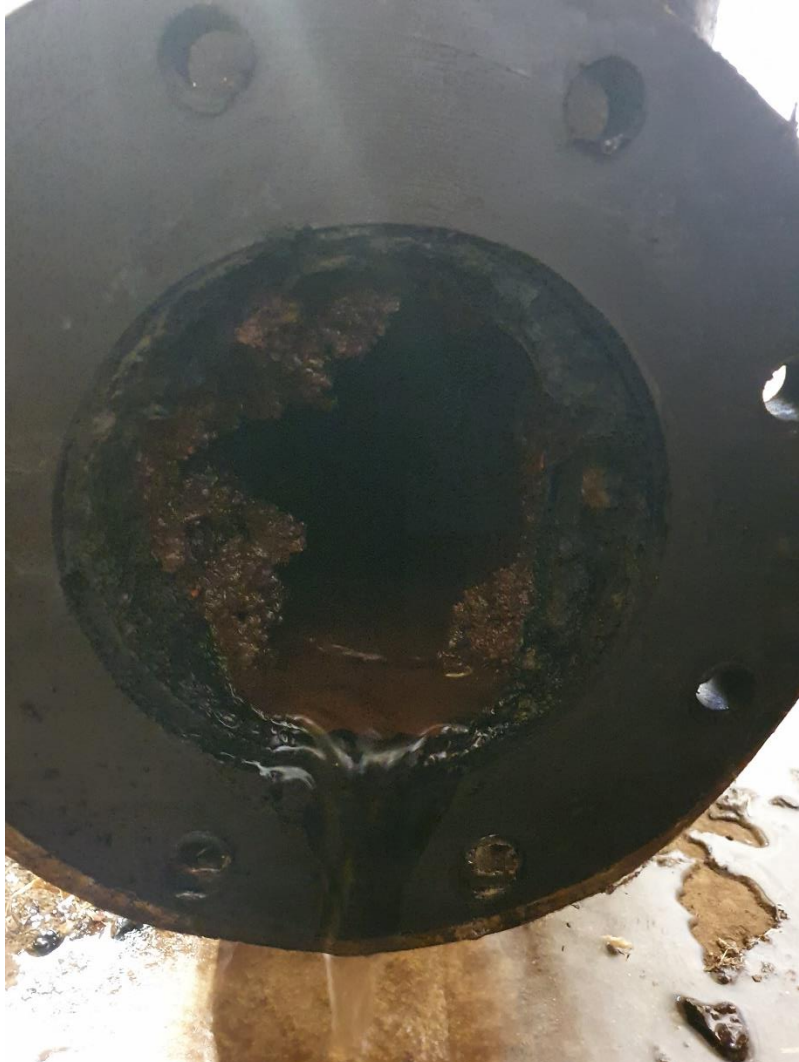
The elevated reservoir was constructed in 1967. The vertical 150mm dia. CIGL inlet/outlet main and a short horizontal section through the base of the structure are original pipework. The reticulation network up to the base of the elevated storage has been upgraded. The network issues indicated a restriction in this pipework. An elbow was removed at the base of the elevated storage and significant iron and manganese scaling was found internally.

Options considered included replacing the pipe, constructing a new outlet line, or trying to descale the existing pipe.

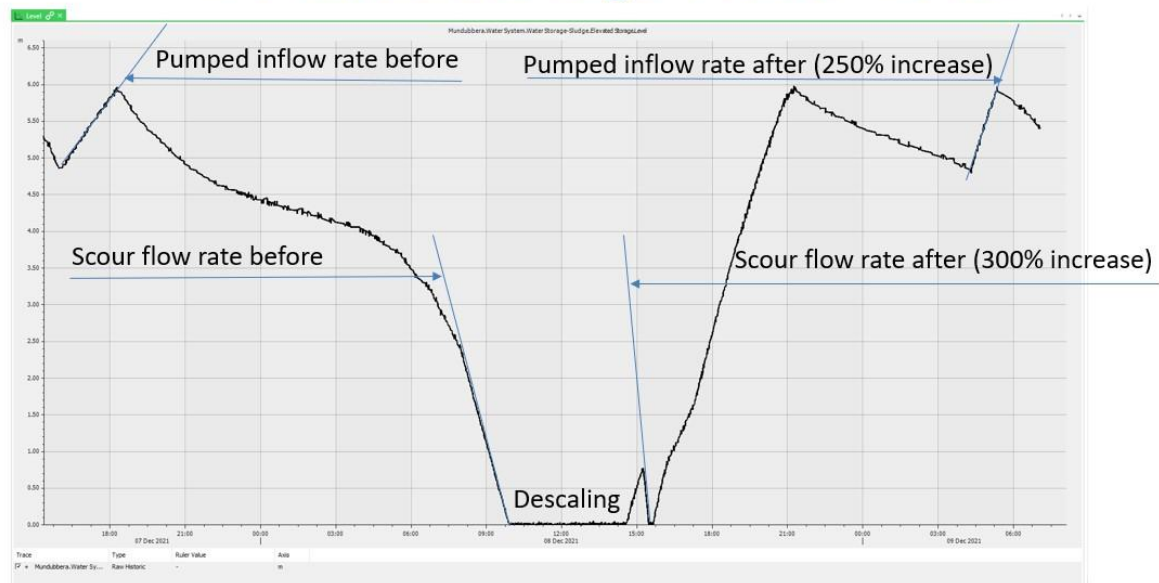
Elevated Storage Water Level

The reservoir was partially filled and flushed before being returned to service. The following SCADA plot of the storage levels indicates the system performance improvements achieved by the descaling work.

Pumped inflow rate showed a 250% improvement, while the gravity outflow rate improved by 300%.
