Iron and Manganese Issues in the Mundubbera Water Supply

By Tim Merrett, Water and Wastewater Treatment Operator, North Burnett Regional Council

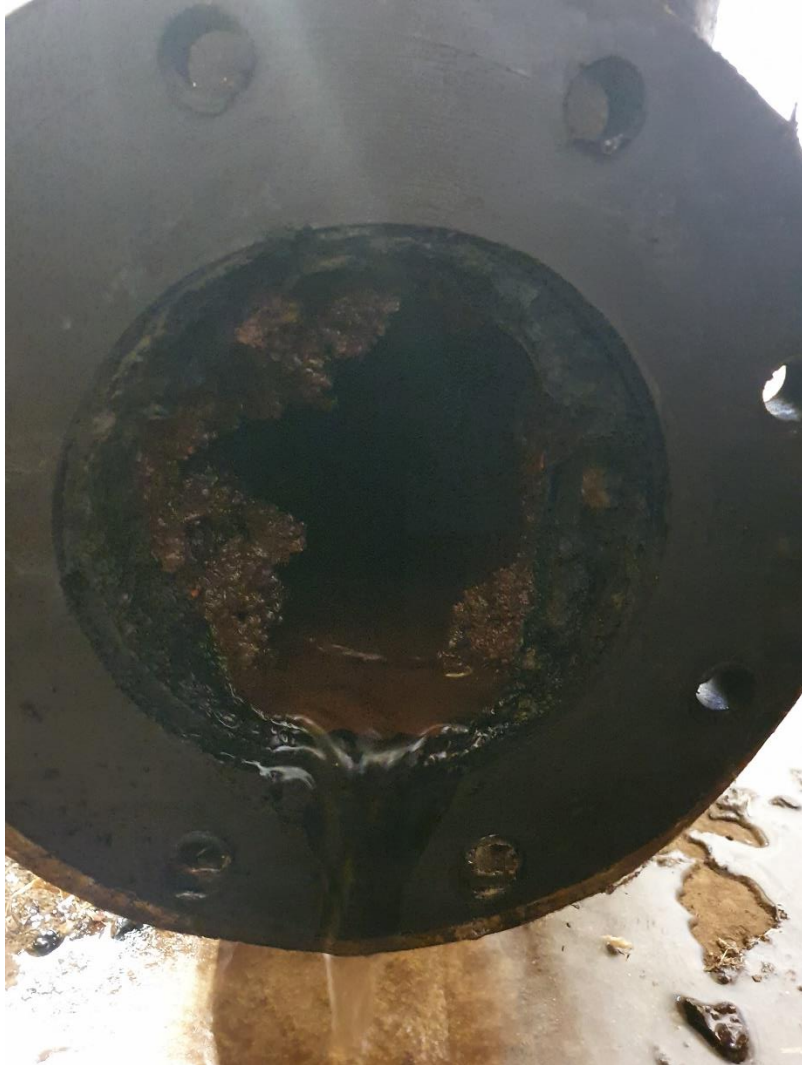
The elevated reservoir was constructed in 1967. The vertical 150mm dia. CIGL inlet/outlet main and a short horizontal section through the base of the structure are original pipework. The reticulation network up to the base of the elevated storage has been upgraded. The network issues indicated a restriction in this pipework. An elbow was removed at the base of the elevated storage and significant iron and manganese scaling was found internally.

Options considered included replacing the pipe, constructing a new outlet line, or trying to descale the existing pipe.

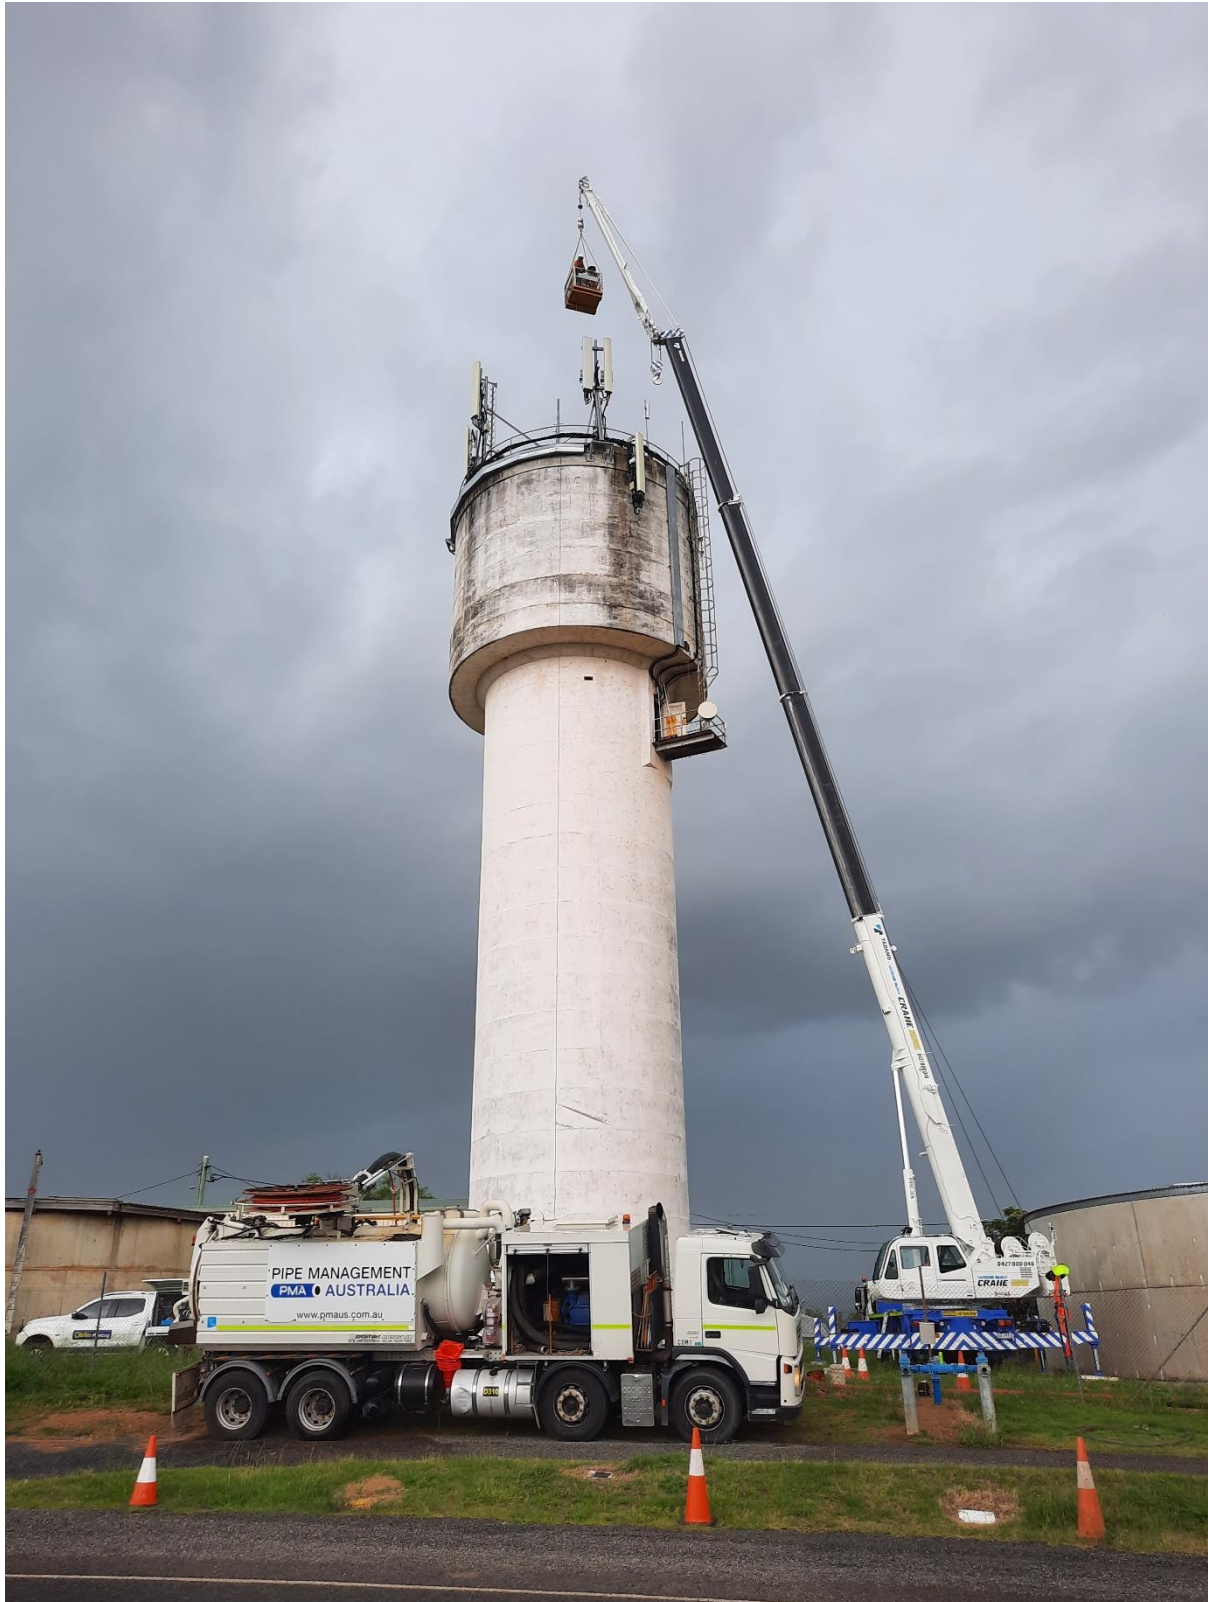
The vertical section of pipework was next to be descaled. The descaling tool needed to be launched from inside the elevated reservoir. This required crews, equipment and vacuum hoses to be craned the 30m vertical distance to undertake the work. Safety issues that needed to be considered included working at heights, confined space entry and working in the vicinity of telecommunications equipment.

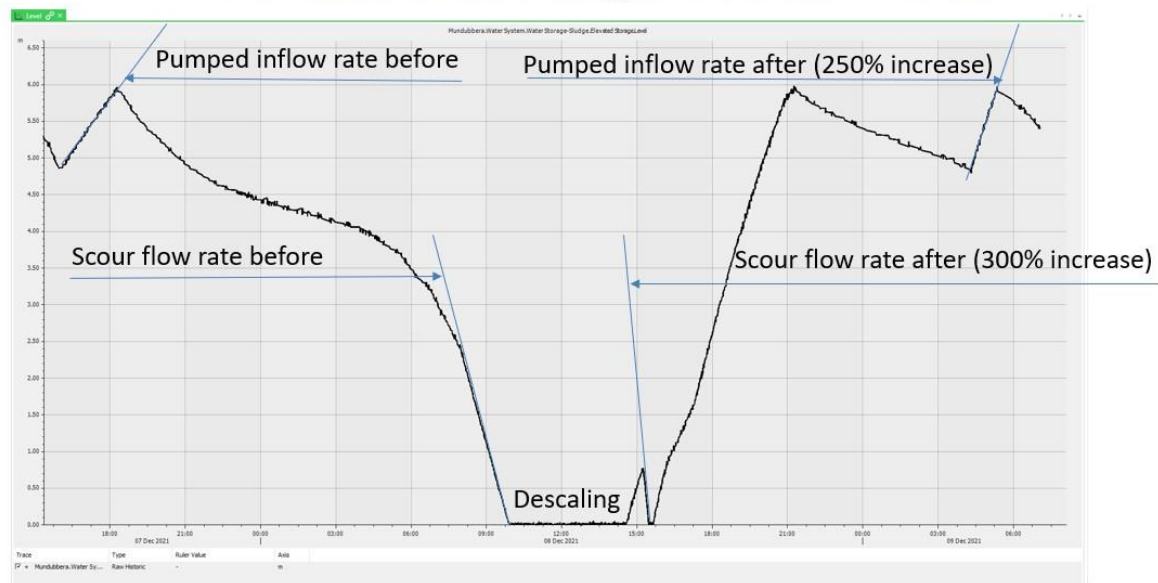
Elevated Storage Water Level

The reservoir was partially filled and flushed before being returned to service. The following SCADA plot of the storage levels indicates the system performance improvements achieved by the descaling work.

Pumped inflow rate showed a 250% improvement, while the gravity outflow rate improved by 300%.
