# WINNEKE FILTERS

## THE ROAD TO BETTER BACKWASH

**John deBoer**, *Operations Specialist, Water Supply, Melbourne Water*

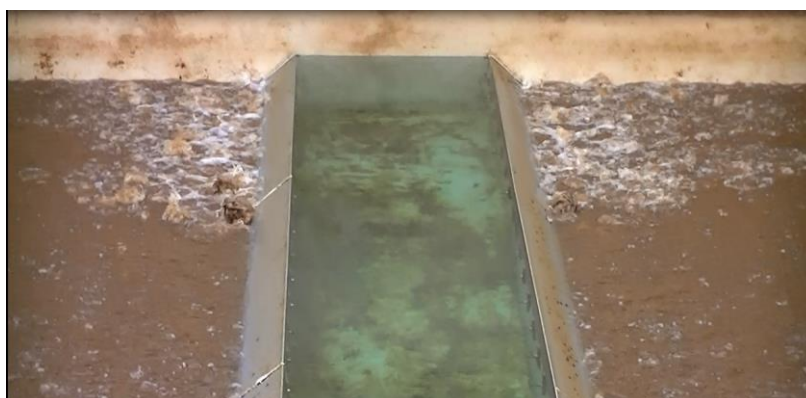
At the completion of the backwash air scour phase a significant volume of air remained trapped within the filter plenum space. Originally, washwater was introduced by two backwash pumps, starting up within 20 seconds of each other, reaching a combined flow rate of 900L/s within less than one minute.

This resulted in the volume of trapped air being forced through the filter media at a rate much higher than that normally delivered during a typical backwash. The high volume air flow resulted in the disruption of supporting gravels and excessive localised boiling leading to media carryover into the backwash launder throughout the washwater cycle.

**Figure 3:** *Boiling occurring due to rapid onset of the washwater pumps*

Previously, air relief valves relieved excess pressure in the air manifold whilst the filter air inlet valves remained shut. The PLC program was modified to hold the air inlet valves open during the air relief process allowing the trapped air within the filters to equilibrate to atmospheric pressure before washwater is introduced. This then reduced the amount of pressurised air being pushed through the filter during the washwater process therefore reducing the amount of disturbance to the media and subsequent media loss. This change alone has resulted in significant reduction in sand carryover and its impact on downstream recovery systems.

The second PLC change involved optimisation of the existing backwash pump VSDs to progressively ramp up the introduction of washwater thus squeezing the trapped air out through the filter nozzles without over pressurising it. This simple change significantly reduced the boiling effect and subsequent disruption of the support gravels and media loss.

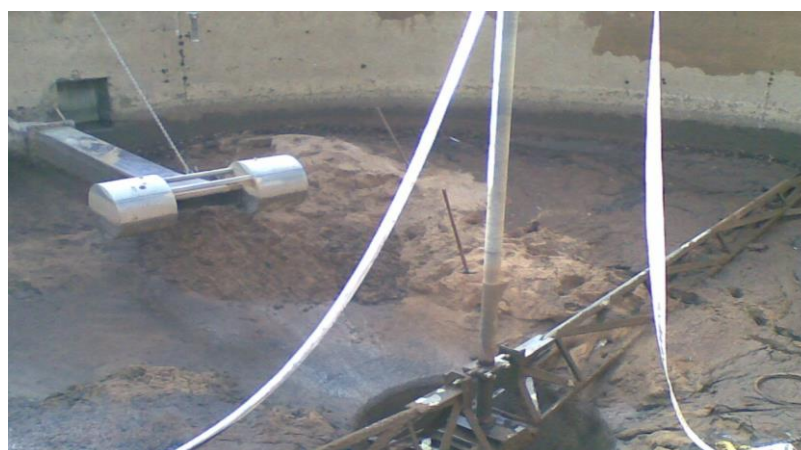
The excessive boiling and disruption of supporting gravels had two major impacts; Sand media carried over into the backwash launder was deposited in downstream systems such as the washwater recovery tanks, sludge thickeners and centrifuge feed systems. This led to blockages in desludge pipework and accelerated wear on the sludge thickener and centrifuge feed pumps.

**Figure 4:** *Sand build up in washwater recovery tank 1*

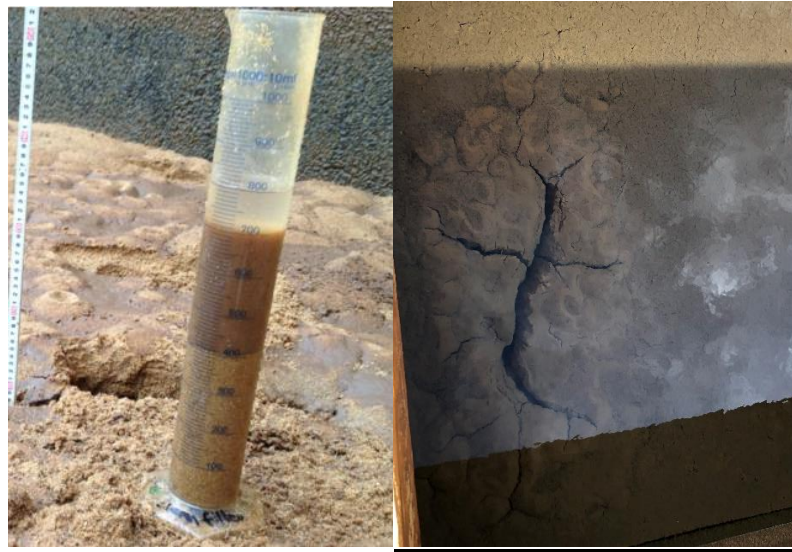
The disruption of supporting gravels also resulted in sand media washing through, and often blocking, filter nozzles with media being deposited in the filter lateral pipes and filtered water plenum space. This further exacerbated the ineffectiveness of the backwash cycle leading to localised areas of extreme mud deposits throughout the depth of the media. Subsequent filter inspections revealed that the solids retained within these areas after a backwash were often in the range of 30-50% which is far in excess of the recommended value of 5-10% solids retention. This

level of mud layering throughout the depth of the media also resulted in significant surface cracking increasing the risk of short circuiting and potential for pathogen breakthrough.

**Figure 5:** *Solids retention test & media surface cracking*

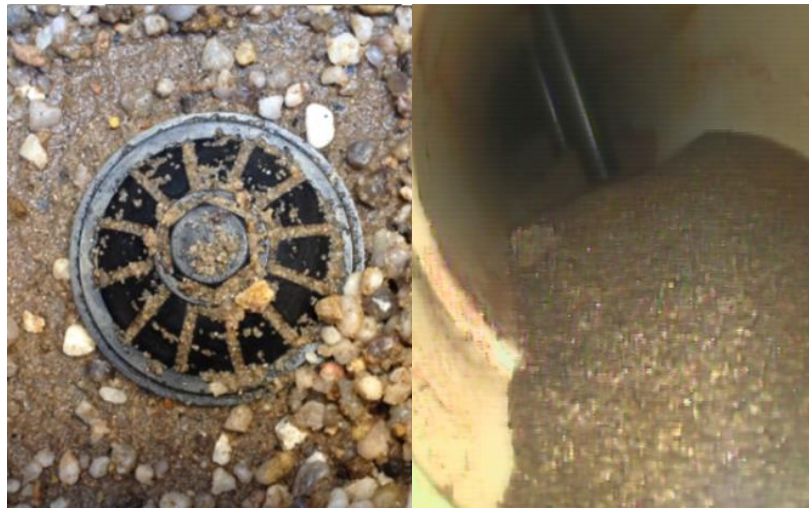
**Figure 6:** *Blocked filter nozzle and sand build up in lateral pipework*

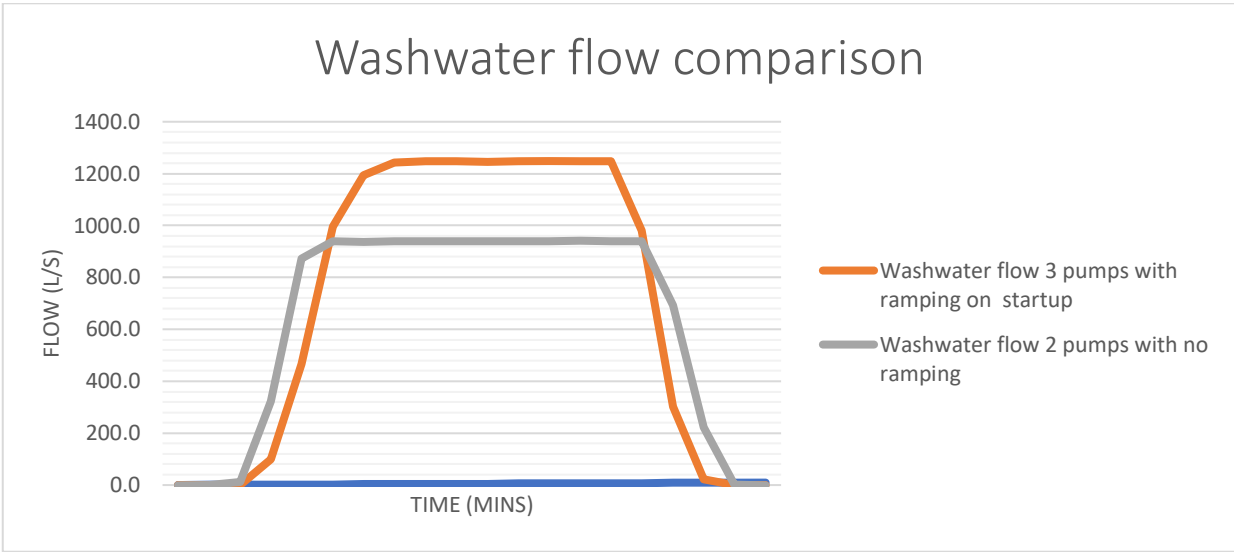
The original washwater phase of the backwash cycle consisted of three backwash pumps operating in a Duty/Assist/Standby mode, providing 900 L/s of washwater flow. This equates to a rise rate of around 22m<sup>3</sup>/m<sup>2</sup>/hr which is far lower than the typical minimum of 37m<sup>3</sup>/m<sup>2</sup>/h recommended

for rapid sand filters. Whilst bed fluidisation in excess of 90% was being achieved, bed expansion was typically around 7-9% which is much lower than the 20-30% expansion required for effective removal of suspended particles and enabling reclassification of the sand and gravel layers.

**Figure 7:** Backwash flow data comparing 2 pumps @ 900 L/s with 3 pumps @ 1200 L/s

This situation was marginally improved by modifying the backwash program to operate all three pumps in a Duty/Duty/Assist configuration. The result of this was an increase in washwater flows from 900 to 1200L/s increasing the rise rate from 22 m<sup>3</sup>/m<sup>2</sup>/h to up to 30m<sup>3</sup>/m<sup>2</sup>/h.

Whilst this still falls short of the desired 37 m<sup>3</sup>/m<sup>2</sup>/h, This was the maximum flow achievable given the hydraulic constraints of the existing backwash pumps, concrete ducts and associated valves and pipework.

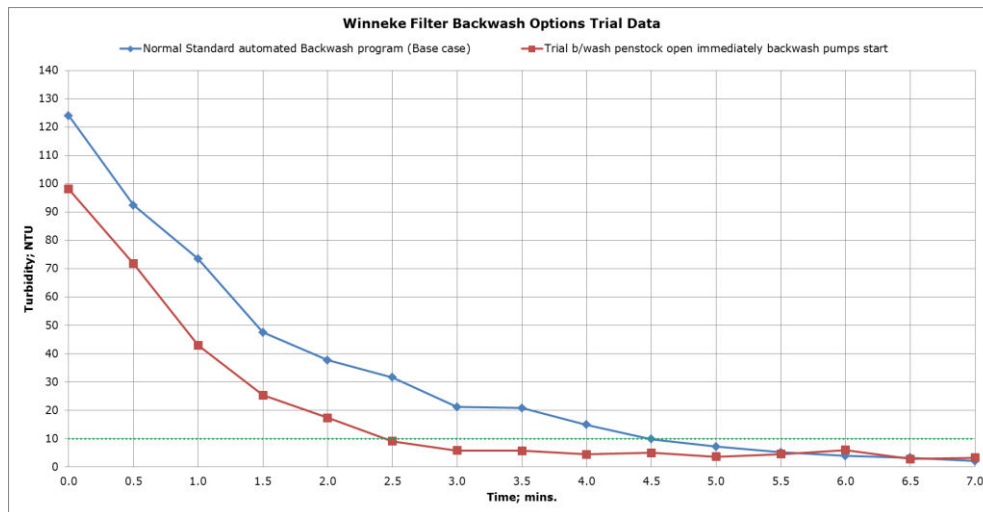
During the previous filter backwash program the opening of the backwash outlet penstock was delayed to allow the incoming washwater to fill the filter to approximately 300mm above the backwash launder before the penstock begins to open. This practice was thought to have been introduced in an attempt to prevent filter media from washing over the launder. The actual effect of this deferred opening delays the wash over of turbid backwash water into the launder and allows suspended solids to settle back onto the media surface resulting in poor turbidity profiles and extended backwash times. It is much more efficient to allow the washwater to enter an empty launder as soon as it is introduced to the filter.

**Figure 8:** *Turbidity profile data comparing delayed opening of the backwash penstock with immediate opening on start up of the washwater phase.*

In order to rectify this issue the backwash PLC program was amended to ensure the backwash outlet penstock opened immediately upon start-up of the backwash pumps. This resulted in a significant reduction in the washwater time required to reach a nominal 10 NTU, of up to two minutes. An opportunity was therefore presented to reduce the washwater phase from six minutes down to four minutes equating to a potential reduction in washwater volumes of up to 30%.
