THE LOOMBAH PROJECT

Grant Waite, *Manager Tactical Operations Ovens & King Systems*, North East Water

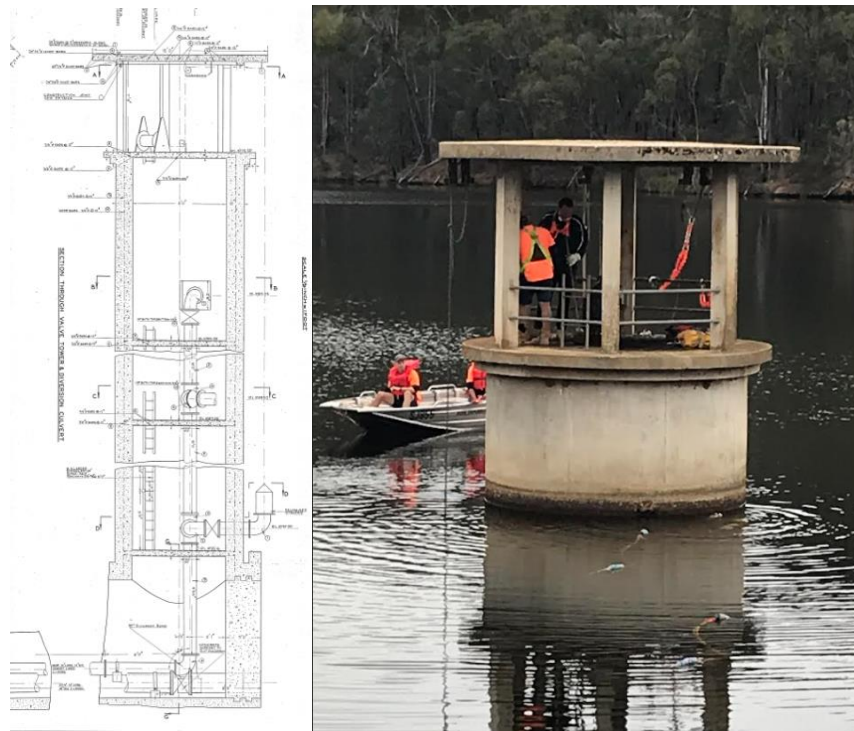
Figure 1: *The construction drawings of the Loombah offtake tower – circa 1940, and the standing platform of the tower.*

The top two offtakes were used as required depending on where the water levels were at the time. The bottom one was never used principally because it was generally never required but also because of the water quality issues. The screens over each of the top two offtakes required considerable ongoing maintenance due to ongoing operational issues. These issues were due to the retrieval mechanism being manual lifting chains to hoist up

the screens which were aged and deteriorated as well as weed and rust barnacles on occasions clogging the screens. In addition to the ongoing maintenance required the water quality issues of increased levels of Iron (Fe) and Manganese (Mn) were a constant challenge and resource drain for the operators.

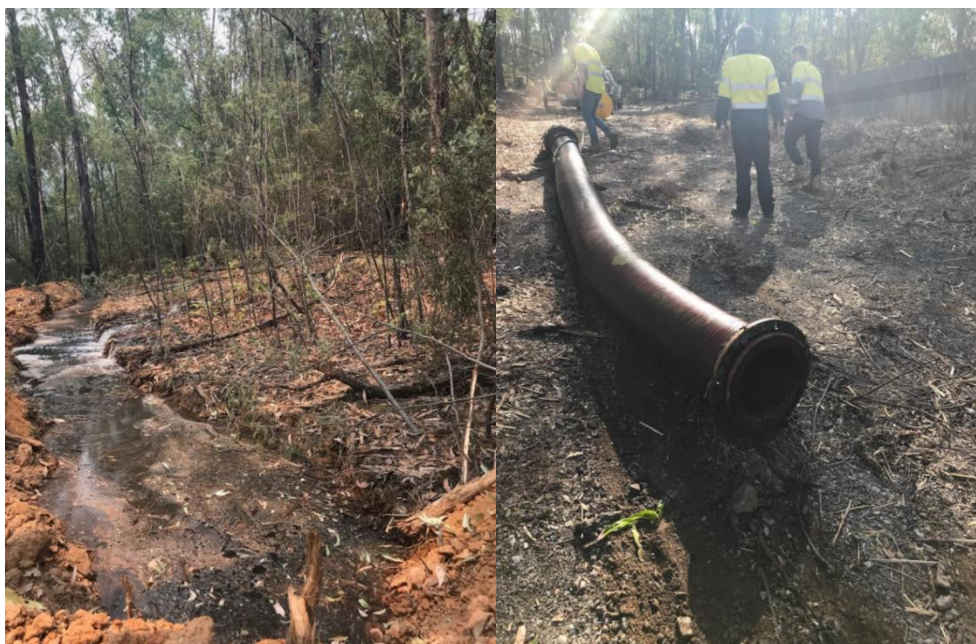
After removing the silt, a flexible offtake was discovered. The divers made an assessment that although degraded due to age it would be salvageable with some engineering work and a decision was made to salvage it. Salvaging it involved removing the old flexible offtake from the flange.

After some weeks the dive team successfully salvaged the 450-diameter offtake. It was assessed that the mechanical joint was fit for purpose and able to serve as the connection for the new offtake structure.

Figure 3: *The silt terrace and the discovered flexible offtake.*

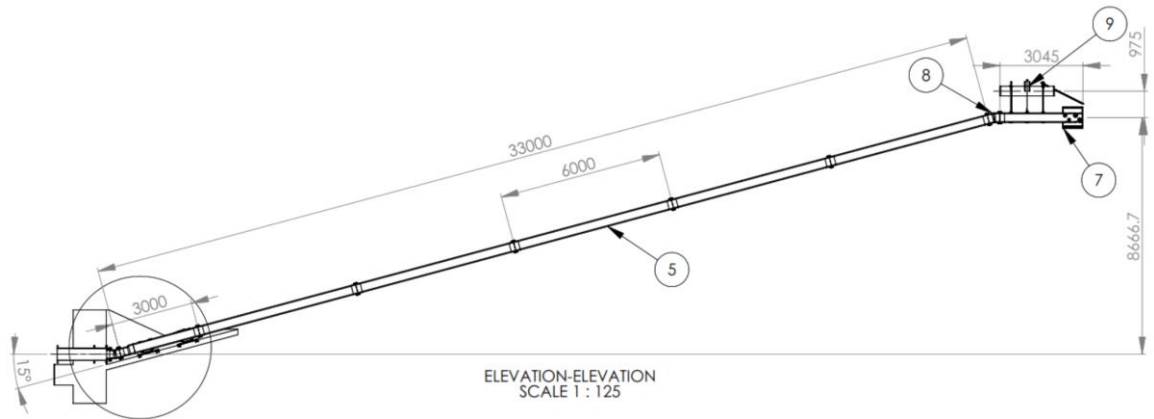
Figure 4: *Newly designed flexible offtake.*

A design was finalised, the new structure fabricated, and the dive team came back to site over a 2 day period to install the new structure. All the same challenges faced during previous stages needed to be managed during the installation but with additional challenge of drilling into concrete to anchor the pipe structure. The installation and project was successfully completed in November 2020.
