# WINNEKE FILTERS

## THE ROAD TO BETTER BACKWASH

**John deBoer**, *Operations Specialist, Water Supply, Melbourne Water*

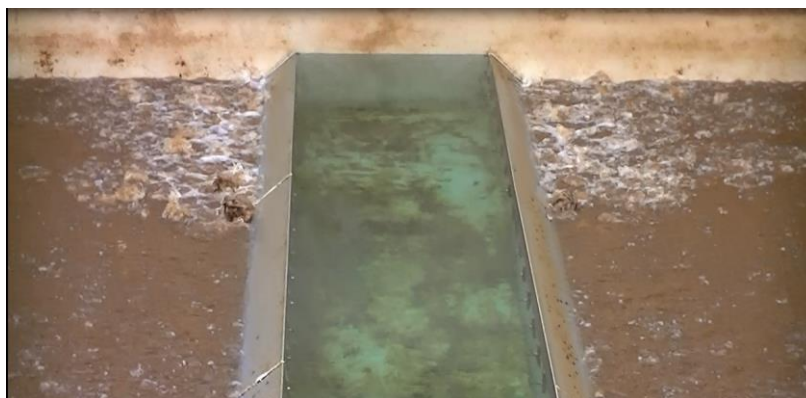
This resulted in the volume of trapped air being forced through the filter media at a rate much higher than that normally delivered during a typical backwash. The high volume air flow resulted in the disruption of supporting gravels and excessive localised boiling leading to media carryover into the backwash launder throughout the washwater cycle.

**Figure 3:** *Boiling occurring due to rapid onset of the washwater pumps*

The second PLC change involved optimisation of the existing backwash pump VSDs to progressively ramp up the introduction of washwater thus squeezing the trapped air out through the filter nozzles without over pressurising it. This simple change significantly reduced the boiling effect and subsequent disruption of the support gravels and media loss.

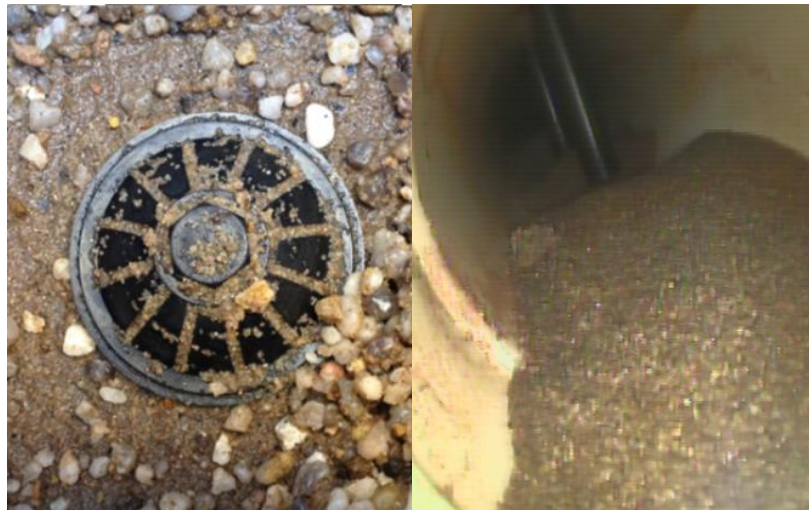
The disruption of supporting gravels also resulted in sand media washing through, and often blocking, filter nozzles with media being deposited in the filter lateral pipes and filtered water plenum space. This further exacerbated the ineffectiveness of the backwash cycle leading to localised areas of extreme mud deposits throughout the depth of the media. Subsequent filter inspections revealed that the solids retained within these areas after a backwash were often in the range of 30-50% which is far in excess of the recommended value of 5-10% solids retention. This

**Figure 6:** *Blocked filter nozzle and sand build up in lateral pipework*

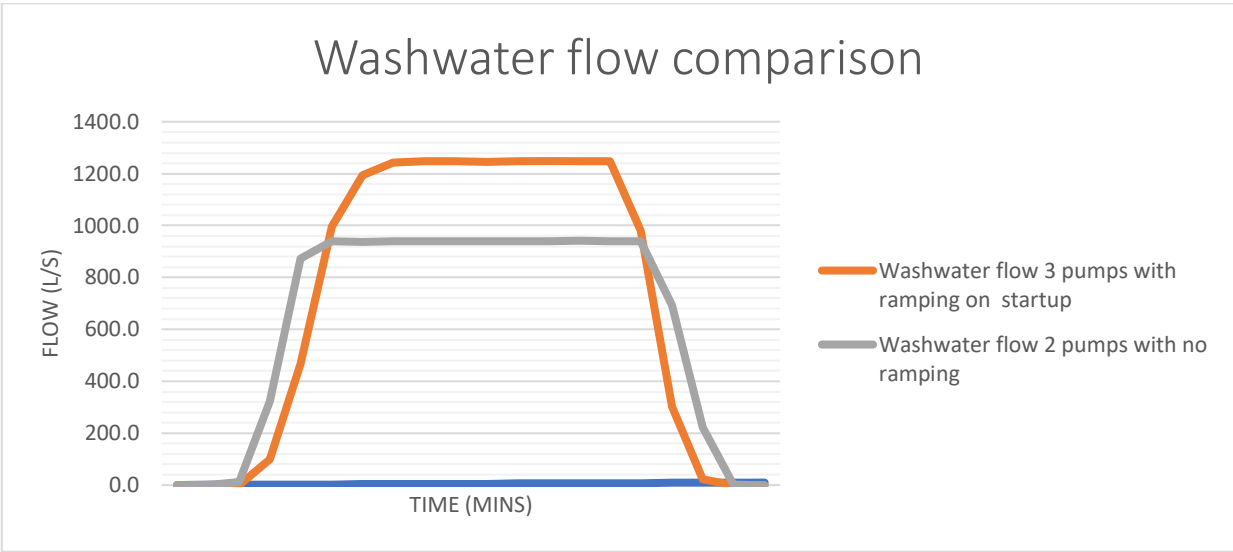
The original washwater phase of the backwash cycle consisted of three backwash pumps operating in a Duty/Assist/Standby mode, providing 900 L/s of washwater flow. This equates to a rise rate of around 22m<sup>3</sup>/m<sup>2</sup>/hr which is far lower than the typical minimum of 37m<sup>3</sup>/m<sup>2</sup>/h recommended

for rapid sand filters. Whilst bed fluidisation in excess of 90% was being achieved, bed expansion was typically around 7-9% which is much lower than the 20-30% expansion required for effective removal of suspended particles and enabling reclassification of the sand and gravel layers.

**Figure 7:** Backwash flow data comparing 2 pumps @ 900 L/s with 3 pumps @ 1200 L/s

This situation was marginally improved by modifying the backwash program to operate all three pumps in a Duty/Duty/Assist configuration. The result of this was an increase in washwater flows from 900 to 1200L/s increasing the rise rate from 22 m<sup>3</sup>/m<sup>2</sup>/h to up to 30m<sup>3</sup>/m<sup>2</sup>/h.

Whilst this still falls short of the desired 37 m<sup>3</sup>/m<sup>2</sup>/h, This was the maximum flow achievable given the hydraulic constraints of the existing backwash pumps, concrete ducts and associated valves and pipework.
