LANDERS SHUTE WTP RAW WATER MAIN DRAIN DOWN, REPAIR & REFILL

Alysha Di Martino, *Operations Process Engineer*, Seqwater
(Co-authors if any) **Chris Brown**, *Operator Supply*, Seqwater
ABSTRACT

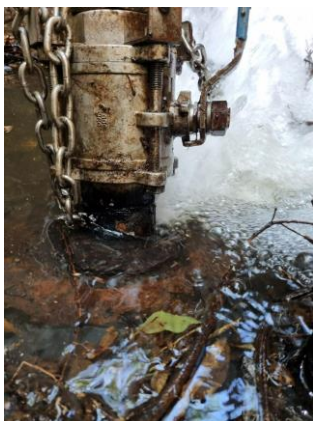
In April 2024 it was discovered that there was a leak on the pre lime connection point on the raw water main. When the leak was discovered, Seqwater engaged a contractor to assess the damage and to conduct repair work. The contractor was only able to complete a temporary repair and advised that the main would need to be de-pressurised to conduct a permanent repair.

Figure 1 Leak at injection point

After the main had been drained and the isolations were in place, the repair work began on the main. The section of the main was removed where the pipe had thinned and failed. A reinforcing pad was welded on which contained the injection point for pre lime. Refer to Figure 8 showing the repair work and Figure 9 showing the finished repair.

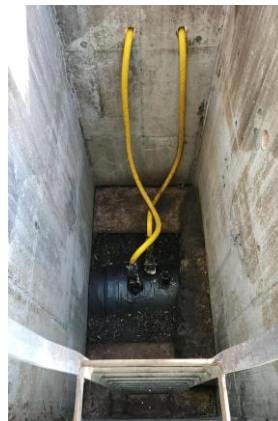
Figure 2 Pre lime dosing pit

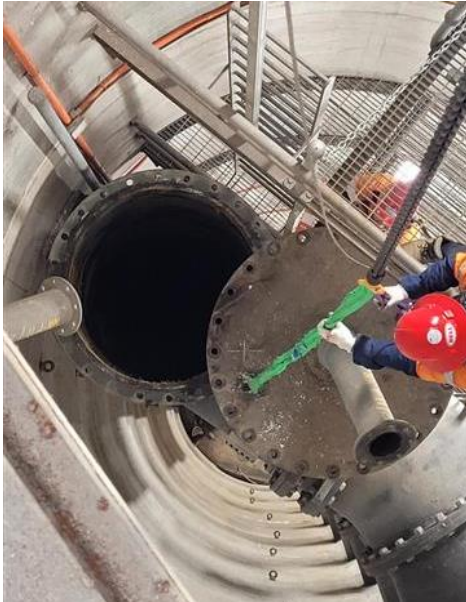
For the drain down of the raw water main, we identified a very high risk of a vacuum being created in the raw water main leading to pipe failure. This was due to inadequate venting. To control for this risk, we decided to remove a DN900 blanking plate at the intake tower. Scaffolding was set up at the intake tower prior to the day of the works to improve access, see Figure 5 below showing the blanking plate removal.

Figure 5 Blanking plate at intake tower

Installing a larger air valve at the intake tower would enable drain down at higher flows without having to remove the blanking plate. The larger air valve could be installed when the dam level is below the blanking plate level to minimise impact on the WTP.

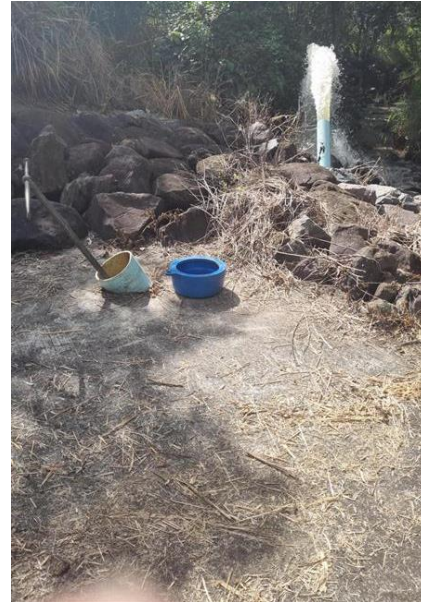
Figure 6 Raw water scour

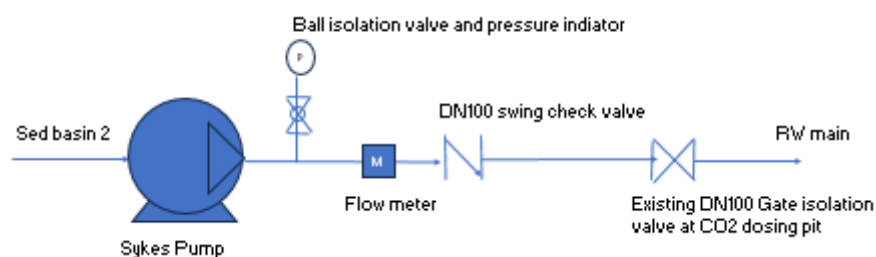
Figure 7 Sykes pump arrangement sketch

Seqwater sourced two Sykes pump (one as a backup) from other sites and had them transported to the WTP. We included an irrigation totaliser flow meter and a pressure indicator on the discharge line of the Sykes pump. The Sykes pump was connected to discharge into an existing DN100 tee in the CO2 dosing pit. Filling from the lowest point on the main allowed for the air to rise and be released through the vent at the intake tower. Figure 7 shows the Sykes pump arrangement.

Regarding the refill, there were extra pressure losses in lay flat hose used for the Sykes pump that were not considered which meant the pump flow rate was lower than expected. The losses could be minimised by using sections of rigid hosing at both the Sykes pump end and the connection point at the main.

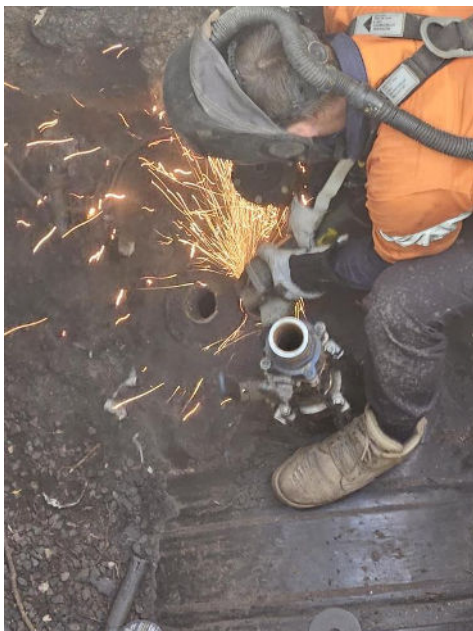
Figure 8 Works in the pre lime pit

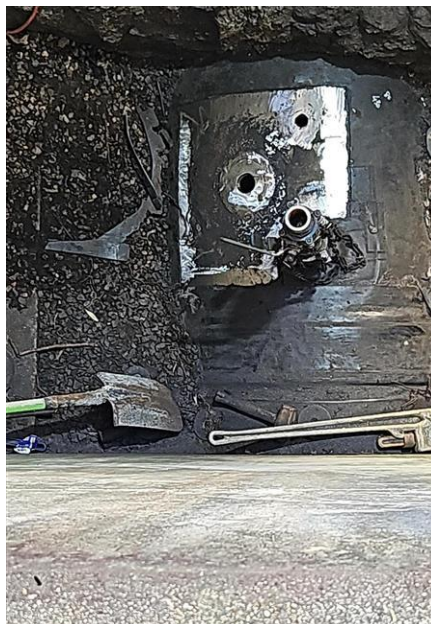
Figure 9 Complete repair work

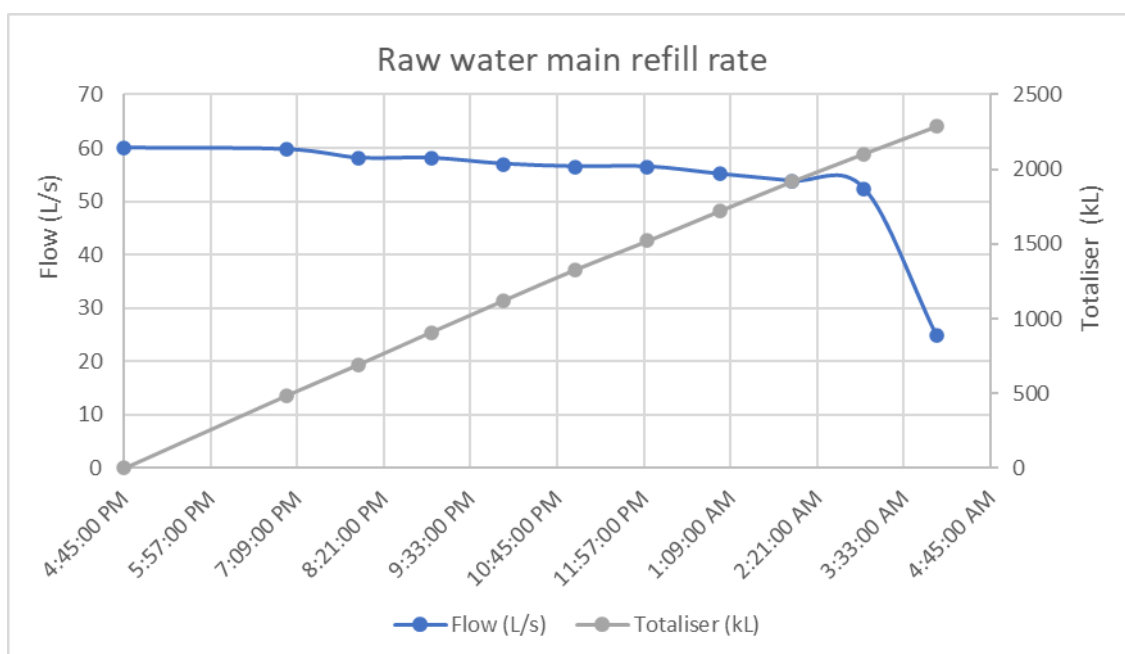
Refilling of the main began at 4:30pm and continued until 4am the next morning. We monitored the progress of the refilling by checking the flow meter totaliser and the pressure in the raw water main hourly. The chart below shows the data collected during the refill. The steep decline in flow at the end is due to the rapid rise in elevation at the intake tower. Upon completion of the raw water main refill, the WTP was deisolated and restarted. The project was a great success and we finished a few hours ahead of schedule.

Figure 10 Chart showing raw water main refill rate
