THE BIGGEST BANG: FIXING WATER HAMMER IN A DAF

ABSTRACT

APPENDIX A: DAMAGE CAUSED IN 2018 STROMLO WTP DAF WATER HAMMER INCIDENT

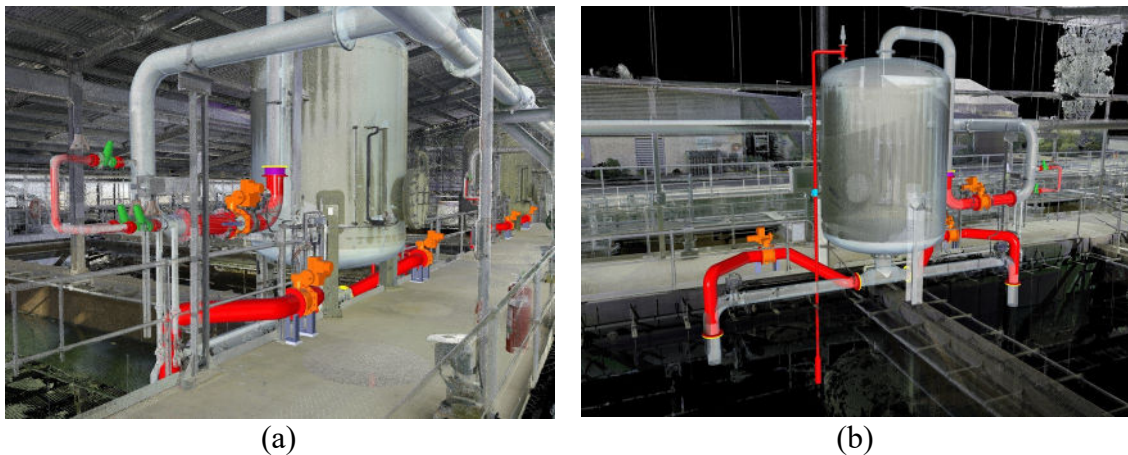
Figure 1: *Visual summaries of the system changes to the Saturation Vessels (a) to the Saturation Vessels, looking southwest; (b) to the Saturation Vessels, looking northeast.*

- *Full automation of system start-up and shutdown:* This eliminates the human error that caused the event. Dedicated pipework was also installed to depressurise the DAF Saturation Vessels when taking them offline or during power failure.

- *Pumping manifold improvements:* The single non-return valve in the DAF Recycle Pumping delivery pipe manifold was replaced, and a new pressure relief valve was installed on the discharge manifold of the DAF Recycle Pump system.

- *Improved water hammer transient protection:* Non-return valves were added to the water inlets of each DAF Saturation Vessel to prevent pressure transients from travelling into the DAF Recycle Pumping delivery main and back to the pump system.

- *Valve and actuator replacements:* The existing pneumatically actuated rubber-seated butterfly valves at the inlet and outlet of the Saturation Vessels were changed for electrically actuated, metal-seated double eccentric butterfly valves. The electric actuators have variable speed drives to initially open the valve more slowly from the closed position.

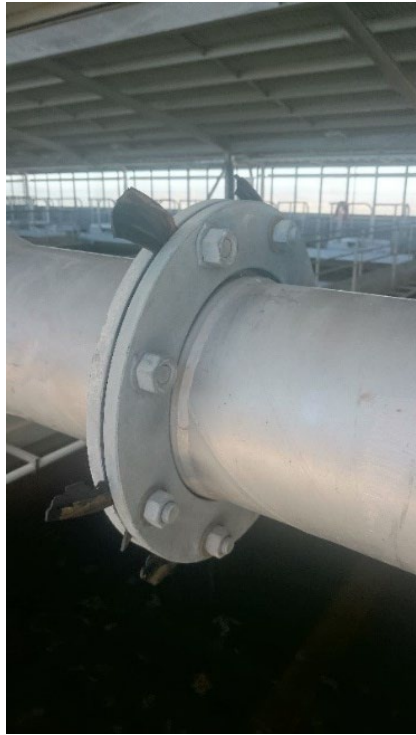
(a) Rubber gasket that was blown out between flanges in the DAF recycle water pipeline approximately 350 m from the DAF recycle water pumps; (b) Damage to pressure regulating valves and PN16-rated pipework for DAFF water spray lines—valve has yet to be recovered or located; (d) Damage to a separate pressure regulating valve and PN16-rated pipework on Saturation Vessel 4 for DAFF water spray lines—fragments found 250 m away; (d) Pressure regulating valve recovered from Saturation Vessel 4, cracks also extend to the base of the valve; (e) Cracking in the concrete plinth adjacent to a rising section of the DAF recycle water pipeline caused by its movement during the event; (f) Vertical movement of DN450 mm spiral stainless steel DAF recycle water pipeline support during the event, being temporarily supported with bricks; (g) Damage caused to the filter building cladding by movement of the DN450 mm DAF recycle water pipeline during the water hammer event; (g) Buckling of a grating caused by lateral movement in the DAF recycle water pipeline during the event.
