Clear Water Storages: Critical Learnings in the Application of Protective Coatings

Report Author: Kate Bardy, Manager Operations Projects & Maintenance, North East Water

Introduction

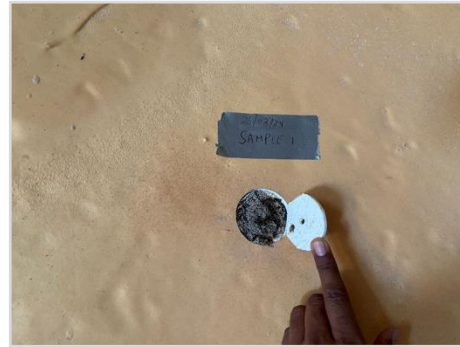
Fig. 3: A liner sample removed for testing.

The DSC analysis confirmed that the coating was fully cured but contained volatile organic compounds (VOCs) consistent with some of those found in the water. Chloroform, ethylbenzene, and xylene were present in the polyurea as absorbed compounds, though none had reacted chemically with the liner.

It remained unclear whether ethylbenzene and xylene would eventually desorb back into the water or persist within the coating. The analysis could not pinpoint how these compounds entered the liner, concluding only that they were likely either introduced during application or formed through secondary reactions soon after application.

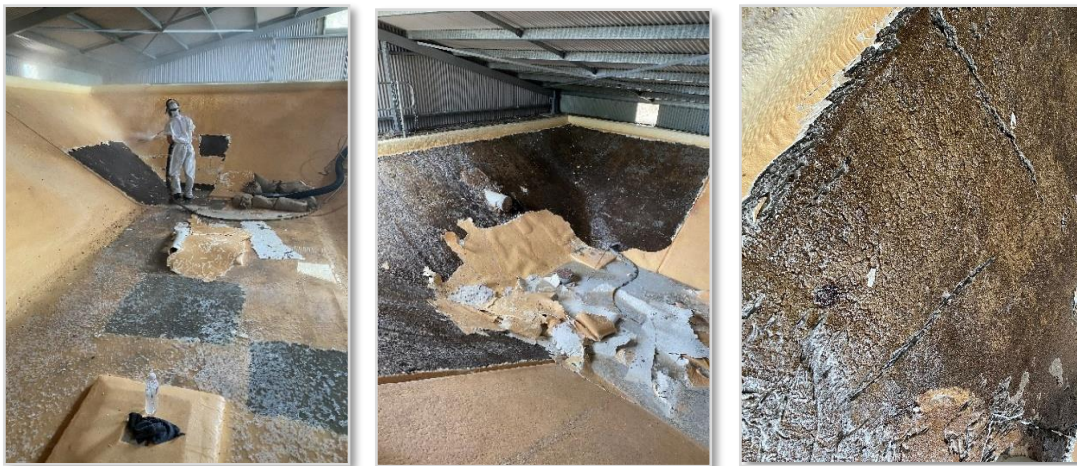
Removal took two weeks and caused variable concrete loss ranging from minor surface abrasion to loss of up to 10 cm in some areas. Extensive concrete and joint repairs were required. Following repairs, the basin was left uncoated to avoid future contamination risk. A full site clean-up was completed to remove loose polyurea debris and a thorough return-to-service plan is now in progress. This plan includes sanitisation, enhanced water quality testing, and formal taste and odour panels.

Fig. 4-6: Removal of polyurea coating from basin

NEW determined the only effective option was to remove the polyurea coating entirely, despite risks to the underlying concrete. Removal of a newly applied coating is not common and posed

risk of damage to the older concrete structure. Trials were conducted with support of the original contractor, and high-pressure water was selected as the most appropriate method.

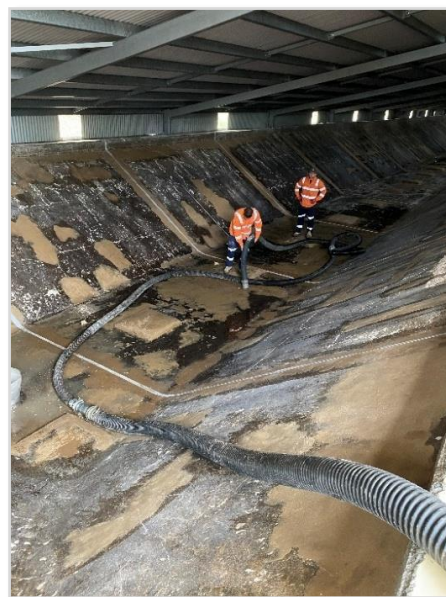
Figure 6: Post coating removal and repair
