a PASS

Problem Accepted - Solution Supplied

Installing a reservoir circulation system including chlorine infusion and monitoring.

Changing from ozone to ultraviolet disinfection: based on reliability and cost factors.

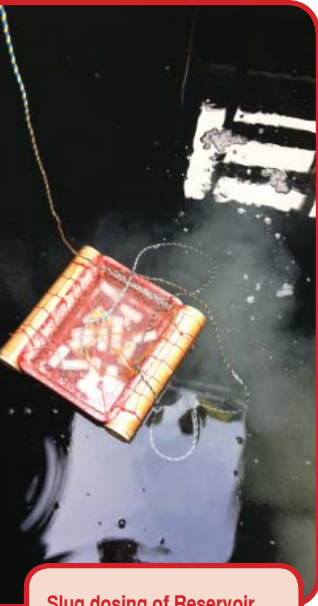
Slug dosing of Reservoir

Cloud of chemical visible causing localised corrosion issue around hatch and internal ladder, inadequate dispersion of chlorine in reservoir, safety concerns with climbing ladder, working at heights, chemical handling and operational cost.

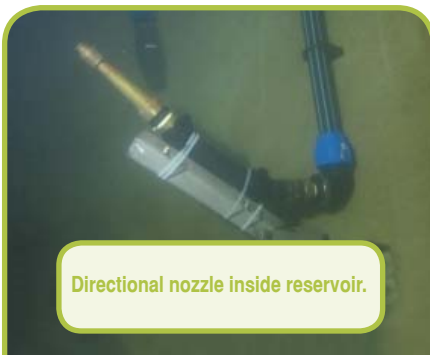
Directional nozzle inside reservoir.

Our workshop made up a swivel mounted fixture to hold the internal jet nozzle in place and to also allow it to be adjusted for angle and direction once it was in operation. The jet nozzle currently is set in the same direction as the larger nozzle unit fitted to the inlet. We had our local divers fit the internal HDPE pipework while the tank was operating. This involved fixing two separate 50mm HDPE pipes into the tank, running them over the wall and back down to the ground. A circulation pump draws water from the foot valve in the reservoir and recirculates it through the nozzle. We can also inject chlorine into the system after the pump. The nozzles can be swapped over to trial different water quantities and pressures once it is operating and our disinfection residual data begins to stabilise. The cost so far has been minimal - 40 meters of 50mm PN 16 HDPE pipe, some elbows, a foot valve and wall brackets and fixings. We reused a pump we had in storage and constructed the chlorine dosing system in house. We also installed 4 sampling points as a way of measuring the results of the project.

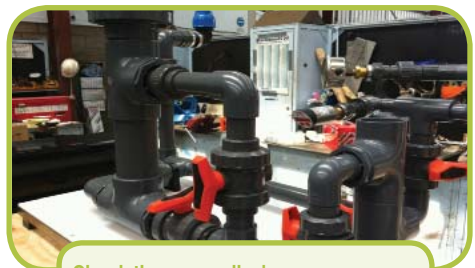
Circulation pump discharge

Pipe-work with Chemical Injection Point and Bypass, and Sample Points

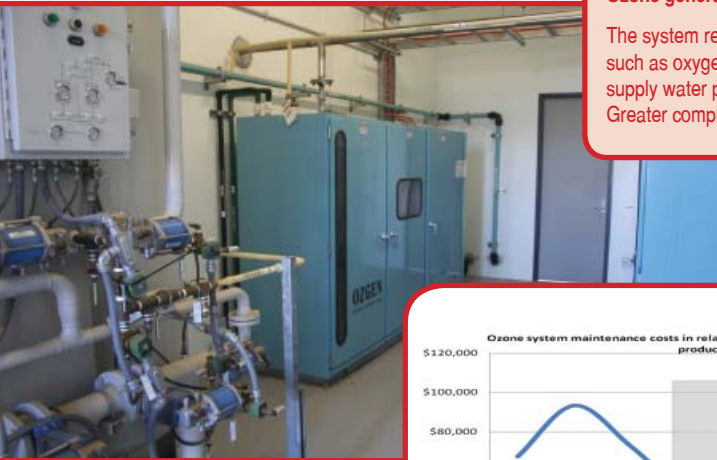
Ozone generators and oxygen production unit.

The system relies on multiple ancillary systems such as oxygen production, air supply, electrical supply water pumps and injectors. Greater complexity = more things to go wrong!

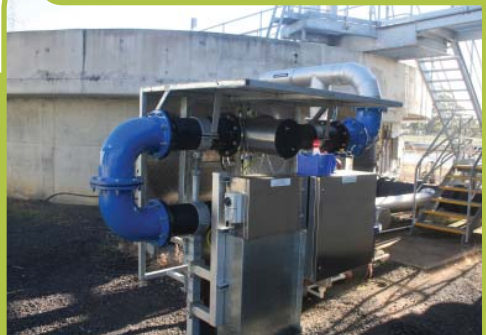
Installed UV system.

Modified pipe work and flanges to allow above ground installation to existing pipe work & future capacity for duplication if required. Simple system reliant on electrical supply only. Less complexity = less things to go wrong!

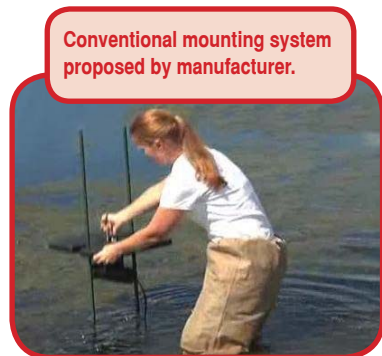
Our mounting system.

Close up of boom and float.

Float switch in off position to reduce risk of ultra sonic operating out of the water & failing at low water level.

The boom is fixed to the shore via a pivot point on a post so it will sit at the high water level and is long enough to reach the low water level mark. The other end of the boom is fixed to a copper pipe which can rotate to allow the float to remain level on the water at all times. The float also is held in position via two anchor lines which maintain the ultra-sonic unit's direction (see photos and schematics below).

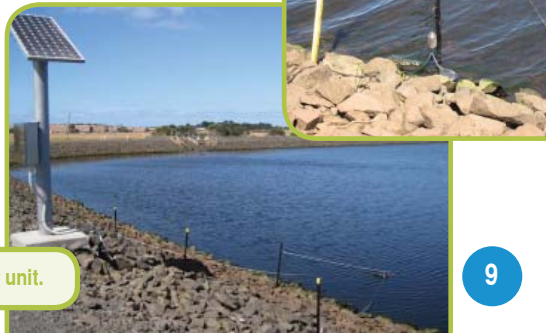
Our mounting system with solar power unit.

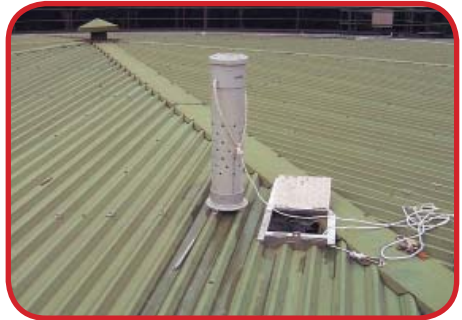
Chlorinated water was contacting the reservoir's metal roof sheets when adding new tablets to the canister.

Chlorinated water was corroding the metal roofing sheets of the reservoir.

By placing a pin through frame and canister, it prevents water contact on roof sheets and holds the canister in place so new tablets can be inserted.

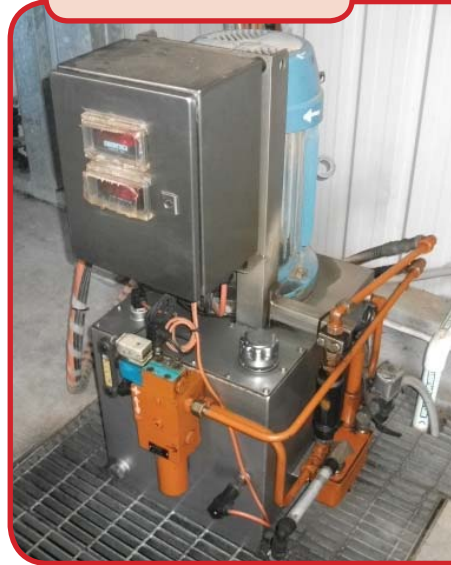
Keeping the Hydraulic motor that runs the centrifuge cool.

We put in a 10,000 litre tank which is filled with fresh water on a ball float. We fitted a small pressure pump with a flow rate of 1 litre per second that feeds the hydraulic pump on the centrifuge to keep the motor cool and the water is circulated back to the tank. This created a high water temperature in the tank so we used the tank water to feed the polymer make up system and the water used in this process was replenished by the town water supply to keep the water cool.

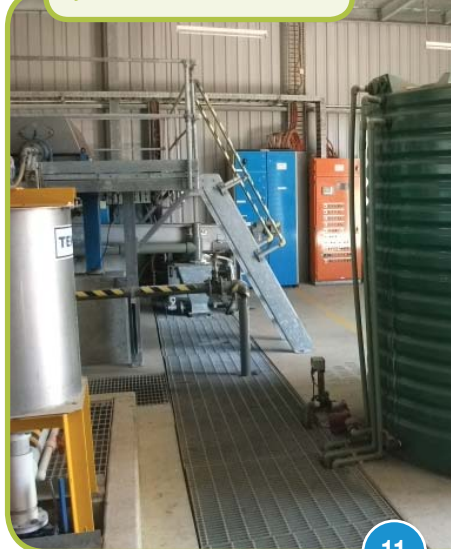
System works.

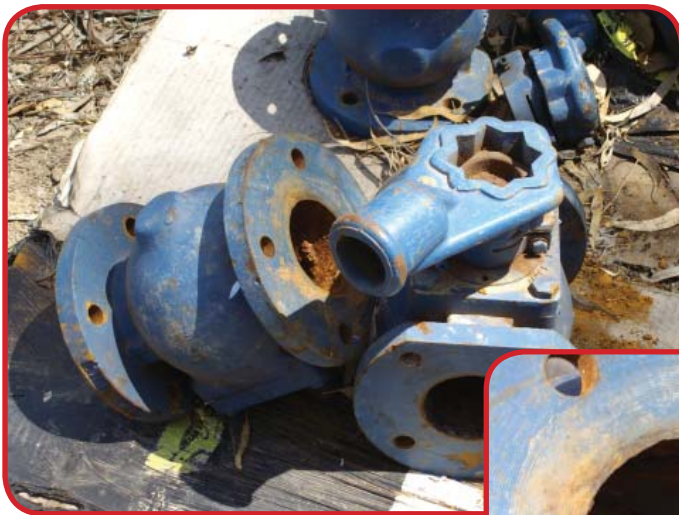
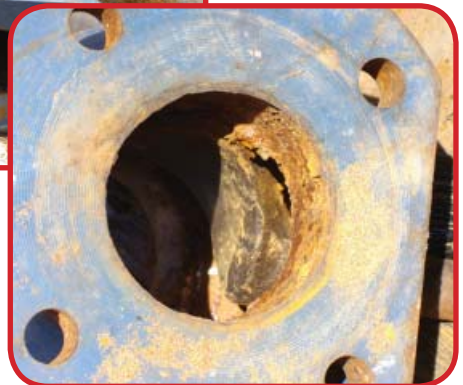
The problem was that the isolation valving on the sand recirculation pumps at the Shepparton tertiary treatment plant had failed.

This problem was caused by a gradual degradation of the valving over a period of years. This wear was not identified during normal inspections because it was occurring inside the valve body. The fact that the valves would not seal was not picked up for a period of time was because the valve was not normally shut outside of the normal maintenance period for the pumps.

After consultation between operators, management and engineers it was decided that a like for like replacement was not a viable long term option. Different designs and types of valves were considered but it was decided to go with pinch valves commonly used in the mining industry. These valves are rubber lined and have some resistance to the residual sulphuric acid and ferric sulphate chemicals in the pumped liquor as well coping with the abrasive nature of the sand in the pumped liquor.

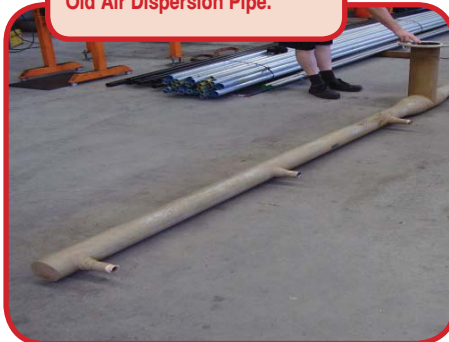
The Shepparton Water Treatment operators found that during poor raw water quality conditions the Dissolved Air Flotation Filtration (DAFF) plant was unable to treat water to meet the Drinking Water Quality Standards. This was caused by poor air dispersion through the bullhorns.

Old Air Dispersion Pipe.

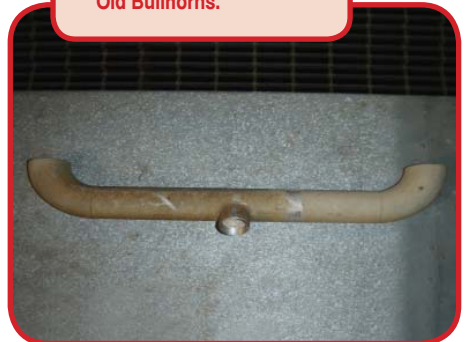
Old Bullhorns.

After talking to a local engineer we trialled a few different bullhorns to see which ones would give us the best air dispersion blanket. With the existing bullhorns, there was 6 across the whole filter. Now there are 24 single outlets every 250mm across the width of the air dispersion chamber. With this design we are able to get an even curtain of milky air dispersion. In the past you could see streaks of water without saturated air. The globe valves were down sized from 1 inch to 3/4 inch to allow the operators to have more control with air dispersion and minimise the pea size bubbles and the train was extended to cover the full width of the chamber.

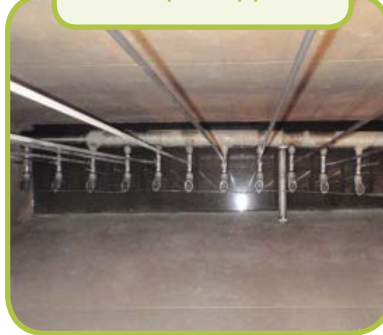
New air dispersion pipe.

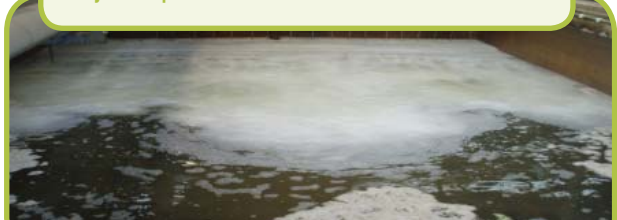
Milky air dispersion even across the DAFF cell.
