a PASS

Problem Accepted - Solution Supplied

2015
WINNER

Sluice Valve Top Remover Tool

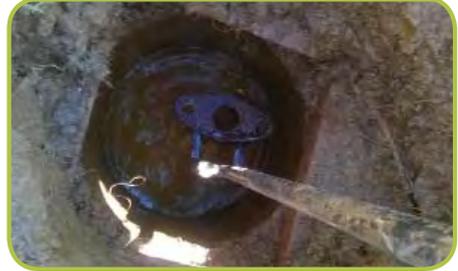
Top of sluice valve removed in a minimal space, with minimal effort.

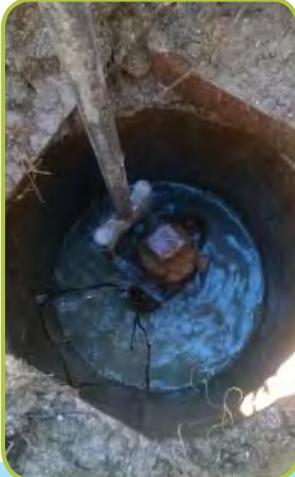
The solution is a tool consisting of a metal rod with two pronged slides at the bottom that you slip under the base of the sluice valve top. There is a heavy metal sleeve that slides up and down along the rod. The sleeve hits a metal stopper at the top of the rod, effectively creating a jackhammer action and allowing the sluice valve top to be lifted. The job can now be carried out on ground level without having to dig a large 1 metre diameter hole just to get the top of the sluice valve to replace the rubber cones. The hole now only has to be 10 cm in diameter and easily dug using a jetter. Even if the bolt securing the valve key head sheared off while trying to remove it you could still hammer it off and not have to cut it off.

Tool prongs are inserted under the sluice valve top and the tool works as a jackhammer to remove the top.

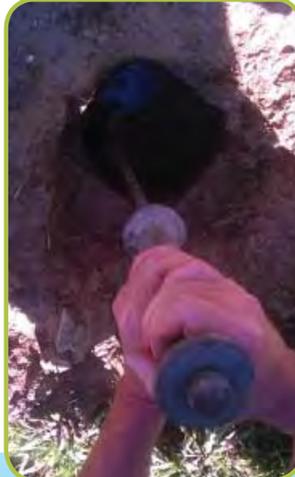
Only a small hole is required (dug by the jet rodder).

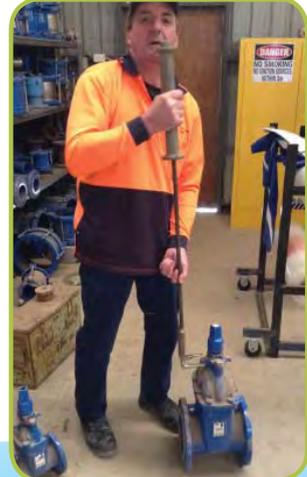
Above ground demonstration of how the tool works

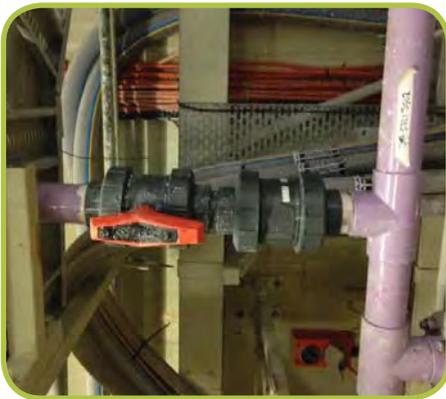
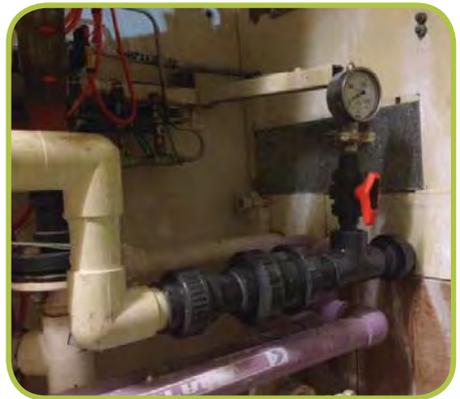
The solution simply involves the installation of two spring loaded non return valves in the Alum solution hose. The upstream NRV is positioned immediately downstream of the dosing pump and prevents the Alum solution in the standby line draining back through the pump to the Alum storage tank. The downstream NRV is positioned immediately prior to the point of service water addition and prevents syphoning and dilution of the Alum solution in the standby line caused by the constant service water flow through the common service water manifold. We also included a local pressure gauge to allow us to monitor the pressure in the dosing line to confirm it was holding pressure whilst in standby mode.

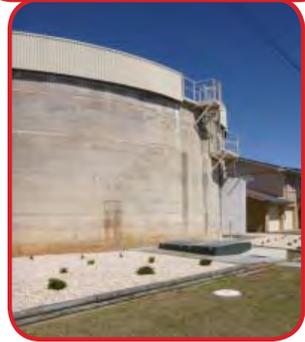
Reservoir Water Quality Monitoring Point.

Pill dosing has been required at the Grants Head Reservoir site for a number of years.

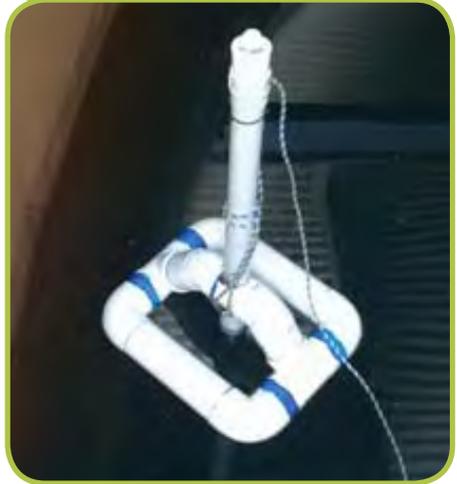
It is a floating dispenser which has a tube for holding dry pills so only one to two pills are in contact with the water at one time. As they dissolve the dry pills fall down into place. The assembly of the units require cheap, easy to source materials that provide a robust device for chlorine pill dosing. Early models held up to four pills while the ultimate design is able to hold up to eight pills, allowing a longer lasting chlorine residual to be maintained.

Pill dispenser in action at Grants Head Reservoir

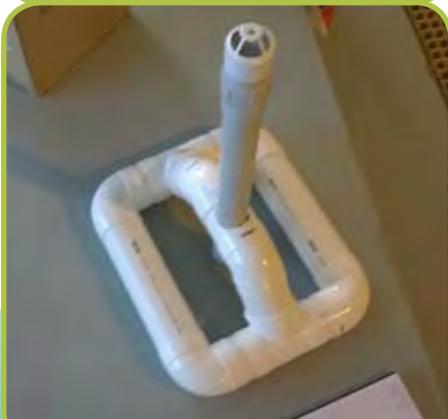
Newly constructed pill dispenser with capacity of 8 chlorine pills

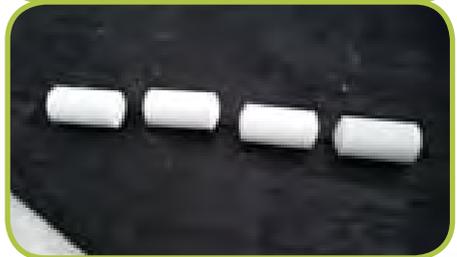
Chlorine pills used in dispenser

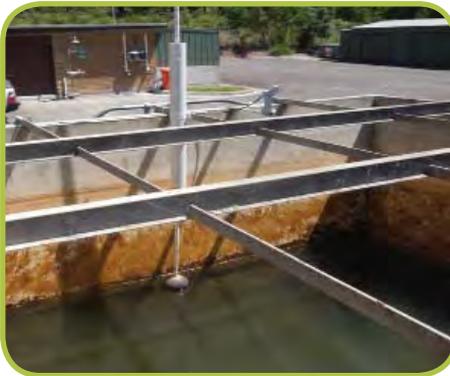
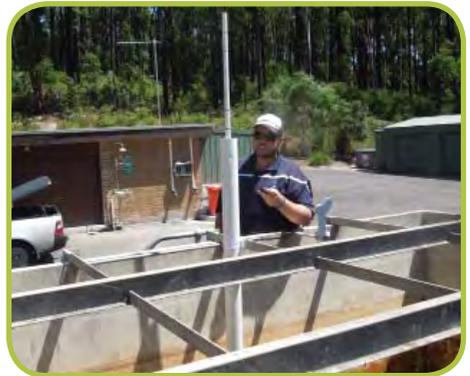
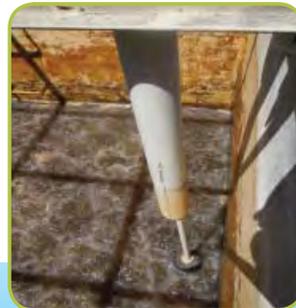
I needed to work out how I could take a measurement without having to guess where the water level was compared to the tape measure, so I designed an extension arm which consisted of a float that would move up and down with the level of the water when doing a backwash. The float was connected to a PVC extension arm which extended up to eye level on the side of the filter with 100 mm increments marked along it to record readings. This was placed into a bracket and mounted to the internal wall of the filters and was made a permanent structure.

This filter inspection aid can be modified and designed to fit any sized filters. This was completely designed from supplies at a local hardware store. It will be designed from more robust materials if given the go ahead to implement into other sites and if site budgets allow. This could also be used to measure tank levels by adjusting the increments on the extension arm to identify how much liquid is in the tank.

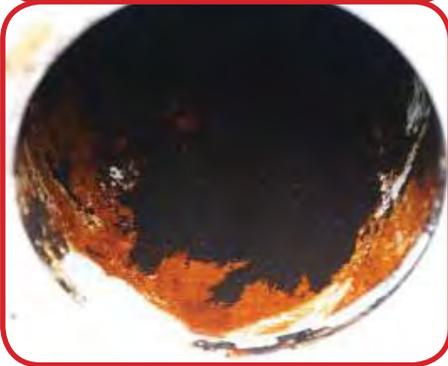
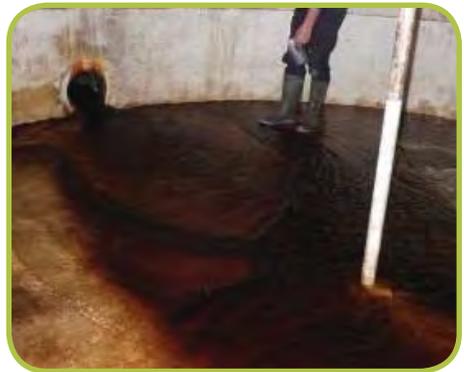
The Yarra Glen microfiltration plant provides potable water to the township of Yarra Glen and produces approximately 3.0 ML/d. The plant has approximately 30 m of filtrate pipework between the outlet of the filter units and the point of chlorine injection. Over a period of years a thick layer of biofilm has developed inside this pipework. Often, immediately after the filter backwash process, particles of the biofilm would dislodge from the pipework causing turbidity spikes in the filtered water. This has also proven to be a problem at our other 2 microfiltration plants.

Inside of filtered water pipework

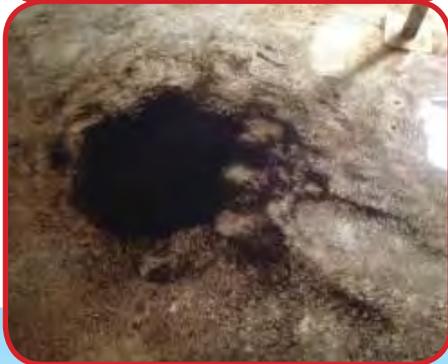
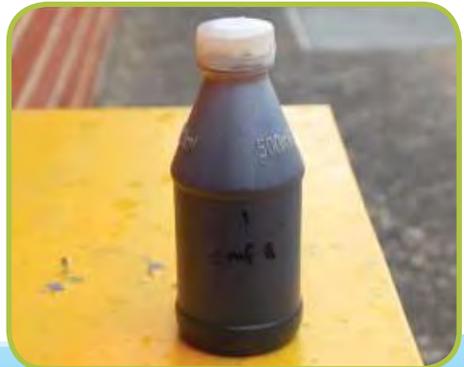
Dislodged particles inside treated water storage tank

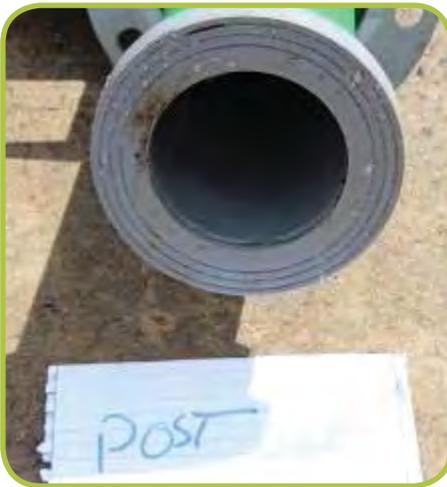
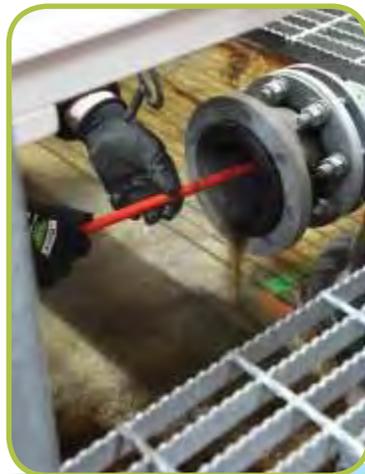
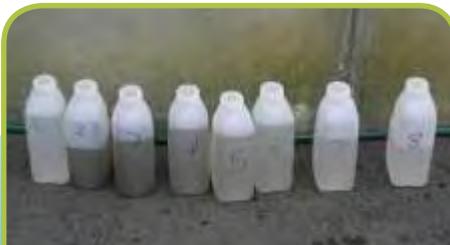
Two methods of cleaning the pipework were trialled. Method 1 involved using the existing plant air supply system to introduce compressed air into the filtrate during operation, thereby air scouring the pipework. This was only partially effective with much of the biofilm layer remaining on the pipework. Method 2 involved removing several pipework sections and introducing a high pressure jet cleaning nozzle into the pipework. The plant was then run at high flows to flush the pipework into the treated water storage which was then educted to waste. This proved to be very successful with almost all of the biofilm layer being removed by the jetting process.

Installation of more jetting access points and scour valves on the filtered water pipework would allow this task to be undertaken much easier in the future.
