# CHALLENGING OPERATIONAL PROBLEMS AT THE BACCHUS MARSH WATER TREATMENT PLANT

*64<sup>th</sup> Annual Water Industry Engineers and Operators' Conference  
All Seasons International Hotel - Bendigo  
5 and 6 September, 2001*

## ABSTRACT

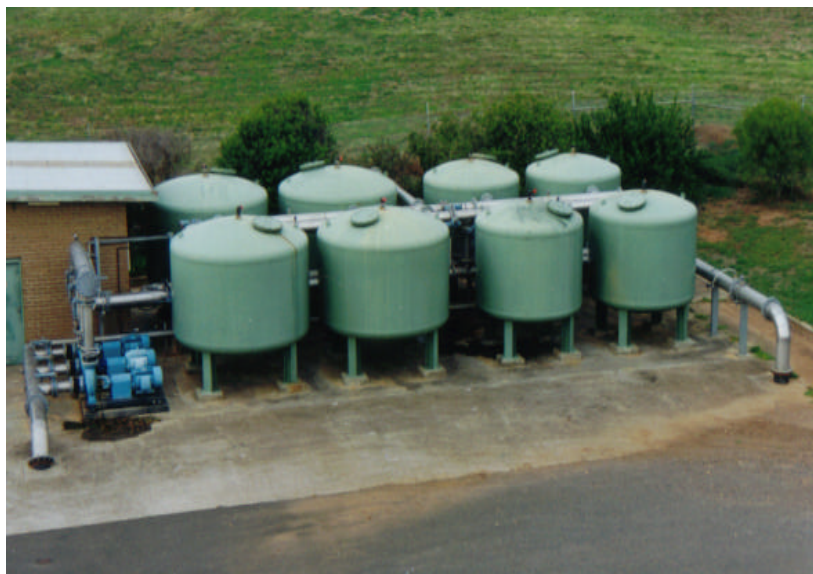
**Figure 2:** *Pressure Filters*

The pressure filters at the Bacchus Marsh WTP are only capable of treating moderately turbid and

coloured raw water. Timers or turbidity set points initiate filter backwash; previous to the poor raw water quality, we had filter run times of up to 24 hours. Afterwards, despite numerous jar tests, we had filter run durations measured in minutes.

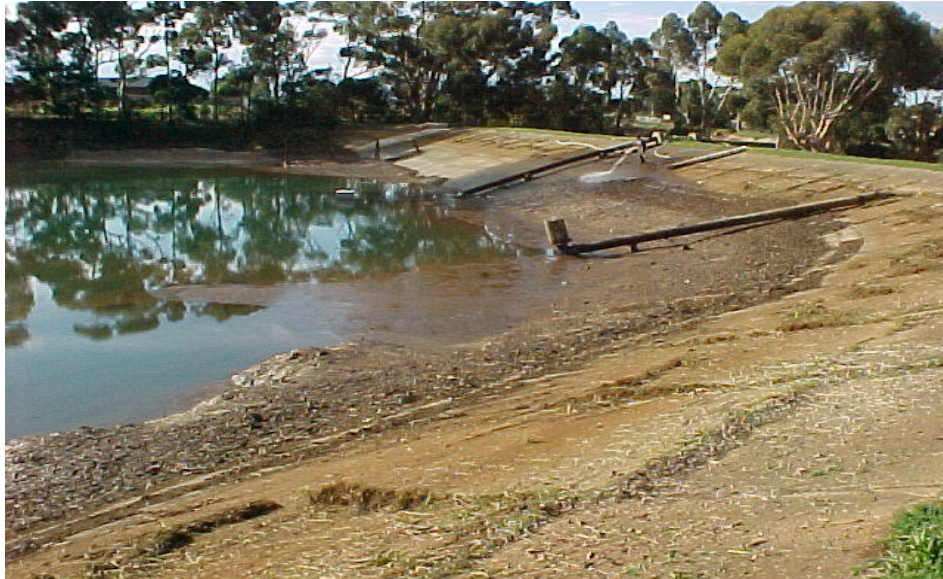
**Figure 3:** *Raw water basin (partially emptied)*

At the Bacchus Marsh WTP there is a 40 ML raw water basin, which is filled from Merrimu Reservoir, the plant then draws water from this basin for treating. Within a week of the fore mentioned rainfall, the basin represented the same quality water as in Merrimu Reservoir. A succession of operational problems then took place.

We then had only one option, which was to pre-treat the raw water at the Bacchus Marsh plant basin. Although not happy with the possible eventualities, we set up Alum dosing facilities with an injection point on the incoming raw water line. Initially we had problems with inadequate mixing, but this was overcome with makeshift in-line mixers installed within the pipe.

After a few days of processing the raw water, enough turnover had occurred and clarification became evident. Initial dosages of 100 mg/l were reduced to 80 mg/l and later 60 mg/l. The raw water basin now acted as a giant clarifier and was performing 90% of the treatment process.

Taste and odour problems commenced in late December 2000, they were earthy/musty/grassy in description. It was soon concluded that the problem emanated from the raw water basin. Working against us was the fact that the basin had not been cleaned since being built nearly 50 years ago. The clarification within the basin also compounded all organic matter to the base of the storage, this in turn allowed sunlight to penetrate deeper into the water column, this causing additional problems in itself.

The major task of cleaning the raw water basin was then undertaken. At the end of April 2001, the Bacchus Marsh plant was shut down, Bacchus Marsh Township being supplied with water from the Merrimu plant, and the basin draining to waste commenced. Steve McKenzie Consulting was employed to oversee the procedure and Tenders were invited to carry out the clean out.

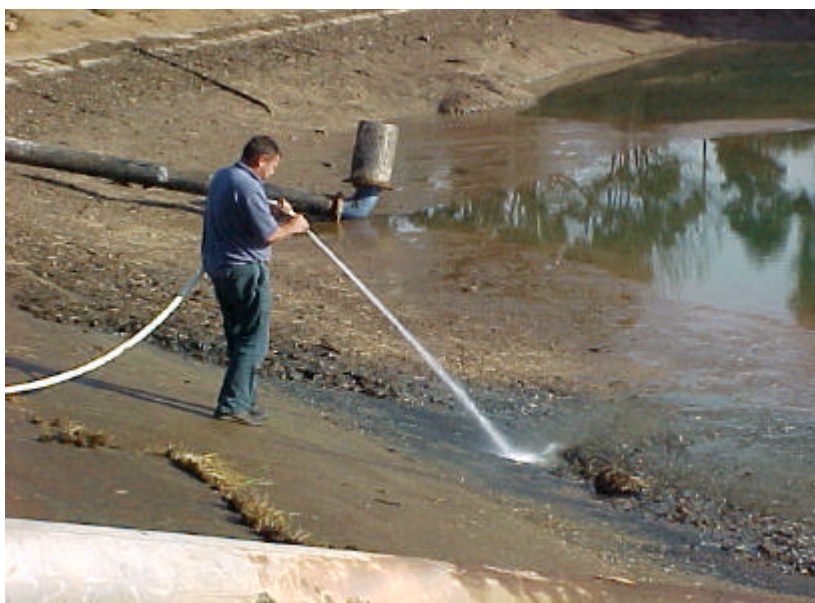
On site disposal of the removed sludge will be possible as we have cleaned out a number of old sludge beds and carried out civil works to allow the possibility of pumping liquid sludges to these beds or to the sewer.

At the submission of this manuscript, the basin clean out contract had not yet been awarded. At the moment there are two preferred tenders. One will use mixers / aerators / pumps to de-sludge the basin. The other contractor will use mechanical means being similar to the clean out of a large farm dam. The latter would provide a more comprehensive sludge removal, but there are noise issues, considering a time estimate on the job of 3-4 weeks.
