# **FLAT SHEET MEMBRANE BIOREACTOR OPERATIONAL EXPERIENCES – A NEW ZEALAND PERSPECTIVE**

**Jason Ewert**, *Technical Director, Mechanical Design,*

*77<sup>th</sup> Annual WIOA Victorian Water Industry Operations  
Conference and Exhibition  
Bendigo Exhibition Centre  
2 to 4 September, 2014*

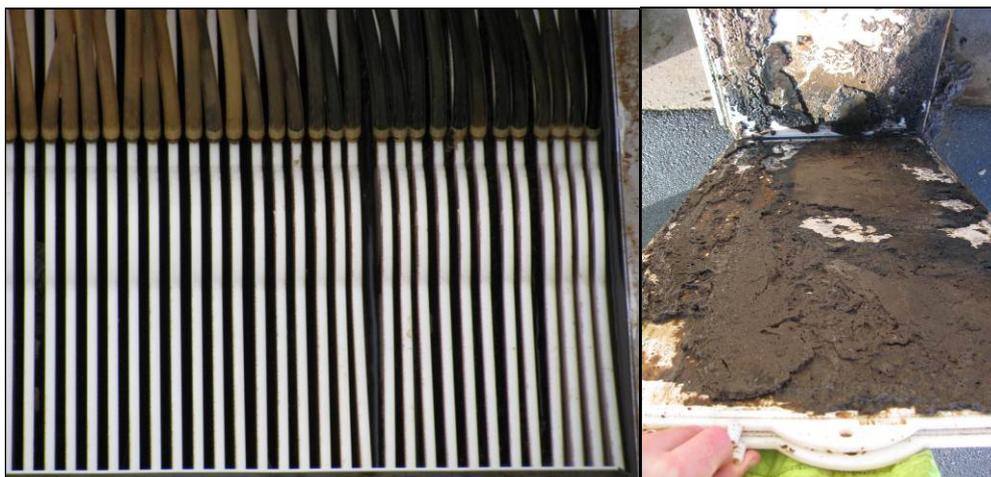
At each of the three plants varying degrees of sludge caking was observed between the membrane sheets at the time of the first membrane inspection. The severity of the sludge caking differed from plant to plant and from module to module. The sludge caking at the Turangi WWTP during the first inspection there was the most prolific and severe.

The sludge caking at its worst was extremely thick and well compacted, forming an almost dry dense and brittle cake, which completely filled the void between the sheets. In slightly less severe cases the space between the sheets was filled but the level of compaction was less, leaving the caking with more typical sludge characteristics.

**Figure 1:** *Sludge caking between membrane sheets (Te Aroha 24/05/2010) causing displacement of neighbouring sheets*

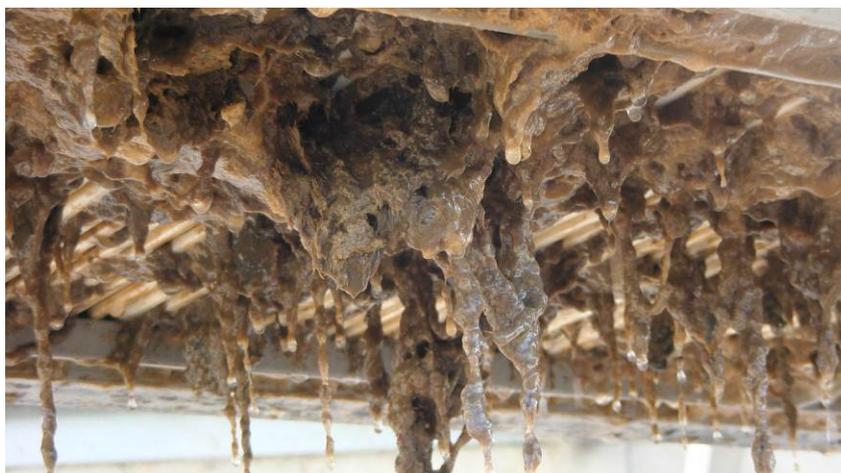
From observation it appears the inlet screening is required to do more than simply protect the membrane sheets from physical damage. The inlet screening stage must also have a high efficiency in removing lint and hair to minimise the amount of this material entering the reactors as the presence of this fibrous material was observed to interfere with the uniformity of the coarse bubble aeration. This is caused by a build-up (agglomeration) of lint and hair at the base of the membrane banks and around the permeate tubes of the lower bank restricting the free passage of airflow between the sheets above the lint agglomerations. Figure 2 illustrates an example of severe lint/hair agglomeration at the base of a membrane module. Significant sludge caking was observed between the membrane sheets above.

***Figure 2:*** *Example of lint/hair agglomeration under membrane module (Turangi WWTP)*

It is recommended that MBR plants are fitted with inlet screens with an aperture size of 1-2mm in all directions with a type of screen that has a 90° change of direction in the water flow as the water passes through the aperture to prevent hair and fibres from “streamlining” through the screen holes. Also screens that have a cleaning mechanism that tends to push material through the screen apertures in the direction of flow should be avoided in MBR installations.

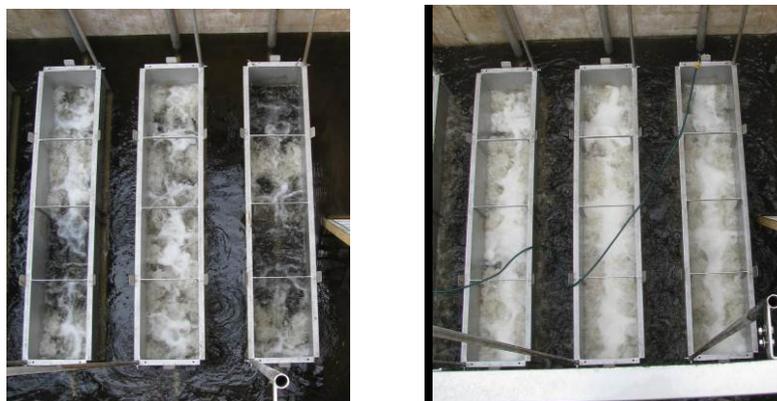
Deterioration of the coarse bubble aeration pattern was witnessed at all three plants over time. Upon draining and cleaning of the reactor tanks at the Te Aroha WWTP, the membrane tanks were partially refilled with clean water and the coarse bubble aeration system operated. The purpose of this was to check the uniformity of the coarse bubble aeration pattern prior to reinstalling the cleaned and refurbished membrane modules. As can be seen in Figure 3 below (left) considerable variation in aeration intensity was evident across each module and from module to module.

***Figure 3: Coarse Bubble Aeration Pattern Pre Diffuser Cleaning (left) and Post Diffuser Cleaning (right) [Te Aroha WWTP]***

The locations of poor coarse bubble air flow noted during the initial uniformity check correlated very well with the areas of heavy sludge caking observed during the sheet inspection. The membrane tanks were drained and the diffusers were cleaned. Figure 3 (right) shows the aeration pattern after the diffuser cleaning operation.

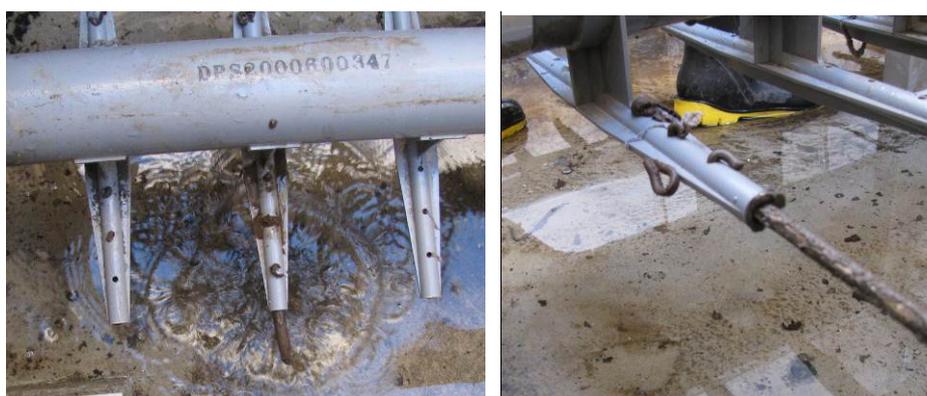
Inspection of the coarse bubble aeration diffusers at both the Turangi WWTP and the Te Aroha WWTP showed significant blockages in both the lateral diffuser pipes and the diffuser nozzles. A significant amount of sludge was extracted from the majority of the diffusers, however, the areas of poorest air flow were not obviously more significantly blocked than the other areas. Figure 4 illustrates the diffuser cleaning process.

***Figure 4: Coarse bubble aeration diffuser cleaning [Te Aroha WWTP]***

The postulated contributing causes of the coarse bubble aeration diffuser blockage are a combination of:

- Ineffective inlet screening – poor fibrous solids capture efficiency allowing large amounts of hair and lint into the treatment plant and;

- The current method of diffuser flushing – in the diffuser flush sequences a venturi effect is induced in the diffuser pipework drawing MLSS into the diffuser pipework. The shear force induced by the fluid flow is intended to clear the diffuser nozzles of fouling and sludge build up. However, it is hypothesised that fibrous material present in the MLSS (lint and hair) drawn into the diffusers during the flushing sequence leads to blockages in the diffusers, which once blocked is followed by the accumulation of sludge. This hypothesis is supported by the observation of hair and lint within the sludge removed from the diffusers during the diffuser cleaning procedure.

1. Improved Influent Screening (1-2mm with 90° direction change)
2. Continuous MLSS Screening (e.g. RAS screening)
3. Alternative Diffuser Flushing Methods (e.g. high volume flushing with permeate)
4. Fail Safe Systems to prevent permeation without aeration
5. Continuous Monitoring of Coarse Bubble Aeration Flow Rates
6. Design of Facilities for Easy Tank Draining and Membrane Cleaning
