THE LAST 5% - IMPACTS ON PLANT OPERABILITY

*10th Annual WIOA
NSW Water Industry Operations Conference and Exhibition
Newcastle Jockey Club,
6 to 7 April, 2016*

ABSTRACT

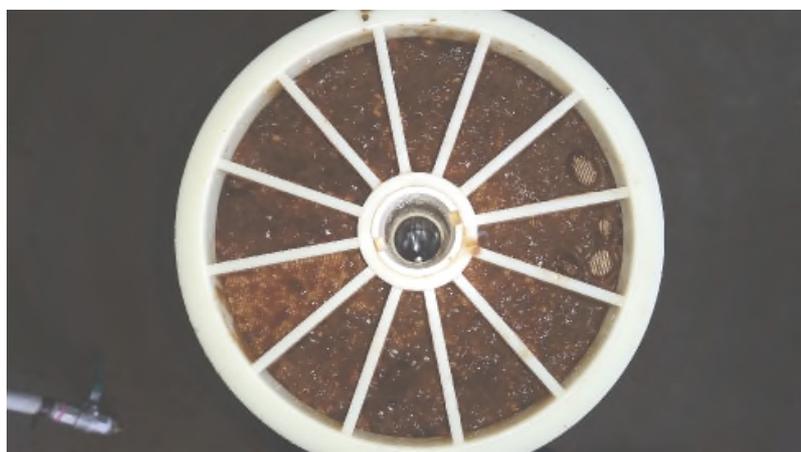
Figure 1: *Solids Ingress into the RO*

Set points and their respective design limits are integral in protecting equipment from operating outside its design criteria. If any process parameter exceeds the operational design limit of the respective piece of equipment, then a warning should be generated on the SCADA. If the values continue to exceed the design limits, typically the plant will alarm and shutdown to protect the equipment. Permeate Partners attended a site in Victoria to investigate the poor performance of their Reverse Osmosis unit (RO). When reviewing the key performance data it was identified that the RO was running with a differential pressure of 10bar across two stages. Whilst there was an alarm setup in the PLC, it had been set to 12 bar to enable the unit to run. This resulted in the unit continuing to run despite significant solids ingress into the machine. Figure 1 is the lead element on the first stage of the RO.

Despite the controls being in place, the set point was set outside of the design limits. Notwithstanding the fact that there were other issues present at the plant, the set point should never have been able to be set outside the design envelope. As a result of this failure, the client needed to replace the entire set of membranes at a cost of approximately \$40,000.

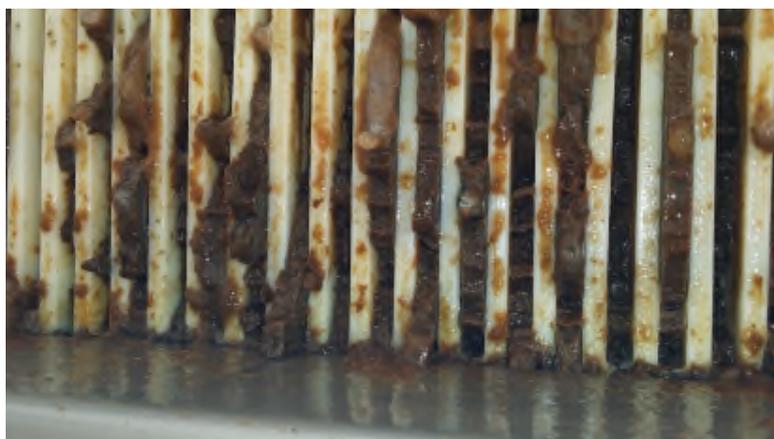
Figure 2: *Sludged Membrane Cassettes*

In order to prevent solids build up in the membrane tank during operation of an MBR, the feed rate to any given membrane system is typically 4-5 times the permeate production rate of the membrane cell. Feed rates below this level can lead to excessive concentration of solids in the membrane tank, leading to the potential breach of the allowable solids filtration limit set by the membrane manufacturers. Permeate Partners attended a MBR WWTP in Victoria to investigate issues with high trans-membrane pressures (TMP's). A review was conducted on the system and it was identified that although the recirculation ratio on the SCADA was set to 4:1, it was not mapped to the correct tag in the PLC that controlled the membrane feed rate. The hard coded set point for the recirculation rate was set to 2:1 leading to excessive solids build up in the membrane tank, sludging of the membranes and a subsequent breach of the membrane warranty. This issue was only identified after the plant had been in operation for 18 months as the effect was not immediately apparent on the new membranes. After some time, the eventual solids build up deteriorated the membrane condition and led to the failure of three membrane cassettes. Figure 2 is an indication of the level of sludging between the membrane panels.

In addition to this issue, the TMP alarm that would usually protect the membrane cassettes was not tested correctly and included a 5 minute delay. This resulted in the membranes never tripping on high TMP and they subsequently ran outside of the membrane manufactures design guidelines. As a result the client was forced to replace 3 of the membrane cassettes at the cost of nearly \$95,000. This major fault could have been avoided if two simple tags had been mapped correctly and checked during commissioning.
