11th WIOA NSW Water Industry Operations Conference and Exhibition

29 & 30 March 2017 - Exhibition Park in Canberra (EPIC)

SOLIDS HANDLING AND DISPOSAL AT LOWER MOLONGLO WATER QUALITY CONTROL CENTRE

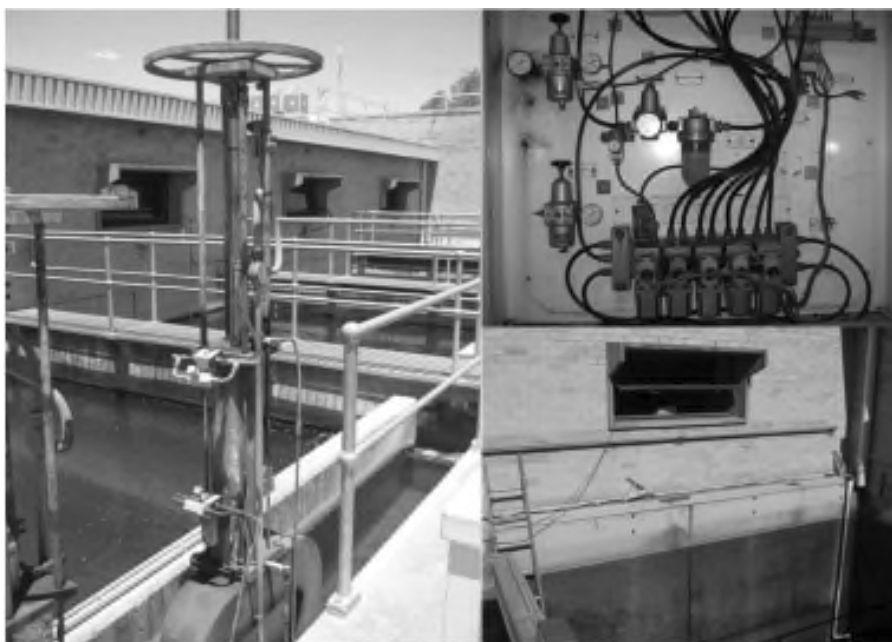
There were a number of WH&S issues identified with the existing filter system. The use of 240v solenoids in a designated wet area created a potential electric shock risk to operators, and deteriorating fibreglass cylinders could potentially burst under the operating pressure of 600 Kpa. Pinch points were also identified on the air cylinders between the exposed cylinder shaft and manual override wheels.

Figure 3: *The old cylinders (L), control panel (TR) & operator access (BR)*

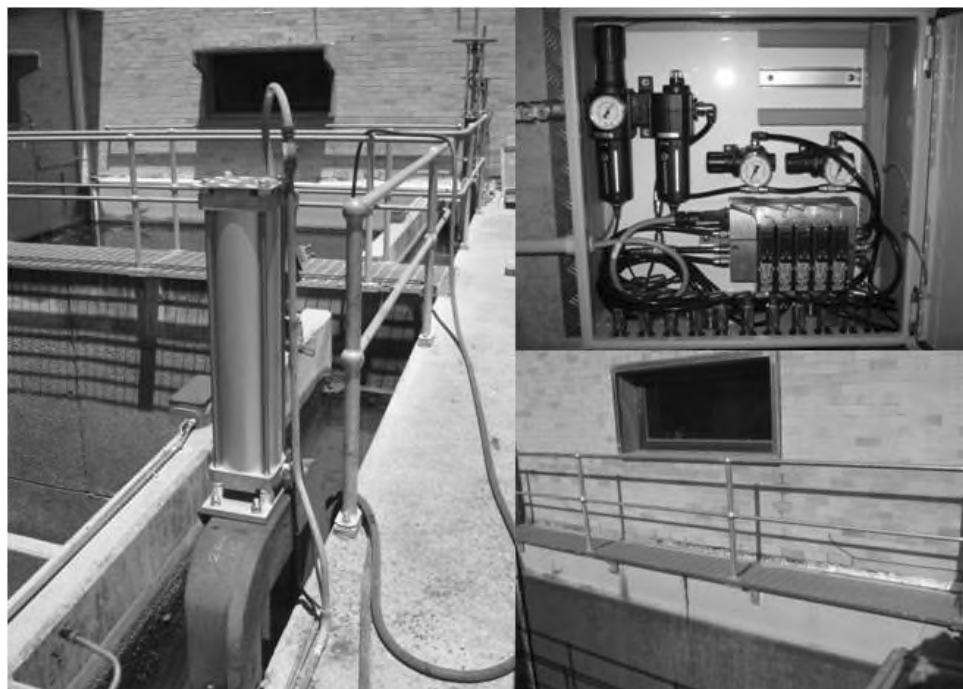
In order to rectify the issues identified in the assessment, a new system was designed and installed by TRC mechanical staff. The new cylinders were required to fit into the existing hardware and 24v air/electric solenoids compatible with the computerised control system. Aluminium and stainless steel pneumatic cylinders were utilised for their smaller size and higher efficient, and the control cabinet and solenoids were replaced.

Figure 4: *The new cylinders (L), control panel (TR) & operator access (BR)*

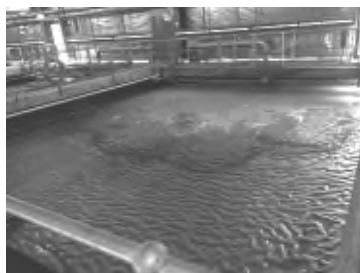
Therefore, during 2016 run, observations were made on the scum blanket on a timed interval and frequency is adjusted to ensure one-quarter to one-third of the blankets lengths is left on the surface of the filter. As a result, the filter ripening period reduced and mud-balling is minimised.

Figure 3: *DAFF scum blanket roll-off*

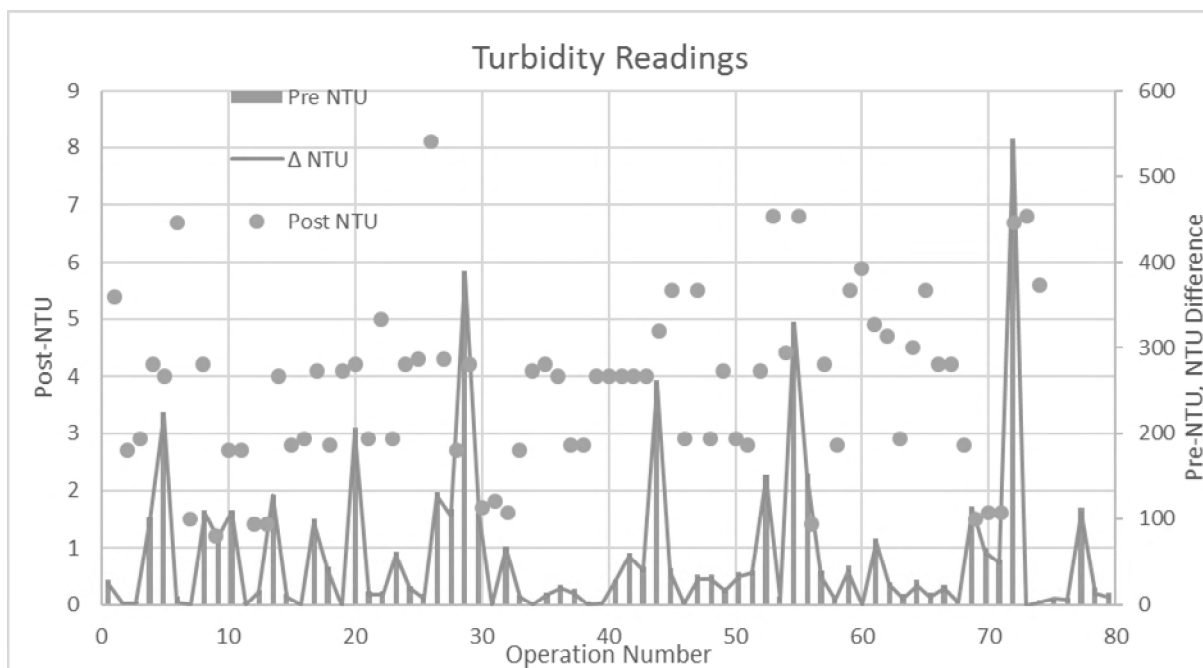
To measure the success of the operation, the turbidity was recorded before the ice was inserted and before the main was returned to service. The average turbidity decrease for all operations was 59.95 NTU with a maximum decrease of 538.8 NTU. A graph showing the turbidity results for all operations is shown below.

Figure 1: *Graph showing turbidity readings for all operations*

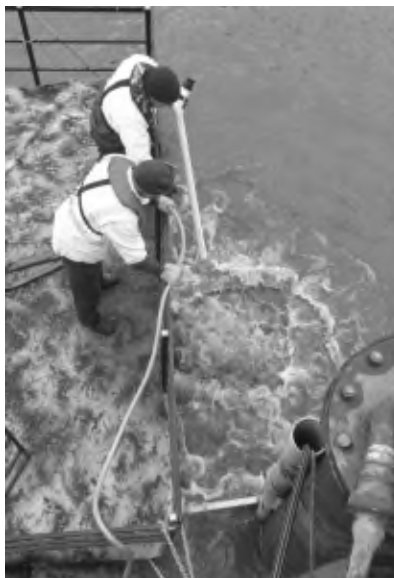
Figure 5: *Jetting with lance while compressed air blowing from inside the screen simultaneously*

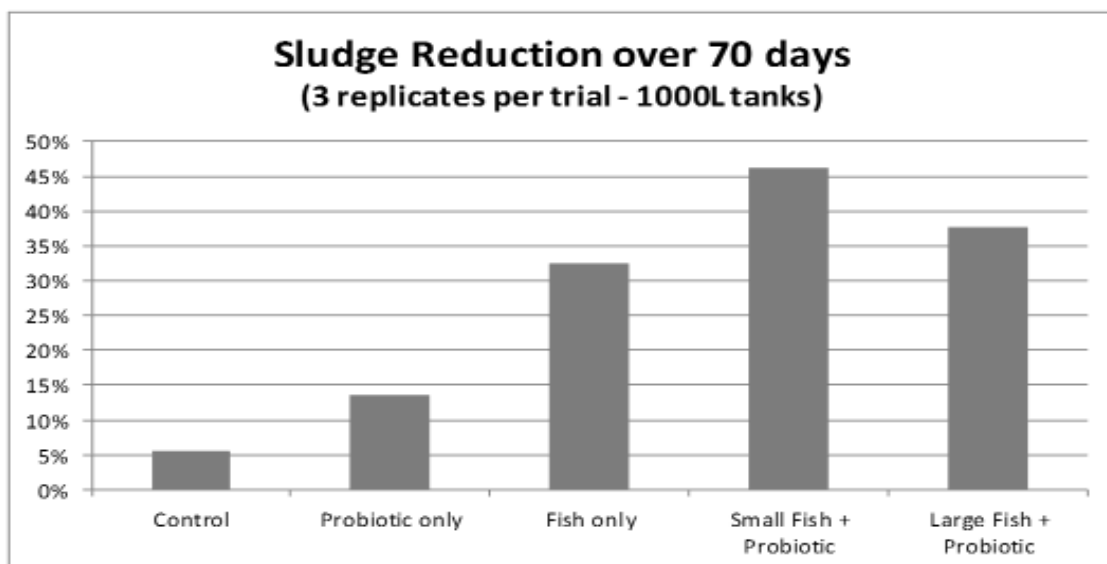
Our results showed an average of 13.5% reduction in sludge volume when probiotic was used alone compared to Goldfish which recorded an average of 32.4% reduction in sludge volume. Of most interest was the combination of fish and probiotics which recorded from 37.6% to 46.2% reduction in sludge volume.

Figure 5: *Sludge reduction over a 70 day period in static trial tanks*

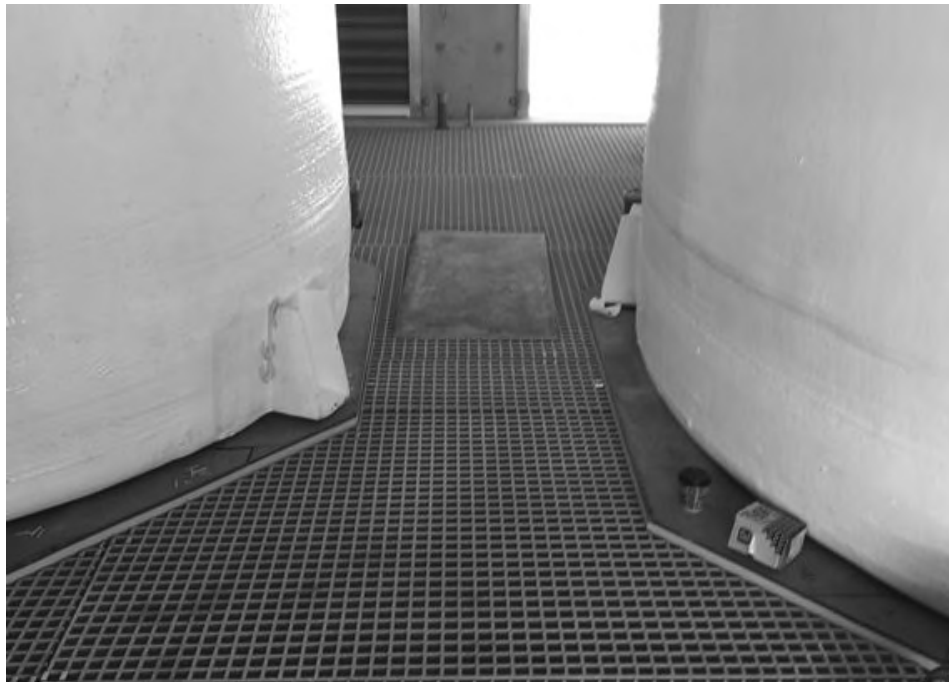
Figure 6: *Bunding below floor level*

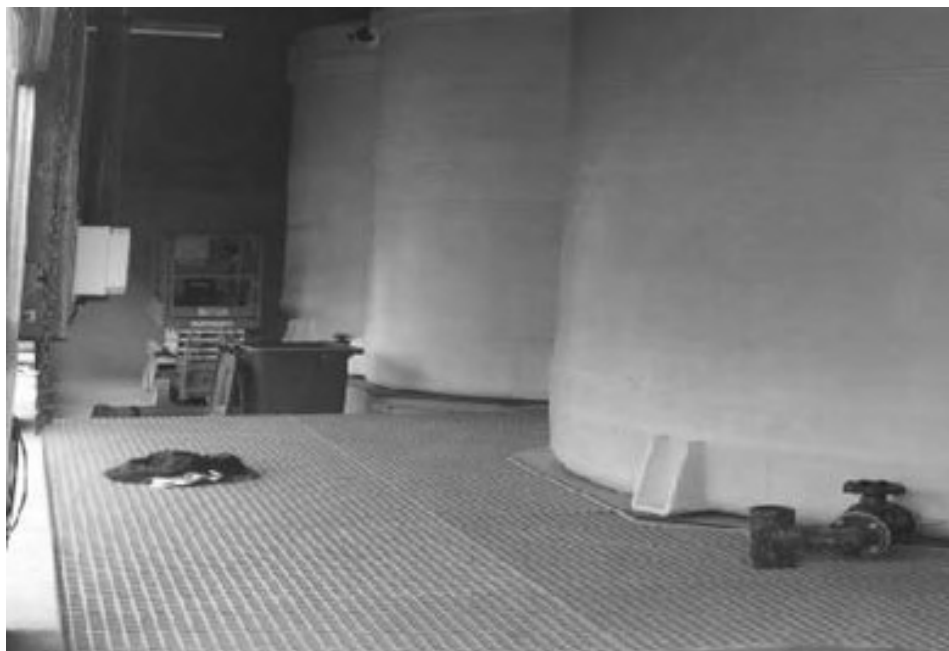
Figure 7: *Bunding below floor level*

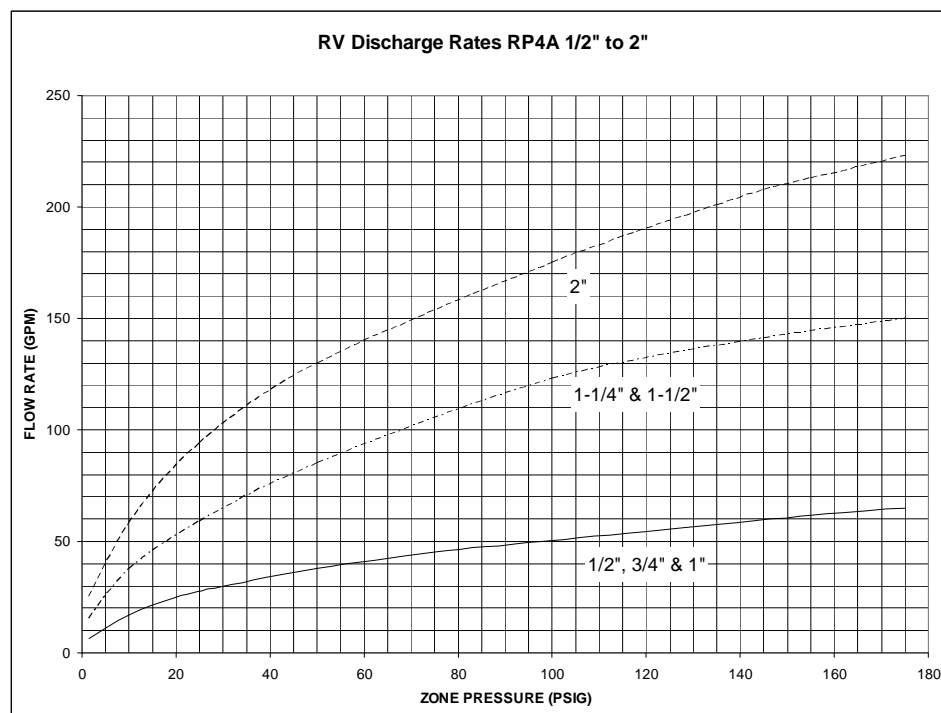
Figure 1: *Apollo Valves RPZ discharge Rates*

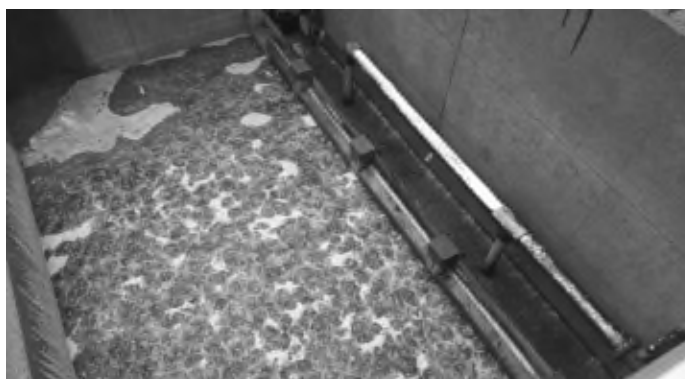
Figure 3: *Air scour pattern-Filter 2 leaks evident along drain and 1/3 media not agitated*

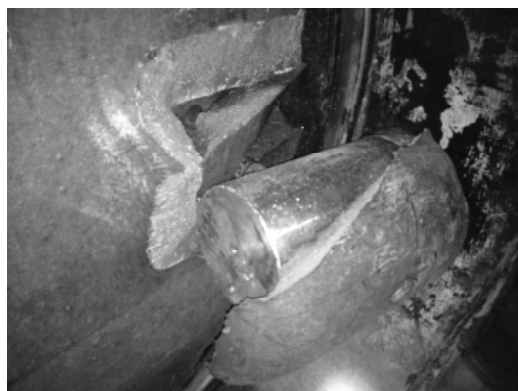
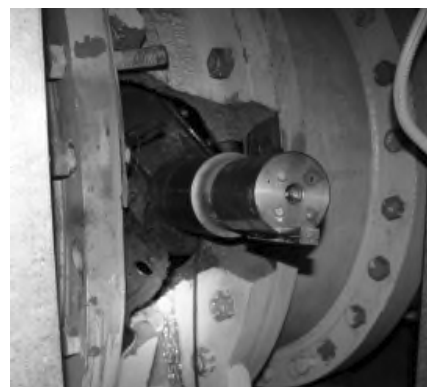
Figure 5: *Damaged butterfly valves*
