# 80<sup>th</sup> WIOA Victorian Water Industry Operations Conference and Exhibition

# OPERATIONAL REVIEW: OPTIMISATION OF POLYMER IN THE COAGULATION PROCESS

*80<sup>th</sup> Annual WIOA Victorian Water Industry Operations  
Conference and Exhibition  
Bendigo Exhibition Centre  
6 September to 7 September, 2017*

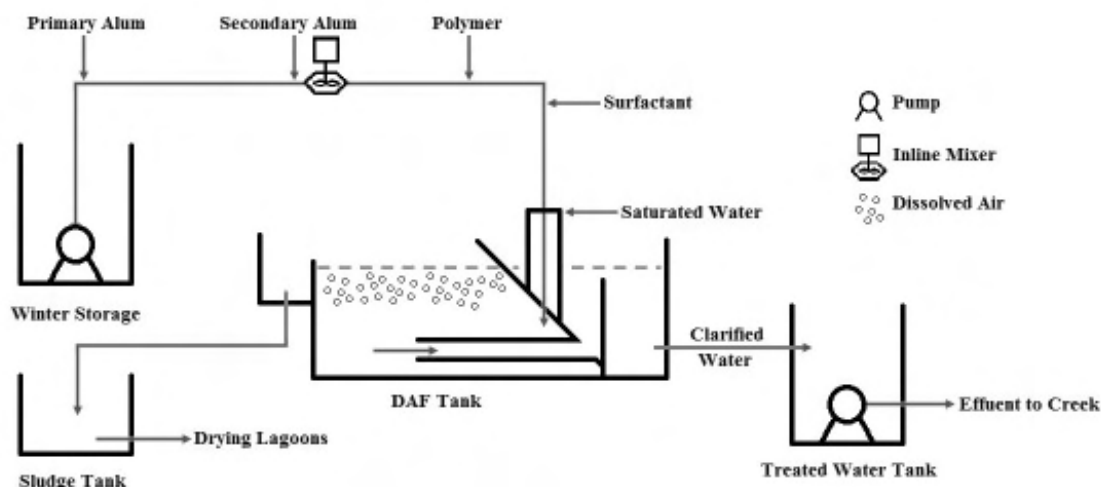
**Figure 1:** *Configuration of DAF Wastewater Treatment Plant*

The lack of substantial change in DAF conditions prompted a reassessment of the type of polymer may best suit the plant. As per Figure 1, the clarified water is drawn into a separate chamber via pipes underneath the sludge blanket. The flow of water in this particular area can be quite high in velocity and assertions were made following jar tests that perhaps the linear polymer was not maintaining large ‘macroflocs’ and stabilising alum particles in the sludge blanket. At this point a stronger, more ‘structured’ liquid polymer normally reserved for centrifuge conditions was introduced for trial (Figure 2).

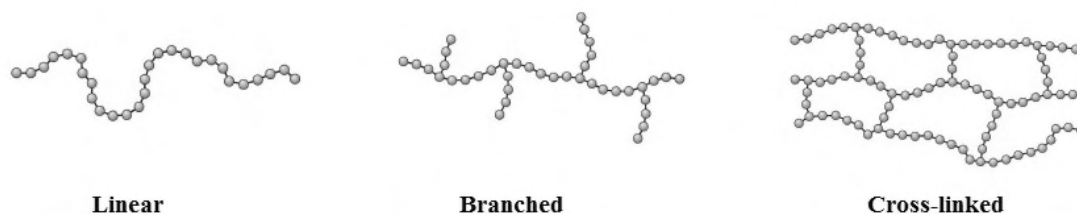
**Figure 2:** *Modified diagram demonstrating chemical configuration of different types of polymer (Groover, 2010); increasing in both ‘structure’ and strength from left to right*

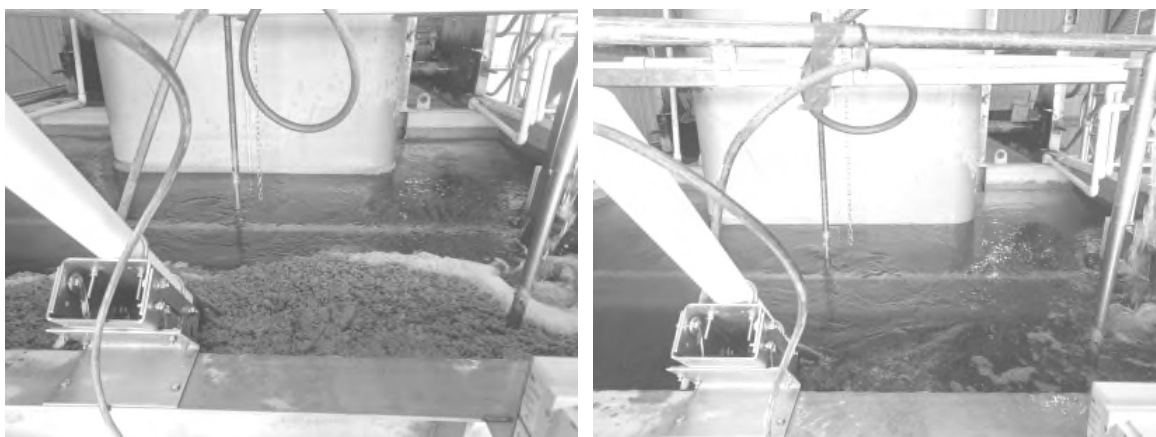
**Figure 3:** *Carry-over present operating powdered polymer vs structured polymer*

As opposed to the linear liquid trial, the structured liquid polymer proved to change the behaviour of the system entirely. It is important to explain that under normal operating conditions at the WWTP, a gradual build-up of alum particles referred to as ‘carry over’ will coat the tank at interfaces and a minimal amount will float. This requires plant shutdown for three hours every week for cleaning. However, running on the structured product reduced this build-up substantially (see Figure 3 for comparison).

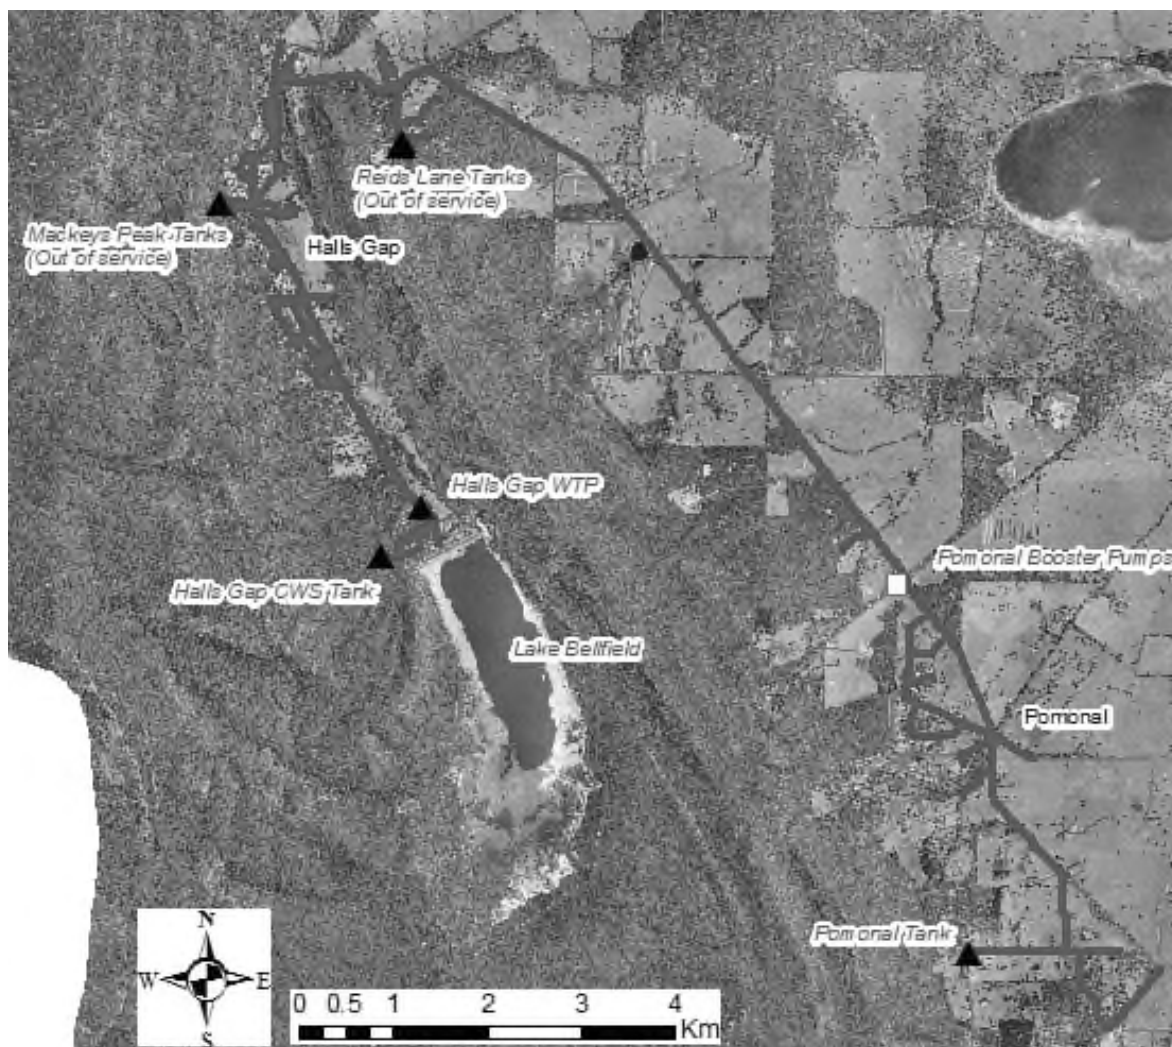
**Figure 1:** *Halls Gap and Pomonal Potable Water Supply System*

Initially it appeared that the network is fed from the elevated CWS Tank, however detailed analysis of the system confirmed that it is split in two parts. The *lower* portion of the township receiving supply from the Booster Pump Station, and the *higher* level of the township receiving water from the CWS tank.

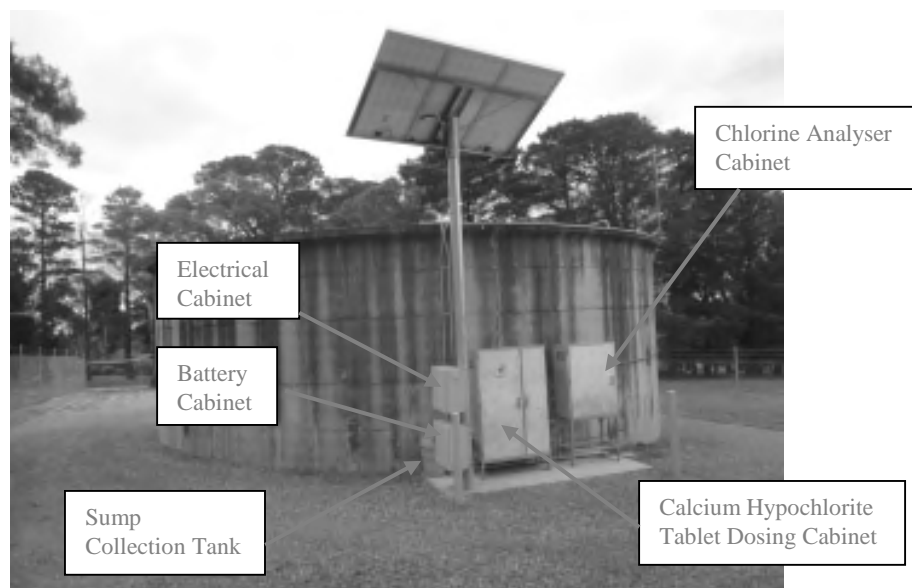
**Figure 2:** Pomonal CWS Tank and Chlorination System

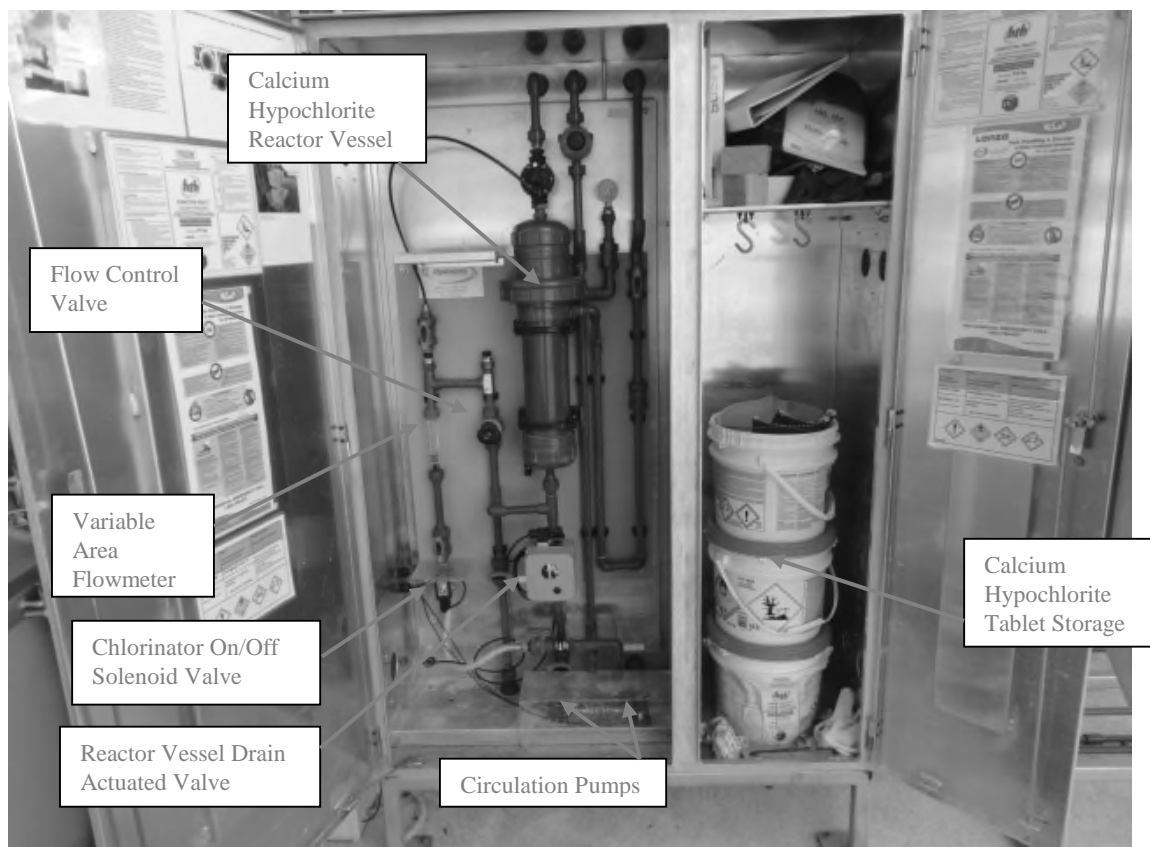
**Figure 3:**      *Chlorinator - Calcium Hypochlorite Table Dosing System*

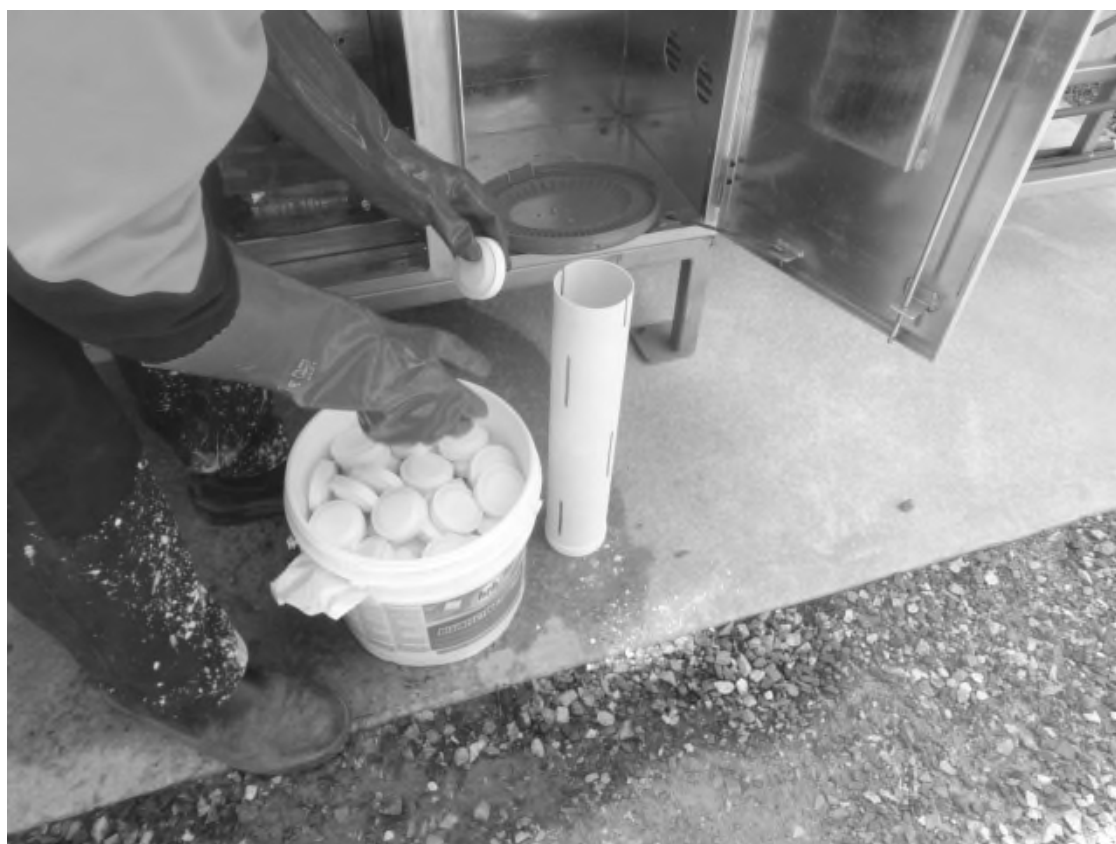
**Figure 4:**      *Loading Tablets into the Canister*

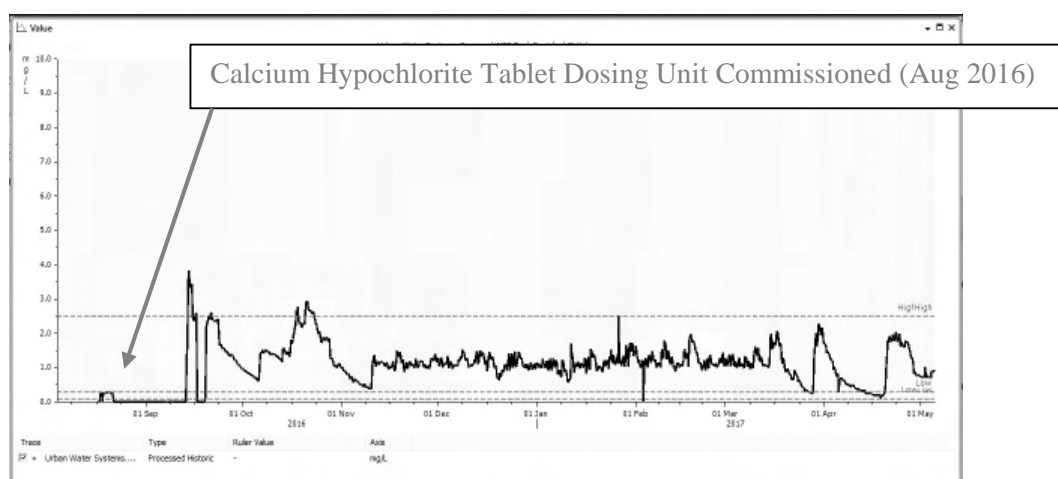
**Figure 5:** *Pomonal CWS Tank – Chlorine Residual SCADA Trend*

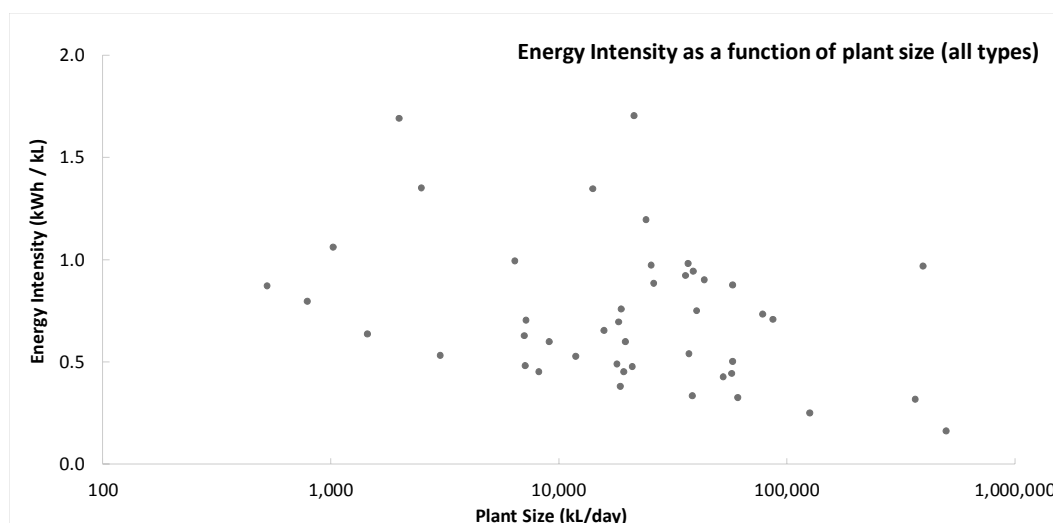
**Figure 1:** *Australian and international energy intensities for WWTPs.*

The WSAA 2013-2014 benchmark study (de Hass, 2014) indicated that larger plants are more energy efficient. However, there is still a range of efficiencies at any given plant size (see Figure 1).

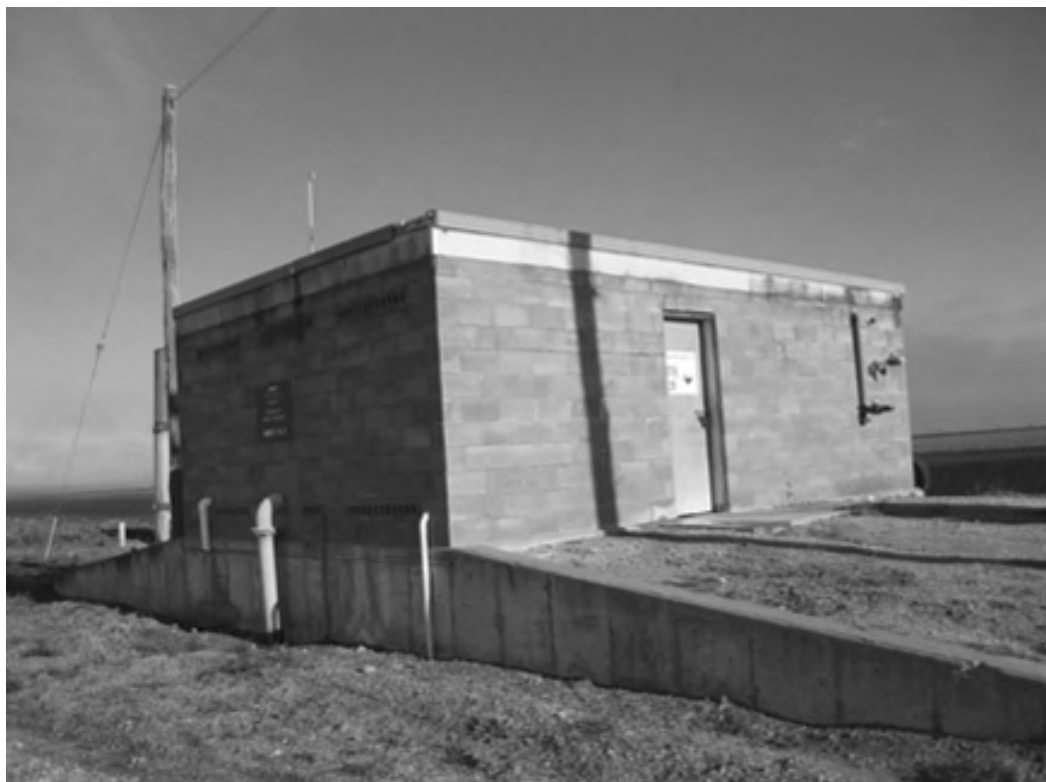
**Figure 1:**      *Curlewis Pump Station and Dose Site 2014*

- Corrosion to the block work and slab
- Rusting supports to the bore perch
- Leaks to the bunding under the hypo tank
- Aging dose pumps and lines with rusted and corroded support brackets
- General housekeeping and maintenance

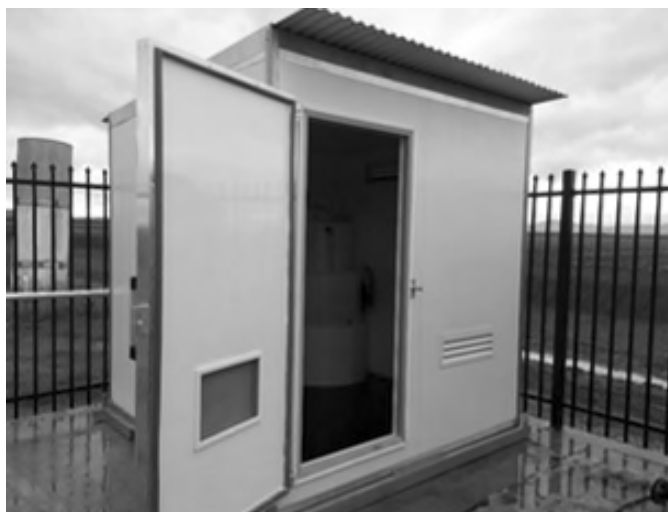
**Figure 2:**      *New Curlewis Dose Plant*

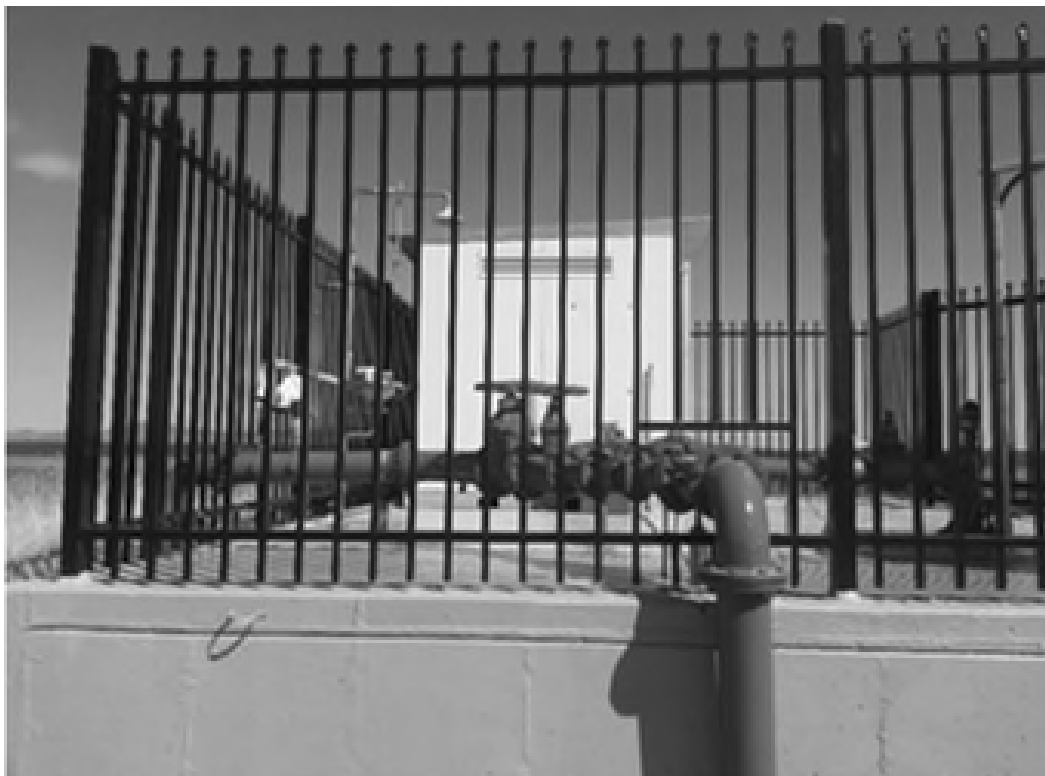
**Figure 4:**     *Completed external works*

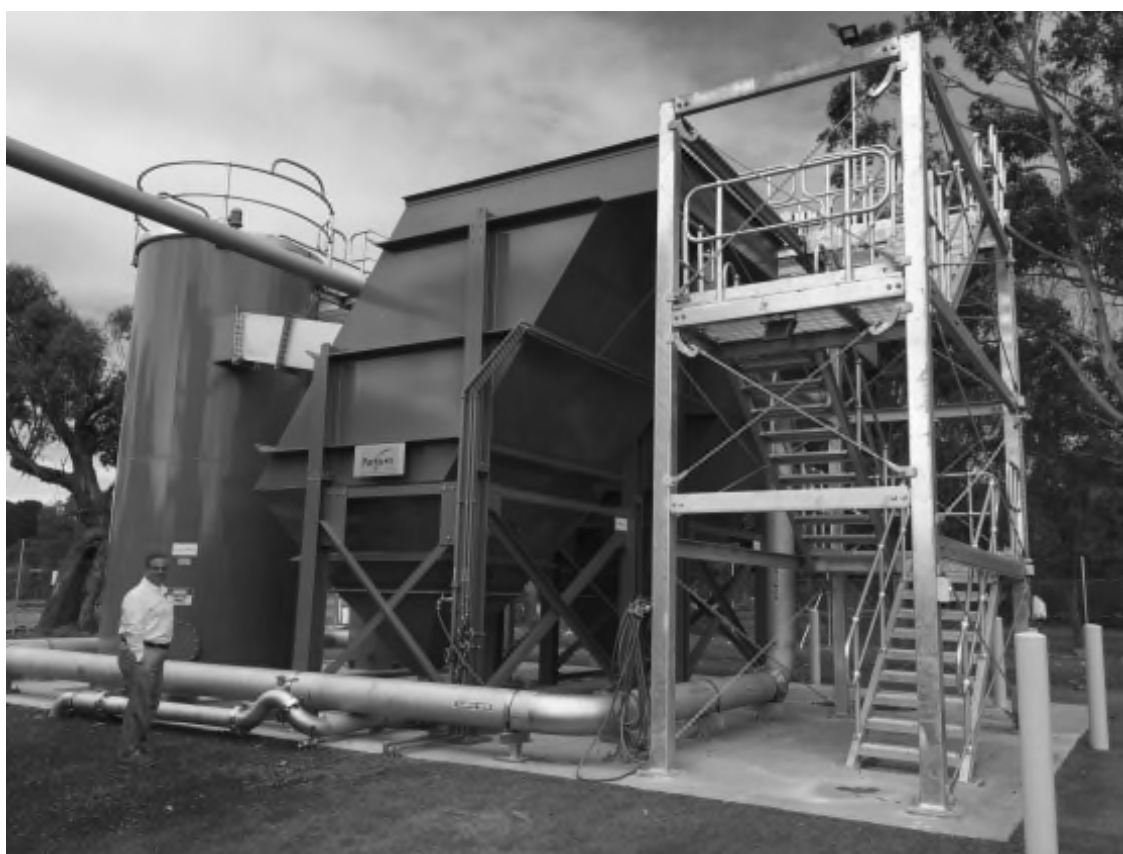
**Figure 1:**     *Casterton Water Treatment Plant Clarifier Installation*

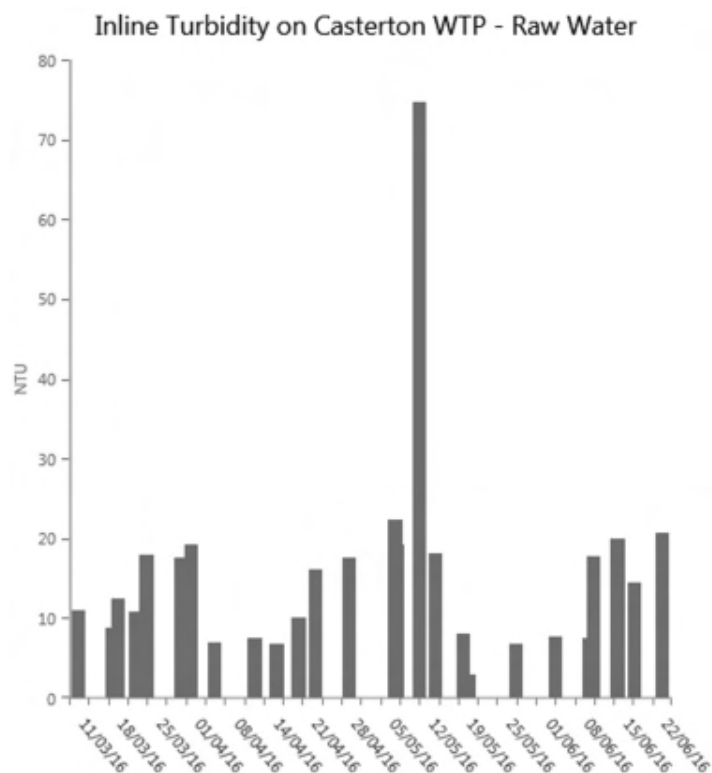
**Figure 2:** *Inline Turbidity on Casterton WTP – Raw Water*

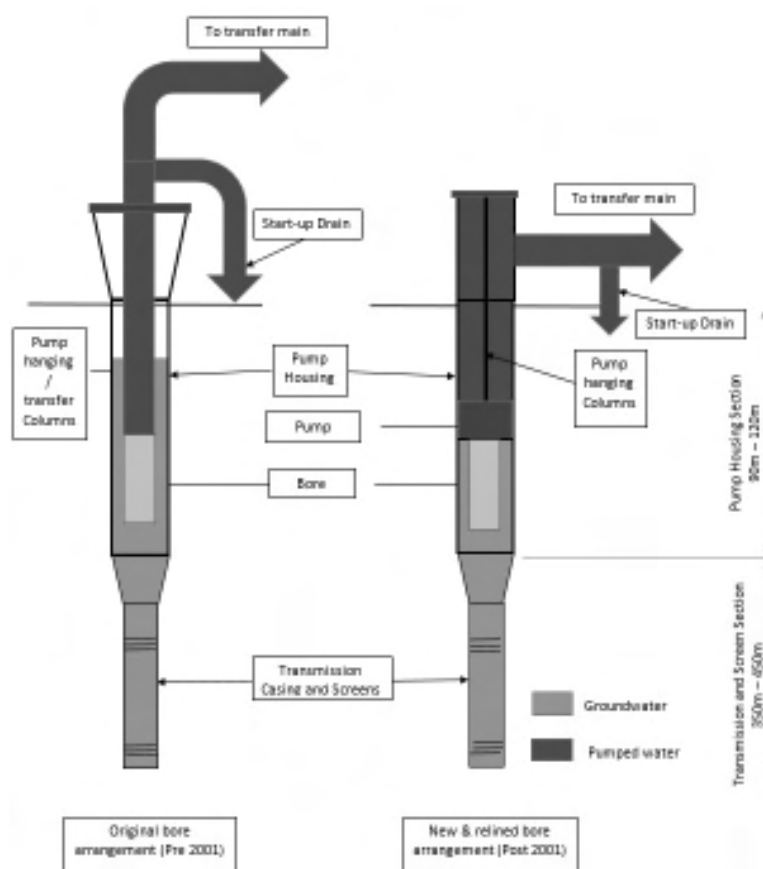
**Figure 1:** *Original and new bore arrangements*

With the bores relined, the pump housing section of the bore can now be used to pump the groundwater to the bore headworks (refer Fig 1). This requires a pump packer system to be used within the bore as is used in the two newer bores constructed in 2001. The bore headworks are reconfigured to suit the riserless system and the bore pump columns are replaced with hanging rods.

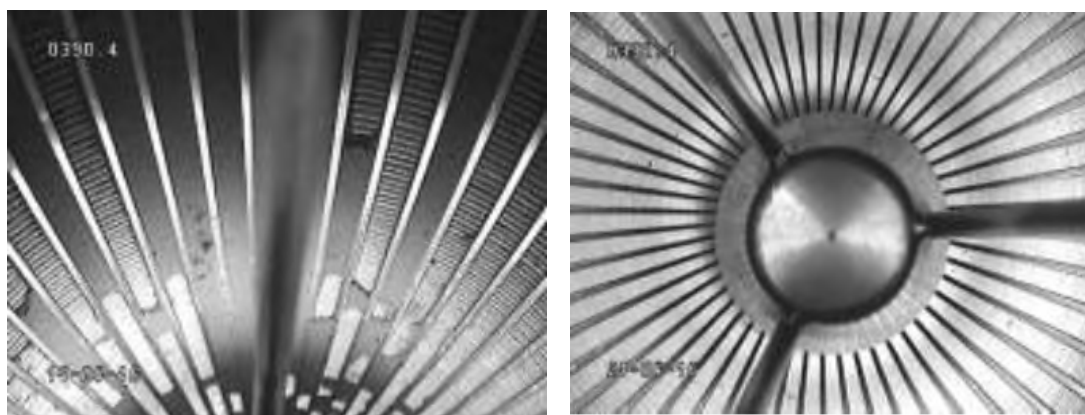
**Figure 2:** *Bore screen before and after cleaning. Note iron bacteria build-up on left*

The bores were again inspected via CCTV to determine the effectiveness of the cleaning and repeated where necessary until clean. The bores were then disinfected to prevent the re-occurrence of iron bacteria which can block the screens and reduce the pumping capacity of the bore.

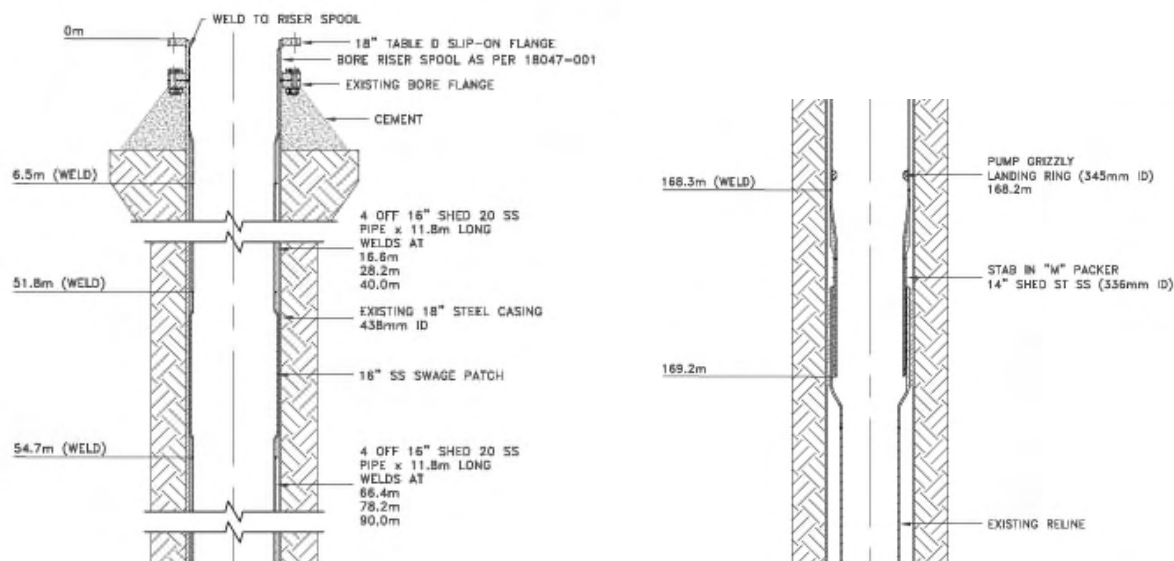
**Figure 3:** *Upper and lower sections of the relining works*

Once the full length of the sleeve has been installed, the new lining is welded to a matching piece at the wellhead to complete the relining.

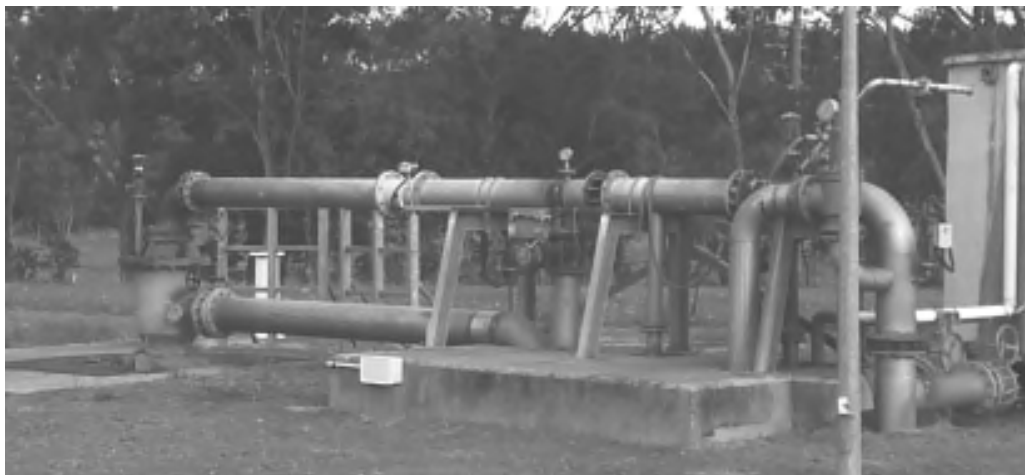
**Figure 5:**      *Original bore wellhead arrangement (GW5, built 1982)*

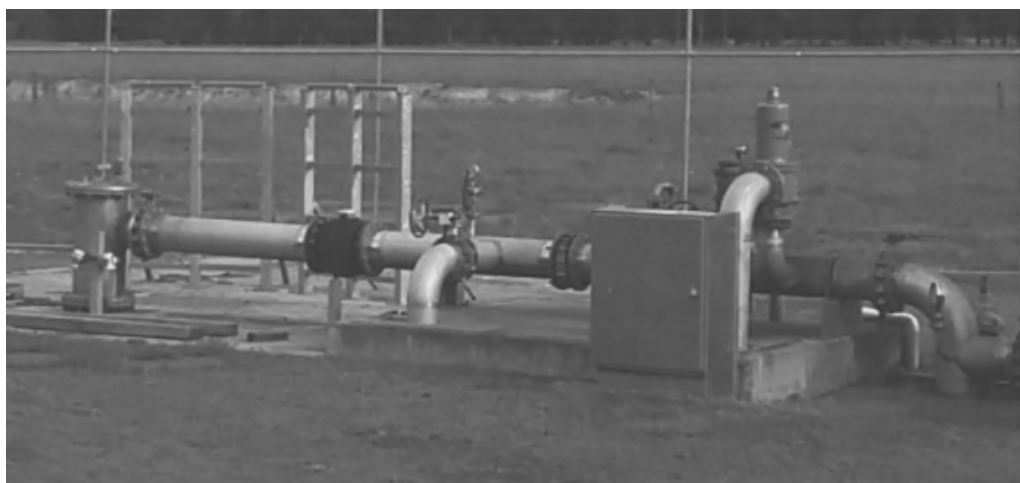
**Figure 6:**      *More compact riserless bore wellhead arrangement (GW8 built 2001)*

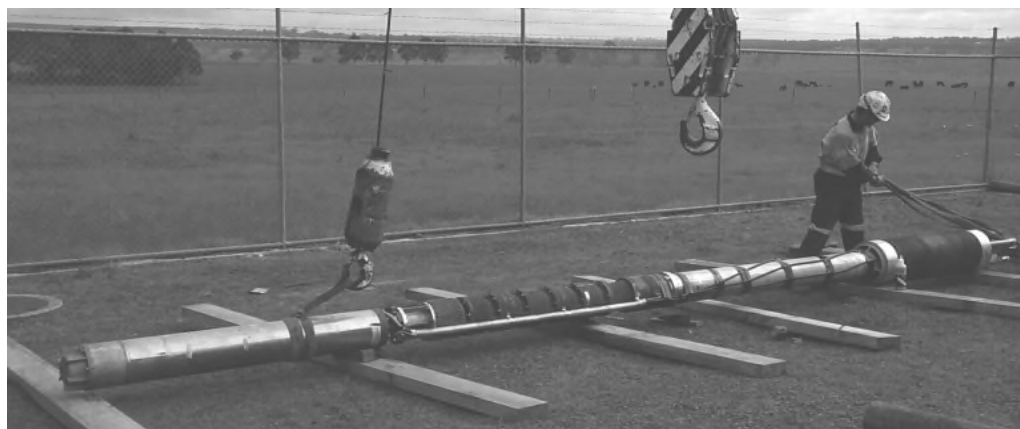
**Figure 7:**      *Pump and packer set up – pump and motor at bottom left, packer at right*

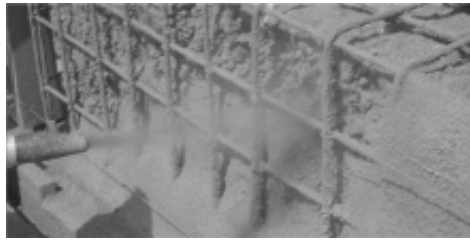
**Figure 6:** *Cementitious mortar being placed over reinforcing steel*

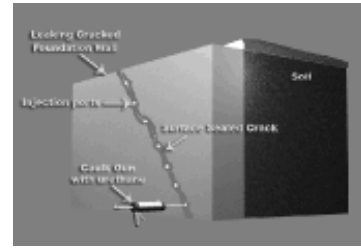
**Figure 7:** *Resin injected crack repair system*

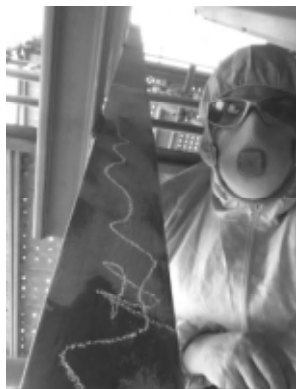
**Figure 11:** *Scaffold not providing adequate access to surfaces preparation*

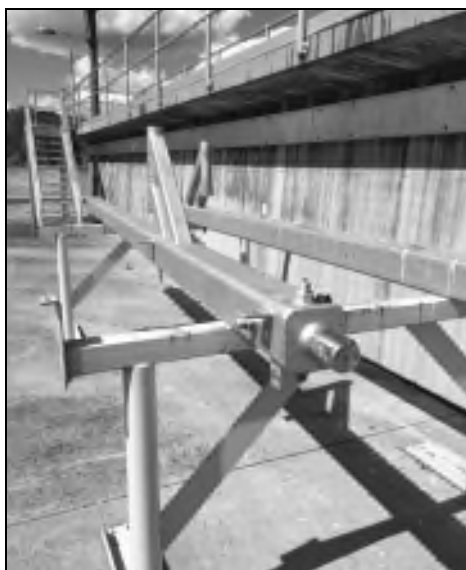
**Figure 1:**     *Mixer mast*

During the biannual maintenance program, maintenance staff noticed significant wear on the mixer mast locating pin (Figures 1 & 2).

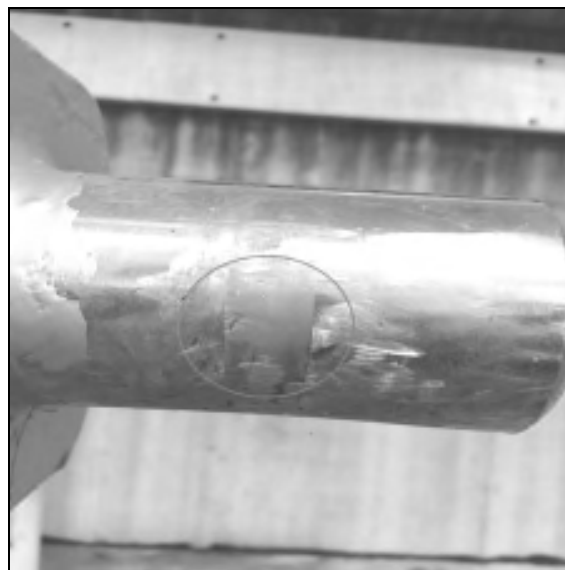
**Figure 2:**     *Repaired locating pin*

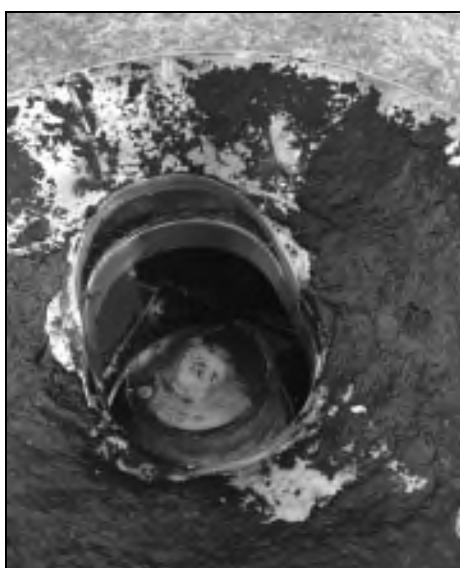
**Figure 3:**     *Worn baseplate*

Each mast locates into a base plate fixed to the bioreactor floor (Figure 3 & 4).

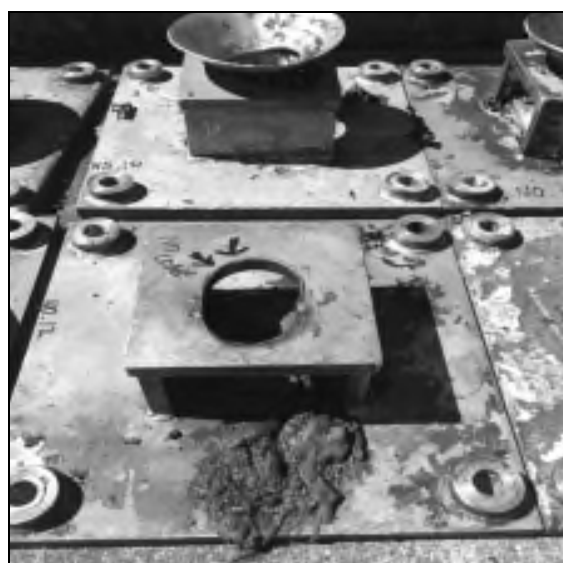
**Figure 4:**     *Worn baseplate missing locating cone*

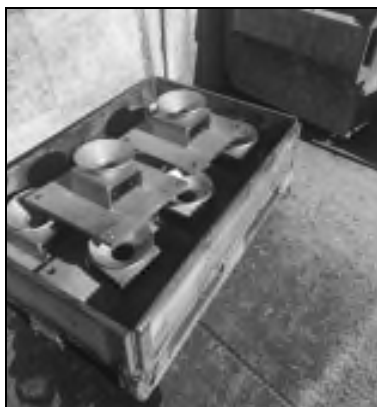
**Figure 5:**     *New baseplates*

While the investigation was underway to take the bioreactor offline, the 14 replacement baseplates were procured from the original supplier. The time to order and fabricate the new baseplates was 16 weeks.

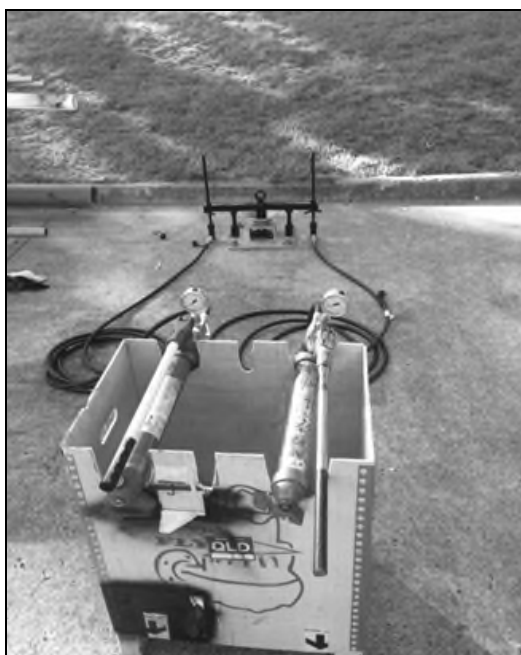
**Figure 6:**     *Lifting tool*

The final result was a lifting device which was lowered to the base plate using the onsite jib crane. A diver secured the lifting tool to the worn base plate using a locking pin. The height of the lifting tool could be adjusted with wing nuts and a hydraulic ram was fitted to each end of the lifting tool connected to two hydraulic pumps. Each pump had a visual gauge so the operator could watch the hydraulic pressure and maintain even pressure on each ram (see Figure 6).

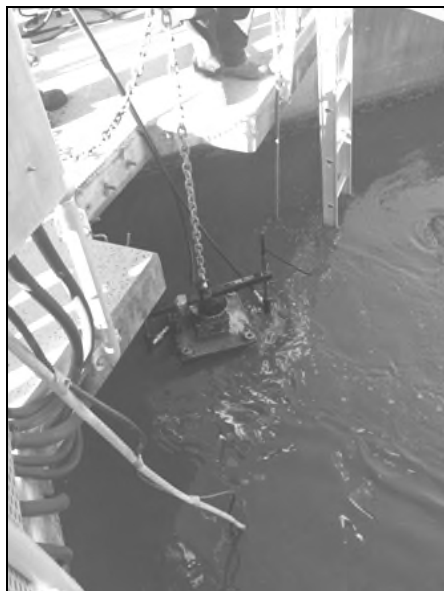
**Figure 8:**      *Removal of first baseplate attached to jib crane*

The idea was to make the tool as easy as possible for the diver to operate. When the lifting tool was fitted, the diver moved away while jacking took place. The diver had full audio communication with the fitters above, which was essential for the safety and accuracy of the project. The hydraulic rams on the lifting tool had 25mm travel so a few ram height adjustments were required to clear the baseplate of the anchor bolts. The diver could feel if the baseplate was lifting off square and re adjust the wing nuts after each lift. When the plate was jacked off the anchor bolts, the lifting tool and base plate could be raised to the surface using the jib crane. This was possible as the lifting tool was still attached to the base plate with the locking pin (see Figure 8).

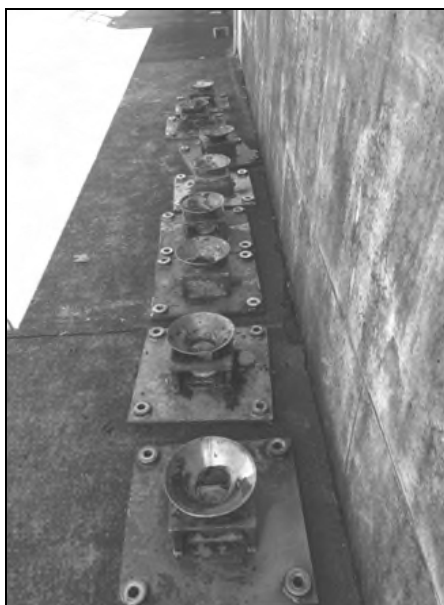
**Figure 9:**      *Worn baseplates removed from service*

The day came to put the lifting tool to work. We had planned the project to take 5 days. The first base plate was removed before morning tea, and there was relief to see the base plate was as worn as expected and was in need of replacement.

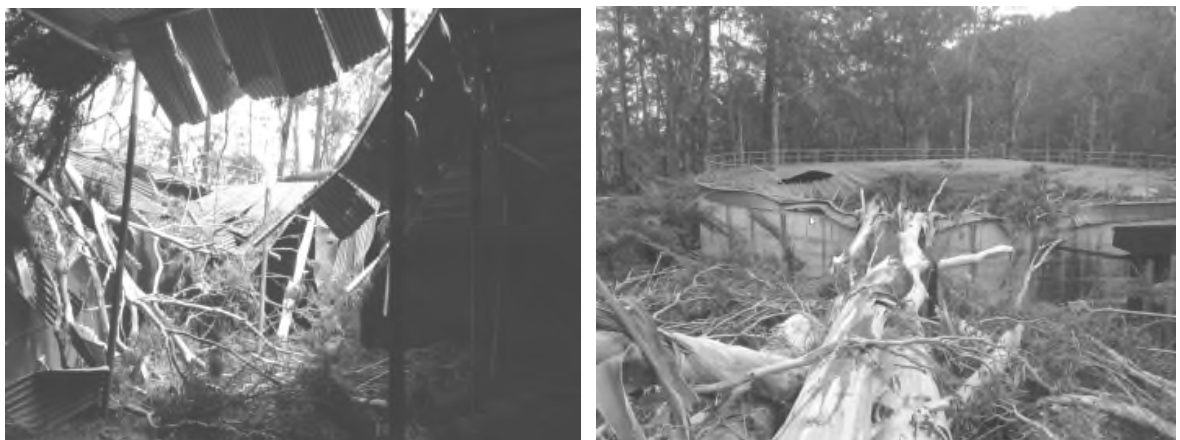
**Figure 2:**     *Internal & External View of Frogley Reservoir*

- A burst on the single feed to the Chum Creek Reservoir resulting in that reservoir completely emptying. Customers did not lose supply due to the location of the burst and the ability to continue pumping from the Mt Lebanon Pump Station.
- Prolonged loss of power to most assets including both treatment plants.
- Blocked access to both treatment plants.
- Damning of the Coranderk Aqueduct so that it no longer could supply the treatment plant
- Most dramatically the insertion of a large tree into Frogley Reservoir (Figure 2)

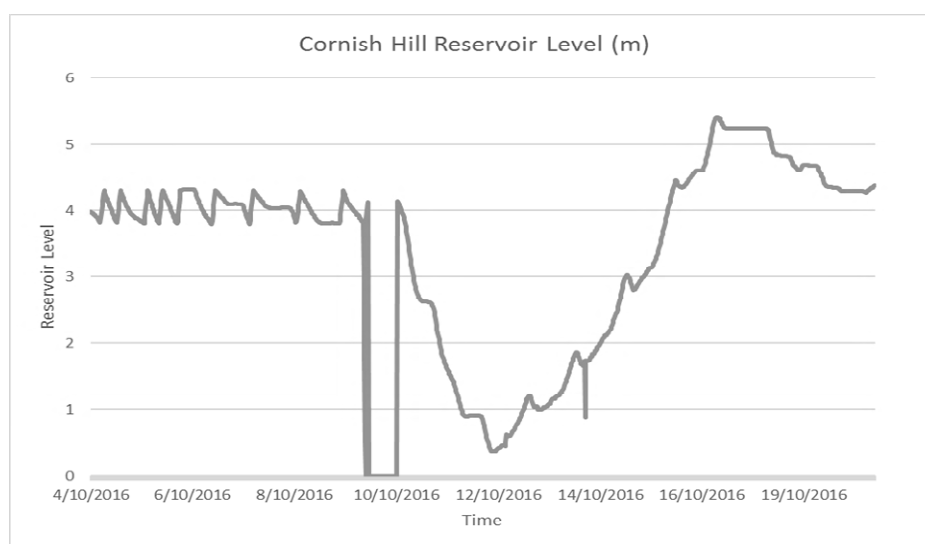
**Figure 4:** *Cornish Hill Reservoir Level*

The solution was that during low demand periods the outlet valve of Cornish Hill Reservoir could be closed and the inlet valve opened so that the mobile pump was supplied with water from Creswell Reservoir, supply the Frogley zone and fill the Cornish Hill Reservoir. During high demand periods the outlet valve was opened and the inlet valve closed so that the mobile pump was supplied from Creswell reservoir and supplied the Frogley zone, whilst the Cornish Hill Reservoir depleted. Fortunately, more water could be supplied to the Cornish Hill Reservoir during low demand than was used in high demand periods. This operation required an operator on site 24/7 for 2 weeks before works were completed to make this automatic and allowed the tank level to recover to within normal operating bounds.

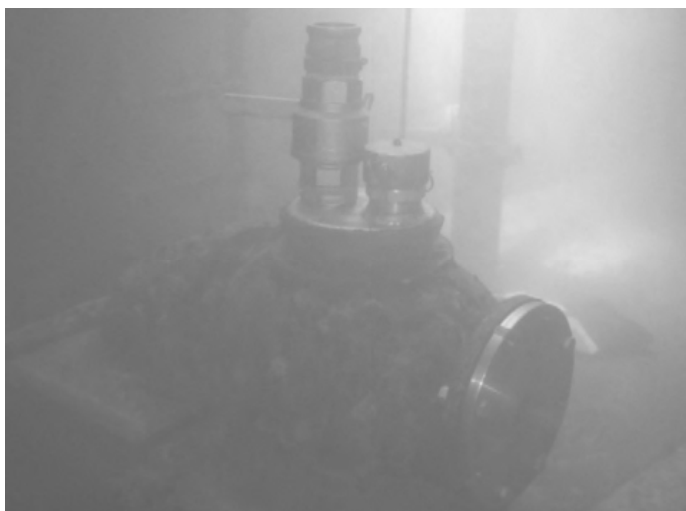
**Figure 5:** *Inlet Structure “Cork”*

After an inspection of the internals of the reservoir using a submersible ROV it was determined that the only way to isolate the failed valve was to have divers enter the online tank and fit what amounted to a large cork into the inlet structure.

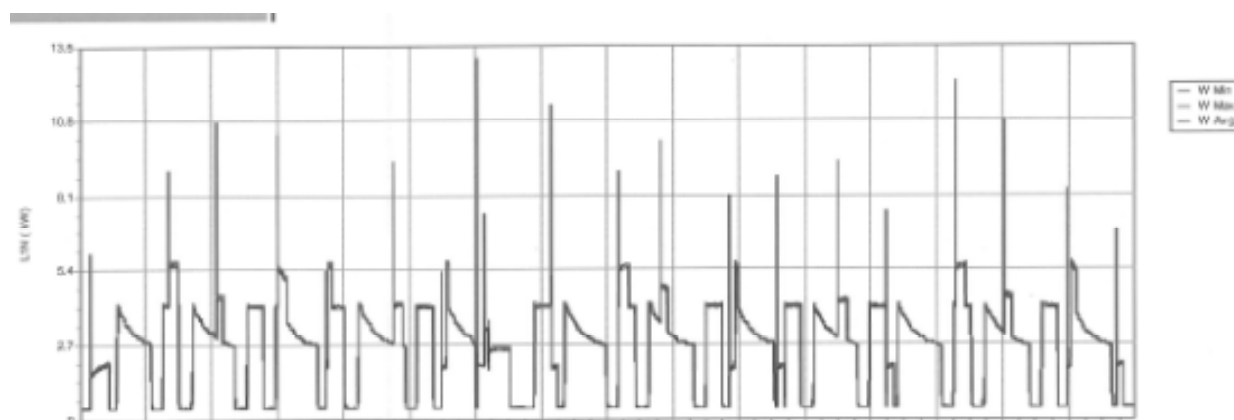
**Figure 2:** *Yackandandah WTP energy use*

The first step to understanding what the project might look like, North East Water first had to assess the energy profile of the plant. This allowed NEW to understand the energy requirements to have sufficient renewable energy and storage to run the WTP “off grid”. It was initially identified through profiling the energy consumption that the WTPs energy use was highly variable showing large spikes during the plants operation (*see Figure 2*).

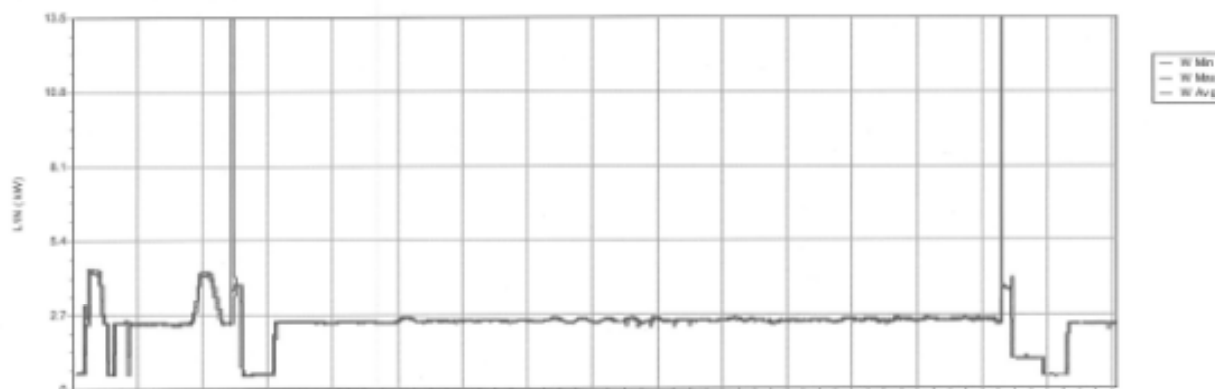
**Figure 3:** *Yackandandah WTP energy use after optimisation*

Both these changes resulted in a dramatic reduction in power spiking and energy use as highlighted below in Figure 3. As a result of these improvements, the design of energy storage and solar generation plant could be reduced from 100 kW solar and energy storage to 40 kW each, bringing the cost of the installation down significantly.

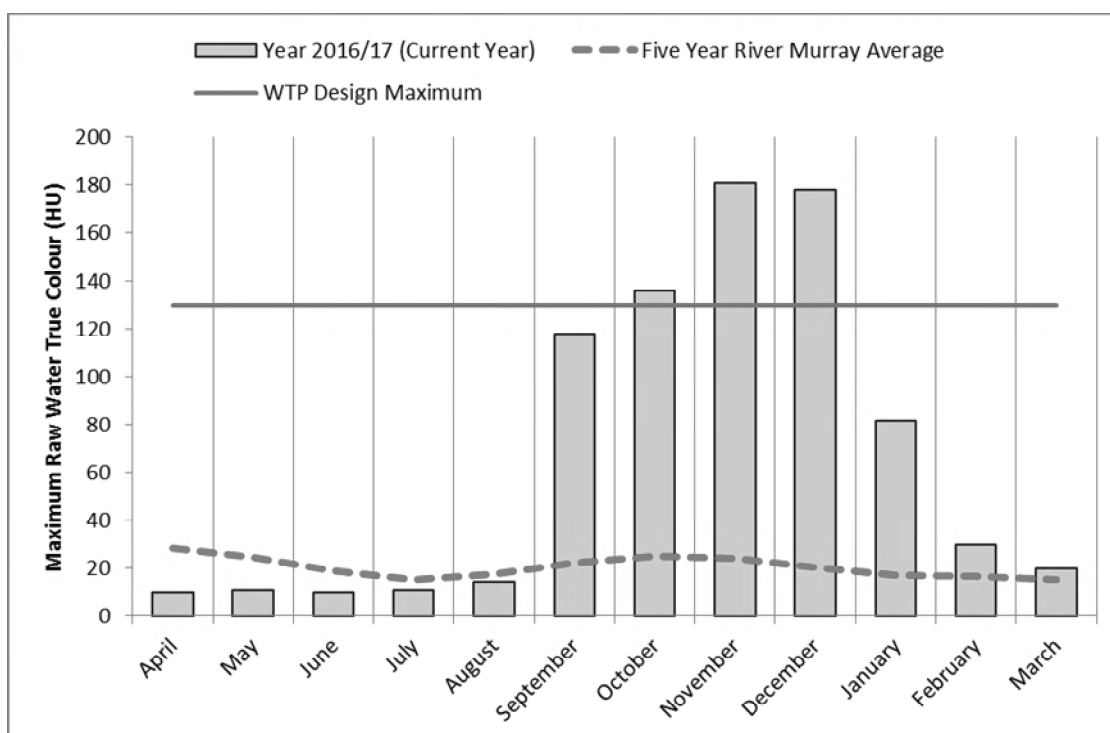
**Figure 2:** *Maximum Monthly True Colour Readings from Mannum WTP*

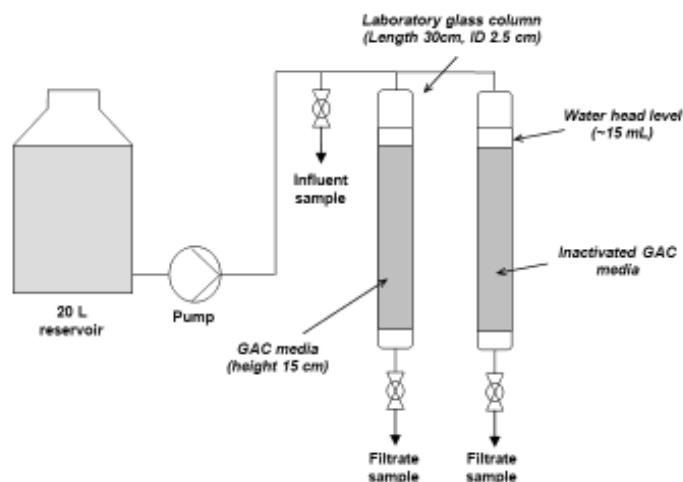
**Figure 1:** Schematic of the laboratory GAC filters

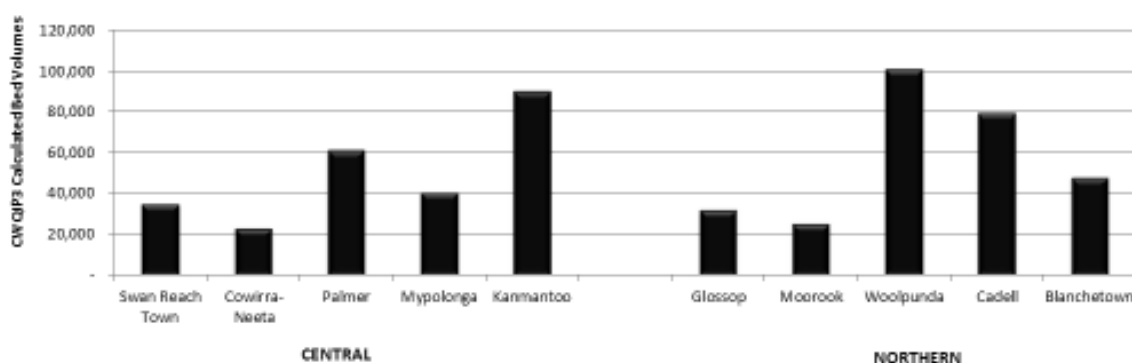
**Figure 5:** *CWQIP3 GAC calculated bed volumes at 15 March 2017*

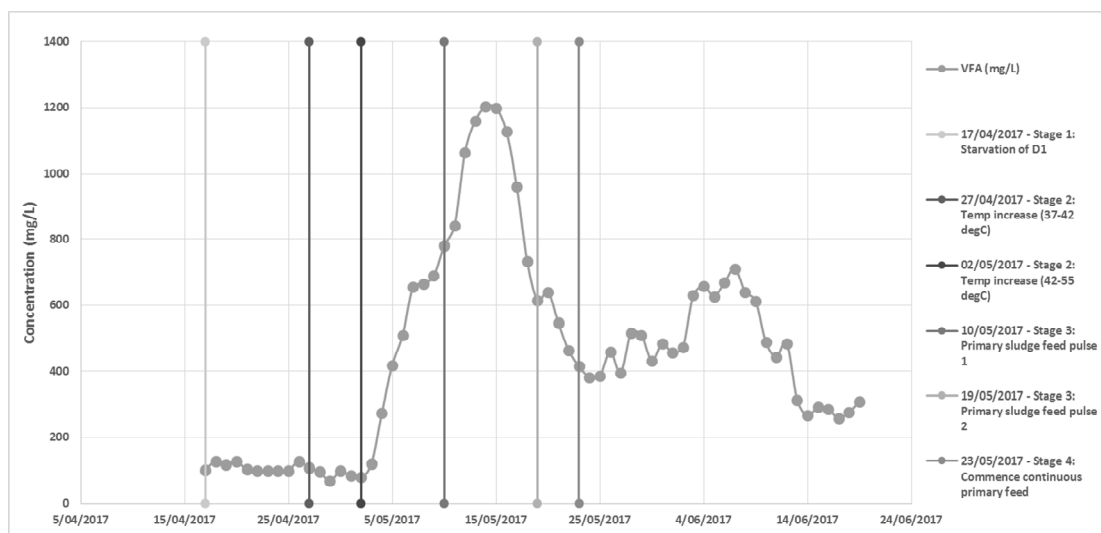
**Figure 2:**      ***Total VFA concentration in Digester 1 during TPAD transition***
