# 80<sup>th</sup> WIOA Victorian Water Industry Operations Conference and Exhibition

# OPERATIONAL REVIEW: OPTIMISATION OF POLYMER IN THE COAGULATION PROCESS

*80<sup>th</sup> Annual WIOA Victorian Water Industry Operations  
Conference and Exhibition  
Bendigo Exhibition Centre  
6 September to 7 September, 2017*

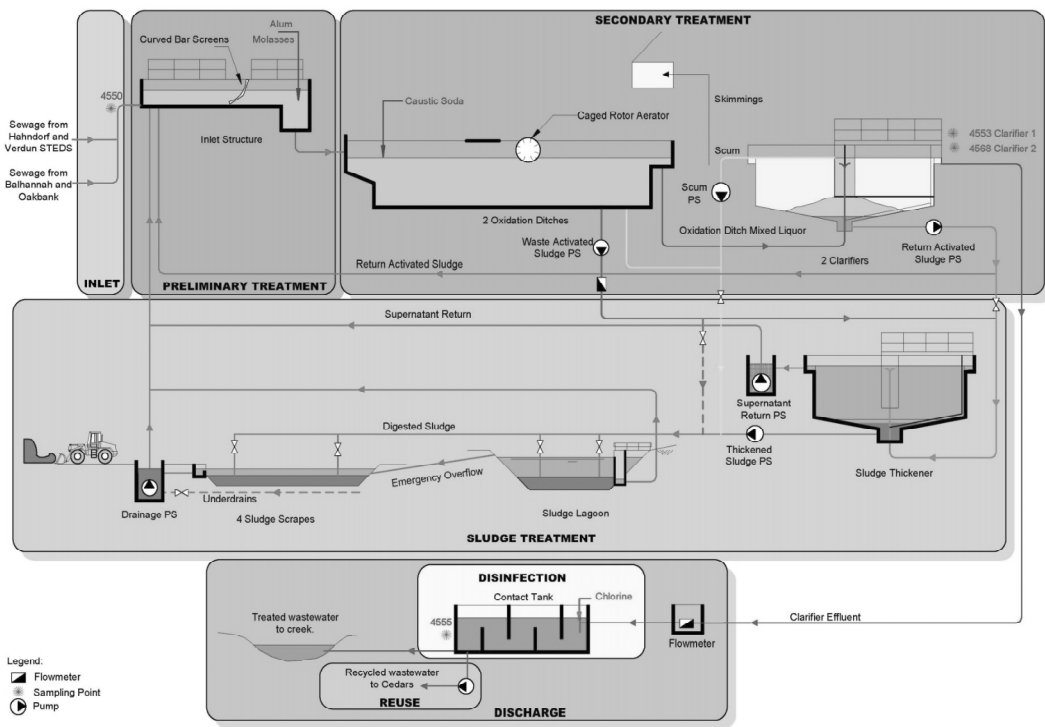
**Figure 1:** *Schematic of Hahndorf WWTP*

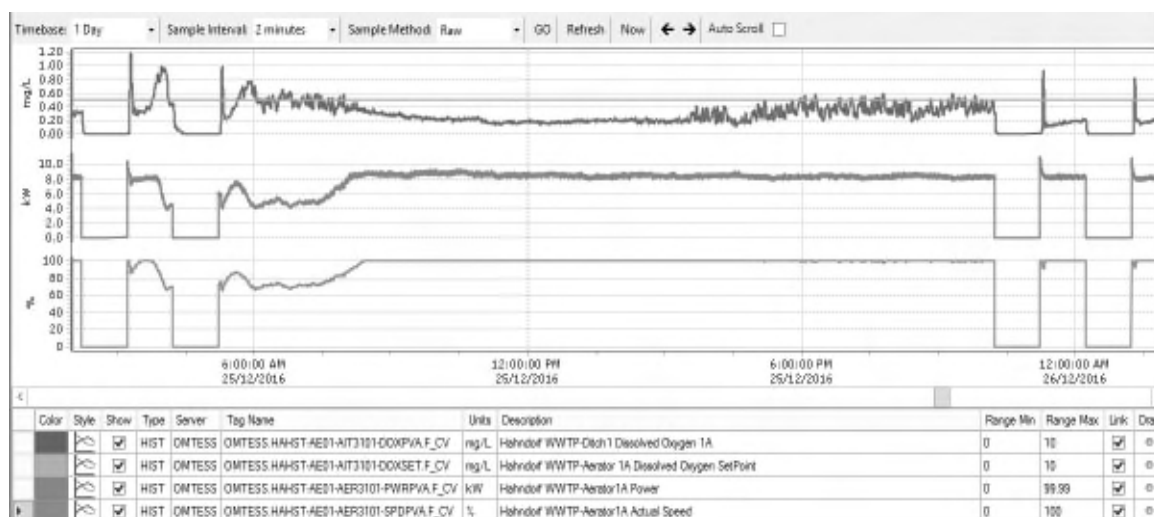
**Figure 3:** SCADA screenshot displaying insufficient aeration even when the aerator rotor is working at full speed (bottom trend). The measured dissolved oxygen (top trend) does not reach the dissolved oxygen set point of 0.6mg/L (horizontal line, top trend) for most of the day.

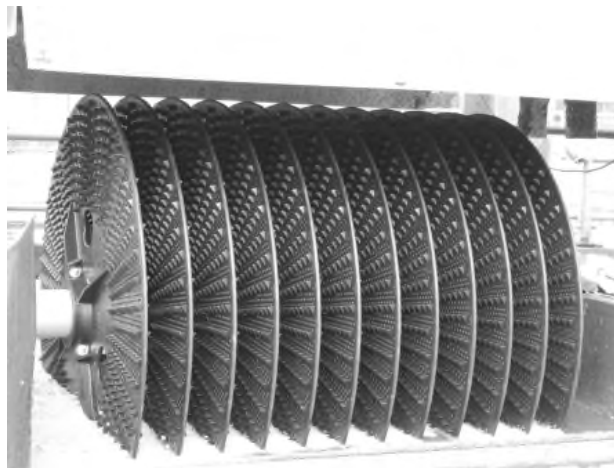
**Figure 3:**     *Disc Aerator*

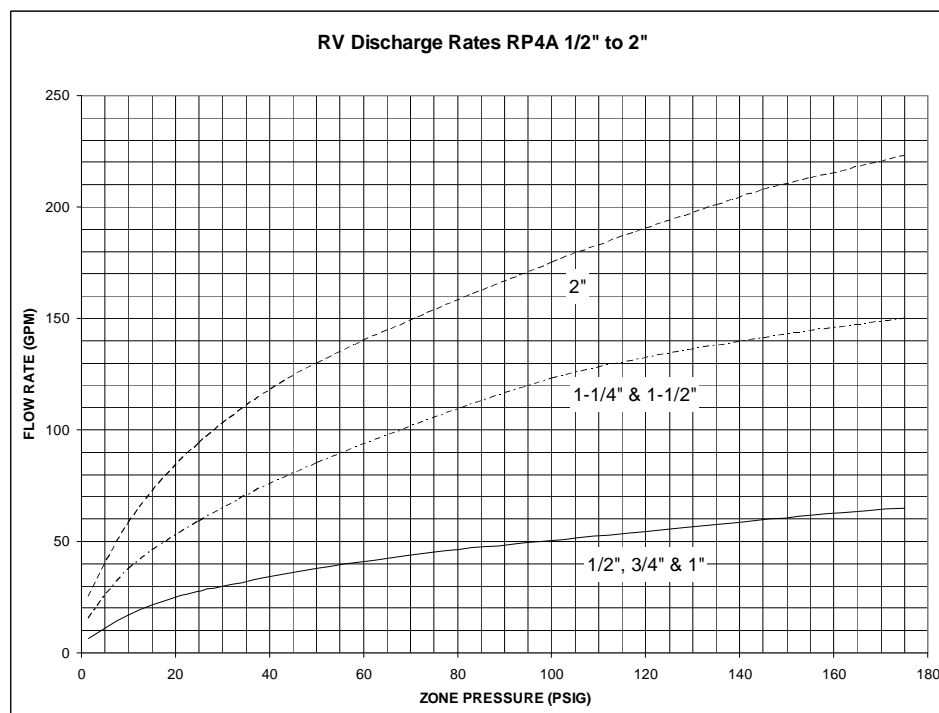
**Figure 1:** *Apollo Valves RPZ discharge Rates*
