**CCTV INSPECTION OF SEWERS AND
STORMWATER DRAINS, TRAINING OF
OPERATORS AND MANAGERS, AND THE CONDUIT
INSPECTION REPORTING CODE OF AUSTRALIA**

*3rd Annual WIOA NSW Water Industry Engineers & Operators
Conference*

Steve Weatherstone, *Principal*, Streamline Learning

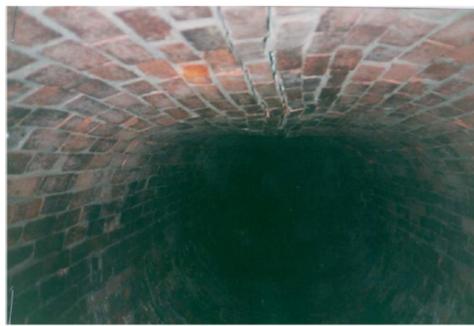
Figure 1: Page from WSAA Compendium

Code	Ch1	Ch2	Q1	Q2	Circ Loc'n	Long'l	Cont	Remarks
D	V		11-15		12		A	Arching support lost
BS			<10		12		A	RHS of central brick
BS			<10		12		A	LHS of central brick

The crown of this oviform (ovoid) brick conduit has deformed vertically (D-V) by an estimated 11-15%. To permit such a deformation the walls must have moved outwards slightly due to loss of ground (side-wall) support. The resultant feature is sometimes referred to as 'hearting' failure of brick conduits.

As far as we can see the deformation is continuous so 'A' (applicable) is noted in the continuous field.

Brick separation in the crown (BS) is also evident. Two observations are reported to record the separation on both sides of the central brick course both with the 12 o'clock location reference. The width of the separation is estimated to be less than 10 mm. Both of these defects are continuous.

Brick conduits exhibiting this feature are at risk of imminent failure and the asset owner should be advised immediately.

A substantial revision of WSA05-2002 got underway early 2005 and I was engaged by the Water Services Association of Australia (WSAA) to assist in that process. Part of this work was to produce guidance coding and commentary for typical and non typical defects in sewers and drains which was to form a 'Compendium' available on the WSAA website. One page from the Compendium is shown to the right.

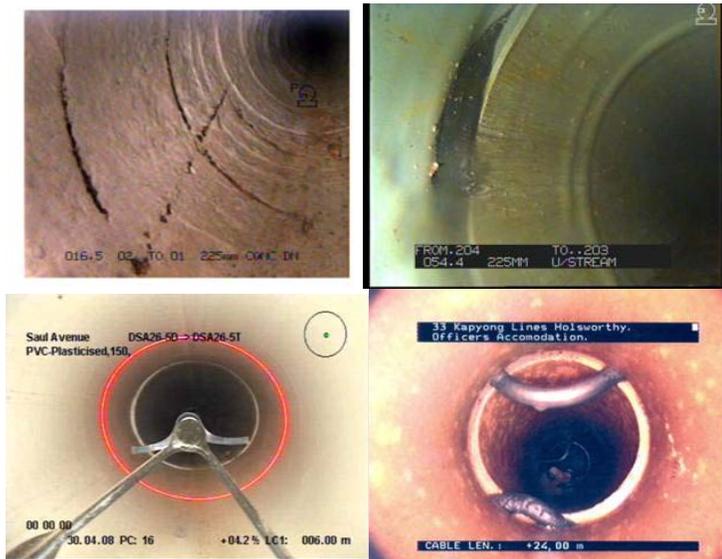
The following examples show some defects that were built in to new assets and can only be detected by CCTV inspection

Figure 4: *Examples of defects in new sewer and stormwater installations*
