# WATERWORKS

OFFICIAL JOURNAL OF THE WATER INDUSTRY OPERATORS ASSOCIATION

DECEMBER 2007

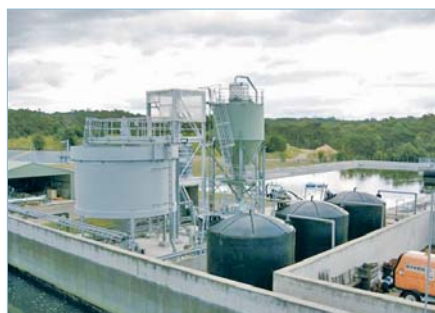
Alum & Lime Dosing at the Mittagong STP.

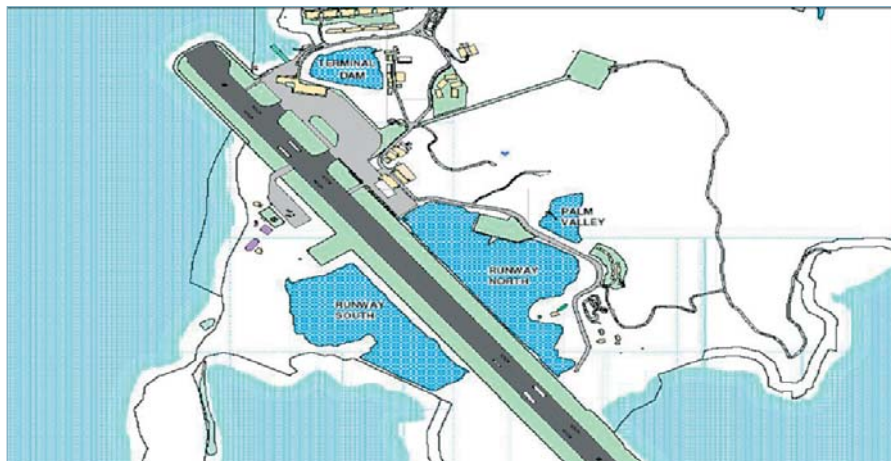
Schematic of the Hamilton Island treatment system.

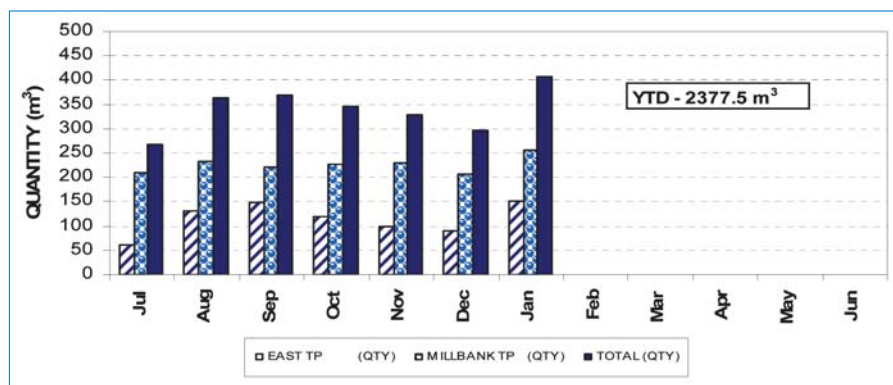
Figure 1. Biosolids removal for the year to date.

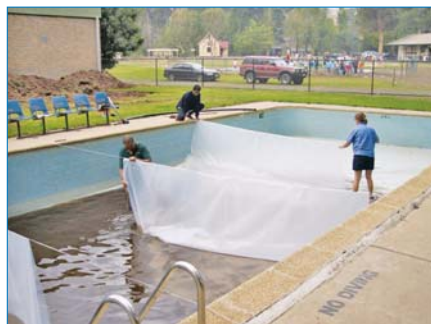
**Figure 5.** Temporary baffles in the Licola swimming pool.

The solid baffles worked much better at keeping sludge from migrating throughout

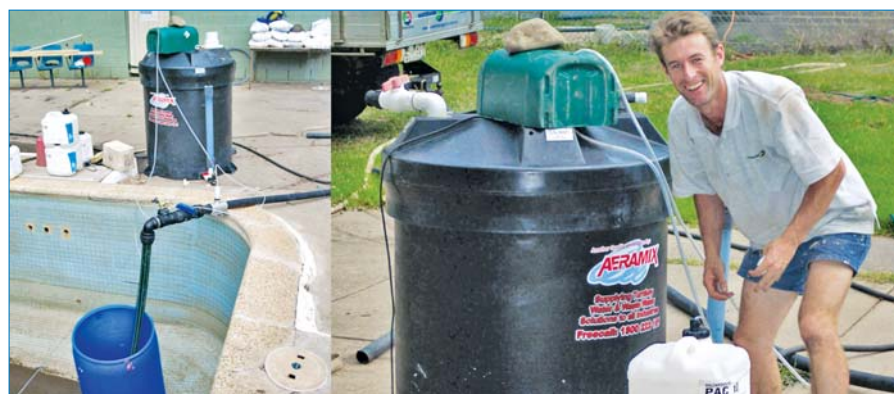
**Figure 7.** The PAC mixing system and 'jerry rigged' rapid mixing and diffuser tank.

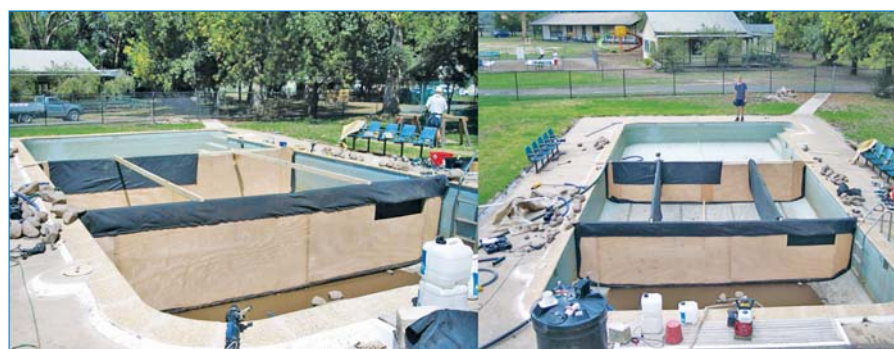
**Figure 8.** The improved baffle system.

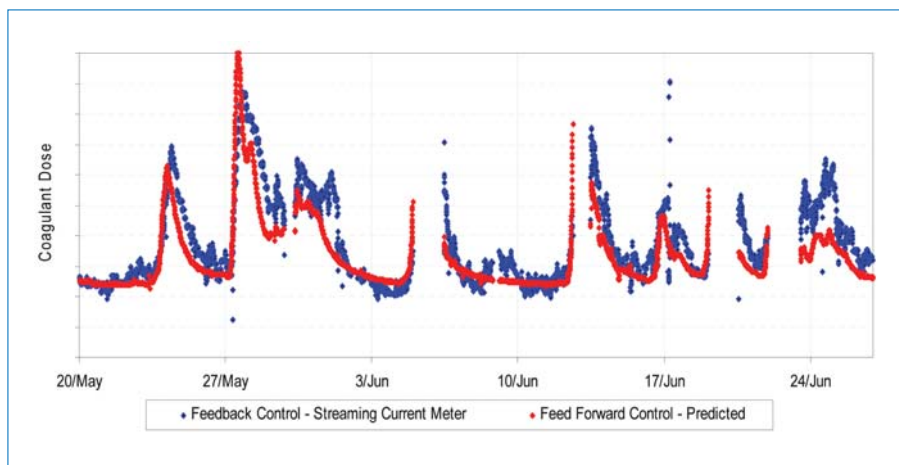
**Figure 2.** Comparison of Feedback and Feed Forward Coagulant Dose (Courtesy of h2ope Controls Ltd, Wellington, New Zealand).

The SCM was also slow to react to **improving** water conditions and the resulting dose often over or under the optimum dose. This is clearly illustrated in Figure 2 which shows actual trends of the

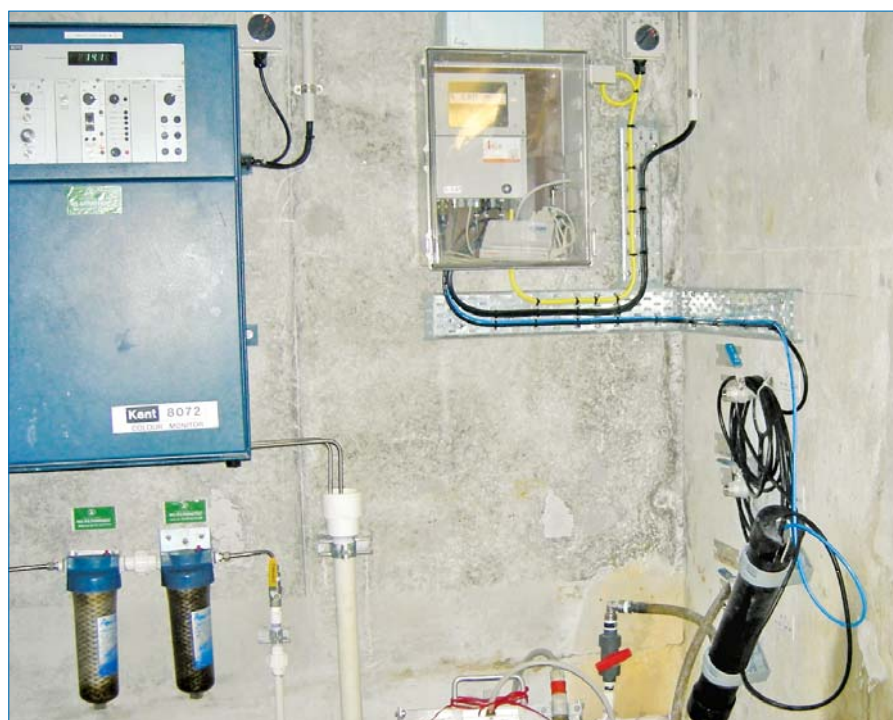
**Figure 3.** The s::can unit is shown mounted against the right hand wall with the output display touch screen situated above it on the back wall. The old colour meter is shown on the left on the back wall.

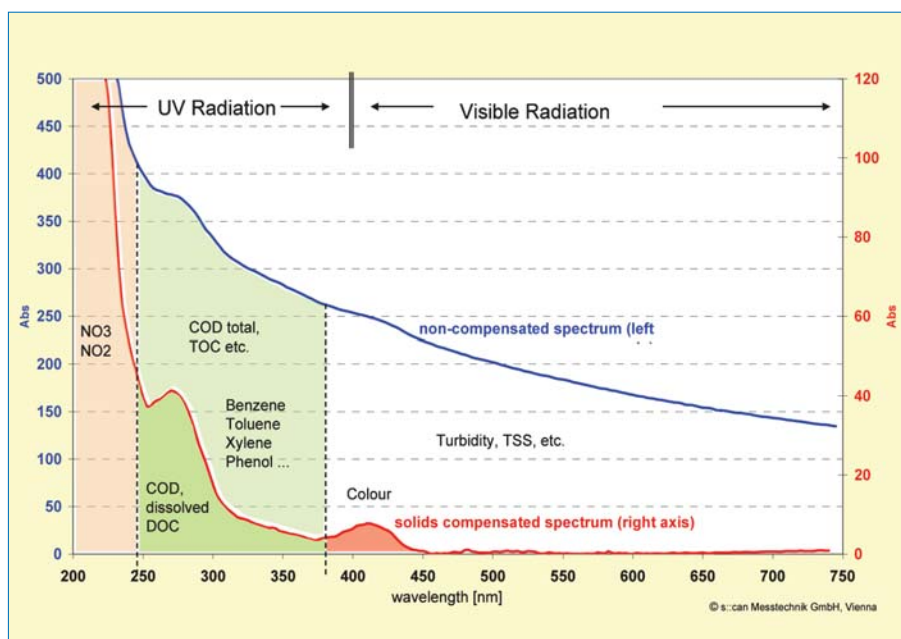
**Figure 4.** S::can Parameters and Measuring Principals (Courtesy of s::can Messtechnik GmbH, Vienna, Austria).

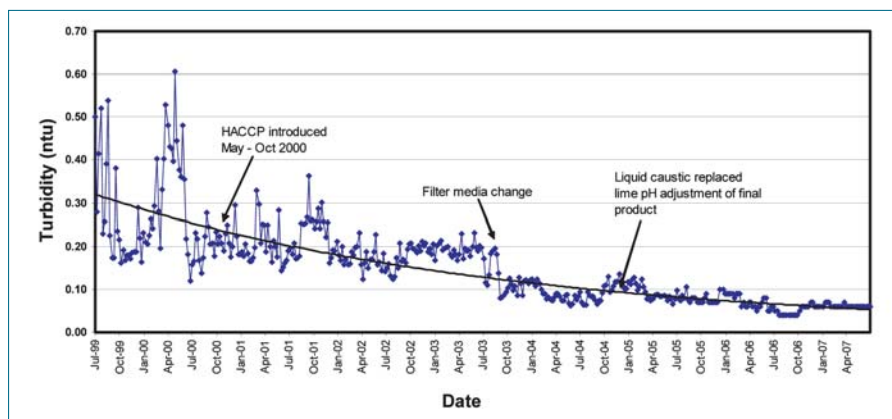
**Figure 1.** Long term turbidity trend of finished water from the Molendinar WTP from 1999 to 2007.

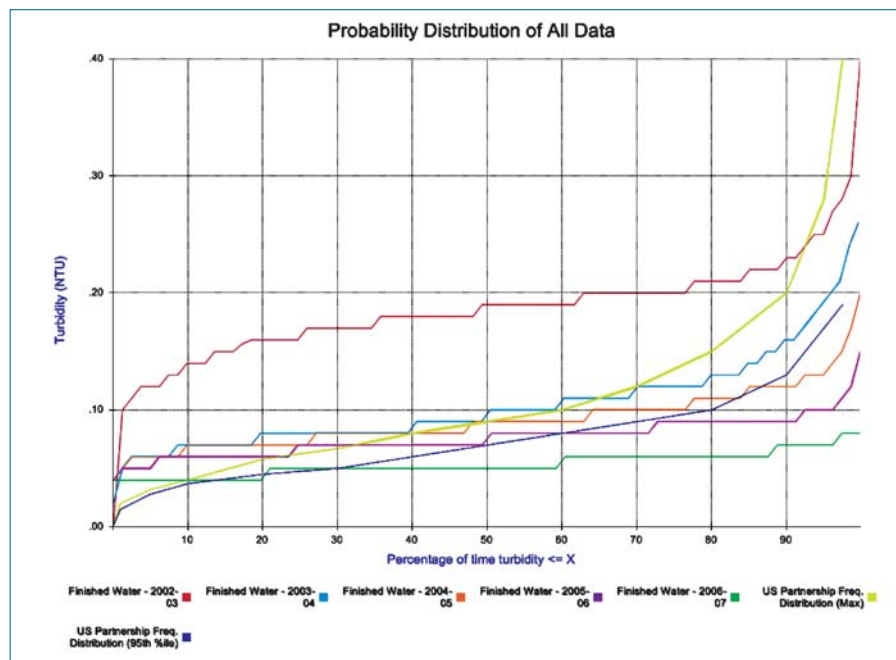
**Figure 3.** Cumulative probability graphs for the finished water turbidity from the Molendinar WTP from 2002 through 2007.

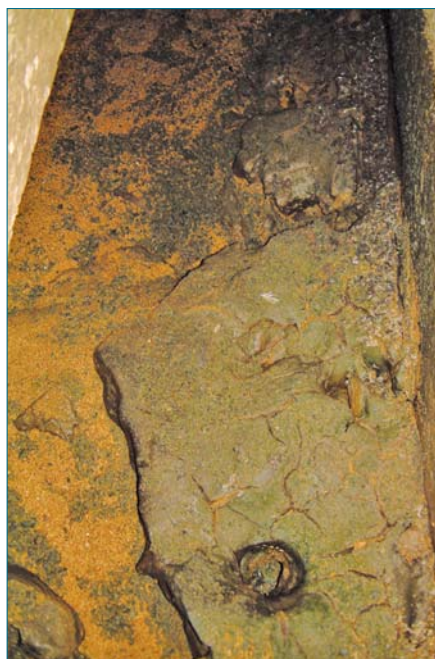
**Figure 2.** The surface of one of the sand filters at the Mudgeeraba WTP in 2003 prior to a rebuild. Note the extensive thick layer of mud on the surface.
