# WATERWORKS

OFFICIAL JOURNAL OF THE WATER INDUSTRY OPERATORS ASSOCIATION

December 2008

Editorial - Filter Training Needed for STP Operators??	3
Letters to the Editor	4
Recycled Water Colour Woes	7
Cleaning Diffusers at Edgeworth WWTW	10
Bright Filtration Shines	13
Kwatye Prize Report: Sewer Blockages and Tree Roots	15
Sewer Response Unit (SRU)	18
Kawana STP Upgrade Sorted	20

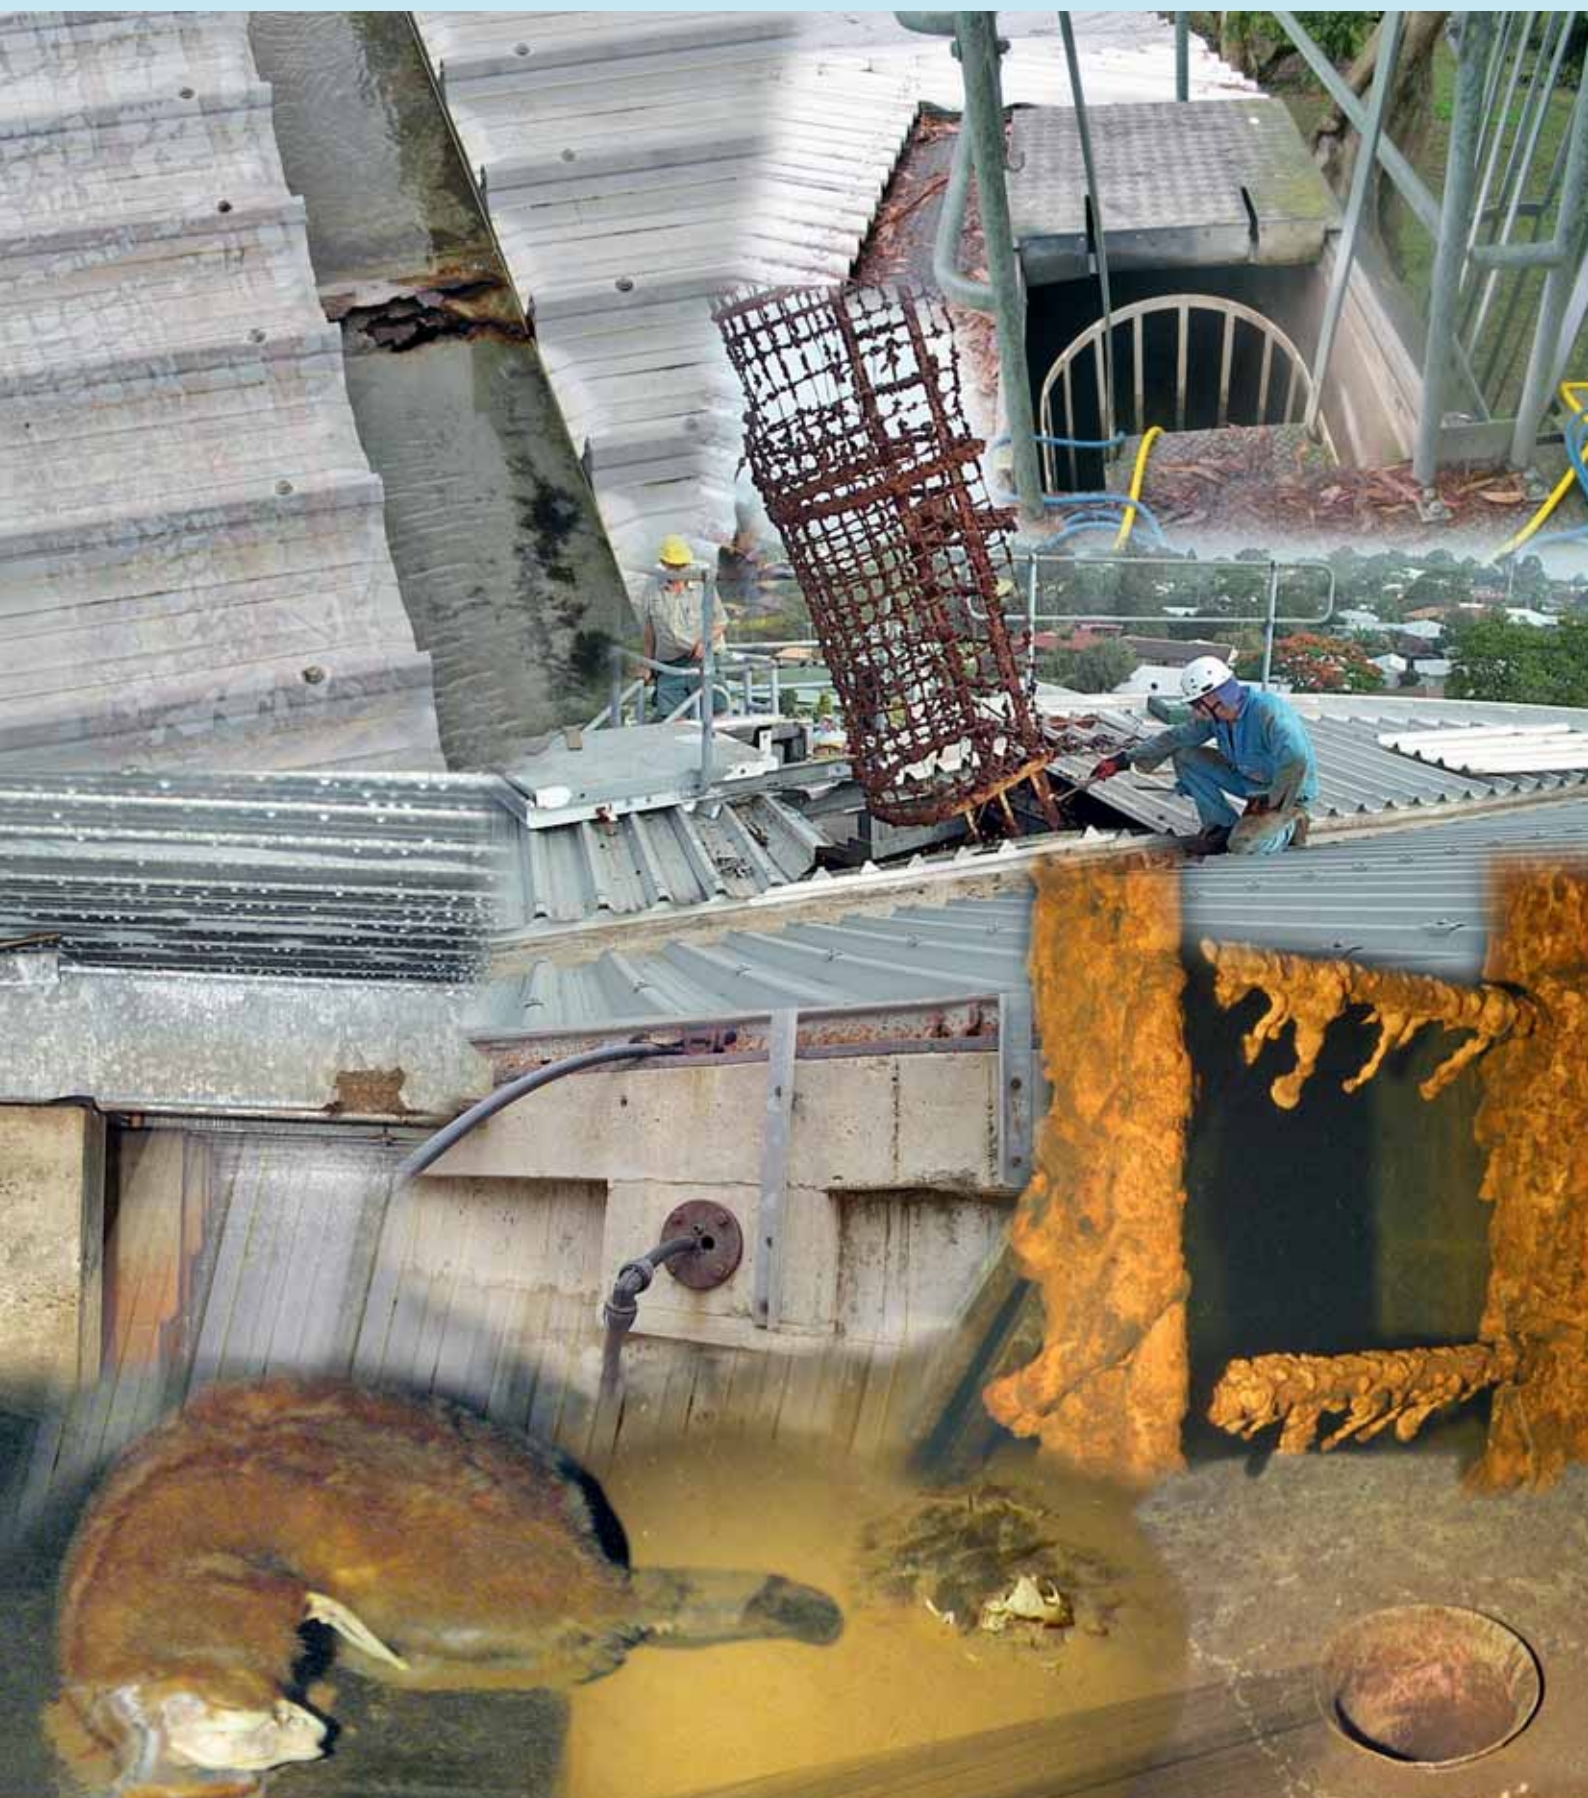
The photos on the front cover show a possum's and a fox's corpse in storages, roofs with holes in and access hatches that allow anything on the roof to easily run into the storage every time it rains. The question needs to be asked, how many people are becoming ill in Australia due to slack maintenance of treated water storages. We know that recontamination of drinking water after it has left a treatment plant is a high risk and yet storages like the ones on the cover are all too common. Isn't it time we cleaned up our act. Imagine seeing storages like this at a dairy factory or brewery?? Why is water different??

Our cover this month is a montage of photographs taken on, beside or in various treated water storages across our country. The photographs have been kindly provided by Dave Barry of Aqualift Pacific. Clearly, many of our treated water storages leave a lot to be desired in ensuring the safety of our drinking water. International events like Gideon, Missouri in 1993 where in a town of 1100 people, 600 people became ill and 7 died due to poor maintenance of a treated water storage and contamination with bird droppings should bring home the message loud and clear. More recently in Australia, Cairns Regional Council issued a boil water alert in Port Douglas and surrounding areas as a result of *E coli* being present in 7 of 12 treated water reservoirs. In an interview on the ABC PM program, Cairns Regional Council Manager of Regional Waste and Water stated that "some of the reservoirs do have small holes and gaps and things in the roofs where this contamination could be coming in through lizards, cockroaches and frogs and who knows what else. We

will be moving to clog up those holes as best we can." Not sure about the accuracy of the implied microbiology however the suspected cause was clear, storages with gaps in them. In a recent event in the UK (reported in *Health Stream* September 2008) a single dead rabbit in a storage resulted in a boil water alert for 250,000 people in England. The event has been linked to several illnesses from a species of *Cryptosporidium* previously thought not to infect humans.

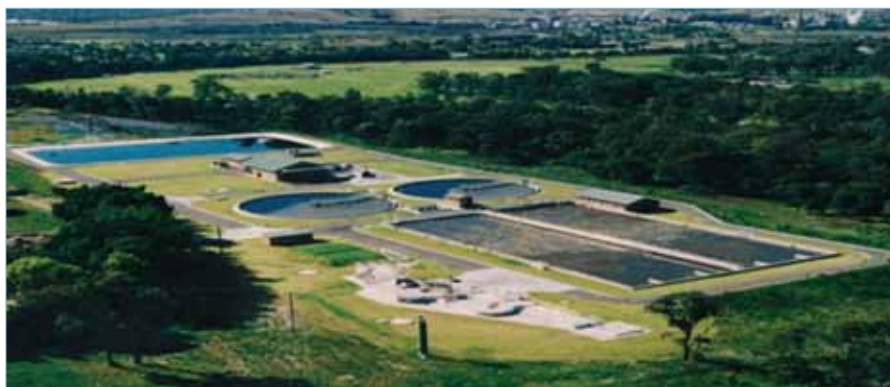
Figure 1. Edgeworth WWTW.

Flow is directed continuously between two bioreactors, which have an anoxic zone and an aerobic zone. Porous polyethylene disc diffusers supply air to the aerobic zones. The diffusers are all Nopon HKL-215 units, which are 215mm in diameter (Figure 2). The porous discs split the supplied air stream into many small bubbles.

There are 1306 diffuser discs in each bioreactor. Each branch of diffusers has a control valve that can be adjusted for flow balancing purposes. The blowers are designed to start automatically to maintain airflow through the diffusers using DO control. The normal operating pressure of the blowers is around 50kPa. The target

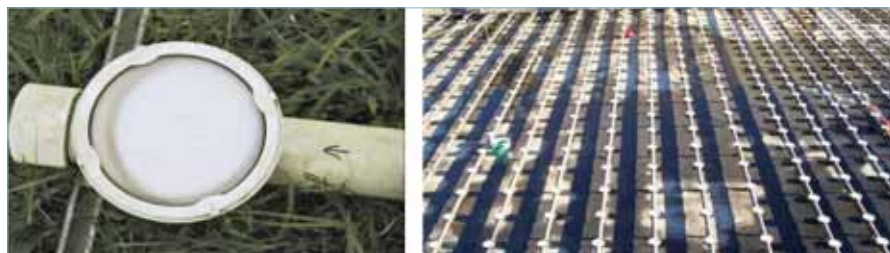
Figure 2. Fine bubble diffusers up close and in situ in the reactor.

These diffusers are subject to fouling and deterioration and need to be cleaned periodically. The inner surfaces may become clogged with air borne dust if the blower inlet air filtration system is

defective. The outer surfaces become coated in attached biological and inorganic slimes. There have been some excessive prolonged air outages due to power surges and blackouts and this will have contributed to solids settling on or entering the diffuser openings, adding to the fouling problem. Increased backpressure on the blowers and reduced oxygen transfer (seen in the inability to meet DO set points) are the best indicators of diffuser deterioration. Fouled diffusers lead to blowers being unable to deliver their capacity without either releasing their pressure relief valves or going into surge.

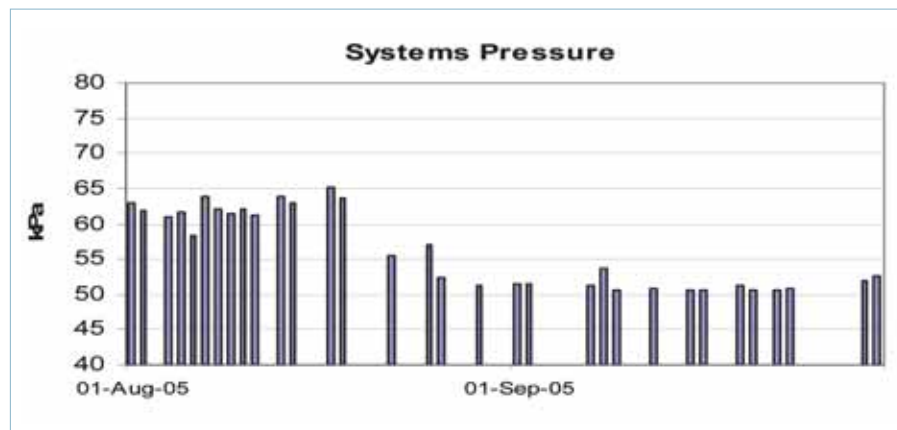
Figure 3. Changes in backpressure before and after diffuser cleaning.

This is the preferred cleaning method recommended by the supplier of the diffusers. Testing was undertaken using this method in 2002, when it was suspected that the diffusers were badly fouled. Backpressures were up to 15-20kPa higher than tests done on new diffusers.

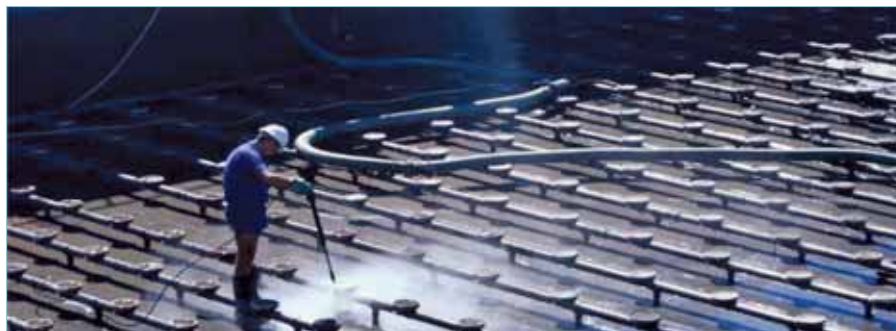
Figure 4. Pressure cleaning of the diffusers in 1999.

One method of cleaning the diffusers is to completely drain the bioreactor and progressively remove the diffusers and clean both sides of each diffuser using high pressure water blasting. This would allow the replacing of the internal check valves. This is a time consuming exercise and as previously mentioned, is dependant on weather conditions. Due to the large increase in backpressure and the heavy fouling of diffusers, this method was used in 1999 with great success (Figure 4). Some thought and research was put into alternative methods of pressure cleaning diffusers where down time could be dramatically decreased. It took 2 to 3 weeks to clean diffusers by removing them and pressure cleaning individually. For this reason an attempt was made to clean the diffusers while in-situ. This was done by maintaining air flow through the diffusers and holding the pressure washer at an angle so as not to further lodge accumulated biological and inorganic slimes. This proved

very successful and it was decided to use this method to clean the diffusers with a crew following behind replacing the internal check valves.

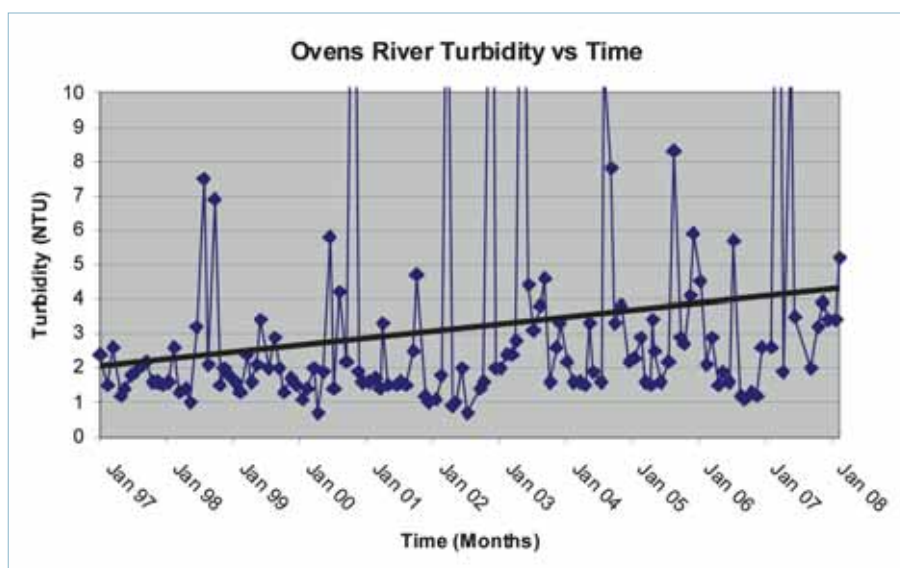
Figure 1. Ovens river turbidity data since January 1997.

Figure 1 shows monthly turbidity data from the Ovens River. The graph highlights both an increase in average turbidity levels and frequency of high turbidity events in recent years.

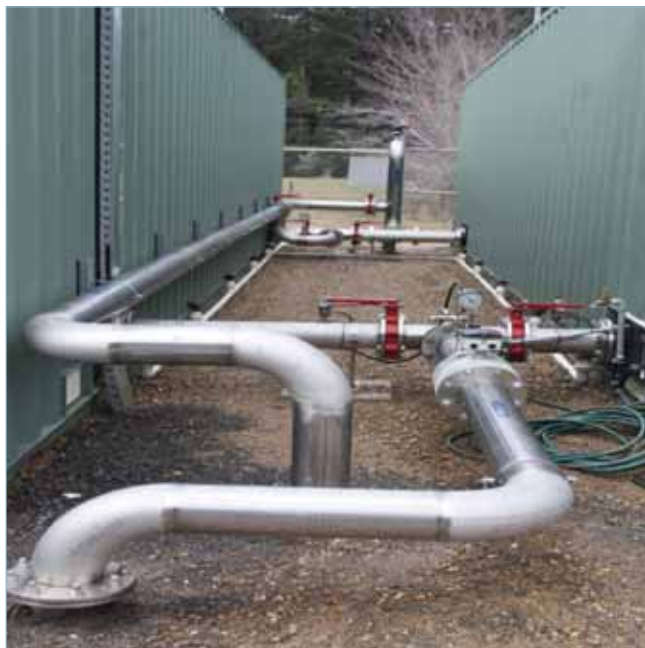
Figure 2. Stainless steel pipe work, fabricated and installed on-site.

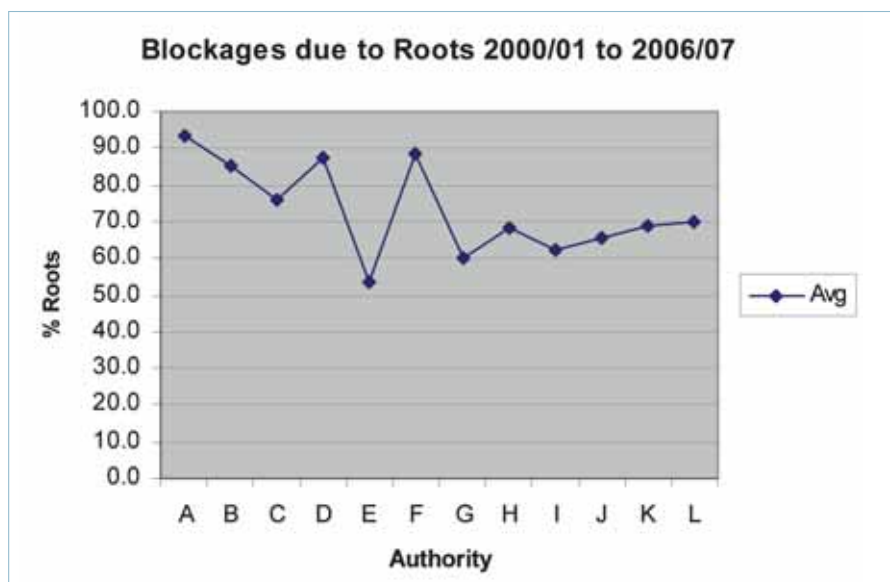
Figure 1. Blockages due to tree roots comparison within Australia.

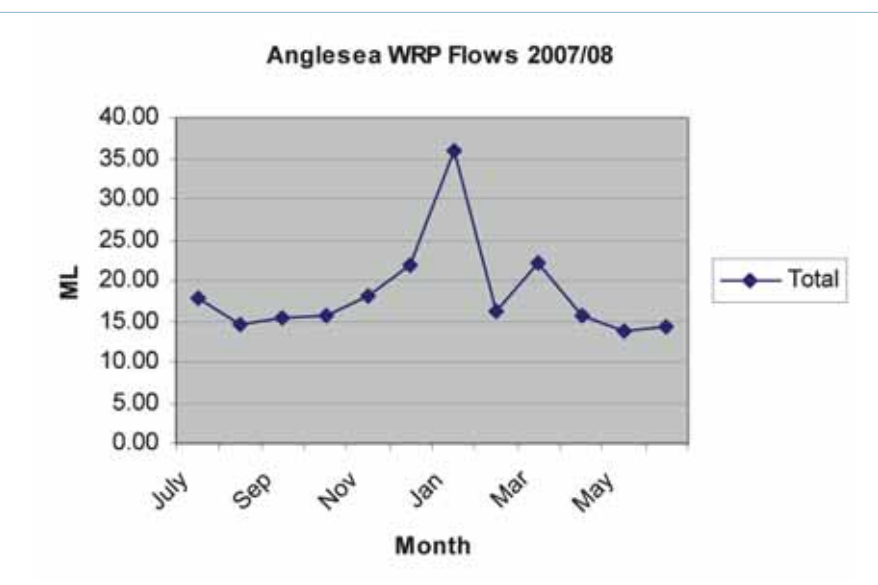
Figure 2. 2007/08 Flows at Anglesea WRP.

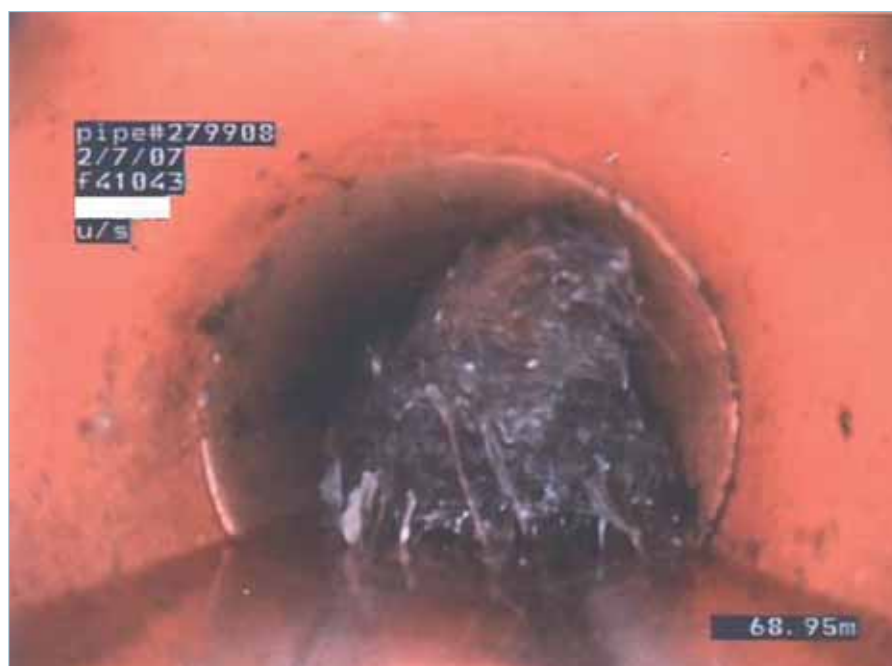
A "typical" root mass in a gravity sewer.

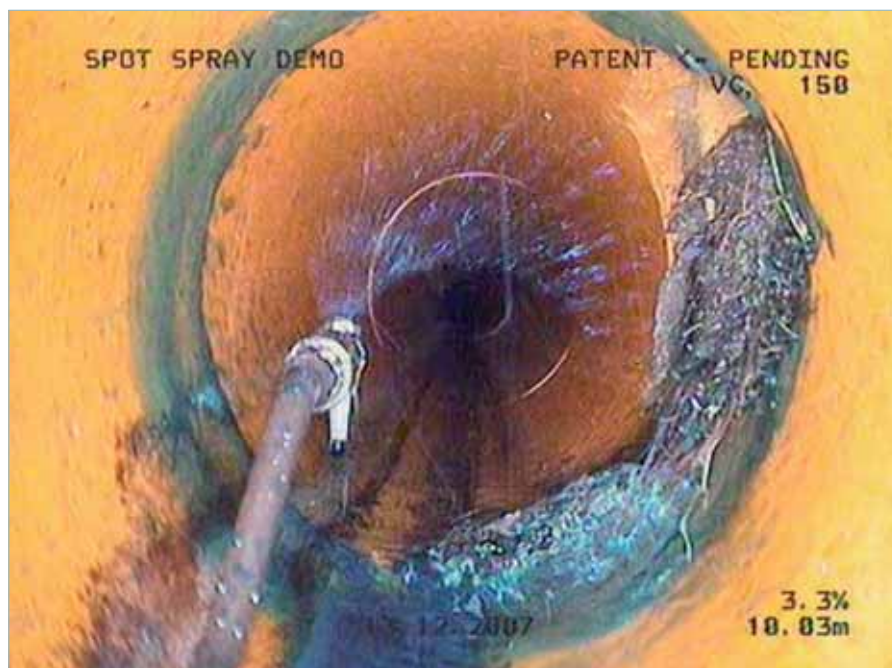
The "spot spray" set up inside a pipe.

The "new" technique of spot spraying that was carried out has the advantage that it is undertaken in conjunction with CCTV equipment allowing observations to

be undertaken on what condition the sewer asset is in at time of application.

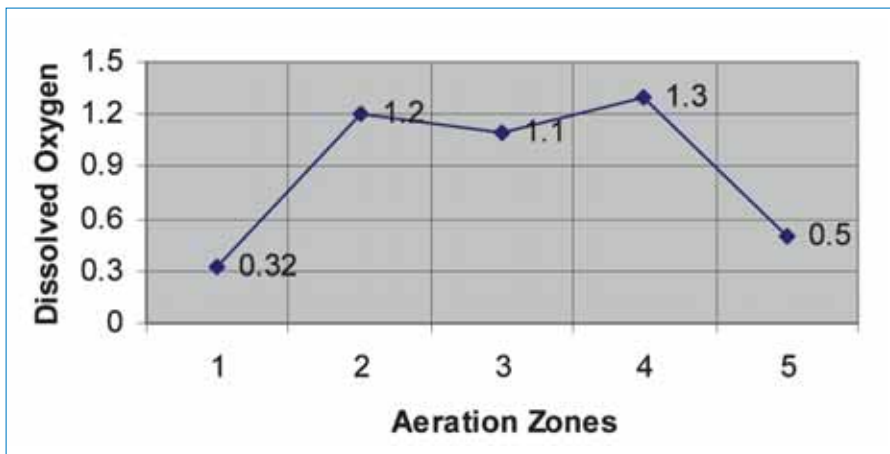
Figure 1. DO levels in the five aerobic zones.
