WATERWORKS

OFFICIAL JOURNAL OF THE WATER INDUSTRY OPERATORS ASSOCIATION OF AUSTRALIA

December 2010

SEWER REPAIRS OVER SHOALHAVEN RIVER

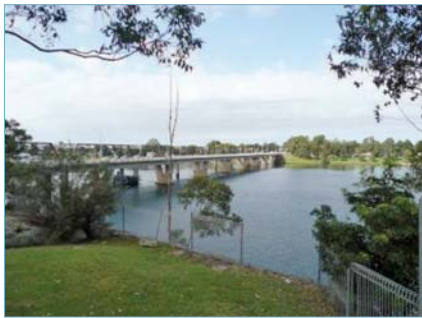
Figure 1. The Shoalhaven River Bridge over the Shoalhaven River.

North Nowra is a suburb of Nowra with a population of 5,445 permanent residents. Approximately 1.2ML of wastewater is transported each day via a 300mm AC pipeline suspended under the Shoalhaven River Bridge to the Nowra STP. The pipeline is made up of 3.0 metre lengths of AC pipe connected together by 300mm gibault joints (86 in total) (Figure 2).

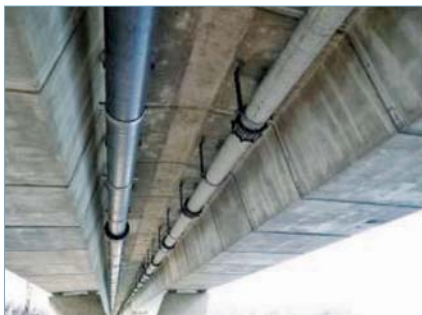
Figure 2. Underside of the Shoalhaven River Bridge with the 300mm AC main on the right.

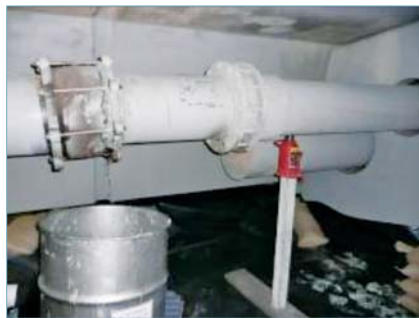
Figure 3. The initial leakage control.

Shoalhaven Water received word that the pipeline appeared to have a minor leak at the northern abutment. Upon investigation, it was found that the first gibault joint past the steel expansion/contraction slip joint was leaking. All the wastewater was contained in a stainless steel 200 litre drum (Figure 3) and natural bund at the abutment which was reinforced by sand bagging. The captured effluent was pumped out by an effluent tanker. The leak was stemmed initially by tightening up the gibault joint while further investigations were carried out.

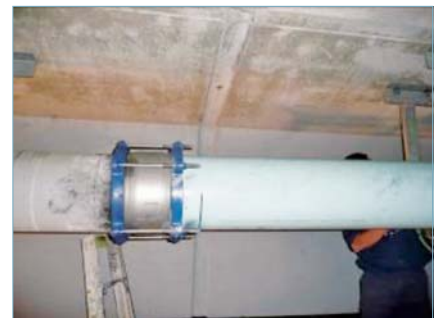
Figure 4. The temporary repair.

The northern gibault joint had moved to a point where the rubber sealing ring had reached the gap between the two pipes and the decision was made to effect temporary repairs by removing that joint and replacing it and the first section of AC main with a new style multi fit collar and a section of PVC pipe (Figure 4) while all the materials for permanent repairs were sourced.

Work started at 10 pm in the evening and the temporary repairs were completed by 5.00am the following morning in time for the morning peak flows. The bridge crossing main was first drained down into tankers using a combination of scour points. Tankers also emptied the upstream pumping stations. All the wastewater was transported to the Bomaderry STP for treatment.

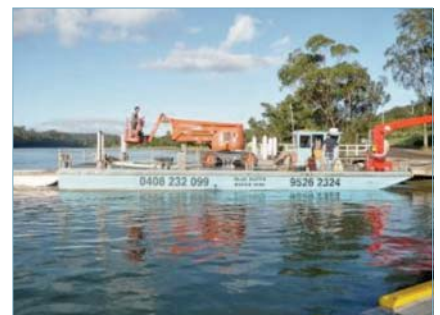
Figure 5. The barge and elevated work platform.

It was decided to check all the remaining gibault joints under the bridge before undertaking permanent repairs. This was carried out by using a hired barge onto which a mobile elevated work platform was placed (Figure 5).

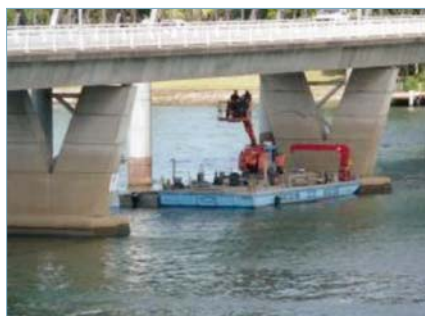
Figure 6. Positioning the barge.

The barge was then manoeuvred into position and held there while the elevated platform was raised. Each gibault joint was checked including the tension of the individual bolts. There were no visible signs of any of the remaining gibault joints having moved (Figures 6 and 7).

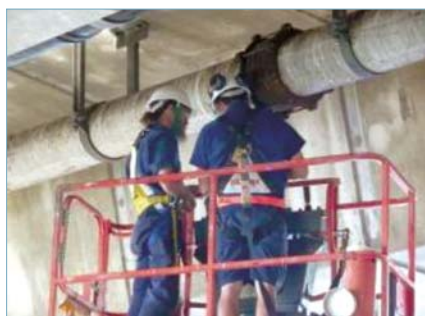
Figure 7. Checking the gibault joints.

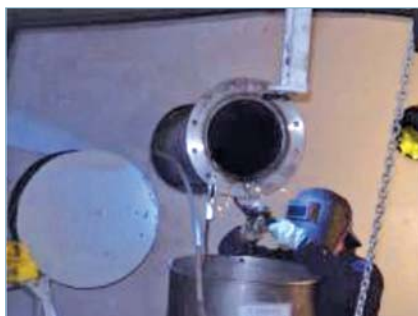
Figure 8. Welding the flange in place.

The permanent repairs consisted of the two existing steel expansion and contraction joints being cut off and in-house fabricated steel table flanges welded onto the steel main (Figure 8)

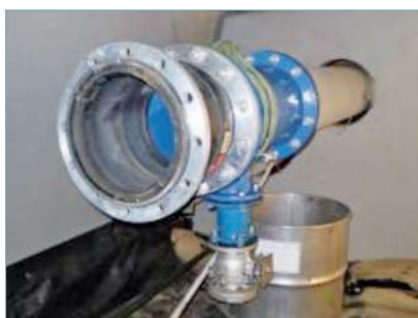
Figure 9. The new expansion joint.

where it exited the bridge abutments. A double diaphragm bellow of a suitable pressure rating was bolted to the flanges (Figure 9). The bellows would flex before there was any movement of any of the remaining gibault joints. The first sections of AC pipe on each side were discarded and new sections of ductile iron, cement lined (DICT) pipe were fitted in their place with new multifit collars.

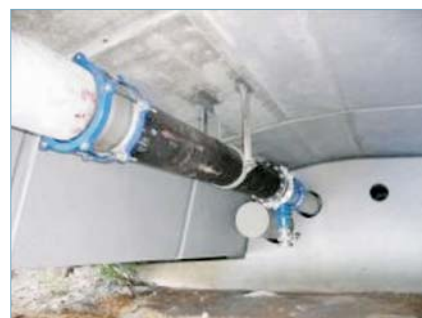
Figure 10. The completed repair.

Two tee sections and locked scour valves were also added at each repair site. A new stop valve and a scour point were also provided either side of the stop valve and inserted as close to the southern abutment

as possible to facilitate any future needs to drain down the bridge crossing for repairs or maintenance. The completed repair is shown in Figure 10.

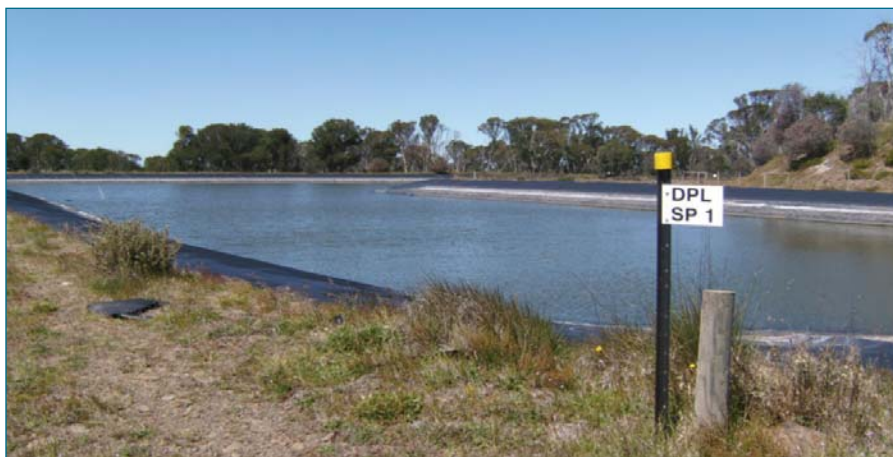
Figure 1. Dinner Plain maturation lagoons responsible for polishing the primary effluent before re-use for irrigation purposes.

Dinner Plains is a small ski resort located in the Victorian Alps. Due to its popularity as a winter tourist destination, the wastewater treatment plant is subject to large seasonal fluxes in the quality and quantity of the influent wastewater. During normal operation, the treatment facility consists of preliminary treatment via a mechanical step-screen, followed by primary sedimentation in a conventional sedimentation tank. Primary effluent is discharged to a series of oxidation/polishing lagoons (Figure 1).

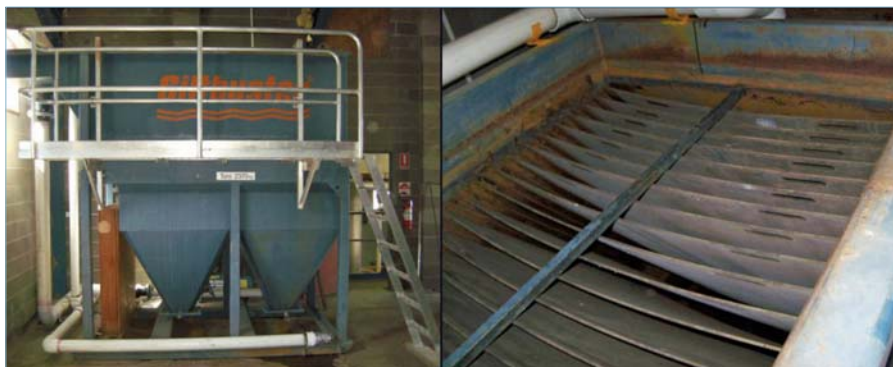
Figure 3. The "Siltbuster" lamella clarifier.

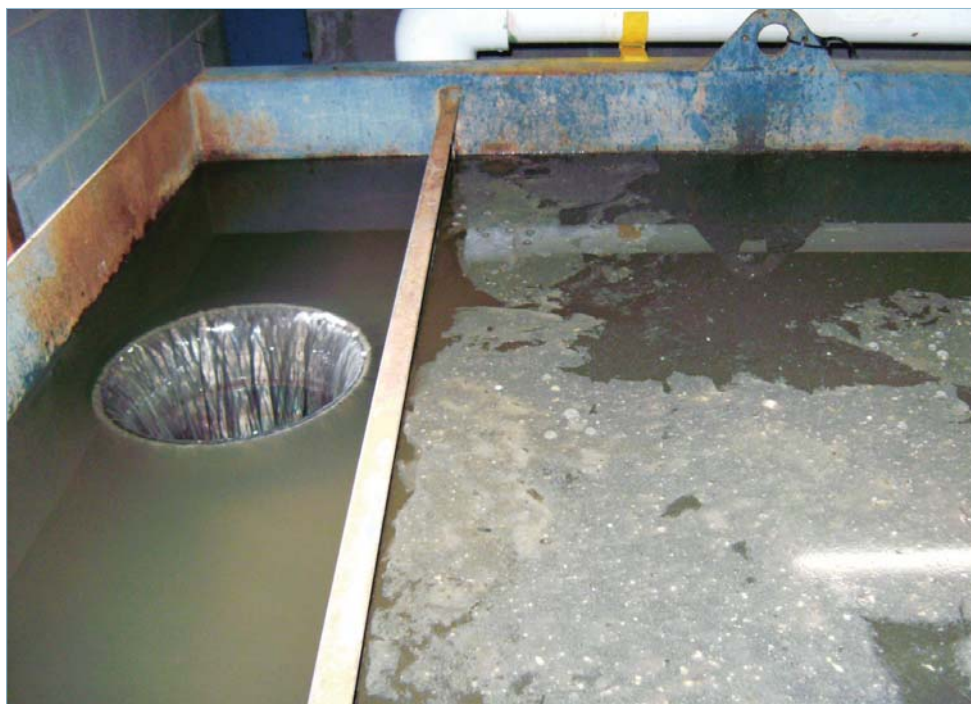
Figure 5. The lamella clarifier unit in operation. A separation plate traps floating scum, allowing the clarified wastewater to exit via discharge weir.

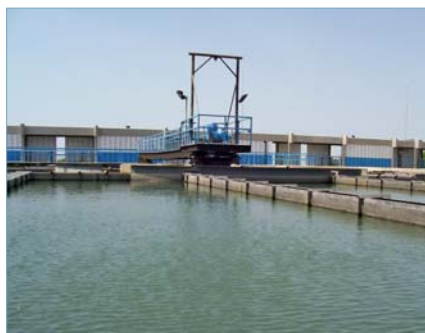
Figure 1. The solids-contact clarifier at Lower Ruvu WTP.

The plant features three clarifiers, two of which use the solids-contact clarification (SCC) process and were provided when the treatment plant was first constructed back in the 1970's (Figure 1).

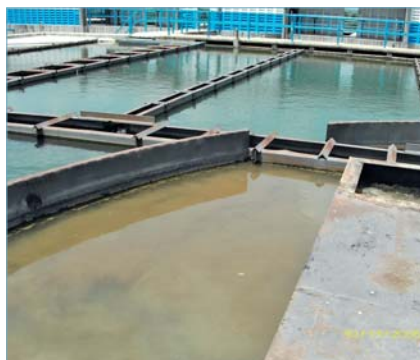
Figure 2. The central flocculation zone of the SCC. Note the clouds of floc.

Key to the SCC process is a mechanical flocculator installed to a central zone (Figure 2). The flocculator slowly rotates through a geared-motor assembly to encourage the growth of floc particles by providing gentle mixing and agitation. These particles then travel radially from the flocculation zone to a clarification zone where settlement occurs. Some of the

settled sludge is recirculated back into the flocculation zone by the action of the flocculator impeller. These act as nuclei, enhancing the development of large, settleable particles.

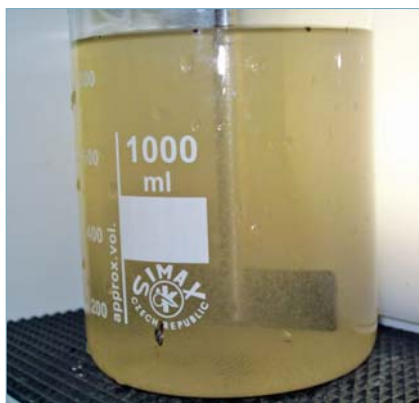
Figure 3. Commencement of the jar-test.

Now, guess what happened?? Within a minute, no make that 30 seconds, these lovely, plump, delicious flocs developed!! And after 5 minutes, the flocs were completely formed and the interstitial water between them had excellent clarity (Figure 3 and 4).

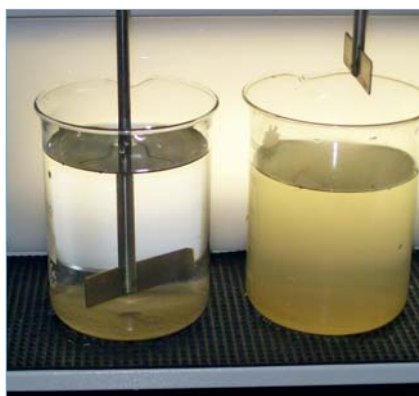
Figure 5. After 15 min settlement. The "Control" without flocculation is on the right.

I then allowed the flocculated sample to settle for 15 minutes. The clarified water was tested and had a turbidity of 3 NTU, compared to the "control" of 45 NTU (Figure 5).

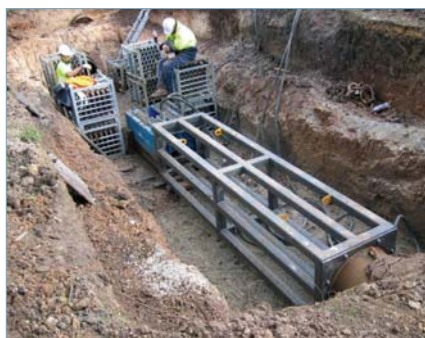
Figure 3. Hydraulics and rods used to pull PE pipe through the host pipe.

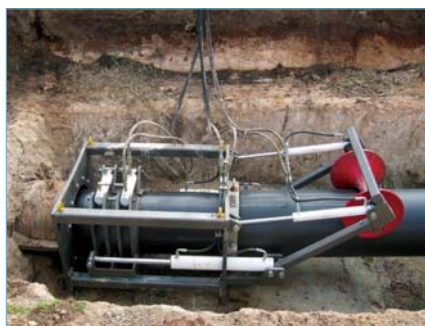
Figure 4. Draw down die to reduce PE pipe diameter.

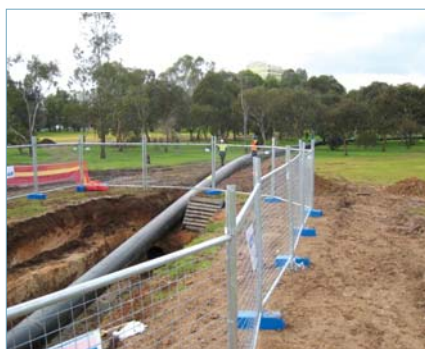
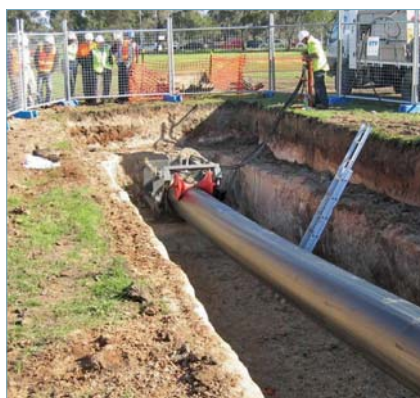
Figure 5. Installation of a 630 mm PE pipe in the Adelaide Parklands into a 100+ year old riveted steel pipe.

Figure 5 shows an example of a rehabilitation project involving a 100+ year old pipe in Adelaide. The first photo shows the welded length of pipe ready for insertion and the second shows the PE pipe being pulled through.

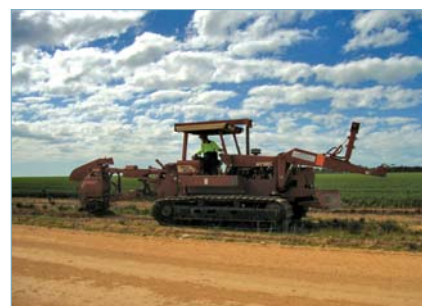
Figure 6. Caterpillar with plough head.

- **"Plough In" pipe laying** – although this is strictly not a trenchless technology, vibratory plough in techniques have been used to lay smaller diameter PE pipe up to 125 mm diameter. PE pipe coils are fed through a vibrating plough head which places and pulls the pipe into a preformed hole at a nominal depth of 600mm. High laying rates in excess of 500 meters per day including all associated site establishment, construction and site cleanup activities have been achieved which results in considerable cost savings. Figures 6 to 8 show examples of this method.

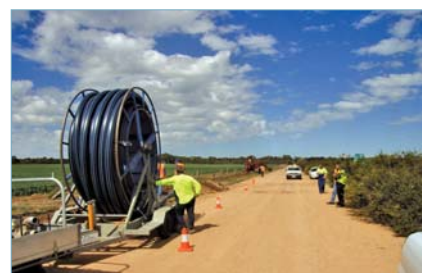
Figure 7. Coil of PE pipe being pulled in.

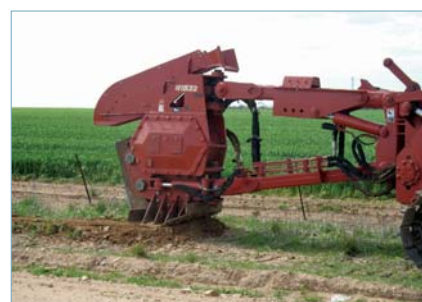
Figure 8. Vibrating plough head which creates hole in the ground.

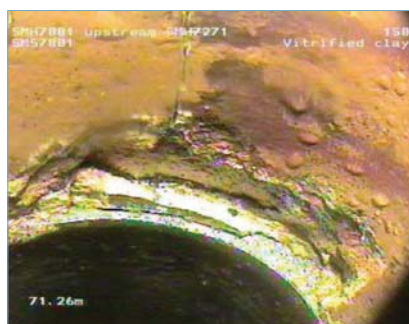
Figure 1. Section of pipe missing.

The cracking, joint displacement and junction collapses is likely to be caused by a combination of ground movement, failing of rubber ring seals and root intrusion. The corrosion mainly occurs in concrete or asbestos cement pipes, where the methane and hydrogen sulphide gases eat away the exposed surfaces of the pipe leading to collapses and severe longitudinal cracking.

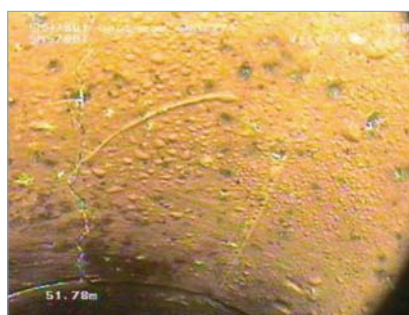
Figure 2. Longitudinal cracking in an earthenware pipe.

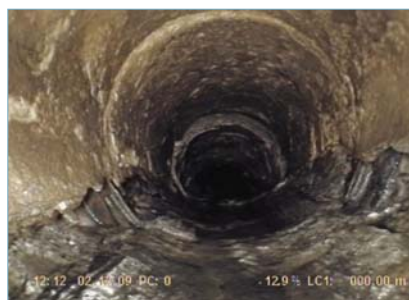
Figure 3. Invert missing, severe gas attack in a concrete pipe. Note the uneven bedding.

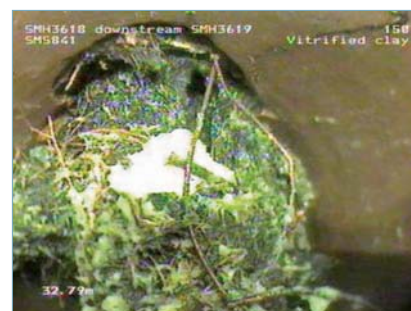
Figure 5. Root growth in a junction.
