WATERWORKS

OFFICIAL JOURNAL OF THE WATER INDUSTRY OPERATORS ASSOCIATION OF AUSTRALIA

November 2013

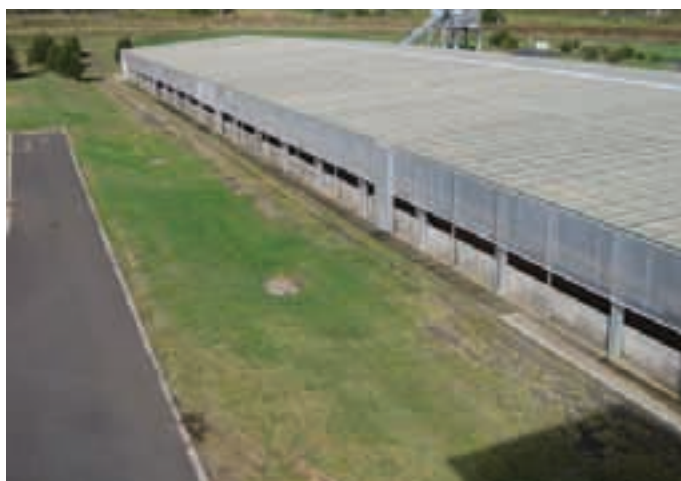
Figure 1. The solar drying halls.

The Wetalla Water Reclamation Facility was upgraded in 2006 with the provision of solar sludge drying halls (Figure 1) and additional belt press capacity. The solar hall, which has fully automated weather, controlled curtains and fans, uses air flow and solar radiation to dry the biosolids as they travel through the halls.

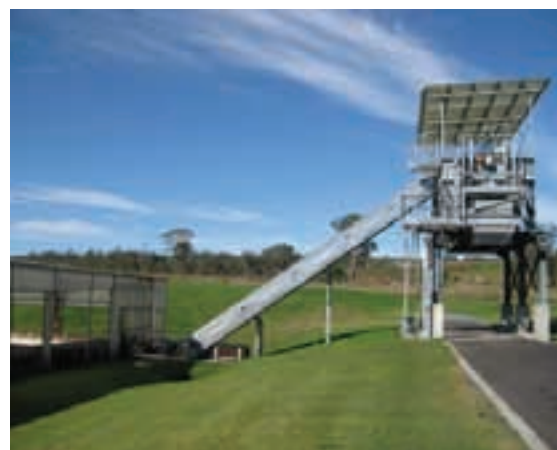
Figure 3. The discharge conveyor.

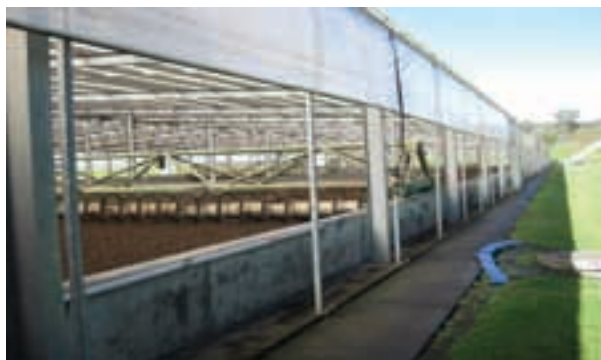
Figure 4. The solar halls with the curtains raised.

This system has never been effective due to the condition that requires the curtains to lift once wind speed is above 20km/h. Unfortunately the weather conditions in Toowoomba are such that much of our rainfall is storm-generated, and the curtains are in the raised position when this happens because of the wind speed. For the best use of the side curtains the automatic control system has been disabled and the curtains fixed about a third of the way down.

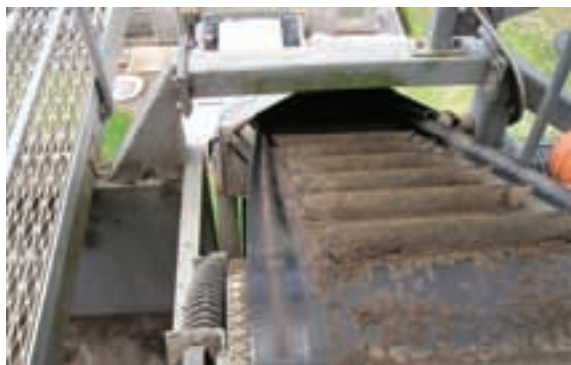
Figure 5. The cleated conveyor.

A cleated conveyor (Figure 5) was needed, as a flat conveyor at this angle did not handle the load due to the biosolids rolling back on the incline conveyor belt and clogging at the bottom, causing conveyor failures.

The height of the dry hopper in relation to the solar hall is a major design factor that needs attention. Reducing the angle of the incline conveyor to the dry hopper would result in substantially fewer failures. Not only would the conveyor system itself be simplified, e.g. non-cleated, but the total product displacement would be substantially increased.

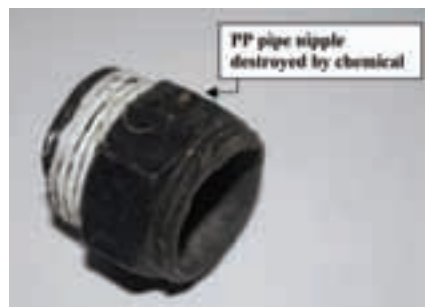
Unfortunately, the material selected is not compatible with sodium hypochlorite solution and gradually degrades internally over a period of approximately three months, finally failing and leaving a trail of destruction and an expensive repair bill for external damage created.

Figure 1. Damaged PP pipe nipple as a result of installation in a system using sodium hypochlorite.

fitting broke, chlorine sprayed all over the electrical cabinet, which was stainless steel and was destroyed along with the contents. One such cabinet involved in another similar event cost \$21,000 to replace. The water pump was also stainless steel and was destroyed. The figure for the penalties for non-conformance water was indicative only and could be much higher as the water was not disinfected, potentially causing illness.

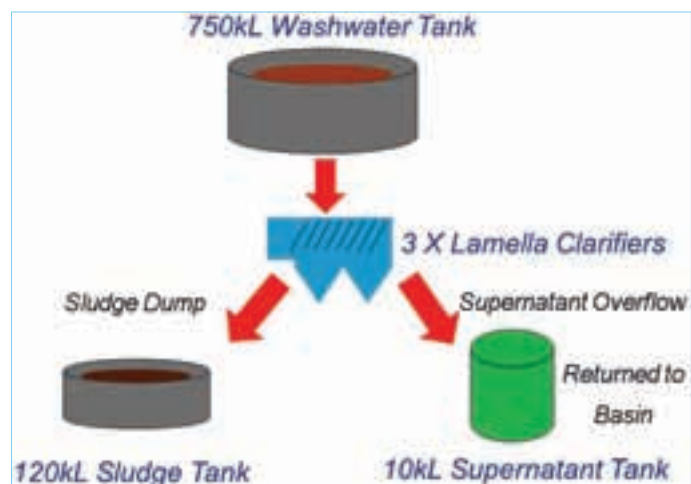
Figure 1. Woodglen WTP washwater system.

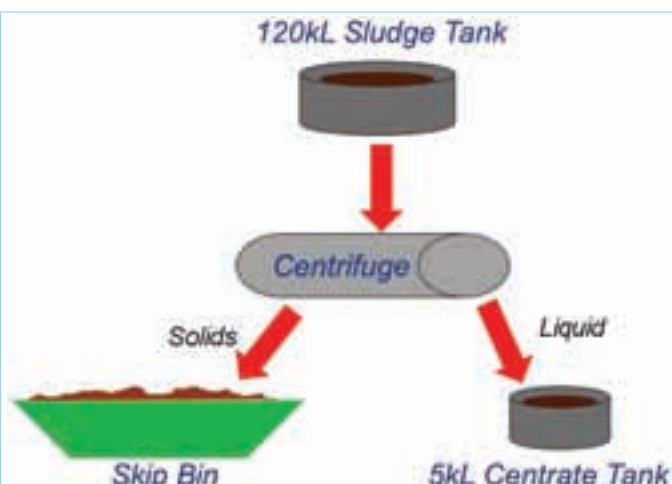
Figure 2. Woodglen WTP sludge handling system.

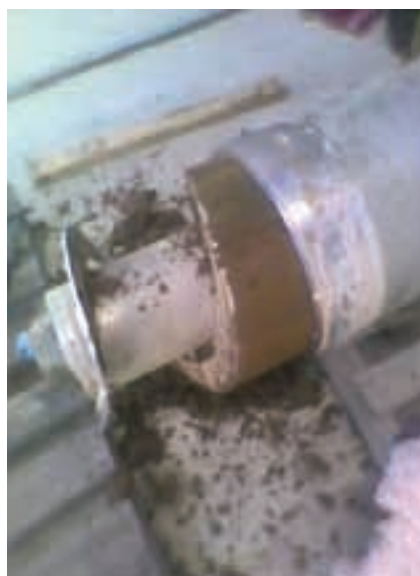
Figure 4. Blocked centrifuge that led to a significant period of downtime for the Woodglen WTP washwater system.

The second point of advice, and the one that proved to be the most important, was the flushing of the centrifuge. As simple as it might sound, the flushing turned out to be the main cause of the centrifuge blockages. Prior to the visit to Gippsland Water, our flushing ran at 2.5L per second and was thought to be ample for the system.

Gippsland Water recommended that at least 3.5L per second or higher should be used for effective flushing. In addition, they advised that alterations should be made to the existing flushing regime to allow flexibility in the duration and initiation time of flushing, facilitating complete cleaning of the internals of the centrifuge after each run.

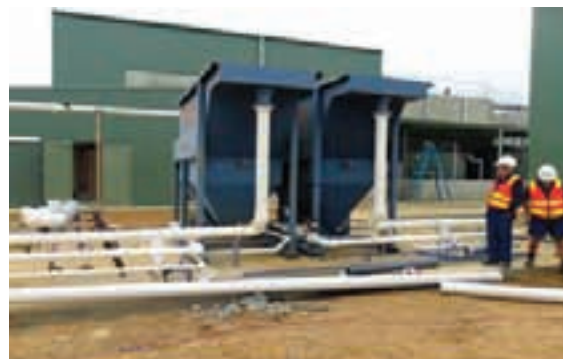
There was little that could be done about the lamella clarifiers (Figure 3) themselves, apart from a complete replacement or major augmentation, which was not viable at the time. They are purpose-built to produce high-quality supernatant and were purchased for another treatment project and reused at the Woodglen WTP. The way they were operated was an area that could be improved and was the focus of some of the rectification works.

Figure 3. Lamella clarifiers used to process washwater at Woodglen WTP.

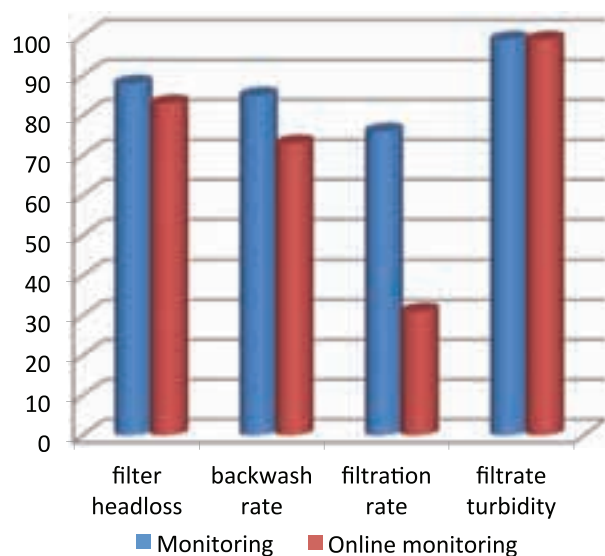
Figure 2. Monitoring of key operational parameters for media filtration.

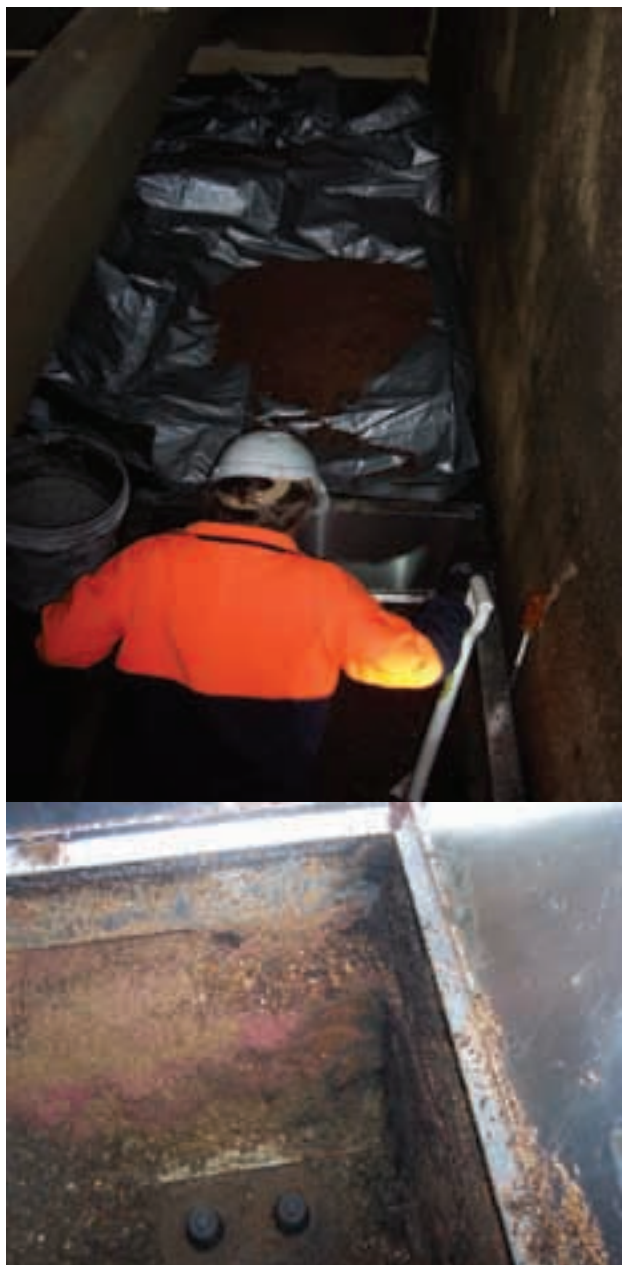
Figure 2. An operator working inside the shoring box (top); and the exposed media and nozzles at the bottom of the shoring box.

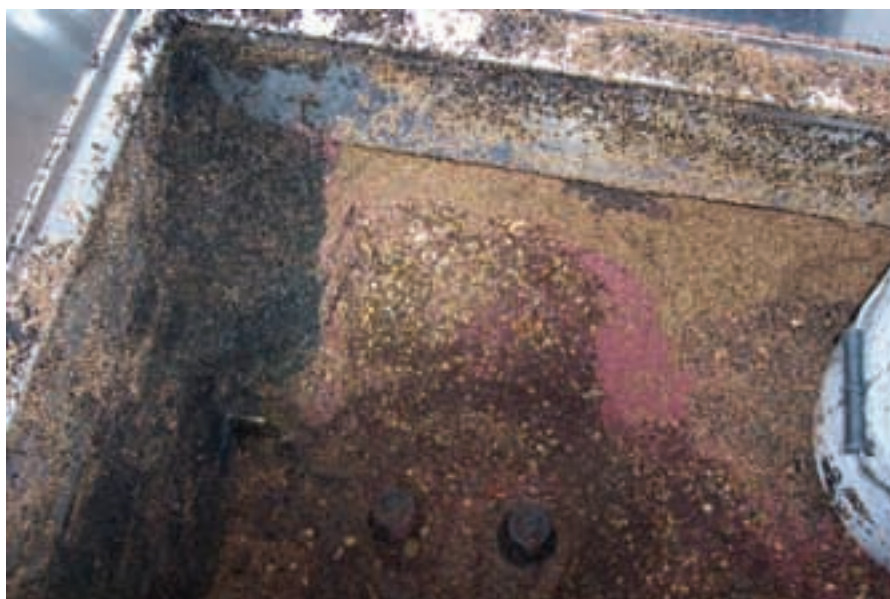
Figure 3. A close view of exposed nozzles, intermixed media and mud build-up along the filter wall in one of the filters at Wodonga WTP.

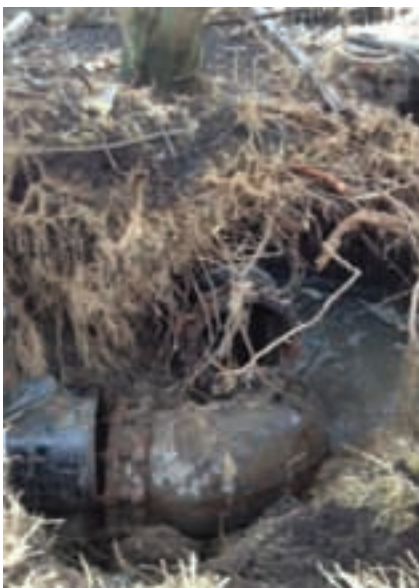
Figure 1. The bend shifted rather than burst.

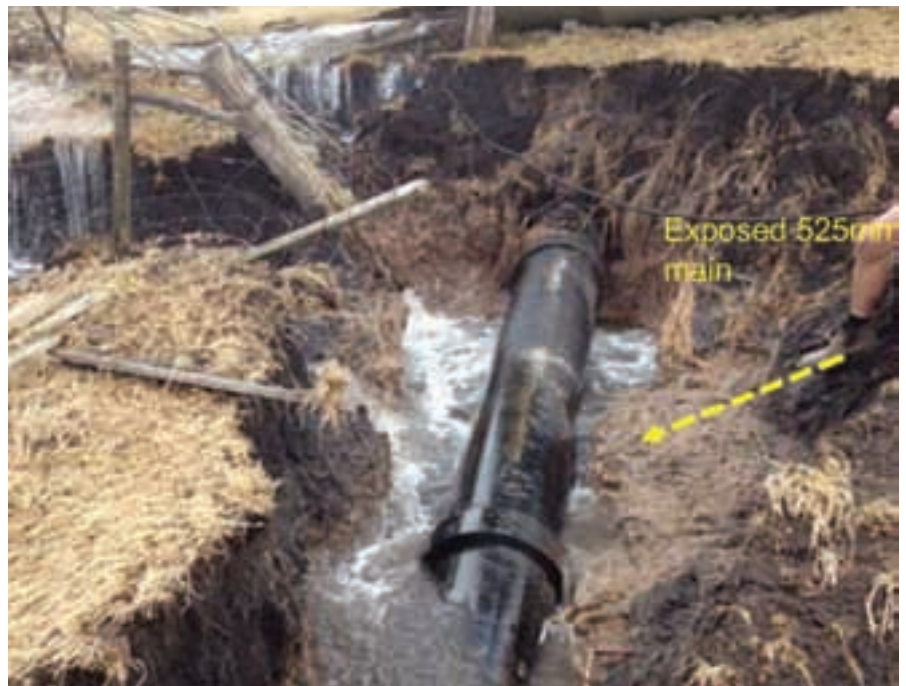
Figure 2. Damage caused by the break.

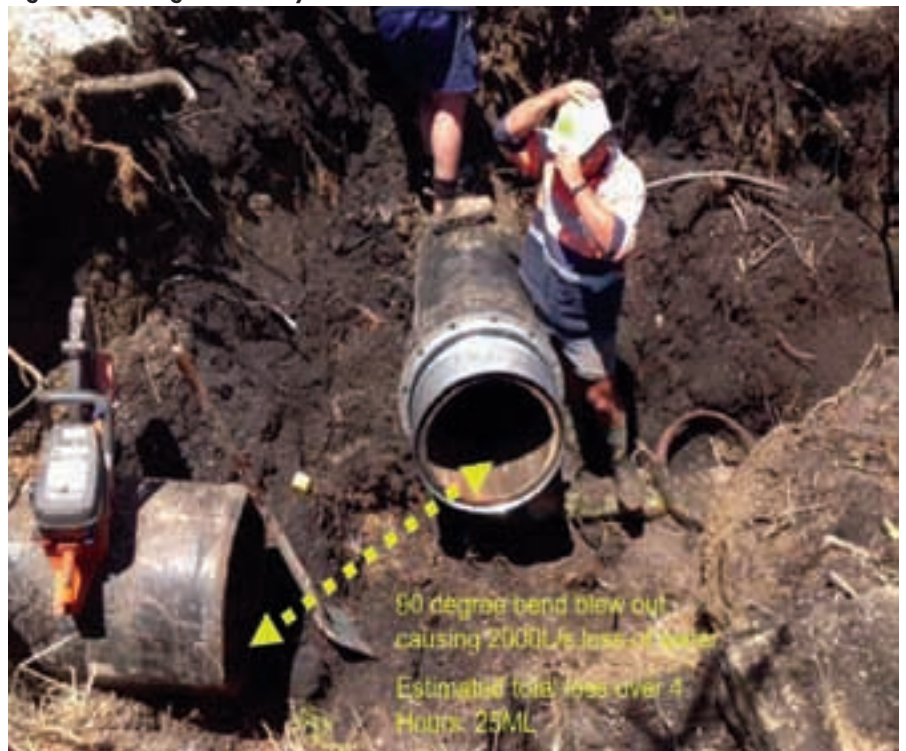
The repair took two days (Figure 3). The cause appeared to be a lack of support for

Figure 3. The repair underway – a 90° bend separated from 525mm pipe.

the bend. A bluestone thrust block was present but not tied into rock foundations. There was also a tree above the main, which may have caused the earth to shift around the pipe, exacerbating the problem.

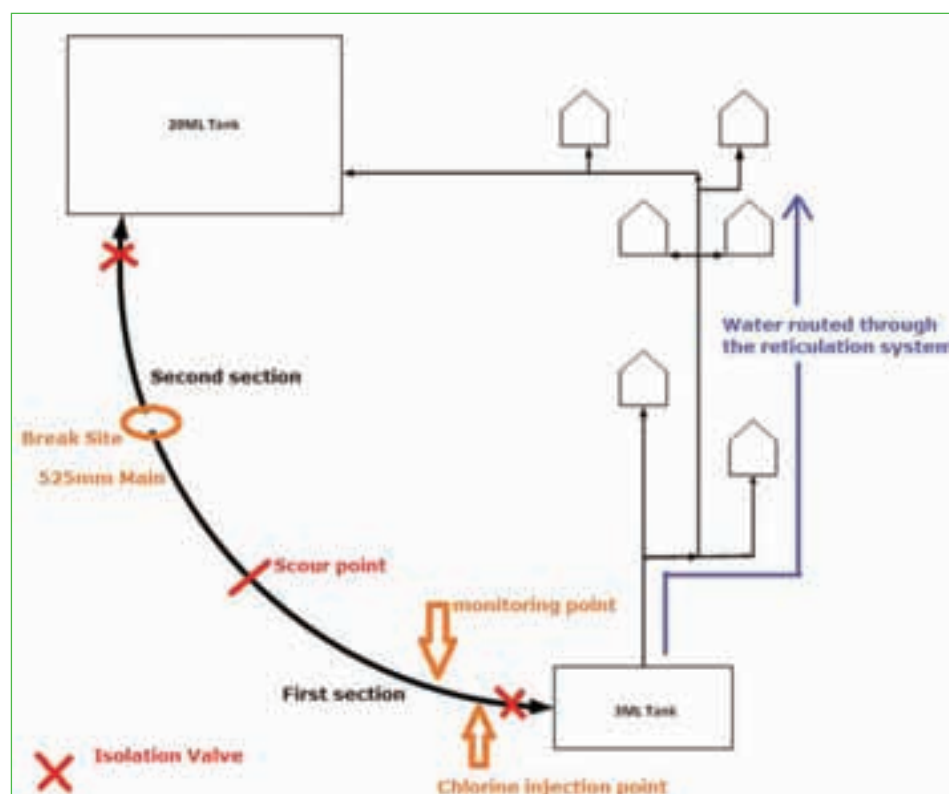
Figure 4. Schematic of the incident.

Due to the late hour of the day it was decided to hold the water as currently dosed in the main overnight. The main was divided into two sections utilising valves. The following morning, chlorine residuals were taken from section 1 and then section 2. The chlorine remained at 2mg/L in section 1, meaning Ct was well and truly achieved at 1560mg.min/L, but was still negligible in section 2.

Section 2 was where the burst had occurred, so getting chlorine into that section was essential to the success of the disinfection.

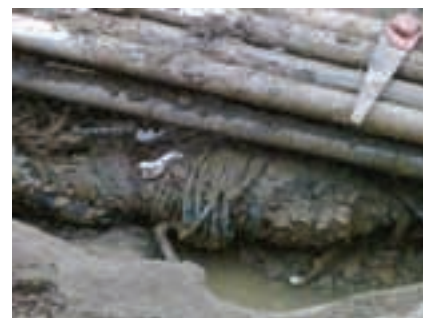
Fibre optic cables not in conduits.

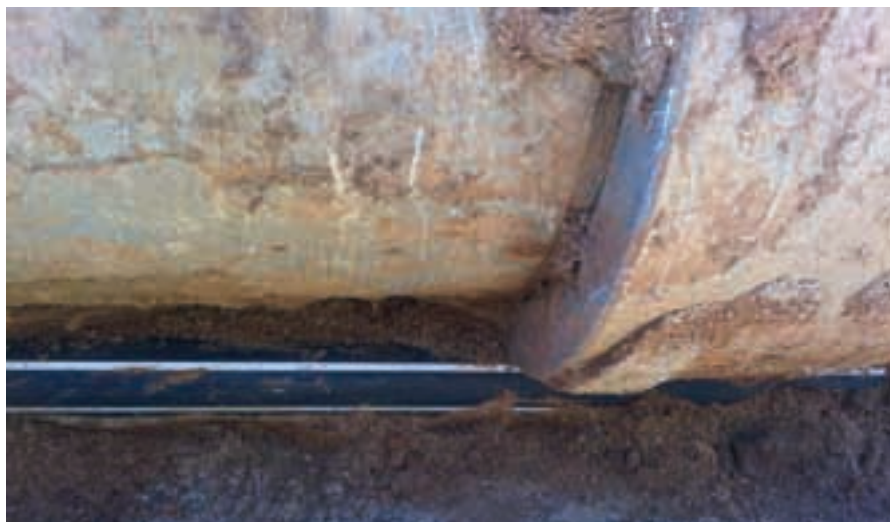
Fibre optic cable installed along the edge of a water main.

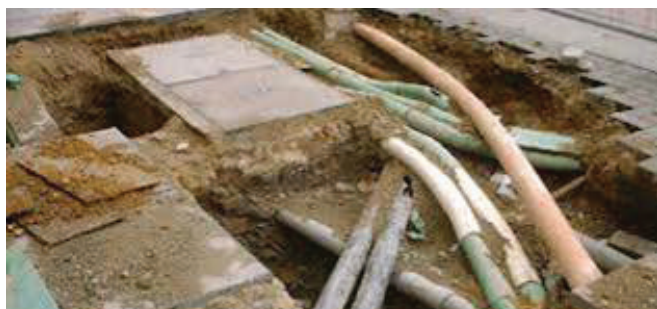
"Spaghetti" in the nature strip.

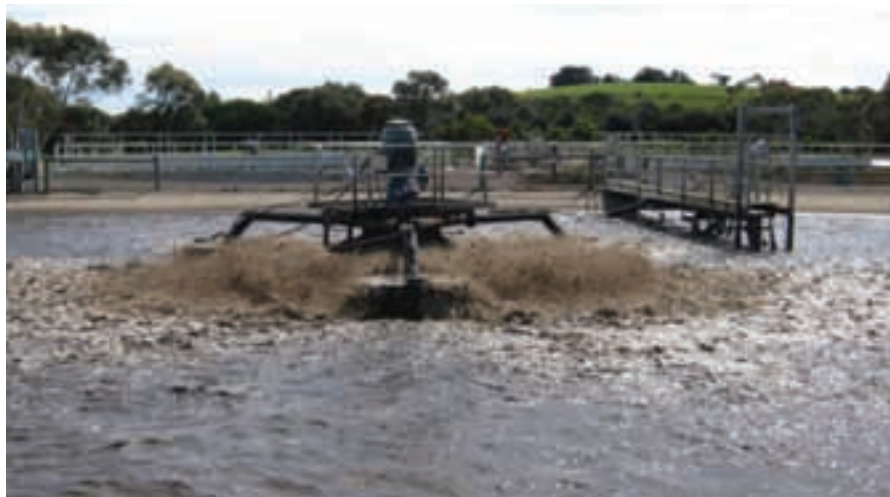
Figure 2. A tripod-style surface aerator.

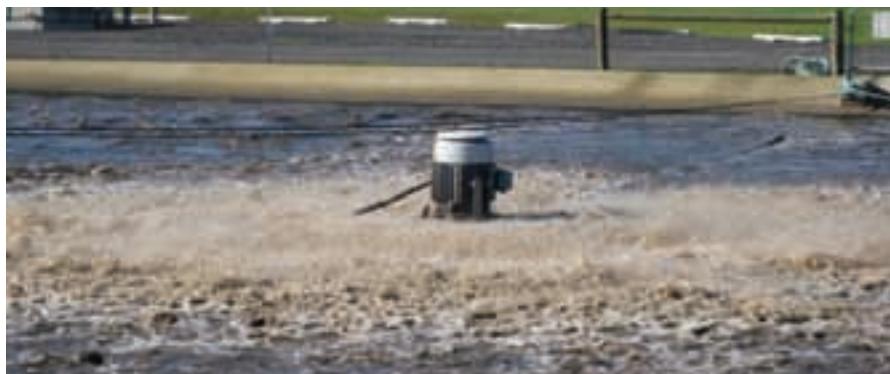
Figure 3. One of the 30kW high-speed aerators.

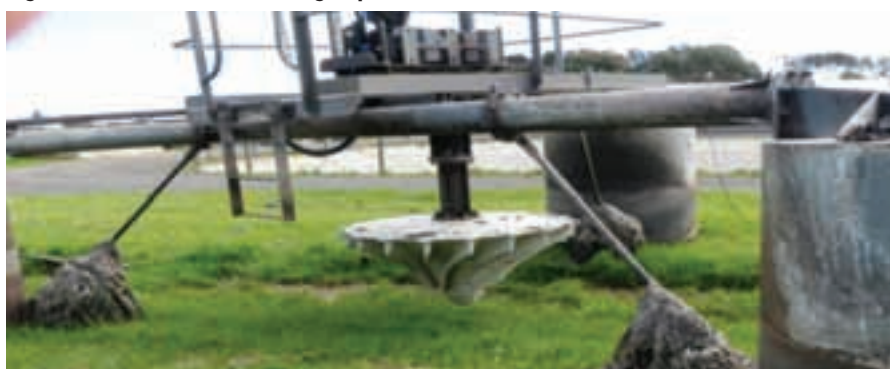
Figure 4. A 45kW aerator showing the rotor.

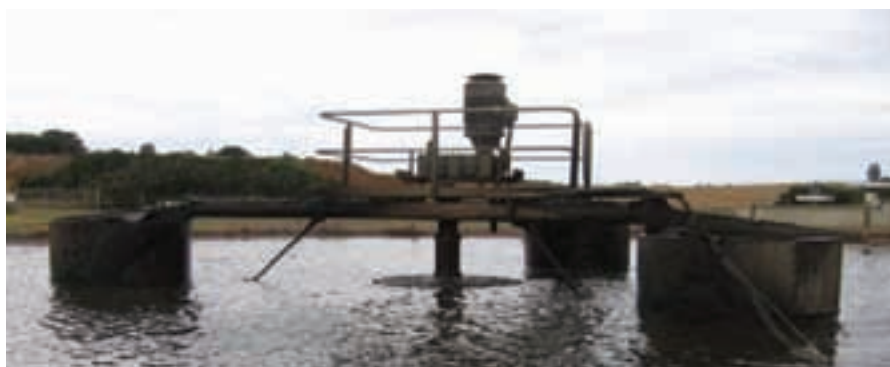
Figure 5. A rotor-style aerator with the rotor adjusted for maximum rotor efficiency.

adjustment mechanism on the rotor height. This controls the rotor efficiency: shallow for less efficiency and deeper for more, and most rotors of this type set the top of the rotor at water level for maximum efficiency (Figure 5). We have all our aerators set at maximum and control their speed by variable speed drives (VSD).

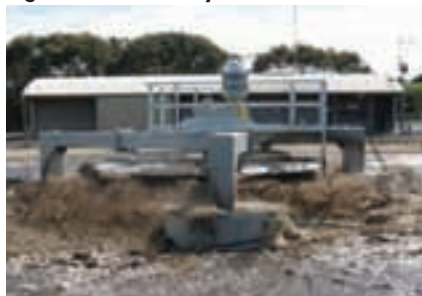
Figure 6. A 55kW tripod aerator.

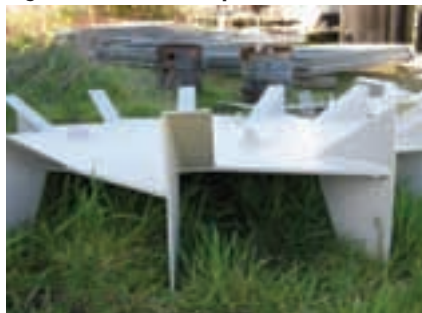
Figure 7. The non-clogging rotor.
