# WATERWORKS

OFFICIAL JOURNAL OF THE WATER INDUSTRY OPERATORS ASSOCIATION OF AUSTRALIA

November 2015

**Managing Water Mains Repairs for Safe Drinking Water**

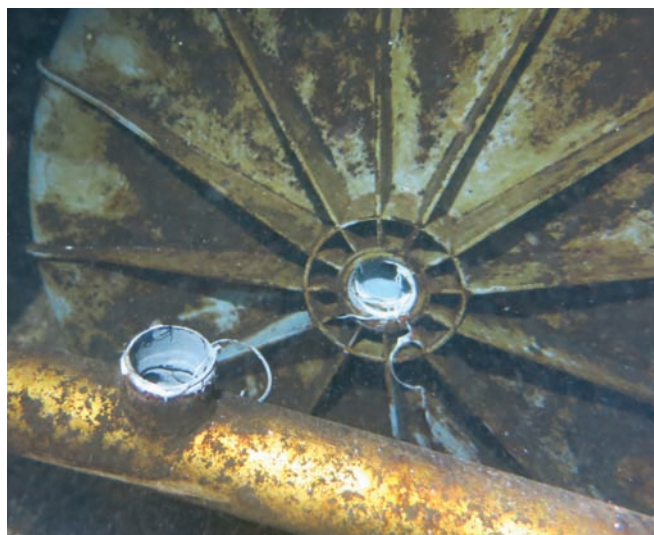
They had drained and inspected the diffusers and discovered that a couple had broken off (Figure 1). It took 18 hours for a shut-down and drain, so after refilling they asked us to dive and check the diffusers, while running air (instead of ozone, for safety reasons).

We found the thin-walled SS tubing was corroded internally around welds, probably from not passivating internally, and the diffuser socket threads had 'let go' in multiple places, causing the diffusers to fall off in at least four places. It was a design fault to use SS tubing with such a thin wall thickness, when the labour costs would be the biggest part of the installation. We are also wondering if Georg Fischer-type PVC tube and glueing may be a better option to SS and welding for repairs.

**Figure 1. Broken ozone diffuser.**

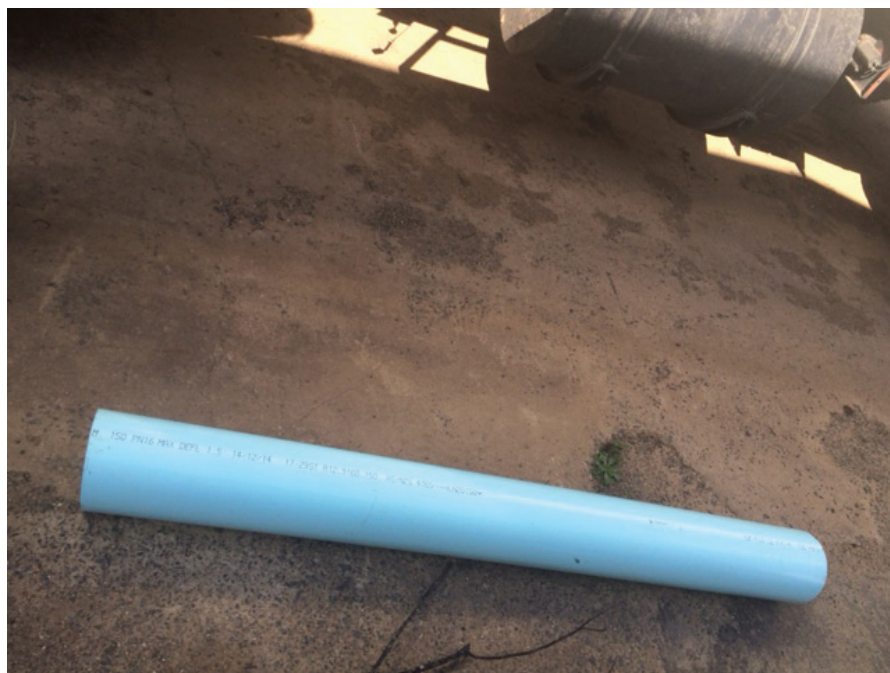
**Figure 1. The replacement section of pipe.**

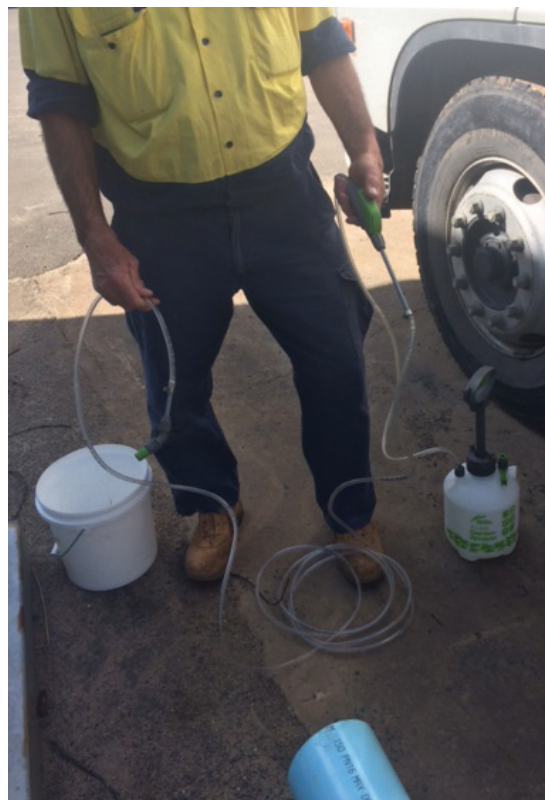
The process of spray-contacting using a portable pump unit involves a high disinfectant concentration of 1000 mg/L over all new fittings and the internal area of the water main section. The process of repair to a water main is as follows:

**Figure 2. Spray disinfection pack with seven metres of flexible hose. The spray nozzle is shown with an arrow.**

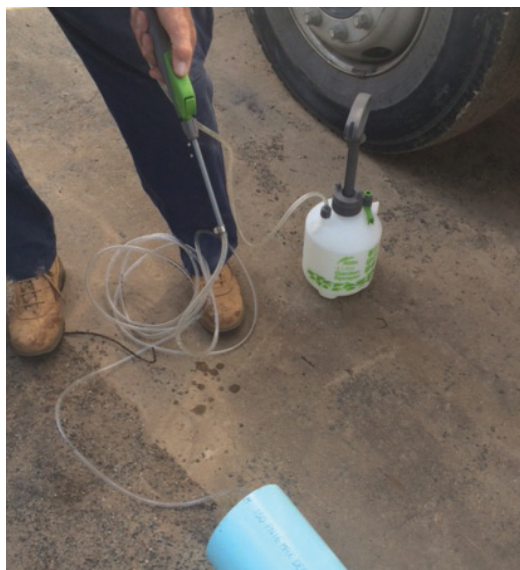
**Figure 3. Spray nozzle being inserted into the pipe section.**

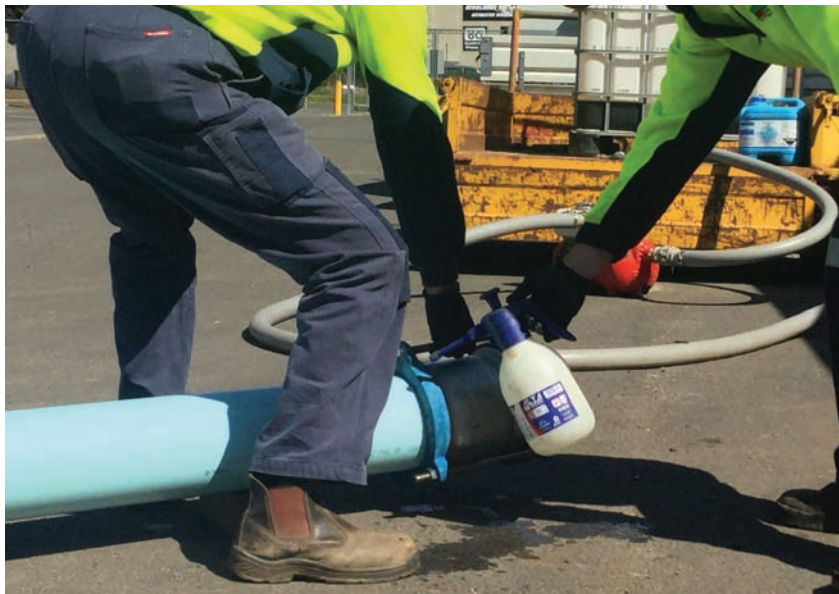
**Figure 4. Spray disinfection of fittings and pipe ends.**

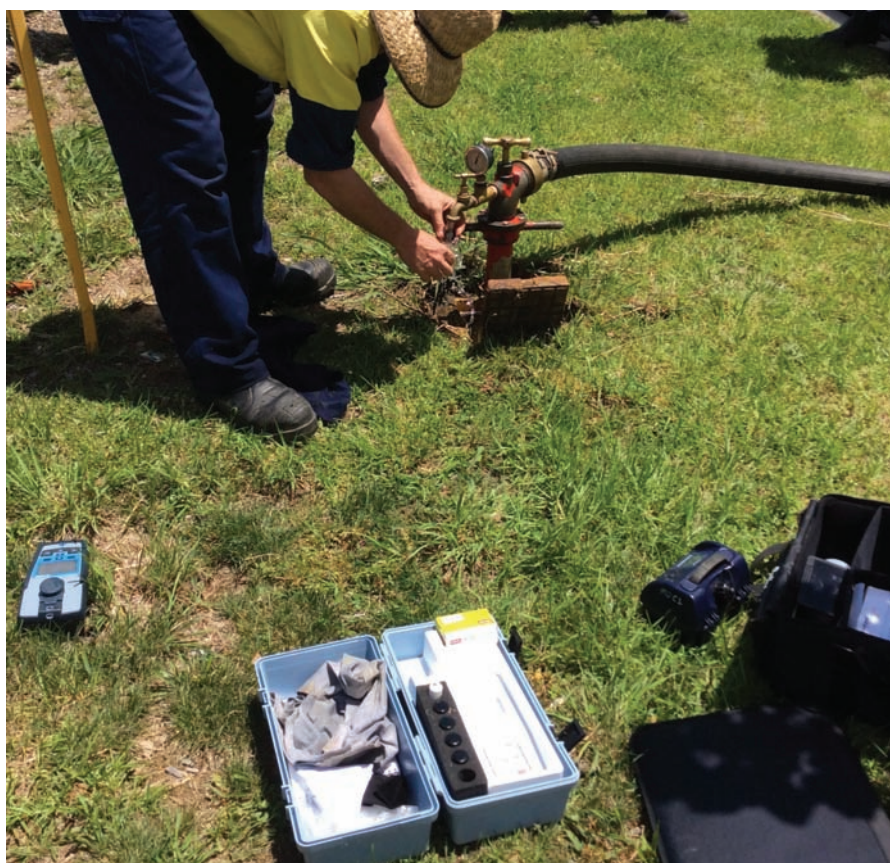
9. Insert a hydrant at the highest point in the water main and open the supply slowly to flush the line. Continue flushing until any discolouration and air is expelled and the main is fully charged.
10. Open the valve completely and conduct a turbidity test to ensure the turbidity level flowing to the repaired area is consistent with the water exiting the new section and according to standard.

**Figure 5. Testing the turbidity of the water being flushed, prior to commissioning the repair section of main.**

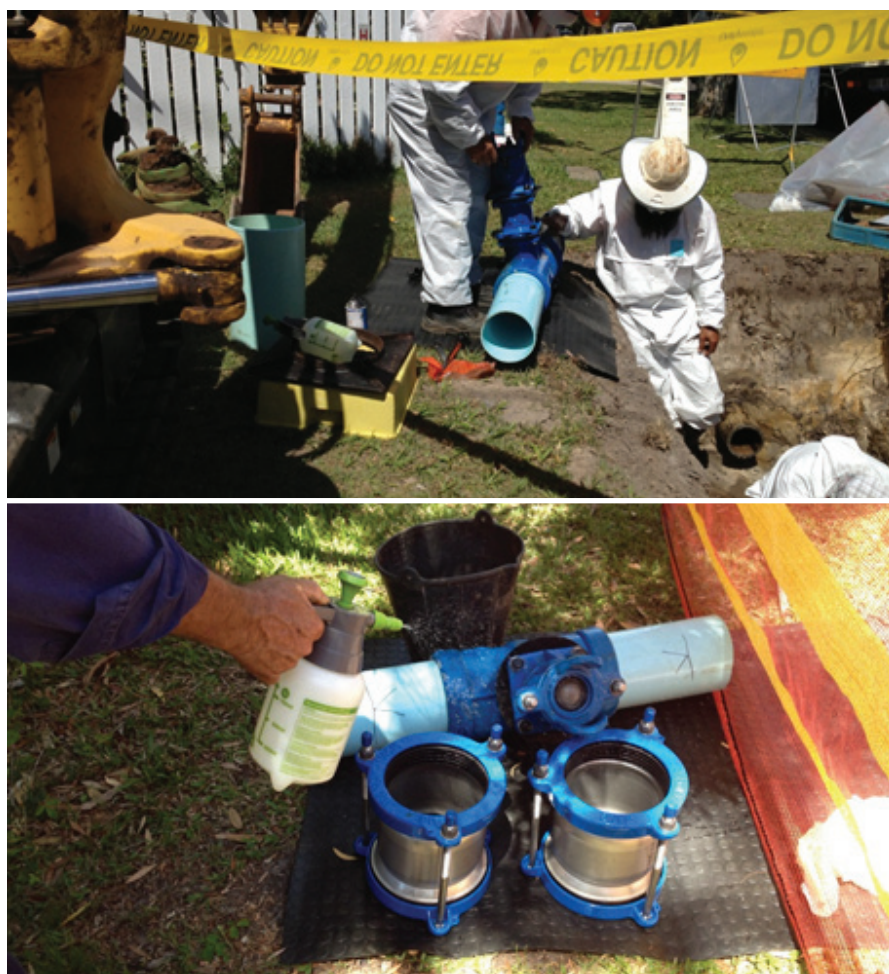
Figure 2. An example of one of the 5Cs, Clean pipes. Pipes are kept clean through the use of mats and chlorine spray.

1. **Clean pipes.** Pipes, pipe fittings and the way they are handled have the potential to introduce contaminants. Placing pipe sections and fittings on a clean mat (Figure 2) and spraying the fittings and pipe ends with disinfectant reduces that risk.

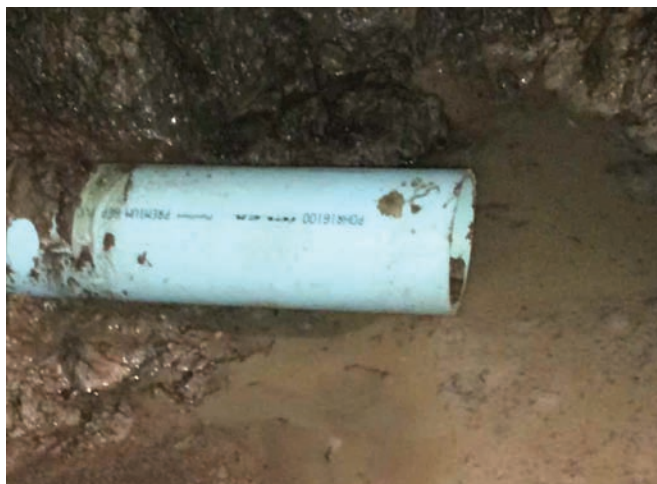
**Figure 3. An example of where more clearance is required.**

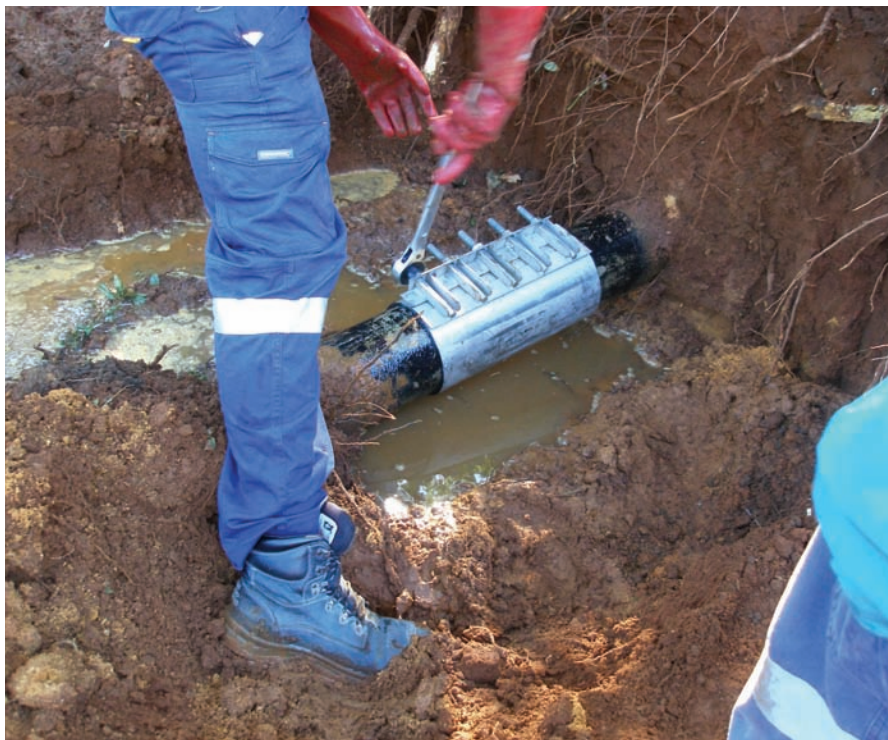
Where the break is a minor one, and the leak small, the main can be repaired without stopping the flow of water by simply placing a repair clamp around the break and tightening it (Figure 1).

**Figure 1. A clamp is applied to a main to fix a small break without dewatering the main.**

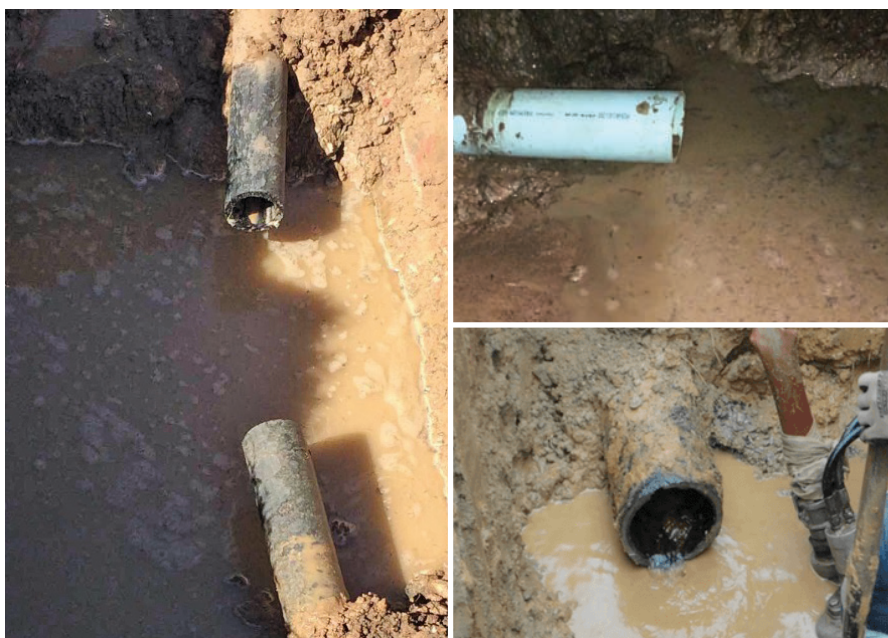
One of the issues is the management of the pipe once the damaged section has been cut out. Photos like the ones in Figure 2 are not hard to get. Universally, they show water, mud or earth very close to the gaping mouth of the cut pipe. In this situation simply moving around in the trench can generate waves that can slosh potentially contaminated mud and water into the end of the open pipe. In a pipe that is fully isolated, this muddy water will sit in the pipe. In a situation where some flow has been maintained, this potentially contaminated trench water will be mostly washed out, but carrying out repairs while retaining some flow from the pipe is not necessarily normal practice.

**Figure 2. Examples of cut pipe ends just waiting to be contaminated with water that is not maintained at a low enough level in a trench.**

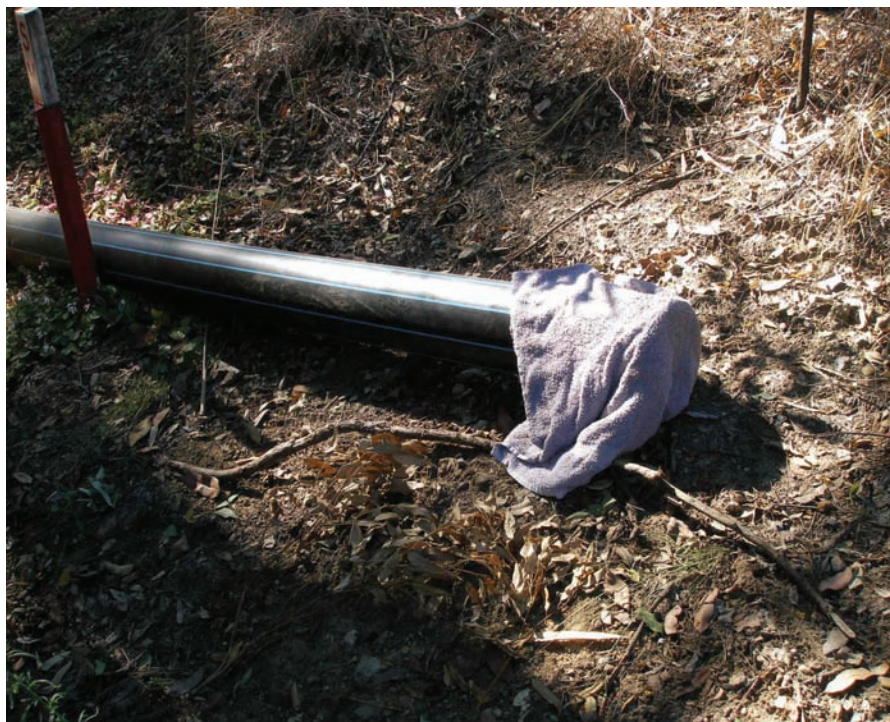
Some maintenance crews are aware of the risks and try to do something. Figure 3 shows a section of pipe next to a work site. The contracting company responsible for the work in this case, being aware of the risks, has made an attempt to limit

contamination by placing a towel over the end of the pipe. Ironically, contract companies are often subject to higher expectations than workers within utilities.

**Figure 3.** A towel has been used to cover the end of a pipe section awaiting installation.

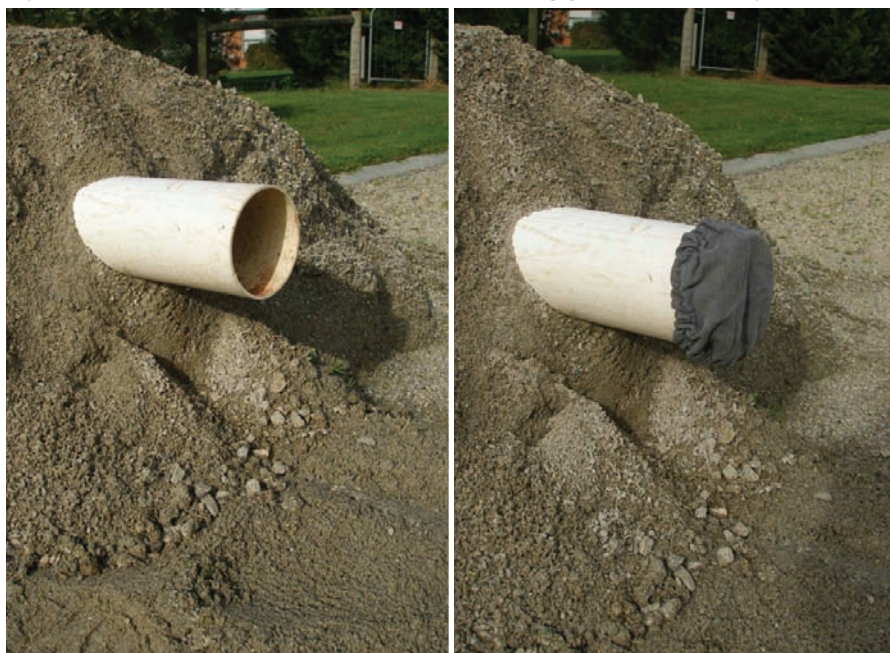
So what if we introduced a pipe end cover? Something like a heavy-duty shower cap made with waterproof vinyl with a

wide heavy-duty elastic base. Figure 4 shows a mock-up of an exposed end of a pipe and the same pipe with a cover on it. The cover is, in fact, a simple blackout mask cover that I used to use as a diving instructor when I was training divers in zero visibility diving.

**Figure 4.** Mock-up of an exposed pipe end before and after covering with a "shower cap" fitting.

It is very simple and easy to use and can be deployed in less than 30 seconds so it really wouldn't add anything to the time to complete a job. The covers could be used to cover the ends of pipe sections on the ground but also, most importantly, the ends of pipes as soon as they are exposed in a trench. They would remain in place right up until fitting of the gibault.

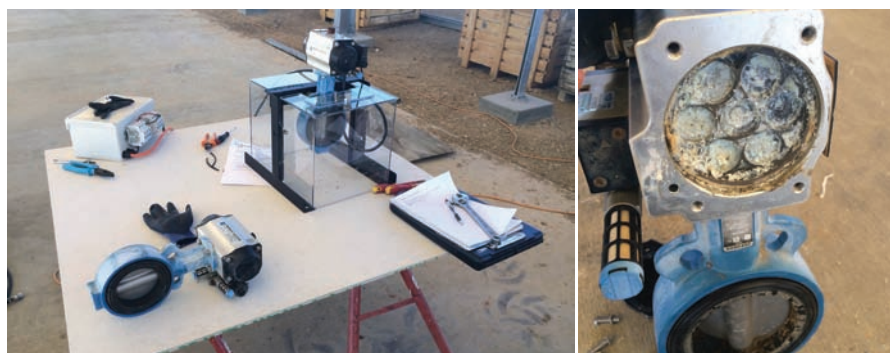
Although 95% of the pressure vessels passed the pressure testing, the pneumatic actuators were a different story. Of approximately 140 actuators that came with the skid-mounted systems, something like 25% failed due to a variety of malfunctions. Fortunately we identified enough actuators in working order to

Figure 1. Actuator test bench and a failed actuator damaged by water.

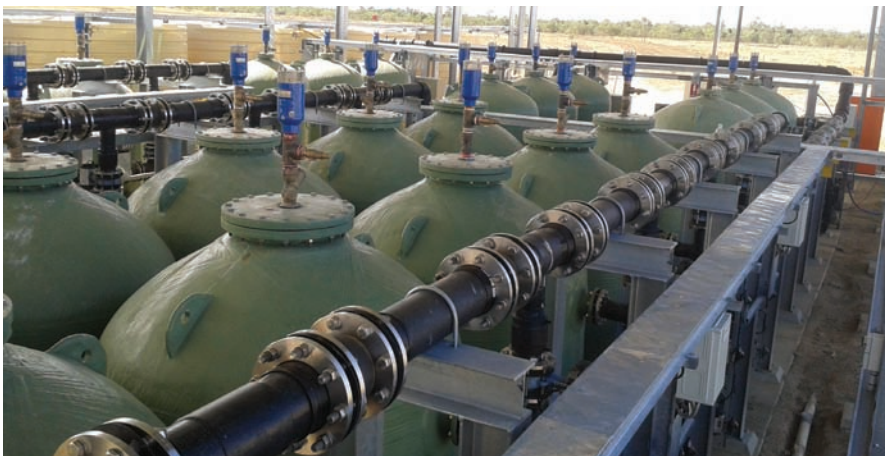
**Figure 3. Richmond WTP filter trains commissioned and working.**

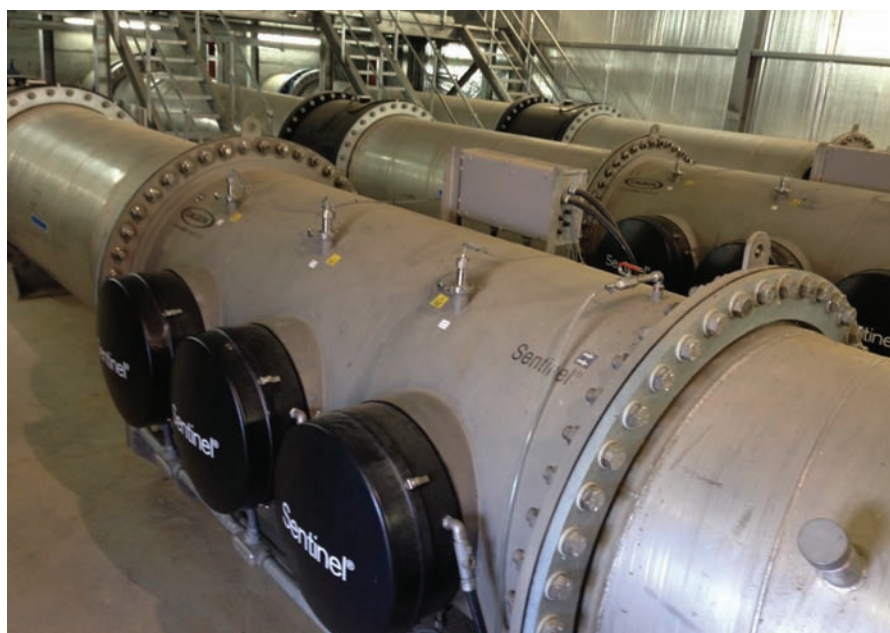
Figure 1. The Stromlo UV disinfection system.

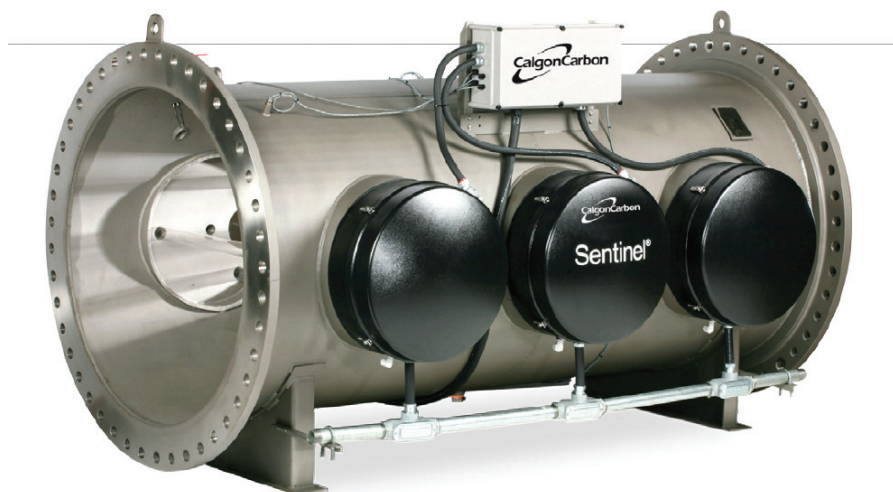
Figure 2. A single UV treatment unit with three lamp banks.

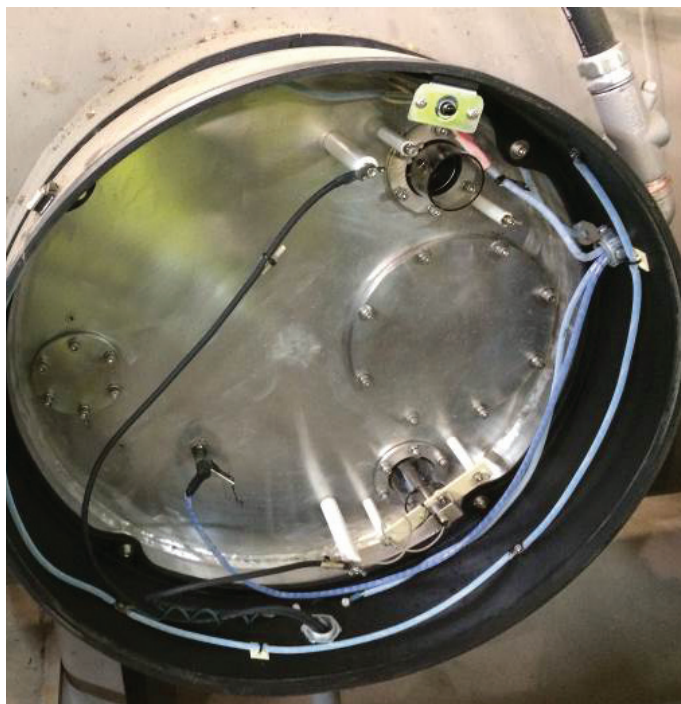
**Figure 3. A UV lamp bank with the cover removed.**

Electricians were sent to inspect the lamps in the offline UV Train 3 at 10am. They removed the covers and found the broken lamps.

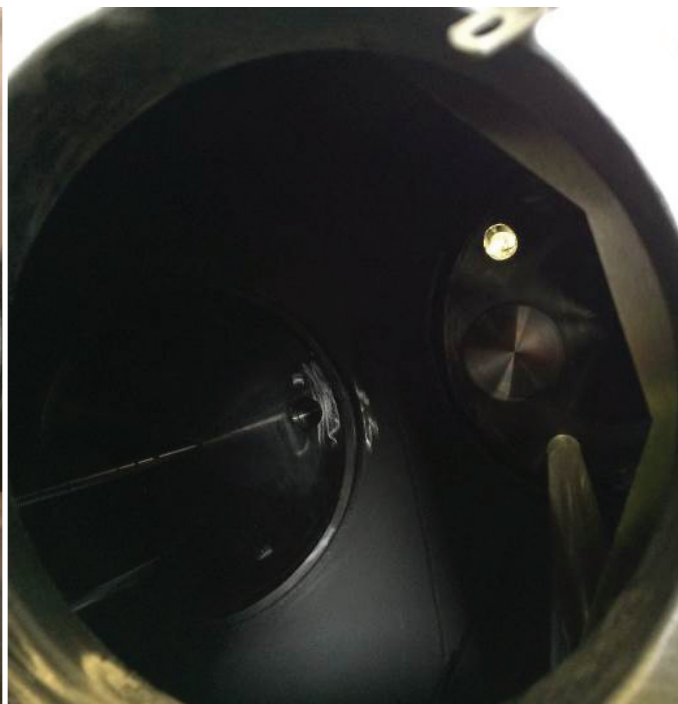
**Figure 4. View through the lamp sleeve mounting.**

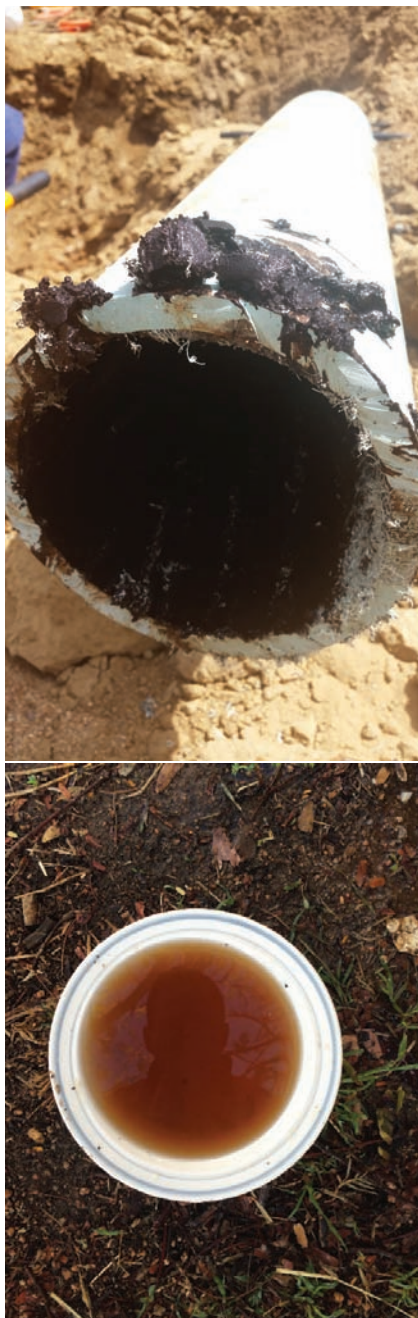
Residents were calling on Council to step in and take corrective action, as the metallic-tasting water and staining was not getting any better (Figure 1). The issue had also appeared on Queensland Health’s radar and had been tabled at

**Figure 1. Manganese residue in a pipe from the Georgetown pipework (top); and a sample of town water during a dirty water event (bottom).**

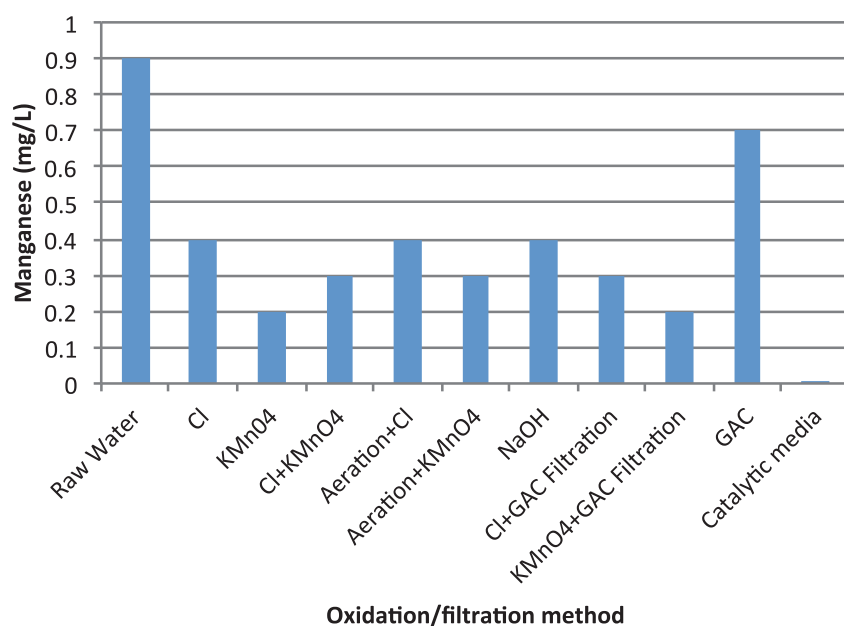
Just like coagulant selection a range of different oxidants and doses were tested. Sodium hypochlorite achieved acceptable results on the dissolved iron, but didn’t come close to reducing manganese to any

**Figure 2. Results of the oxidation tests.**

level below the ADWG aesthetic value of 0.1 mg/L, let alone the health value of 0.5mg/l. In previous jobs we have seen manganese stain down to levels of 0.05mg/L, so we knew we would have to achieve filtrate waters below this level to ensure client satisfaction. Potassium permanganate ( $\text{KMnO}_4$ ) did offer a bit more punch, but was still unable to achieve results below 0.1 mg/L – and with raw water manganese at this point fluctuating between 0.7–1.5 mg/L, it was unable to repeatedly achieve below 0.3 mg/L in the treated water. With this it was back to the literature in search of a new direction.
