12th WIOA NSW Water Industry Operations Conference & Exhibition

11 & 12 April 2018

KEYNOTE ADDRESS
CASE STUDY: HAVELOCK NORTH, NEW ZEALAND –
WATERBORNE DISEASE OUTBREAK

CASE STUDY: HAVELOCK NORTH, NEW ZEALAND – WATERBORNE DISEASE OUTBREAK

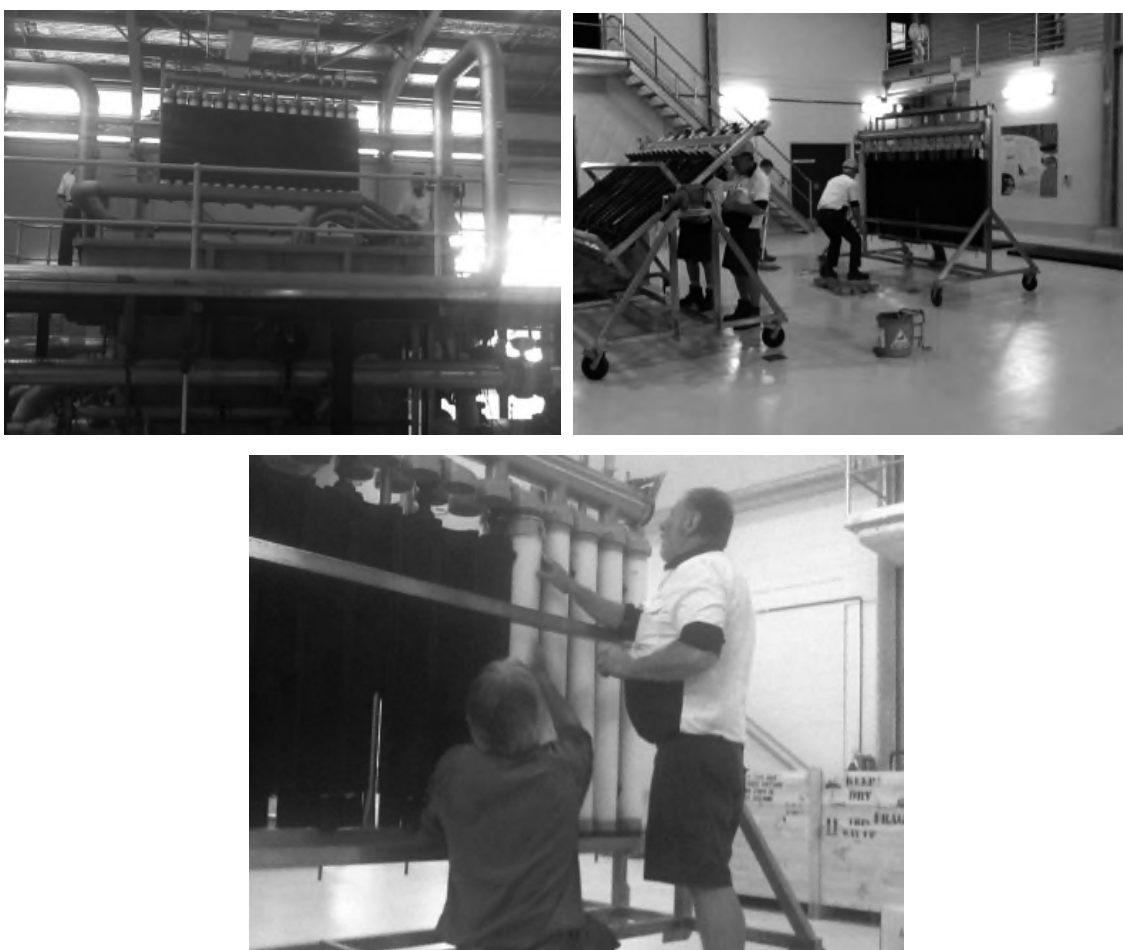
Figure 2: *Photographs showing the Membrane Replacement Process*

All 4 potable membrane filtration plants and the reclaimed water plant have had new membranes installed (all ultrafiltration). The process is very simple and took no longer than a day for each plant. The membrane replacement process is shown in Figure 2.

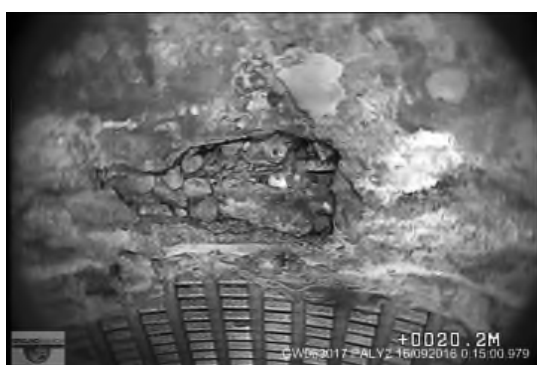
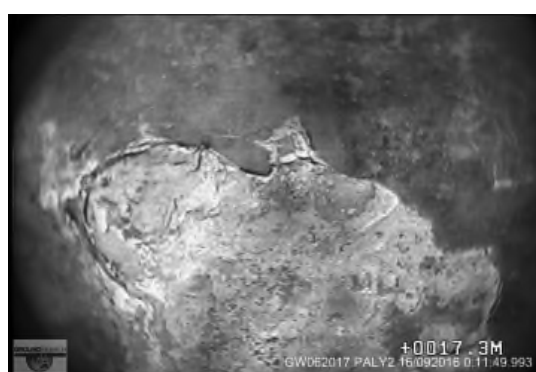
Figures 1 & 2: *Photos of Pallamallawa Bore No. 2 Condition*

Moree Plains Shire Council (MPSC) supplies potable water for a small town, Pallamallawa, located about 30 km's east of Moree. The potable water supply consists of a duty/standby bore arrangement which pumps to a cooling tower from which it is treated and pumped to a reservoir. In June of 2016, during a clean and inspection of the bores, it was noted that there was serious concern for the integrity of the Bore No. 2 as can be seen in Table 1. The report from the cleaning contractor identified multiple points in the casing and screen that were corroded, several holes were identified and sections where the gravel packing was visible, as can be seen in Figures 1 and 2. The recommendation from the contractor was that the bore was in a poor condition and was subject to potential imminent failure above both screens.

Due to the age and condition of the bore MPSC decided to commission a replacement bore. Department of Industry Water Division advised MPSC that a hydrogeological assessment would need to be completed outlining the effects of the bore on the existing aquifer and how it would affect neighbouring bores within 200 m.

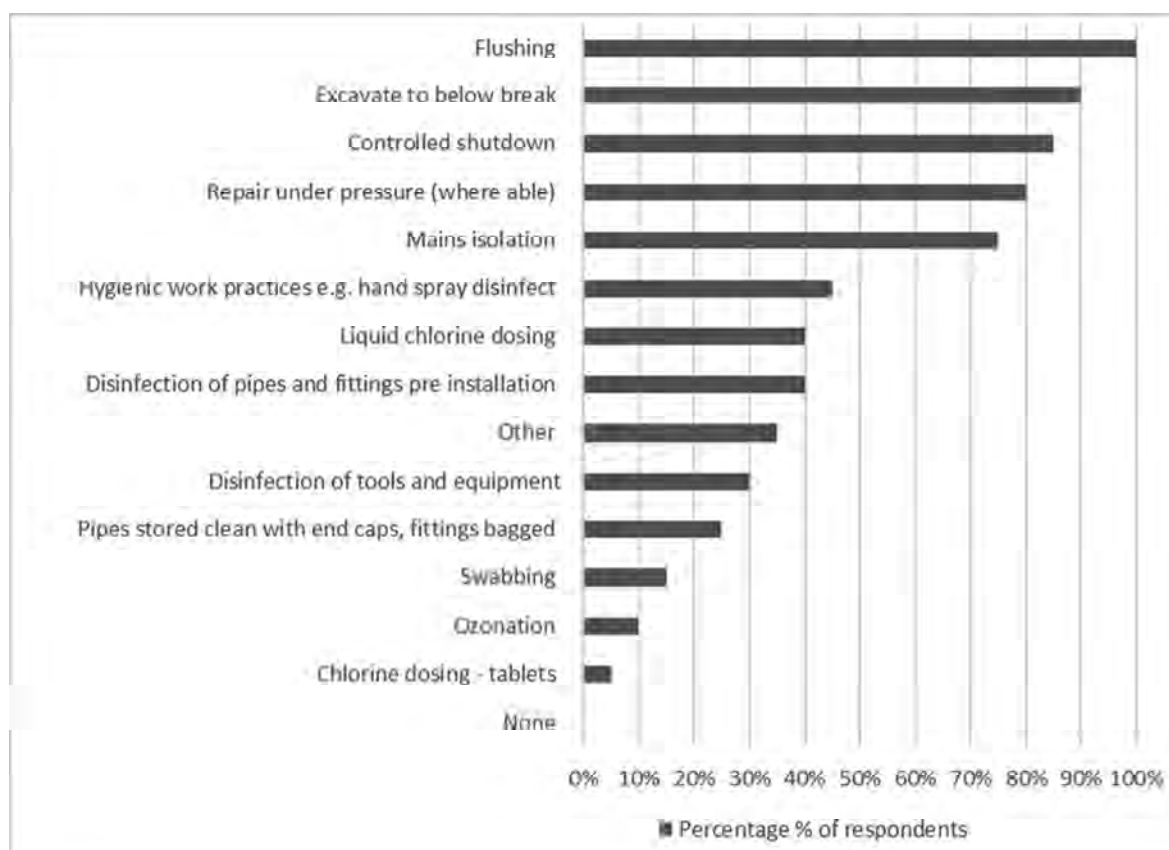
Figure 3: *Implementation of pipe break repair and renewals control measures by surveyed Australian water utilities*

A summary of the percentage of control framework measures being implemented by surveyed utilities is shown in Figure 3. It was noted that some of the reported controls are for high risk repairs only, e.g. ozonation and chlorine dosing.

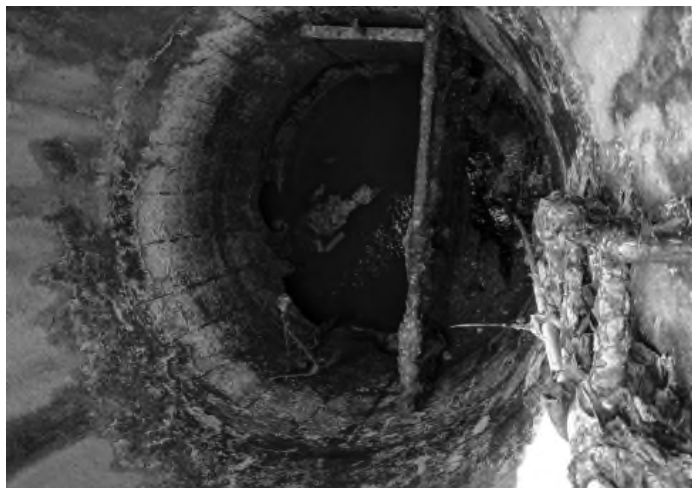
Figure 1: *A pump station inlet well showing typical hydrogen sulphide corrosion*

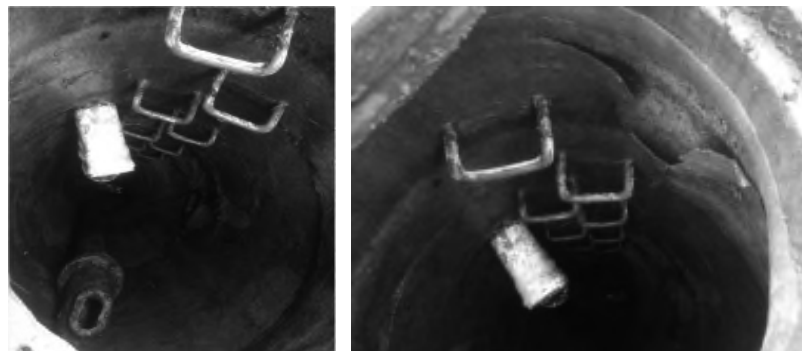
Figure 2: *Example of a typical polymer liner failure*

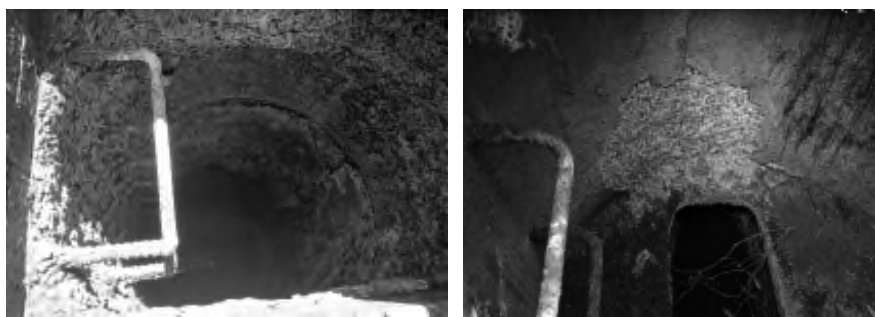
Figure 3: *Without protection some concrete assets degrade quickly*

Photos in Figure 3 show concrete surfaces which have been blasted with water or scratched to expose the extent of the concrete mass loss.

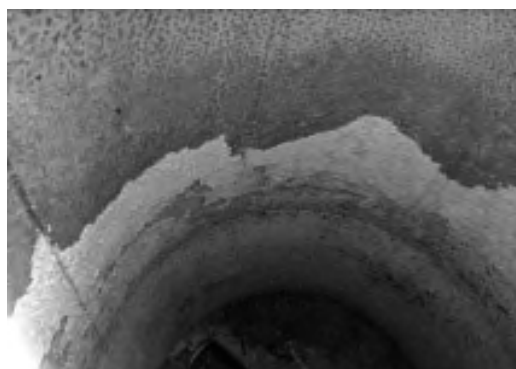
Figure 6: *Calcium Aluminate Cement consumed by strong acid attack*

The Calcium Aluminate Cement coating in Figure 6 has come to the end of the life, having been consumed by the acid within this rising main discharge manhole.

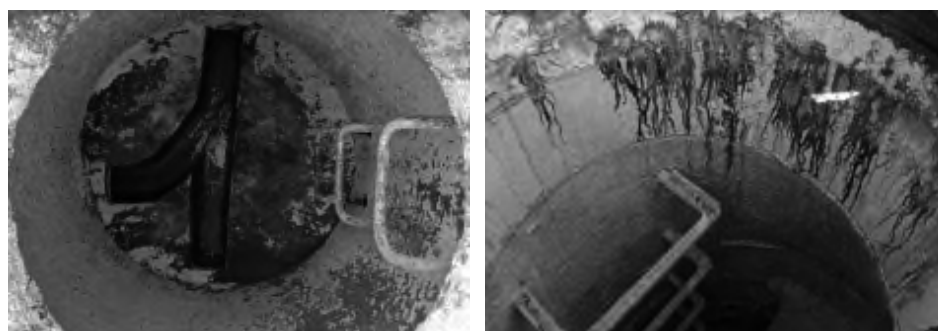
Figure 7: *MHL Coating taken off by storm water coming through lid*

If an appropriate procedure of Magnesium Hydroxide coating is not followed, coatings applied at the wrong thickness can result in the material cracking and falling off the concrete surface.

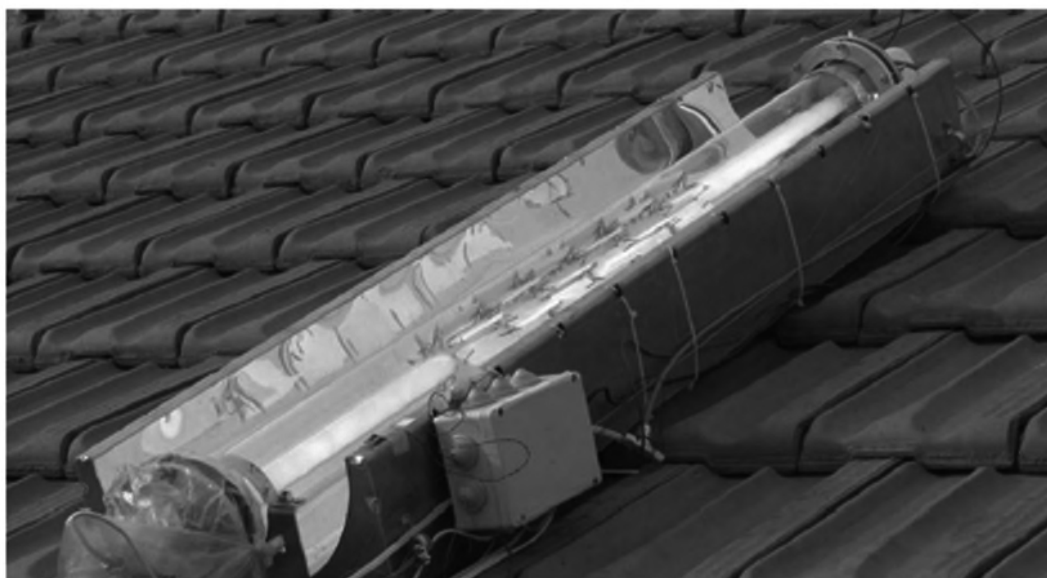
Figure 2: *Sample photoreactor. Note the UV bulbs set on a timer side-mounted to the unit. During this experiment, bulbs were activated during non-daylight hours (Portella, 2012).*

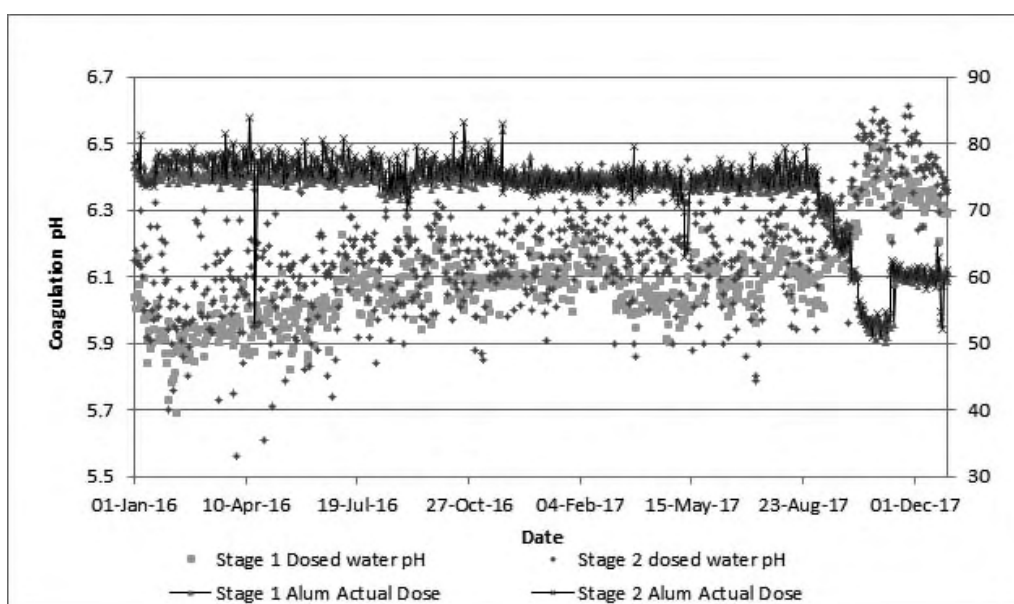
Figure 3: Alum dose and dosed water pH

There are several approaches that can be taken when optimising the alum dose at a WTP for low filtered water turbidity including jar tests and using online instrumentation such as streaming current, zeta potential and UV254 measurement (Ratnaweera and Fettig 2015). The approach taken in this study was to reduce the alum dose in small steps (approximately 5mg/L) and review filter performance. Alum dose changes were made over a period of several weeks in the period September to November 2017. This approach was taken to avoid breaching operational and aspirational filter targets. Figure 3 shows the alum dose and dosed water pH trend for the study period. The dosed water pH increased from pH 6.1-6.3 to pH 6.3-6.6 when the alum dose was reduced from 75 to 52 and then 60 mg/L.

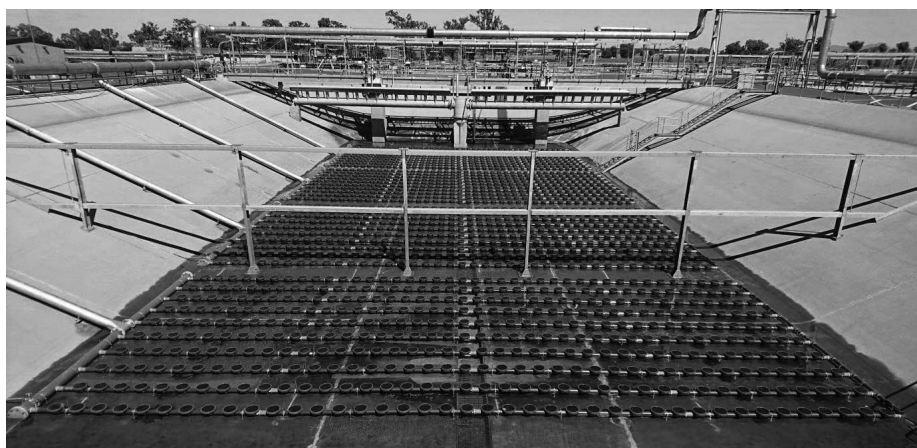
The Westdale WWTP upgrade was completed in 2011 and included 4 new Intermittently Decanted Aeration Lagoons (IDALs) as the source for Primary and Secondary treatment of waste water. Each IDAL consists of 5 banks of air, each bank has 10 lateral air pipes off the header pipe and every lateral pipe has 40 disk diffusers. In short there are 50 lateral rows of pipes about 17 metres long with a total of 2000 diffusers in each tank. These pipes are raised off the floor with roughly 140mm clearance at the shallow sides to about 300mm along the centre channel.

Figure 1: *IDAL 1 empty and clean*

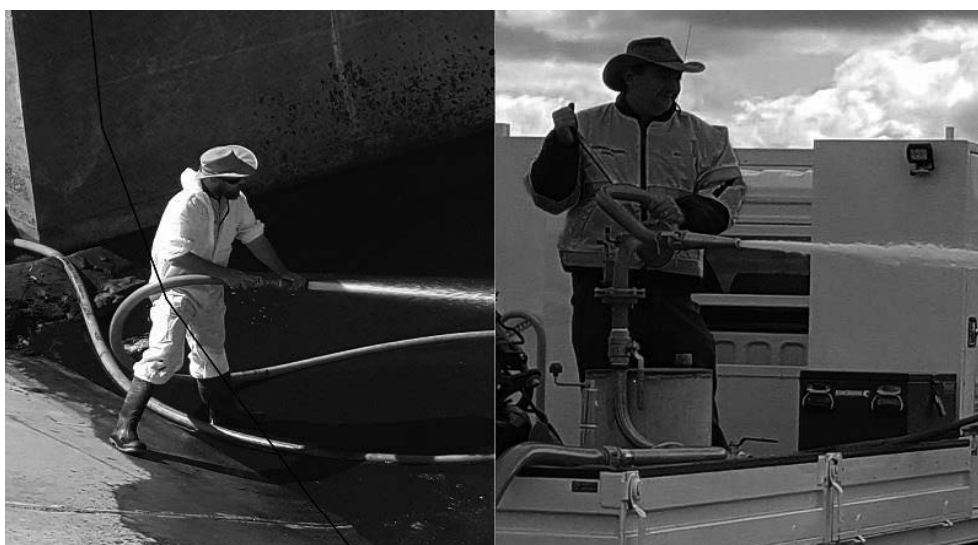
Each IDAL took around 2 weeks to clean adequately down to the floor with the use of lay flat hoses and a “water cannon”. The water cannon was purchased after the cleaning of the first IDAL and made a huge difference to the time of hosing out by helping operators control angle and concentrate water flow. Sludge was hard to fully hose out between the brackets and pipes so once sludge levels were almost to the floor and all the diffuser pipes exposed the focus shifted to pipe removal.

Figure 2: *Hosing without and with the cannon*

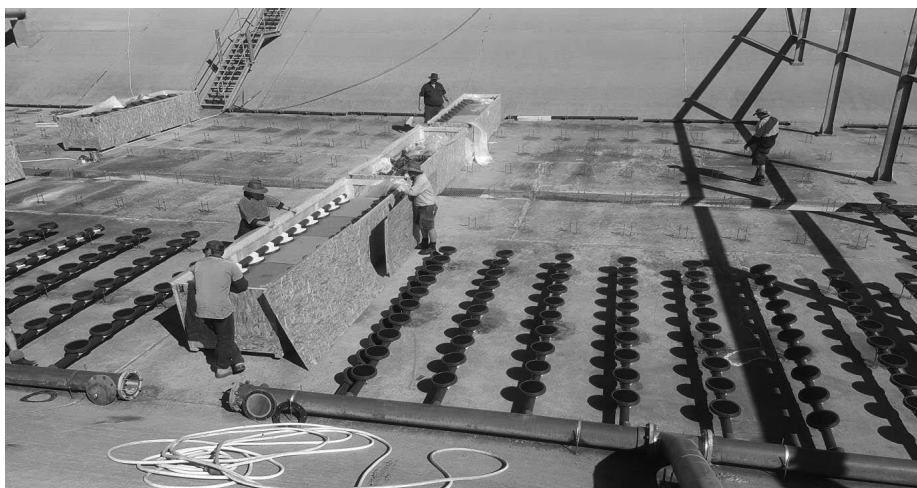
Figure 3: *Unpacking boxes and placing diffuser pipes on brackets*

With the floor clean and old pipes out of the way all the new equipment could easily be installed. Each new lateral consisted of 4 lengths of PVC pipes with each pipe containing 10 already fitted diffusers. The preassembled aeration pipework arrived in 5 metre long pallet boxes and within a few hours of boxes being lifted into the IDAL floor, all the pipework was sitting in position on the existing brackets ready for boxes to be removed out of the way.

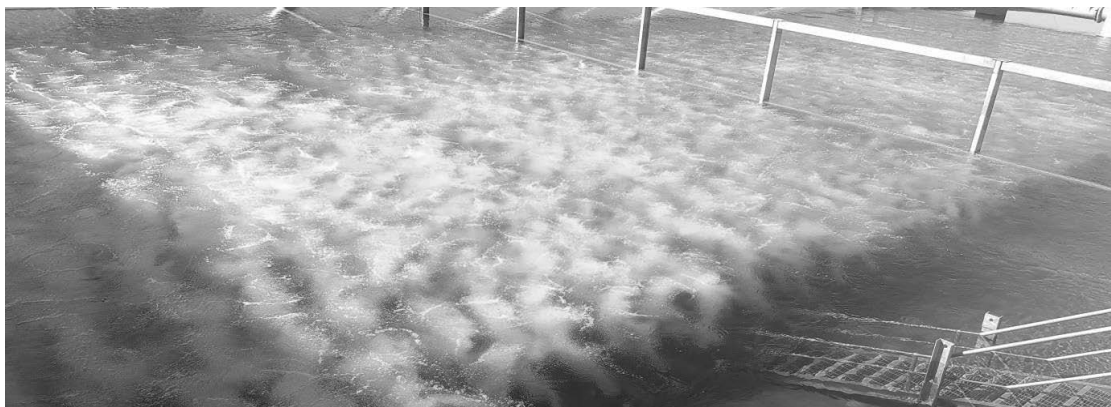
Figure 4: *Bubble testing before commissioning*

Now we get to test all the hard work we’ve done for the last 3-4 weeks. After running potable water into the first IDAL, it’s time to crack open the air valve gently and just a little bit.

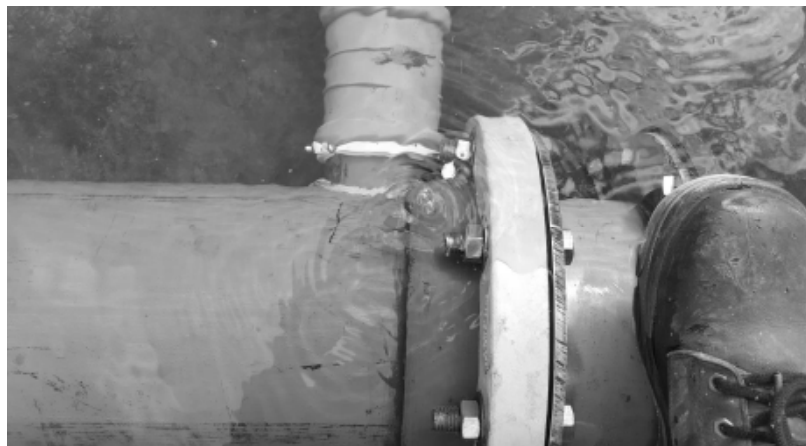
Figure 5: *Leak found on header pipe flange*

The biggest issue encountered along the install was with the header pipes before the lateral pipes. The original pipes are heavy wall PVC and over the 6 years in service they were sagging a little in the middle between brackets. Whilst this didn’t really cause much concern initially it was discovered many had small leaks when bubble testing the diffusers. When the header pipes were unbolted it was found that the lip holding the welded uni-flange on was cracked and in some cases was all but broken off the header pipe altogether. On some the spigots off the header pipes also had small leaks where they had been welded.

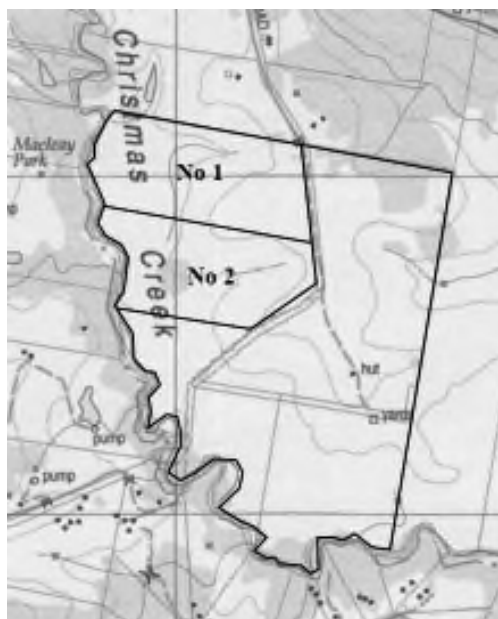
Emptying of the large sludge lagoon took approximately 54 days, and more than 4,000 wet tonnes of sludge was removed. Approximately 2,500 dry tonnes of biosolids was applied to the farm by 375 truckloads in two designated areas (Figure 2).

Figure 2: *Trial biosolids application sites in 2010 (No 1 and No 2)*

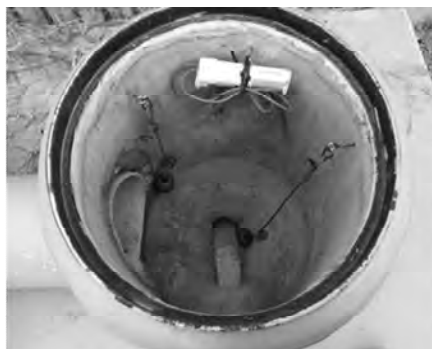
Low-cost sewer overflow sensors are now finding their way into chambers at many water utilities. Aside from the obvious benefit of being able to warn of a potential overflow, something every water utility wants to avoid, these sensors, combined with data from others such as rain gauges and water level sensors, are also providing clues about inflow and infiltration issues. Knowing the recent history of rainfall and, perhaps, the level of nearby creeks, the speed of increase of levels in sewers can quickly identify if inflow or infiltration is occurring. This can help reduce the cost of testing.

Figure 3: *LPWAN-connected sewer overflow monitoring*

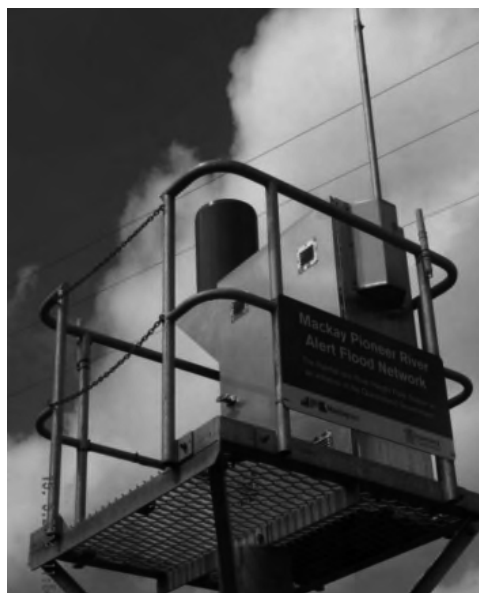
Rain gauges installed across a water supply service area can provide contextual data for a number of potential situations. In addition to the sewer monitoring described above, knowing how much rain falls in an area combined with detailed water use within the area can provide useful information on how potable water is being used for outdoor use. This can then be used to inform community education programs about water use and the need to conserve water.

Figure 4: *Rain Gauge*

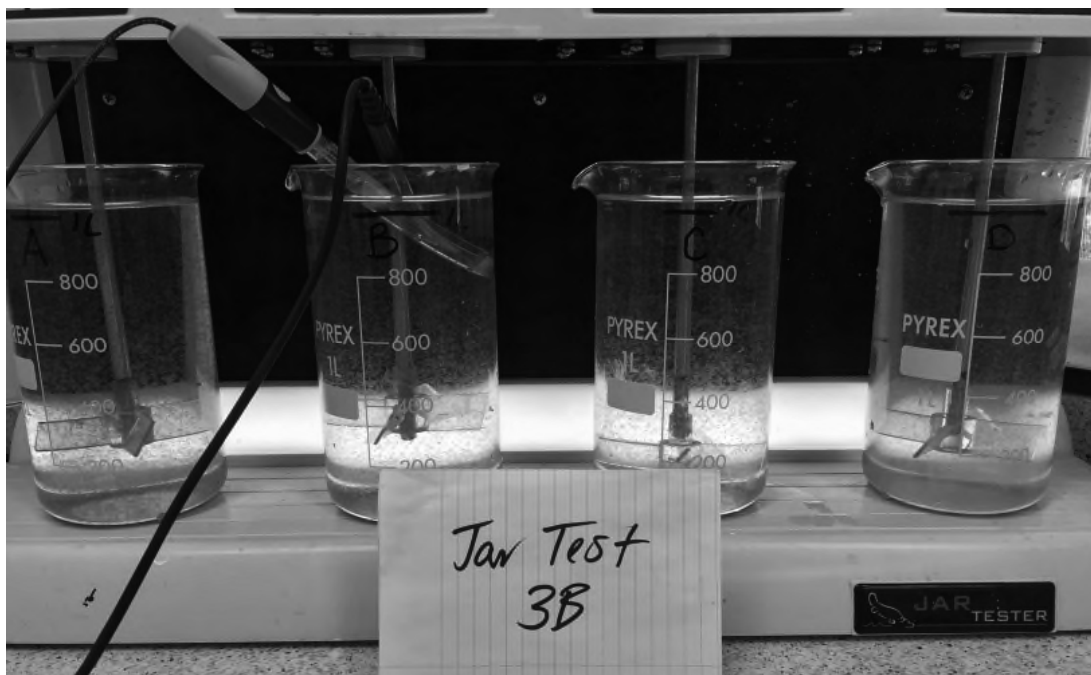
Eight ferric dose rates were tested from 8.4 – 46.2 mg/L. A ferric dose rate of 38 mg/L was found to be optimal in terms of settled and filtered water quality. Similarly, seven polymer dose rates were tested, from 0 – 0.3 mg/L. Settled and filtered water quality were found to improve up to a dose rate of 0.15 mg/L; however, did not change significantly thereafter.

Figure 2: *Jar Testing completed onsite at John Gilbert WTP*

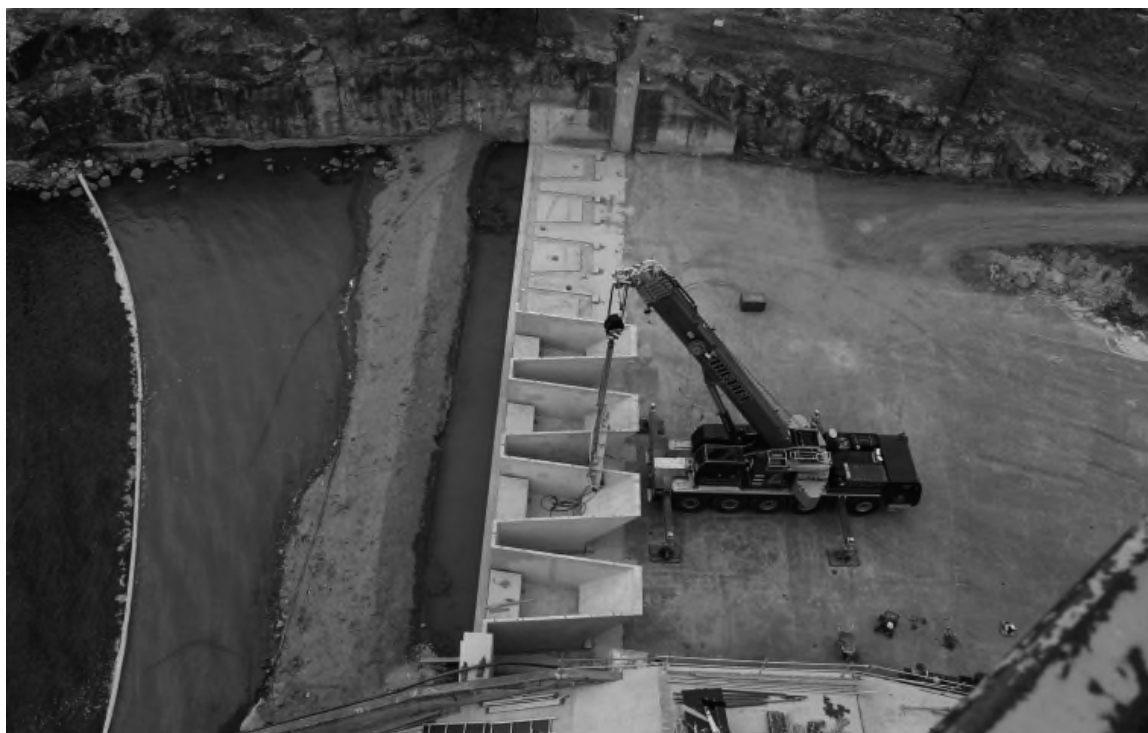
Figure 1: *Installation of Fusegates within the original spillway width.*

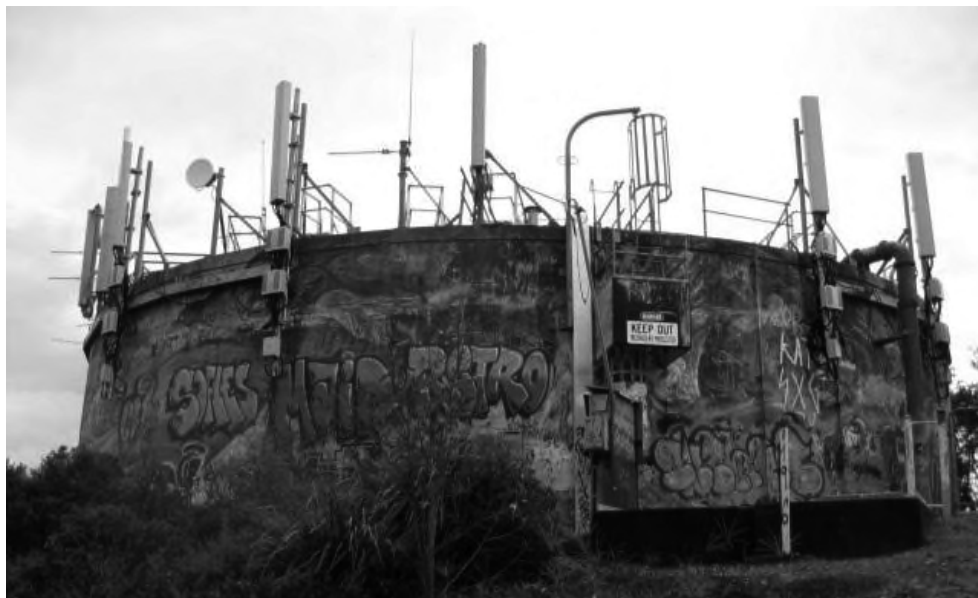
However, if the facility is categorised as Low Impact under the *Determination*, then there's no need for the Telco to obtain development consent through State or local government planning processes. This is the area of greatest concern for LWUs, as many of their reservoirs, towers, tanks are considered candidates to host Low Impact communication facilities.

Figure 1: *Example of a Low Impact Facility posing risks to water supply operations and public health*

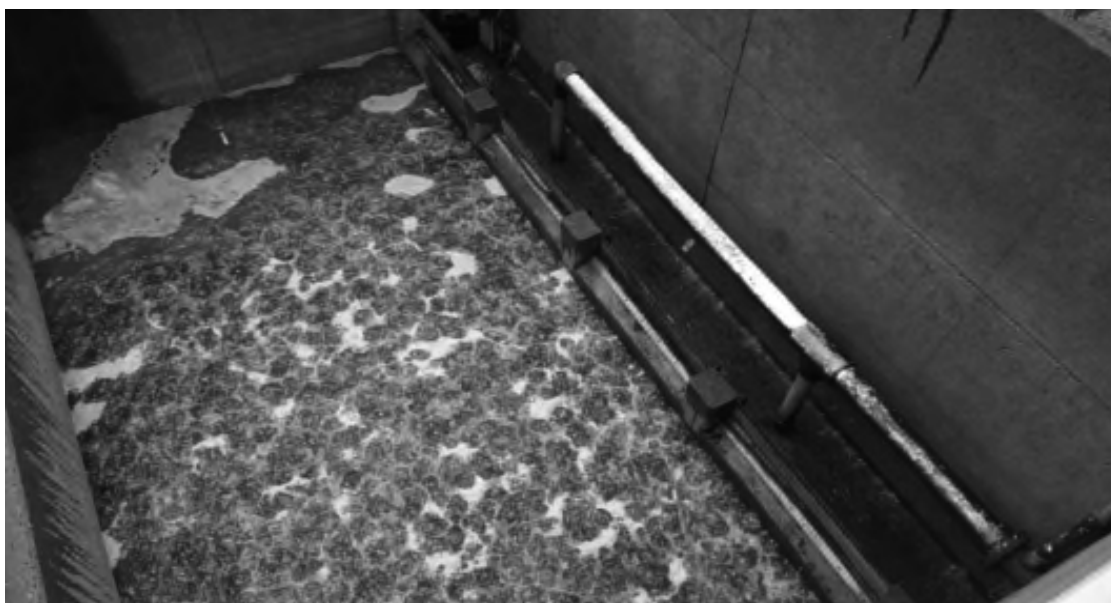
Figure 2: *Air scour pattern-Filter 2 leaks evident along the drain and 1/3 media not agitated.*

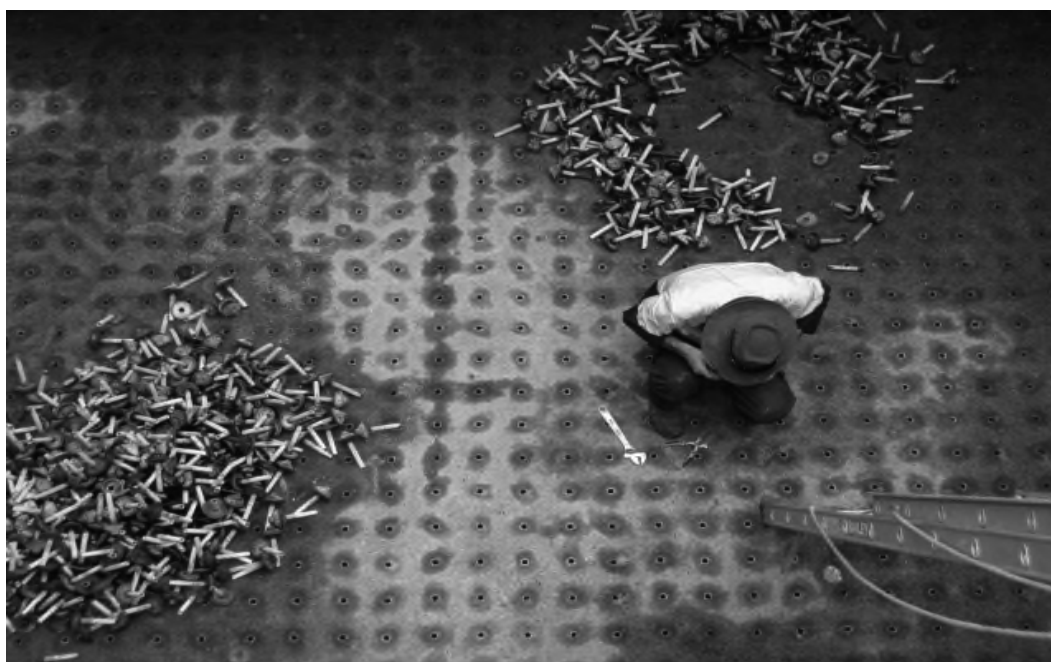
Figure 3: *Labour intensive rosette removal. Many nozzles were broken and threads damaged*

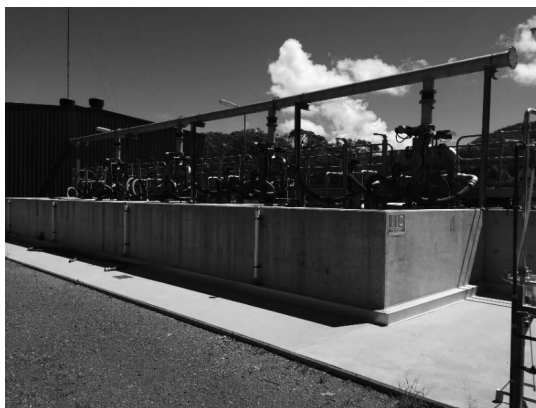
Camden Haven Wastewater Treatment Plant is located on the Mid North Coast of NSW and services the Camden Haven region. The plant has a dry weather flow of 2 ML/day, and in periods of heavy rain, can receive over 10 ML/day. The plant consists of 4 MBR trains with each being able to draw 20 L/s permeate with a capacity to ramp up to 32 L/s in wet weather. The plant has a capacity of 15,000 EP (equivalent persons).

Figure 1: *Membrane Bioreactors at the Camden Haven Treatment Plant*

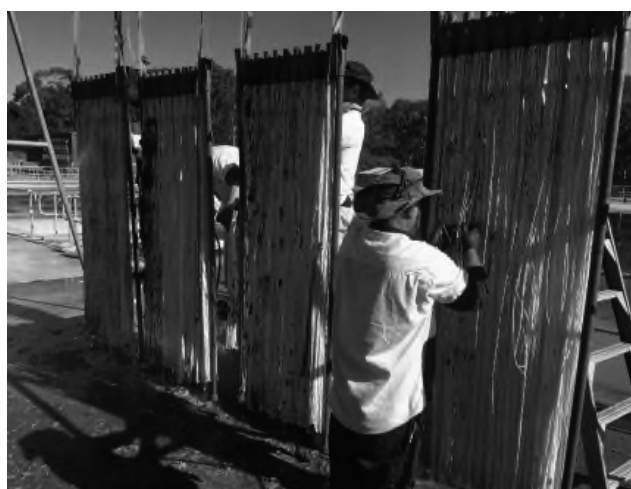
Figure 5: *Membrane Fingertip Cleaning Process*

After cleaning the membranes, they were placed in a water bath and low-pressure air was pumped into the membranes to see if there were any holes within the membrane strands. Any large holes in the fibre were removed, glued and retested in the water bath before being placed back in the train.

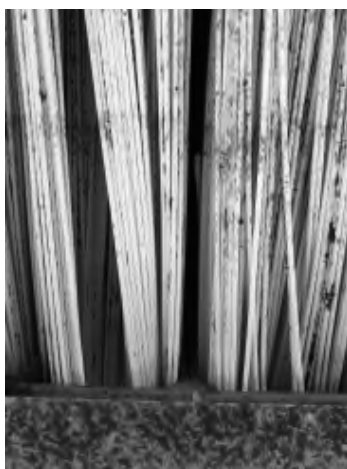
After recommissioning the MBR's and implementing the above changes, the TMP and membrane resistance of each train were back to normal values. There were no issues evident and after a month it was decided to pull out Train 2 and inspect the condition of the membranes. It was found to be completely clear of Alum sludge and it was evident that the changes made through the control systems had made a drastic change to the process of filtering mixed liquor.

Figure 6: Membranes after One Month of Recommissioning

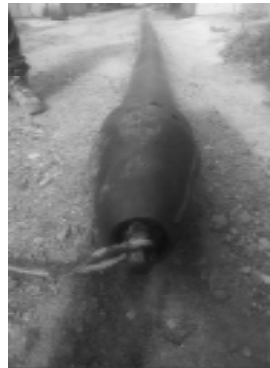
Figure.2: *Pipe Bursting head setup at Heber Lane*

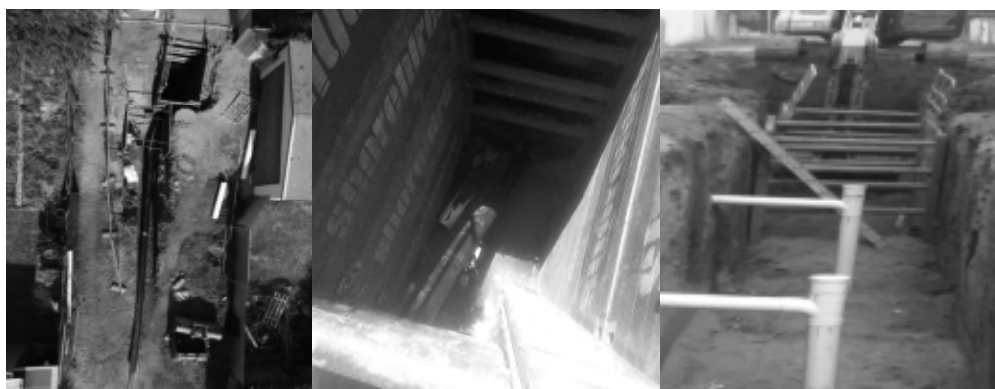
Figure 3: *Pipe Bursting with Shallow Rider Main in Heber lane*

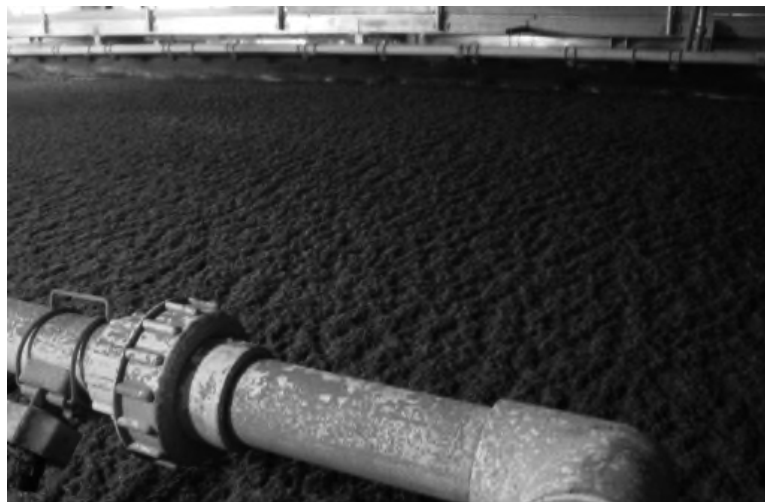
Figure 2: *DAF float*

During the troubleshooting process, many variables were examined to determine where the root cause may be for the plant performance issues that were being experienced. During observations of the operation of the WTP, the flocculation tank appeared to contain many small floc, while the DAF saturated water looked good being white and milky. DAF sludge was observed on the surface of the DAF system meaning floc was being floated (Figure 2), however, the DAF subnatant turbidity was still high measuring 3.7 NTU.

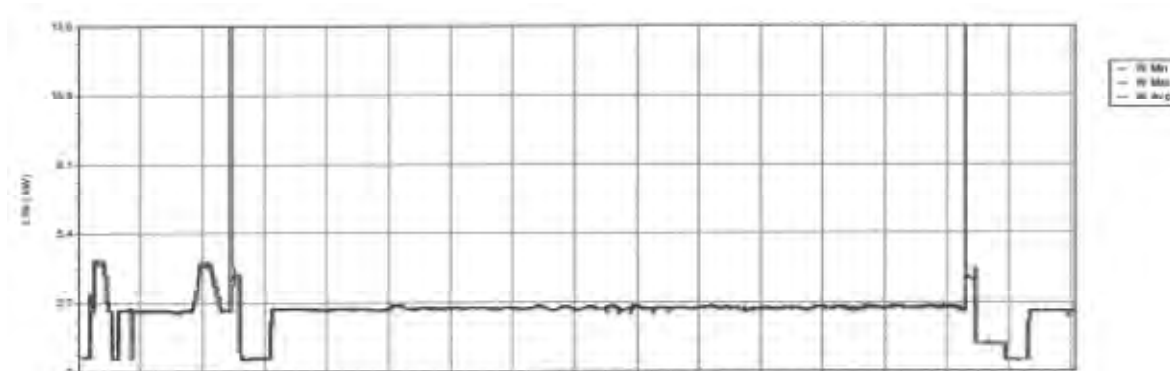
Figure 3: *Yackandandah WTP energy use after optimisation*

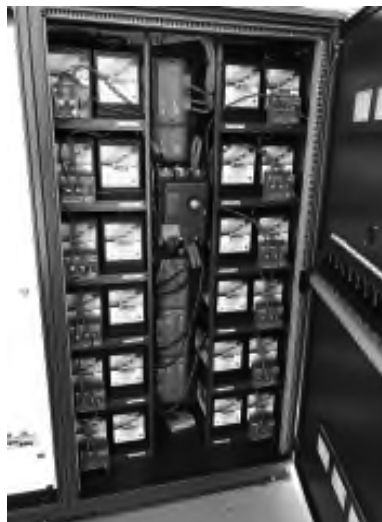
Figure 4: *Weatherproof switchboard*

The generated solar power feeds the plant while the WTP is running, the excess energy tops up the batteries at the same time or when the plant is idle. When the solar panels no longer generate the plant will switch over to the battery supply. The batteries also can top up on cheaper off-peak power then run during the day during high peak power supply. This operating mode can be very useful in overcast periods when solar power isn't generated but real saving in energy costs can be made.

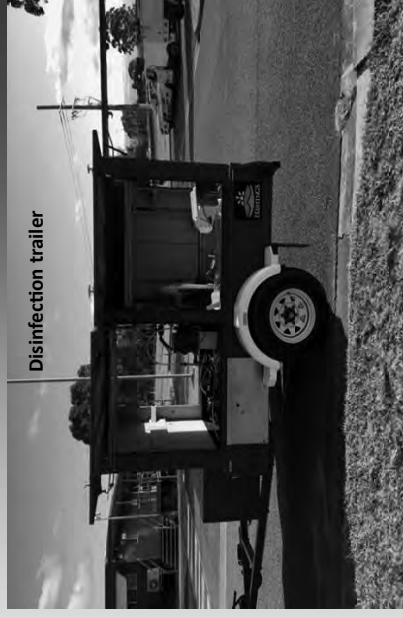
Disinfection trailer

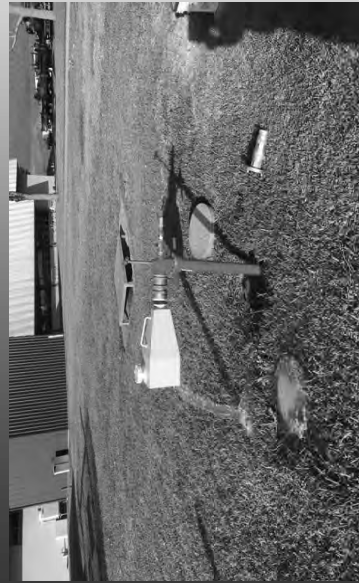
Example of hydrant de-chlorination unit using ascorbic acid

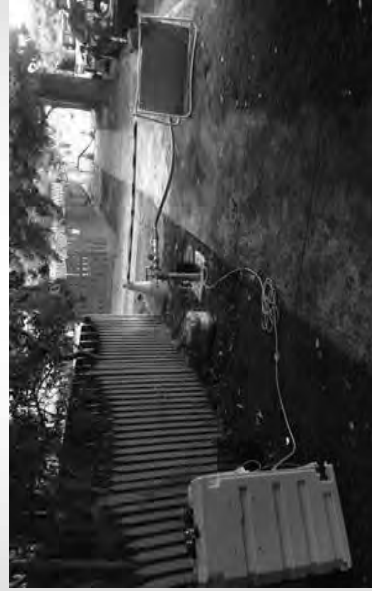
Example of hydrant to hydrant dose for mixing and injection

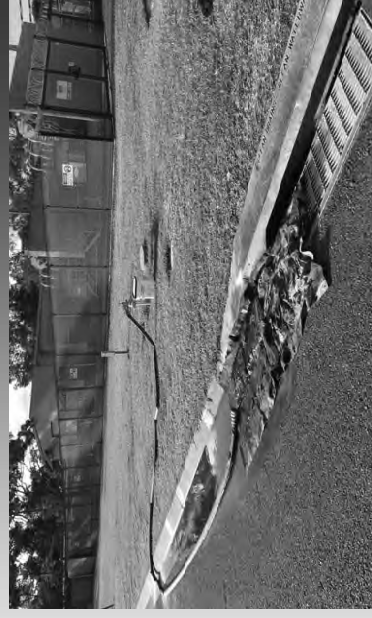
Example of hydrant de-chlorination using mats & ascorbic acid

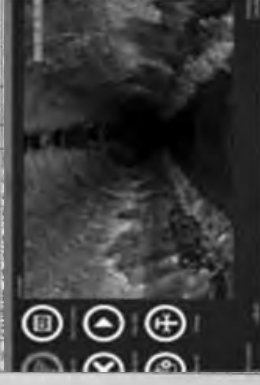
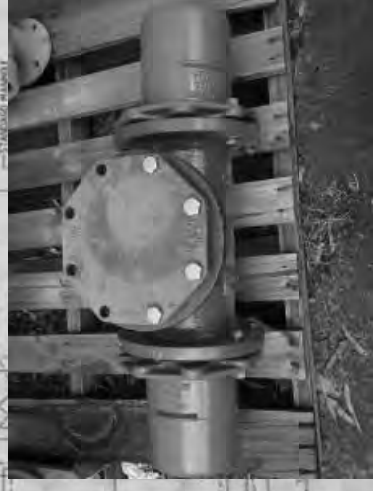
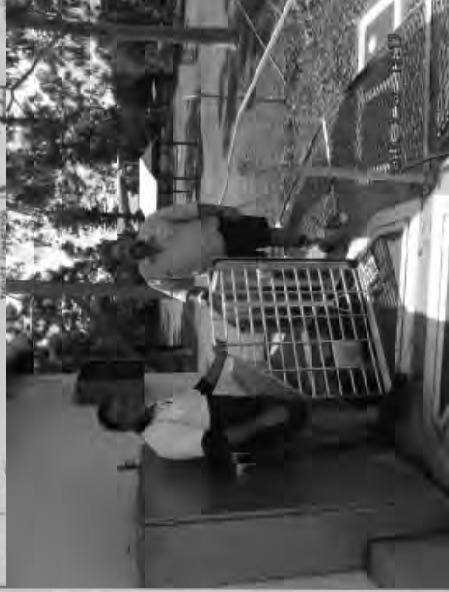
- Two trials are currently in progress
- Installed two new manholes in rising mains, cut 0.5m section of rising main and corrected with 0.5m of vacuum suction hose clamped with 150mm travis clamp/ 2nd trail connected with T Flange blanked off one end and connected with spigot flange couplet and connected back to main
- The clamped suction/ T flange hose acts as an inspection portal for pipe cleaning, CCTV condition assessment and future rehabilitation and maintenance works.

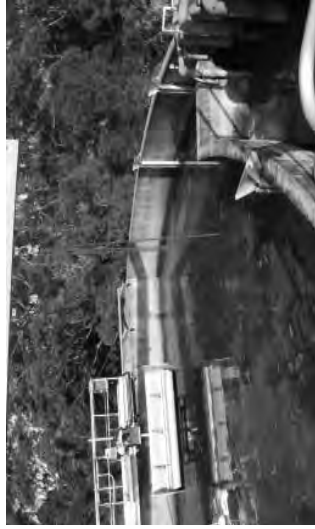
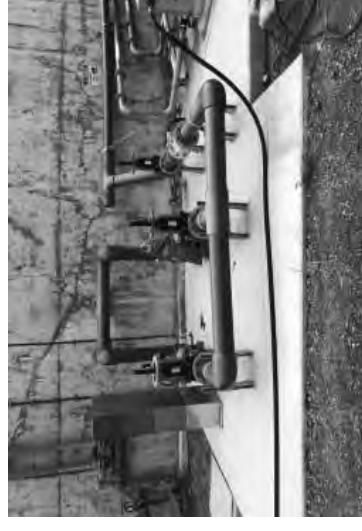
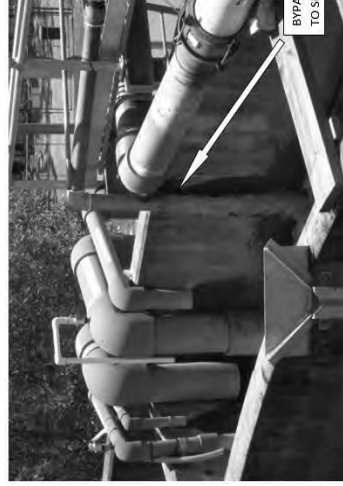
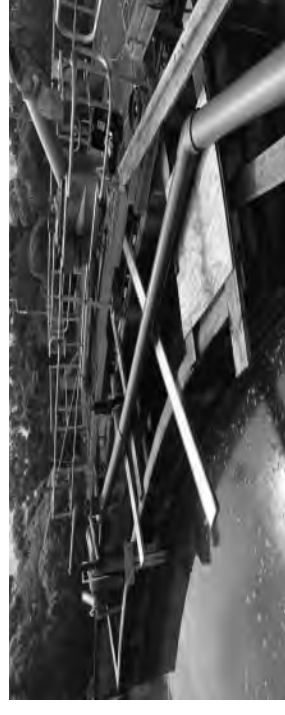
Hat Head STP Modifications

During holiday seasons and peak summer months the population of the small village of Hat Head increases dramatically. With this increase, the sewage treatment process traditionally struggled to cope with the increased daily inflow above 125KL/day. This was due to the short circuiting of incoming flow during the settle-decant period of the process. The plant displayed the ability to treat higher flows by reducing ammonia to acceptable limits and settling well. However during the settling/decant phase inflow would disturb the sludge blanket, causing an increase in turbidity and ammonia. During peak holiday flow periods the volume of inflow during the settle/decant phase (which has a duration of around 80 minutes) could approach 20KL. This figure represents about 33% of the current weekday diurnal flow

After a lot of discussions it was decided that a full time diversion would be put in place without any actuated valving and a pump returning the diverted inflow from the bypass tank (old #2 aerated sludge tank). To control the process, once the decant has finished and the plant resumes its treatment phase the pump will resume normal operation and empty the storage tank into the selector. The pipe work for the diversion was already on hand at the plant. It was previously used for the installation of new Aquablade air diffusers. A second hand submersible sewer pump was sourced from the spare pump shed. This pump had a floor stand already fitted which placed the bottom of the volute about 160mm above the floor of the bypass tank (#2 sludge tank) and had a flow rate of approximately 10-12L/sec, which made it ideal for the job. The pump can be lifted to remove chokes (which is unlikely) via a gantry and hand winch. A flexible 3" fuel delivery hose was used to transport the pumped liquid into the selector exiting via a short tailpipe.

From the successful trials an augmentation design was created. The design included a permanent influent line to the bypass tank with provision to bypass straight to the selector, two dry mount pumps capable of 14l/s @0.5m tank level, a bypass return line to the selector, level sensors, flow meter, automation and associated chemical dosing lines were upgraded while works were being completed. Before the augmentation was started the process team decided to upgrade the platforms, walkways and all working at heights and associated safety equipment.
