13th WIOA NSW Water Industry Operations Conference & Exhibition

WHAT CAN YOU DO, TO GET TO 0.2?

Michael Carter, Senior Process Engineer, Hunter H2O

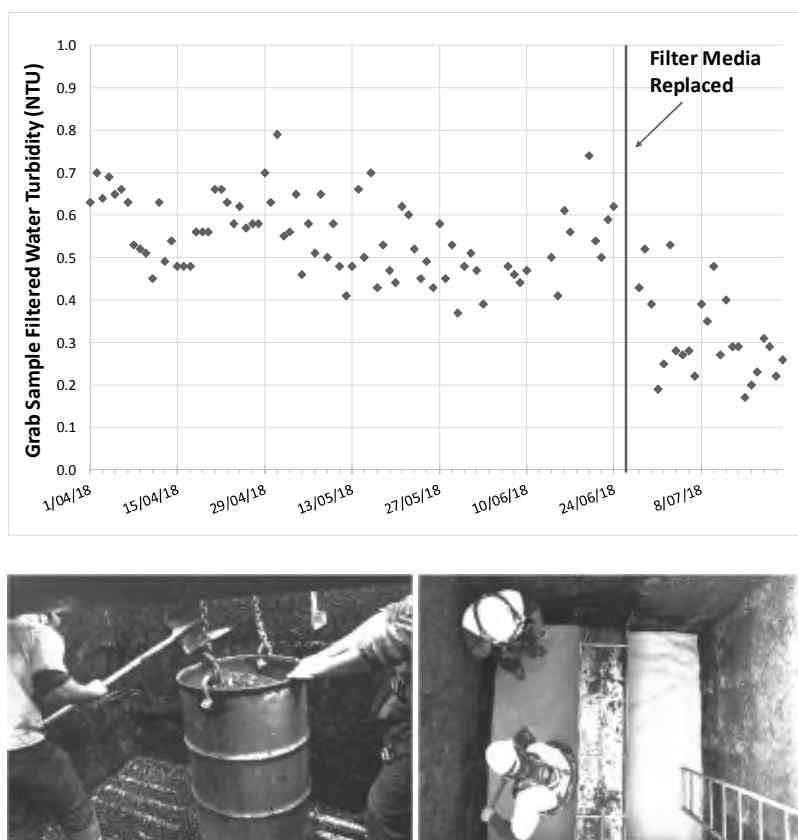
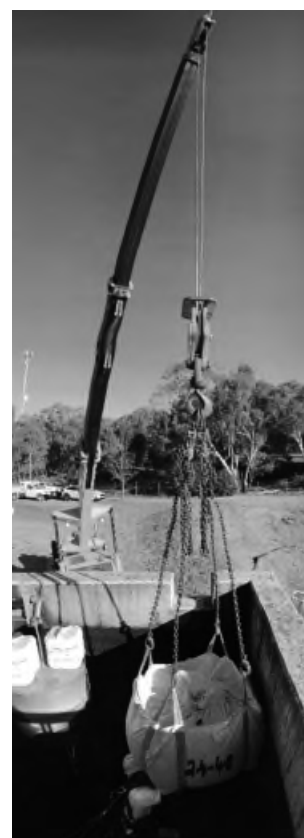
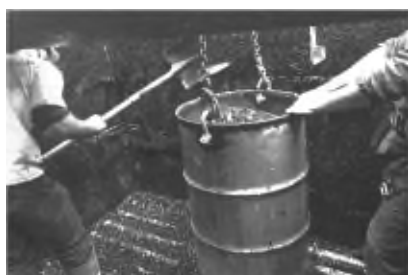
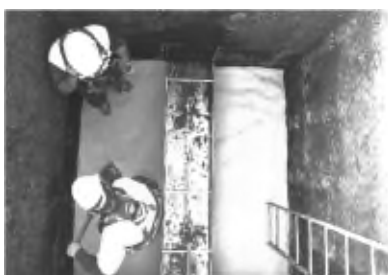
Figure 1: *Filtered water turbidity and filter media replacement photos*

At Plant A, the Filter Inspection identified that the filter media required replacement due to excessive manganese's build-up and shallow media depths due to loss of filter media during backwashes. The inspection was crucial in determining if the filtered water quality issues were related to the filter itself or due to ineffective pre-filter conditions (coagulation and flocculation). Once it was confirmed that the filter media was the cause of the poor filtered water turbidity, Hunter H2O was then engaged to plan, prepare and assist Council with the work required to replace the filter media. The work undertaken included the filter media and support gravel design, cost estimating, preparation of filter media specifications, media quotation review, procurement assistance, preparation of a risk management plan and installation procedures, followed by onsite assistance during the media replacement works.

Following the successful filter media replacement, the filtered water turbidity has improved by ~40% with results now lower than 0.3 NTU able to be achieved and some results <0.2 NTU. Further ongoing coagulation and flocculation optimisation work will ensure that the filtered water turbidity can continue to achieve very low results and eventually drop below 0.2 NTU continually.

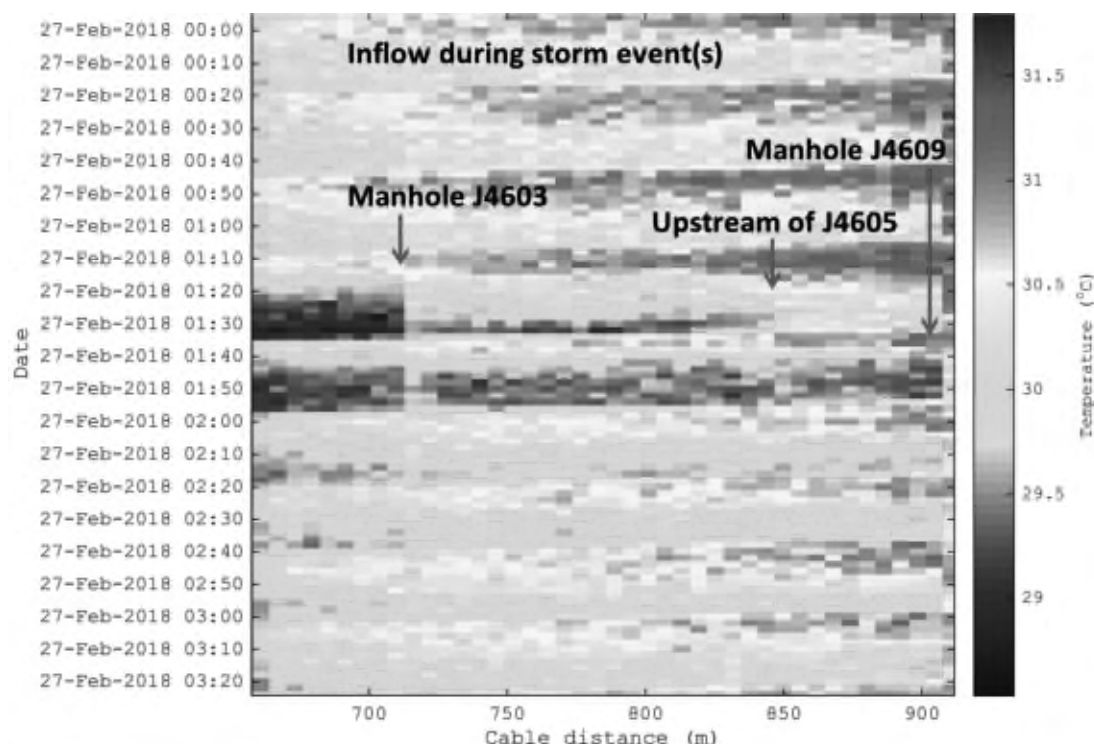
When inflow was detected in the cables, it can be seen as a temperature drop which affects the downstream flow but not the upstream flow. The temperature changes observed along Cable A during a rainfall event all correlated with a maintenance hole, as shown in Figure 3. There is a potential that illicit connections or damaged assets may occur at these locations and additional condition assessment is required to determine the nature of the I/I source.

Figure 3: *Cable A DTS output during wet weather*

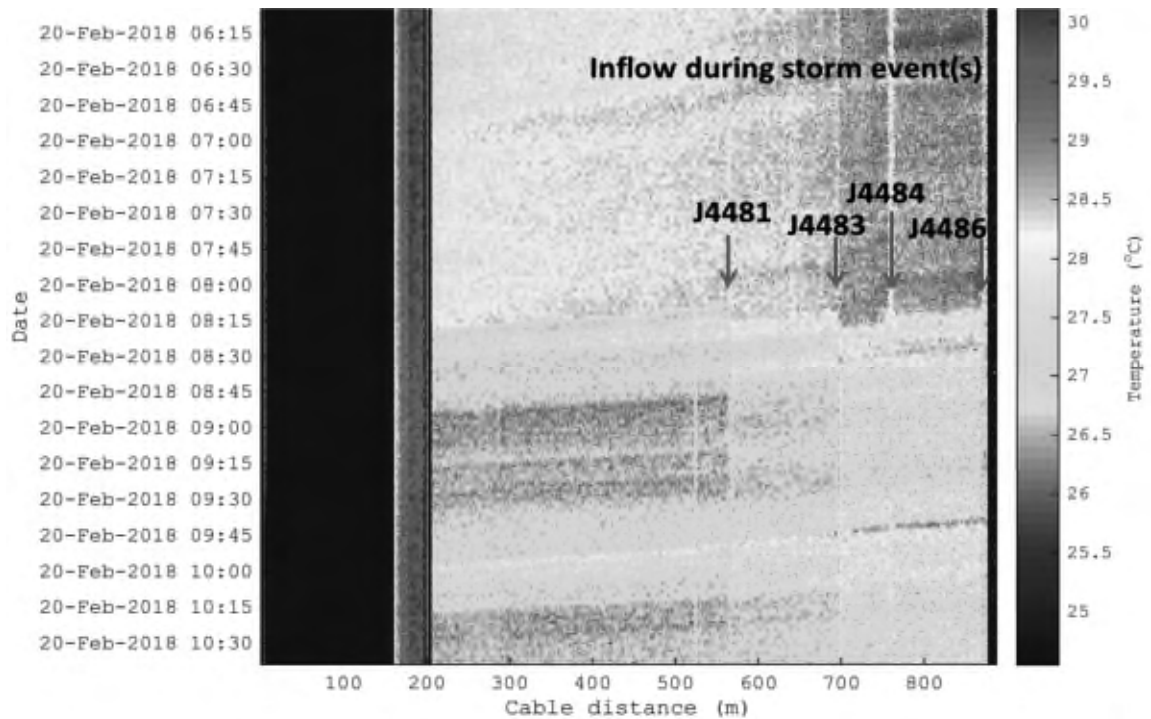
Figure 4: *Cable B DTS output during wet weather*

As such, future investigations at both the maintenance hole and the side branch catchments are required to assess the location and nature of inflow.

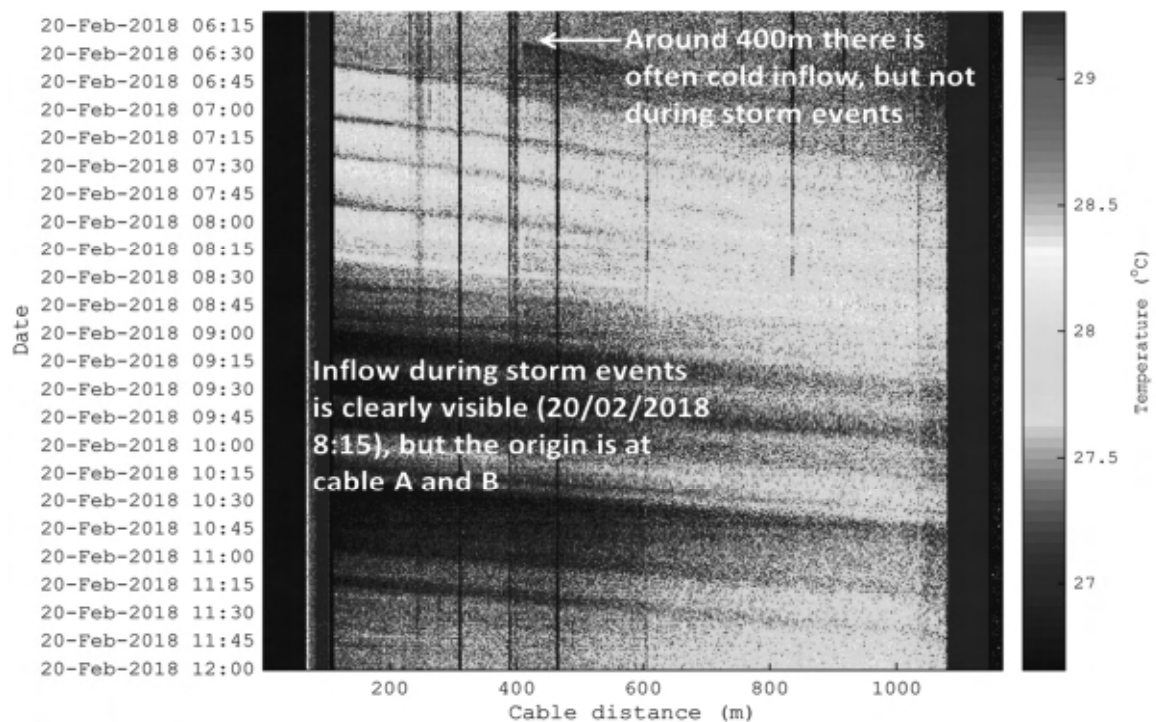
Cable C output indicated possible dry weather I/I, shown in Figure 5, that is most likely related to the assets near Myall Creek. In April 2015, a large storm resulted in the destruction of 3 houses near this location and it is likely that assets deteriorated at this time, although I/I was not immediately observed.

Figure 5: *Cable C DTS output*

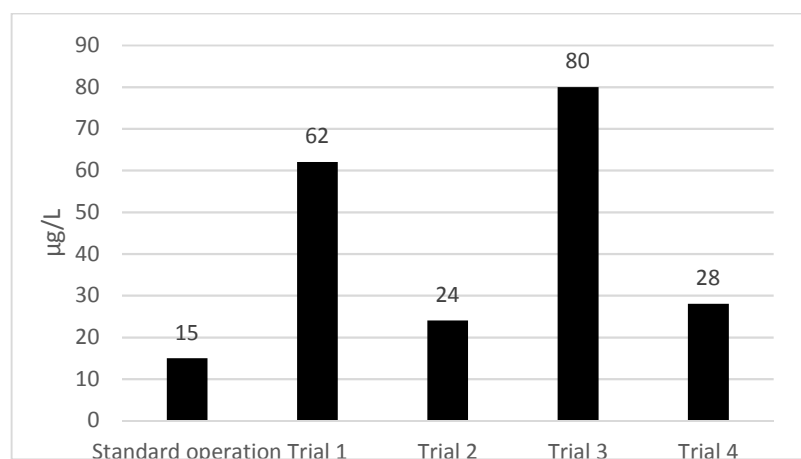
Figure 3: *Clear water DBP*

The generation of DPB increased under all trial conditions. The largest increases were recorded during trial Nos.1 & 3. Only slight increases were detected during trial Nos. 2 & 4. Under all trial conditions the ADWG health based target of 250 µg/L was not exceeded.

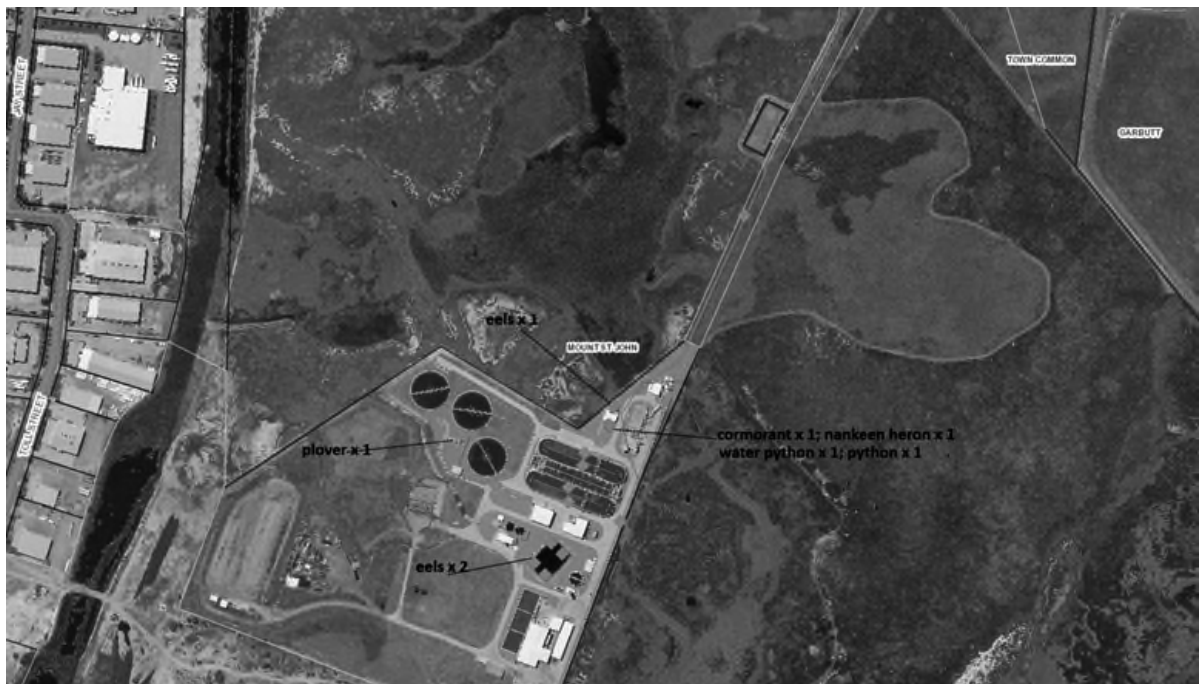
In November 2017, MSJSTP staff began recording duck deaths in and around the clarifiers, disposing of 25 duck carcasses per week. In December 2017, the quantity of removed ducks increased to 100 per week, and up to 100 Tilapia per day. In December other species of birds and eels were also removed (see Figure 1). In January 2018, the quantity of ducks and Tilapia removed had decreased immensely. No wildlife was found deceased after January 2018. All species of birds and fish were adults.

Figure 1: *Location of deceased wildlife; green - ducks, orange – Tilapia*

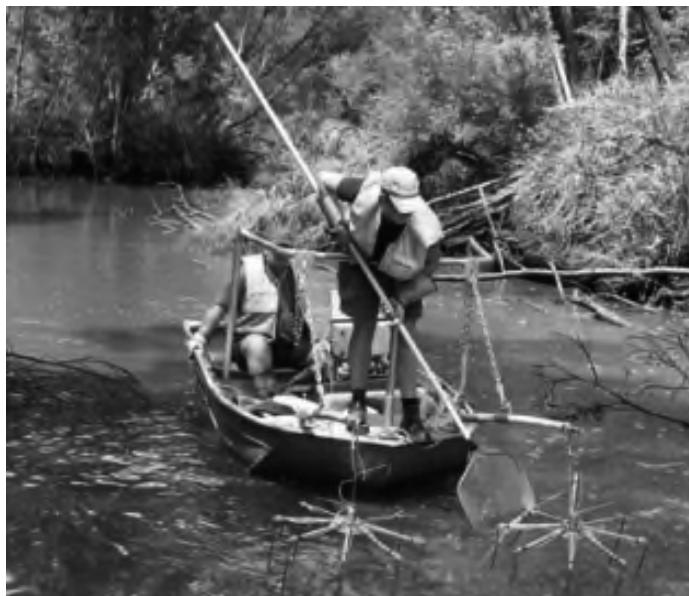
Options to humanely remove the existing population of fish from the clarifiers, DAF lagoon and UV structure are being investigated and TCC is in discussions with Tropical River Consulting regarding this. Options include draining of structures and electrofishing.

Figure 3: *Example of Electro Fishing*

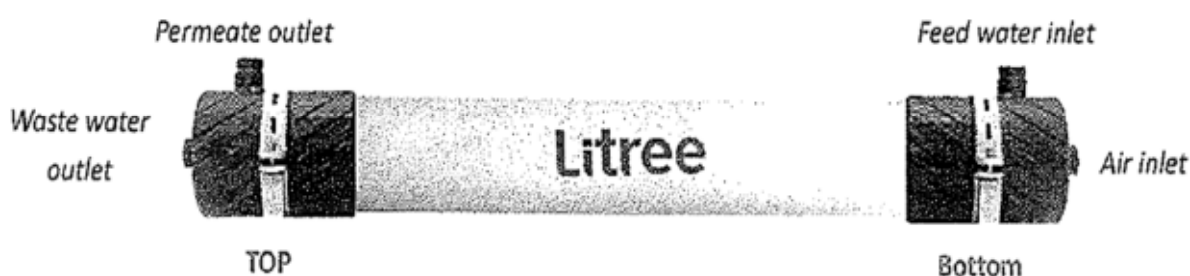
Figure 2: *Membrane Module*

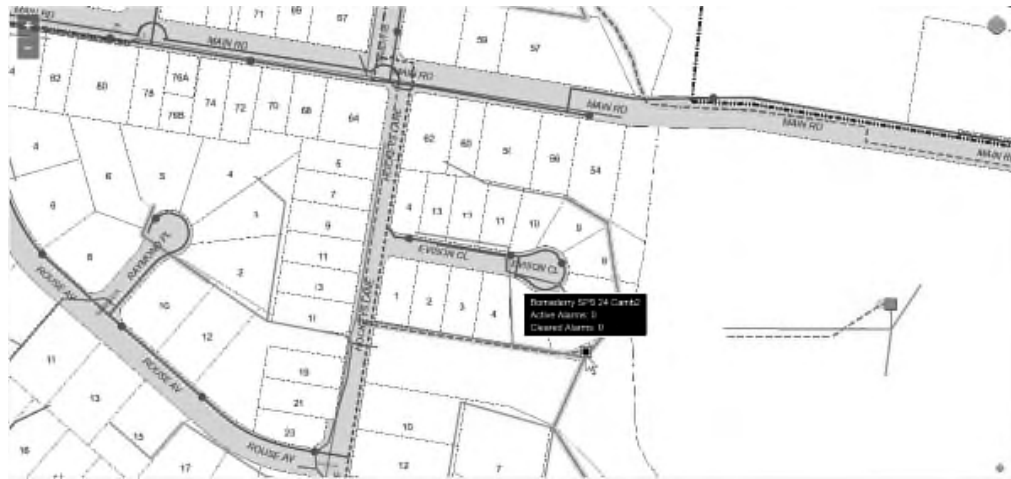
More focused on the scheme-based overviews, the recent upgrade to ClearSCADA 2017 software has enabled the inclusion of map-based geographic displays. This, in turn, provides the ability to overlay web-based map service layers such as internal GIS layers and Bureau of Meteorology data-feeds. This functionality has allowed vastly improved management of emergency response. These are shown in figures 5 and 6 below respectively.

Figure 5: *Geographic overviews – ArcGIS layer*

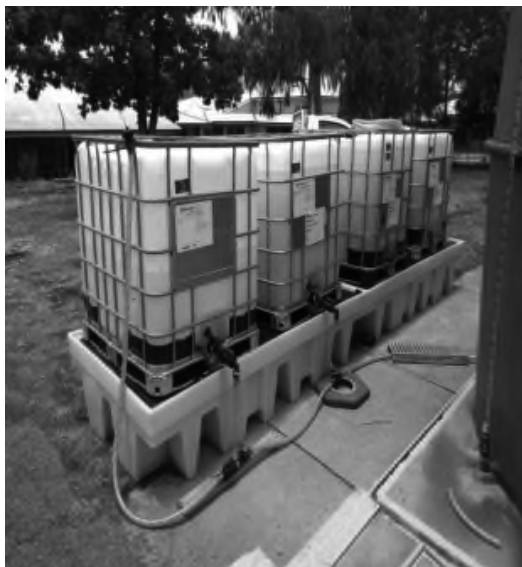
The WTP operators and technical support staff set up a ‘temporary’ dosing system consisting of four IBC’s that were retrofitted into the dosing pump previously used for Alum. As a result, dosing of PAC-AC at 20 mg/L commenced on the 16th of August 2018 with operators closely monitoring.

Figure 1: *PAC-AC filled IBC's atop bunds retrofitted to the Alum dosing system*

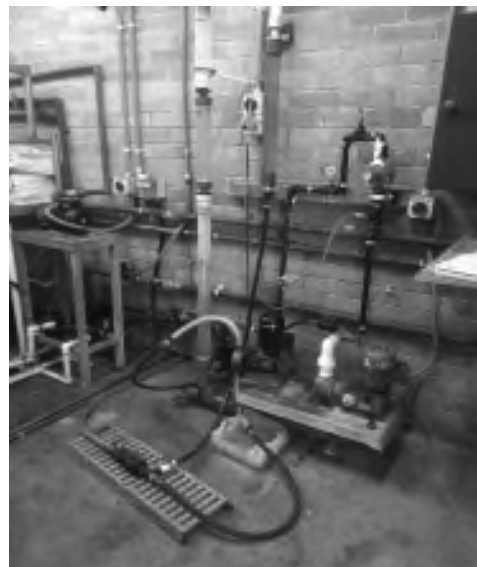
Figure 2: *Retrofitting PAC-AC to chemical dosing pump previously used for Alum*

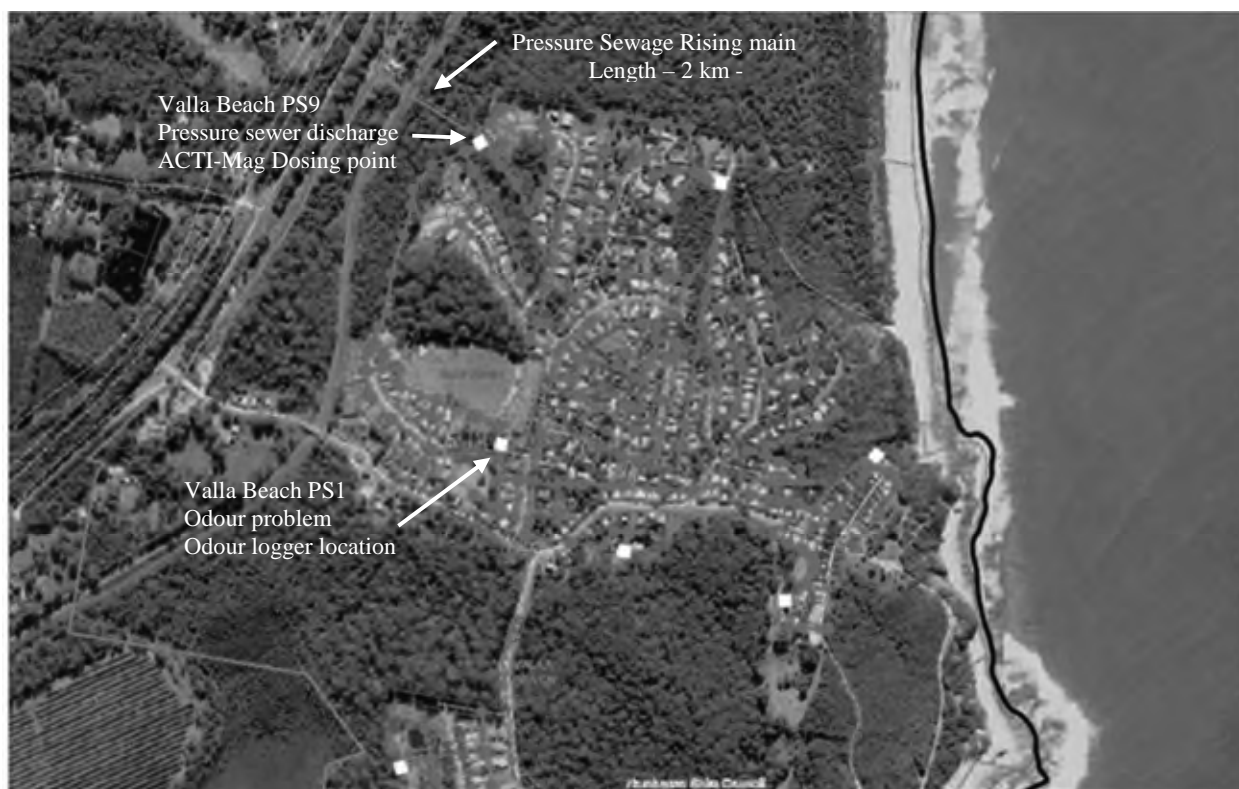
Figure 1: *Valla Beach Sewerage Layout showing PS 9 where ACTI- Mag was dosed and PS 1 where the odour problem was occurring*

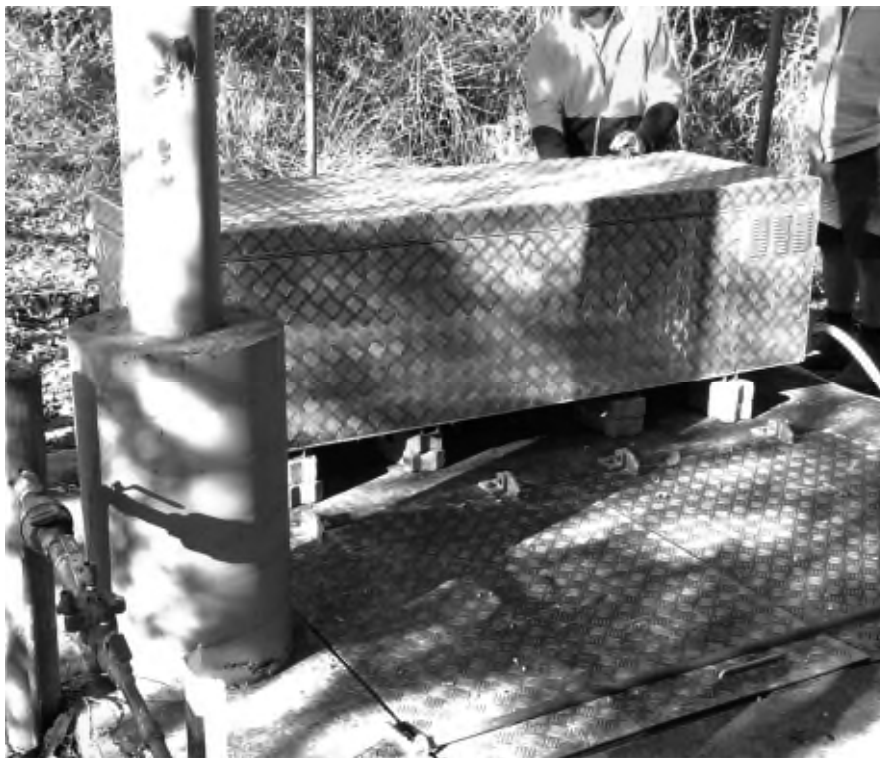
Figure 2: *Toolbox dosing unit being installed at PS 9*

A photo of the dosing unit is shown below.

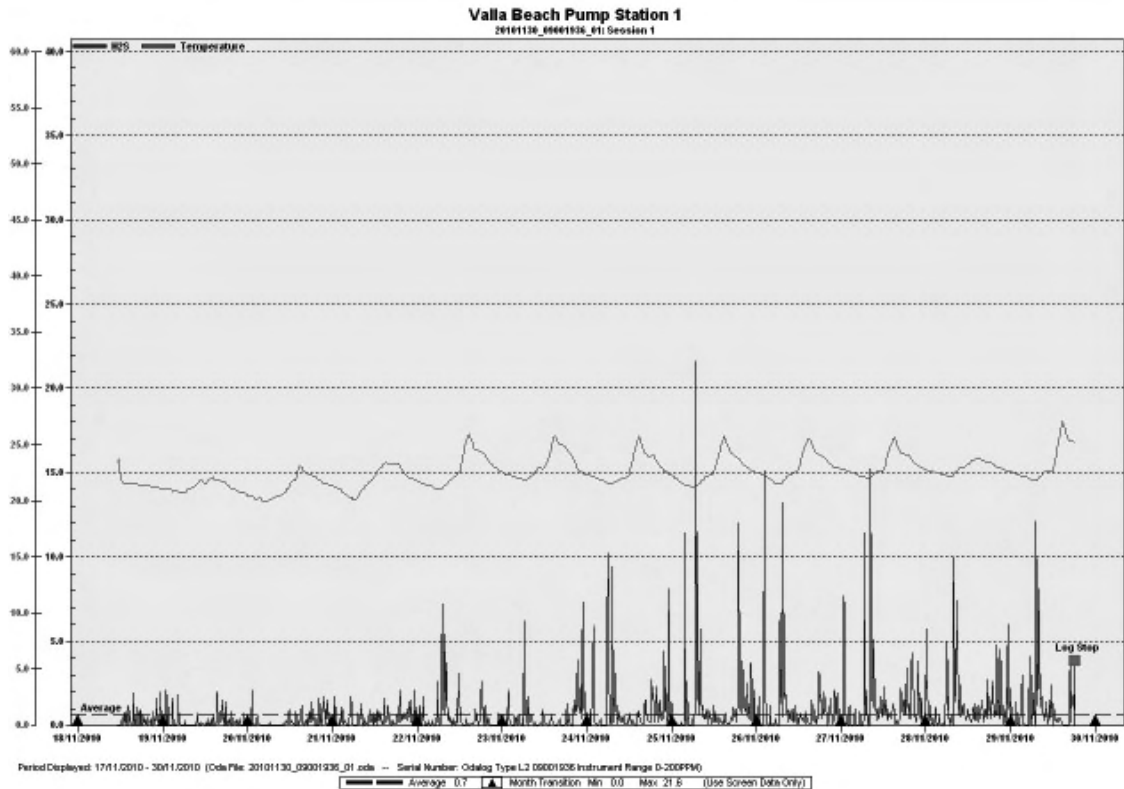
Figure 3: *Typical odour logging data prior to ACT-Mag dosing (Scale: 0 to 40 ppm)*

Logger charts of the typical gas concentrations without dosing and during a period of dosing are shown in Figure 3 and Figure 4 respectively below.

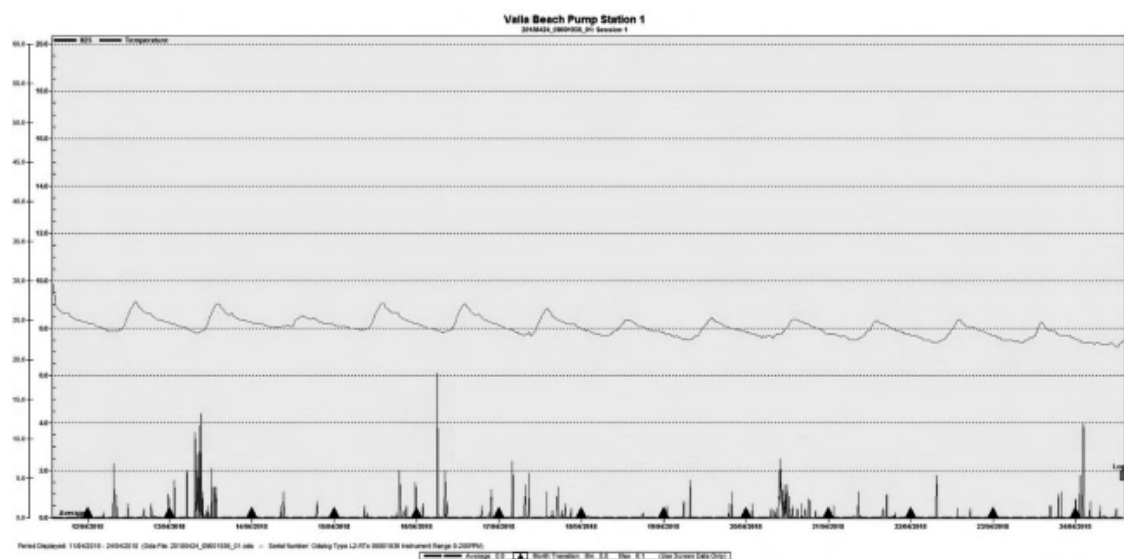
Figure 4: *Odour logging data during a week of ACT-Mag dosing (scale: 0 to 20 ppm)*

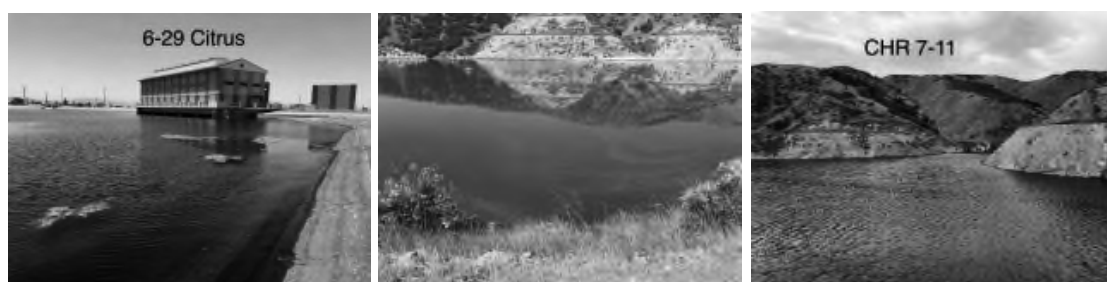
Citrus in California had a major issue with their drinking water storages. The treatment plant reservoir is connected to a “feeder” reservoir via a 16 km pipe (fig. 4). The systems were experiencing an algae bloom that was affecting taste and odour of the treated water.

Figure 4: *Photographs of the two pipeline-connected reservoirs used as the source of municipal water in Citrus, CA*

EarthTec was added to the lined water reservoir and, as illustrated below, numbers of problematic algae were reduced to an acceptable level within 48 hr. A qualitative index of the success of this treatment program was that the treatment plant was backwashing their filters at 2-hr intervals – after EarthTec was applied, the backwash interval increased to once every two weeks.

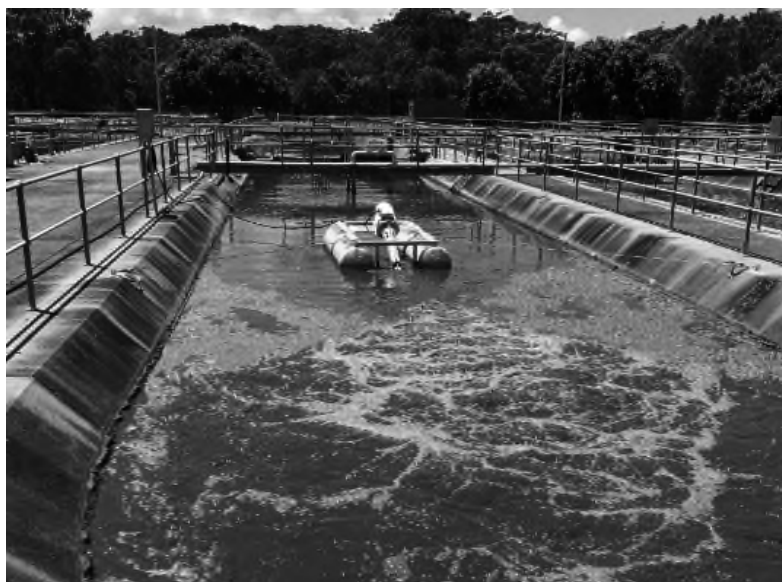
To limit the risk to Council we purchased one new aerator to be controlled on a VSD to give us full control over its performance range. This unit was put through extensive testing to allow a thorough evaluation.

Figure 2: *Bonny Hills WWTP Aerator Trial*

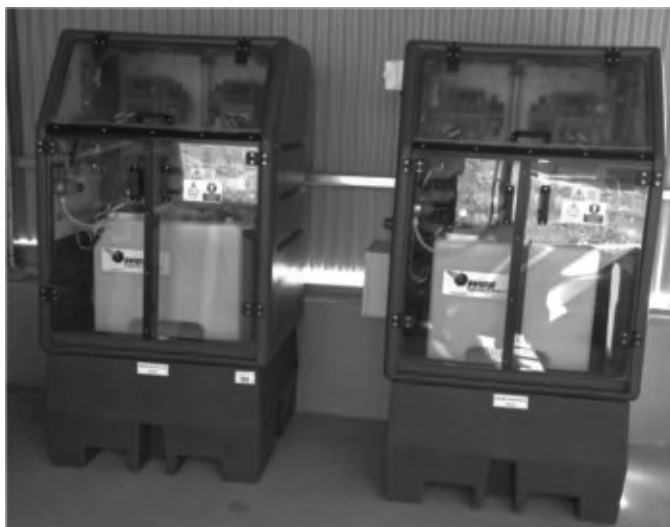
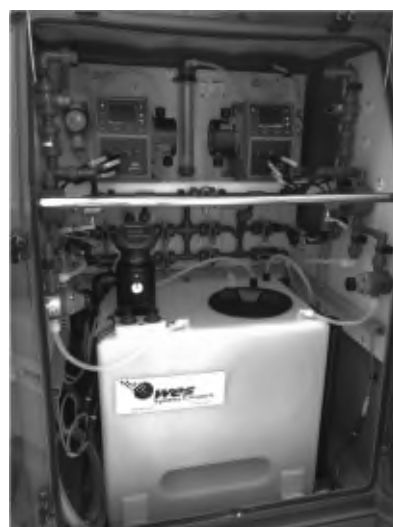
In late 2018 a project was scoped to upgrade the current sodium hypochlorite dosing system. The existing system had been in service since the upgrade in 2009 and had a number of design issues from excessively long dosing lines (200m), flow meter measurement issues and pump air locking.

Figure 6: *New chemical dosing skids*

The skids are installed (Figure 6) and are able to run as a full duty standby rotation on either manual, auto flow paced or auto flow and residual trim control options.

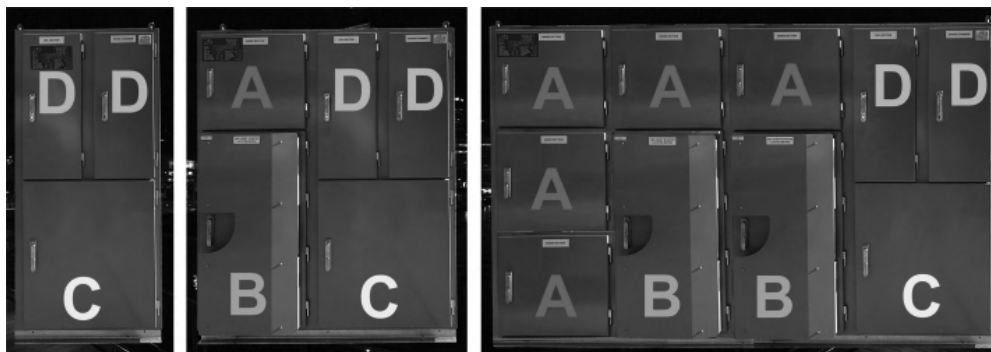
A modular design for the ABCD board was required because it's impossible to test every variant of outdoor switchboard employed by industry and public utilities. To date, four different sized modules, a wide range of functional escutcheons and two variants of exterior doors, have been certified. These represent 95% of all water industry outdoor applications.

Figure 3: *Modular sections required to configure to suit a wide range of applications*

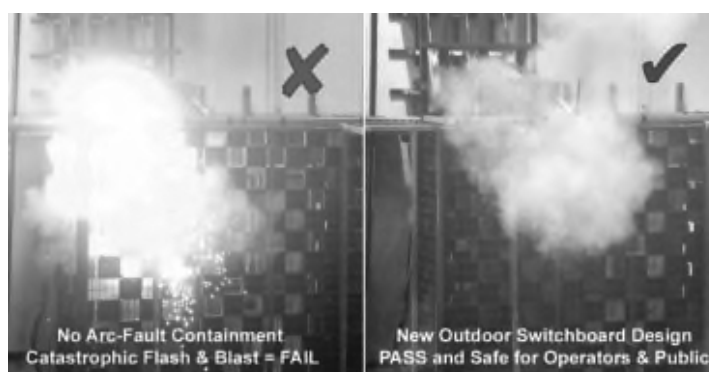
While many switchboard characteristics can be verified by calculation or by extrapolation of an existing design, AS61439.1 requires that some important ones can only be certified only by testing; like arc-flash containment.

Figure 4: *Contrasting outcomes demonstrated in testing laboratories*

Tests proved the ABCD switchboard design can endure an arc-fault incident and be returned to service.

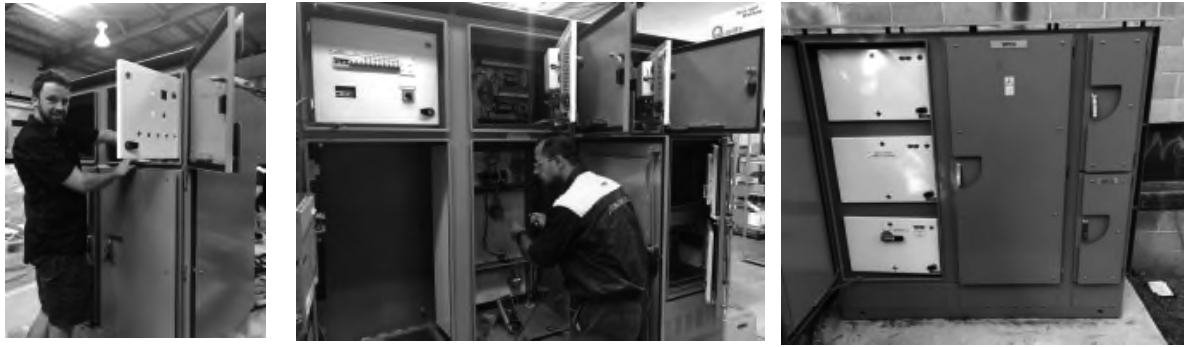
A range of alternate doors and internal fittings have been tested to provide variations for different equipment or applications that require sunshields and ventilation cowlings. The ABCD modular design certification offers customers flexible configurations; units are being built as double sided, three sided, and longer units for a wide range of equipment.

Figure 5: *Three forms of ABCD modular outdoor board in production and installation*

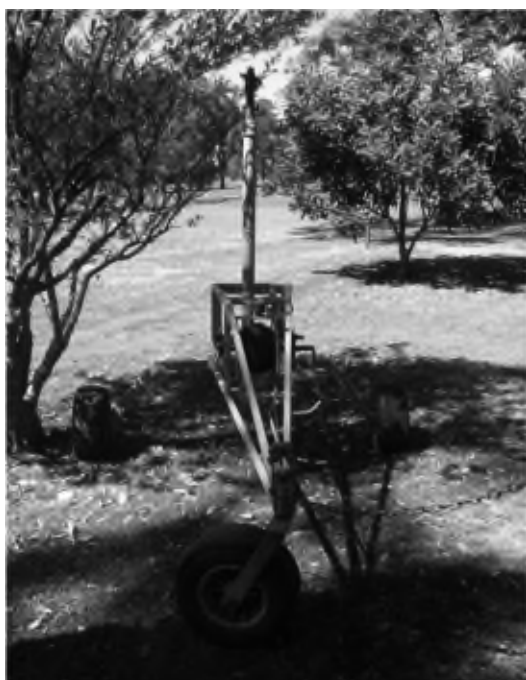
The reclaim water is utilised by one private property owner, for pasture improvement for cattle grazing. On this site, cattle were able to graze while the paddock is being irrigated and were likely ingesting the reclaim water. The landowner had not been advised of the requirement to allow the grass to dry, prior to grazing, and hence minimise these health risks to his cattle.

Figure 1: *Travelling Irrigators*

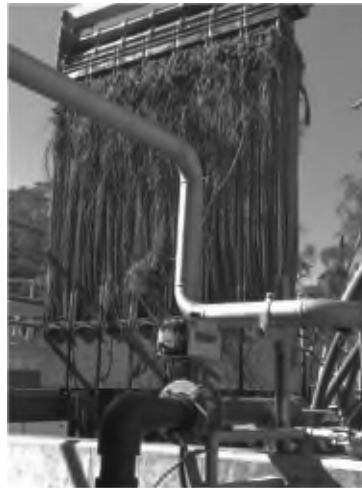
The main cause of the inorganic fouling of the filtration membranes can be attributed to the macerated feed solution being pumped to the plant which was not properly filtered during pre-treatment due to incorrect sizing of the inlet works drum screens.

This incorrect sizing of the drum screens then manifested into various problems including ragging of reflux valves, submerged pumps and most importantly the membrane filters.

Figure 4: *Heavily Ragged Membrane Cartridges Removed from the Filtration Tank*

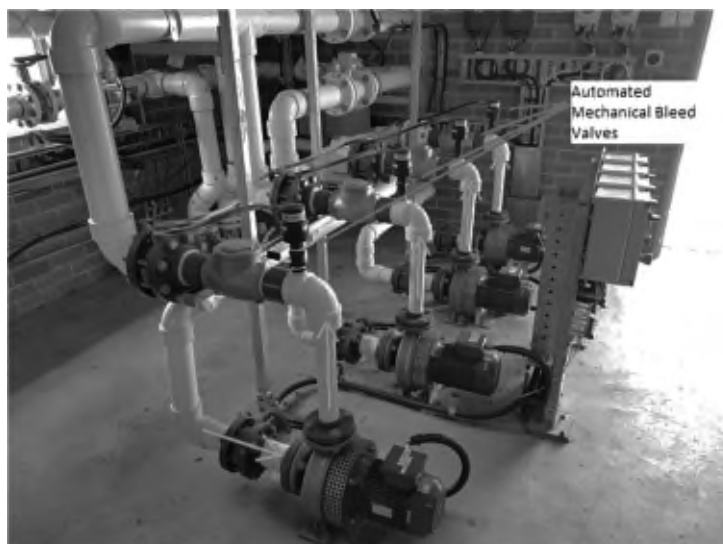
Figure 6: *Automated mechanical bleed valves*

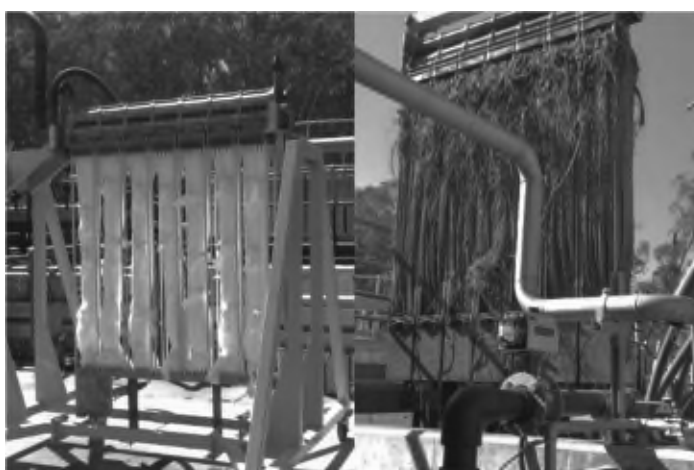
Figure 7: *Comparison between old and new membranes*

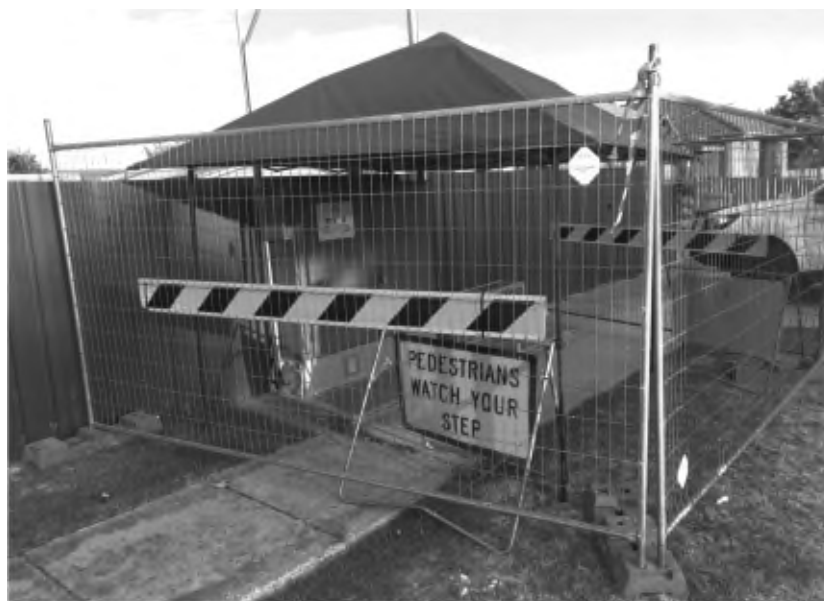
After a few days of temperatures in the 40's and no sign of relief we started to get some failures in sewer pump station switch-boards. The VSD's were the first to fail, members of our electrical team took thermal guns around the sites and recorded temperatures in excess of 60°C ambient cabinet temperatures and some electronic components reached 70°C well above their operating parameters. We immediately looked into ways to cool down the internals of the switch boards to get critical pumps running before any sewer spills or water supply issues occurred. Sites that had minimal venting on the electrical cabinets had large meshed vents cut in, cooling fans were purchased and installed, spare VSD's were purchased for redundancy, gazebos were erected to stop the direct heat on switchboards, some switchboards were opened and continuously manned with a fan blowing on them. The external covers of our critical water pump station switchboards were even given a hose down in an attempt to drop the internal temperatures. All this and we still haven't made it to the hottest day. Figure 2 is a sewer pump station site we had to erect a gazebo over to prevent the direct sunlight on the switch board in an attempt to cool it down so the pumps could be restarted. Due the switchboard being in close proximity to a property boundary fence and pedestrian foot path we had to erect temporary fencing to deter anyone from tampering with the gazebo or tripping over the poles. We had to also ensure there was adequate access for pedestrians to navigate around the barricaded site.

Figure 2: *Gazebo over sewer pump station switch-board*

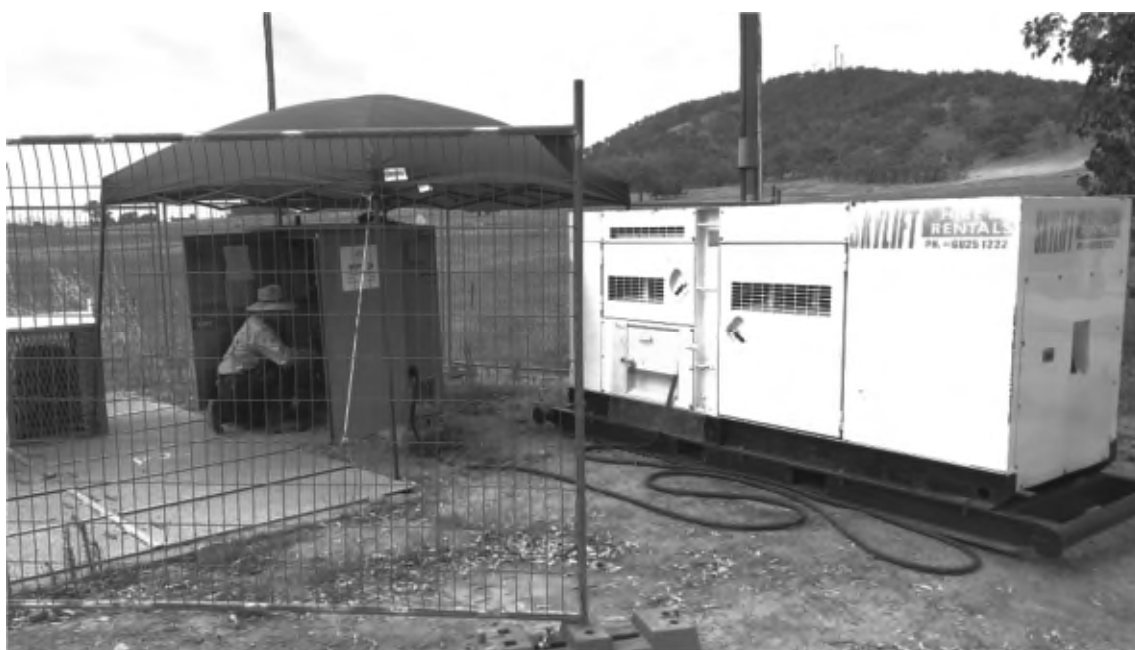
Now we were facing other problems, the hotter the weather got the more water our customers used. The residents of Albury nearly doubled their average peak water use and were 42% above the average January total demand. With this came strain on our water pump stations and reservoirs. Some customers were experiencing low water pressure and in extreme cases some customers with elevated blocks for short periods of time even ran out of water during peak periods as the reservoir levels dropped below normal operating levels and water demands soared. This was a growing concern as the forecast wasn't offering any cool changes and the maximum level in the, Table Top Reservoir, water reservoir 28 was on a steady decline every day the heat wave continued. This put more households at risk of low or no water pressure. Our teams acted quickly and came up with a solution to put in a generator to run an additional pump, so the water reservoir levels had a chance to replenish overnight, this plan worked, and our water supply issues eased.

Figure 3: *Temporary generator to run the standby pump to increase the water supply to reservoir 28*

Albury City Council are about to upgrade the Water Pump Station supplying water reservoir 28 and with new pipework already installed, this will allow larger pumps to maintain the reservoirs level in peak times into the future. Planned augmentation of the water supply mains north of the reservoir will also assist in ensuring continued water supply to residents during periods of peak water demand.

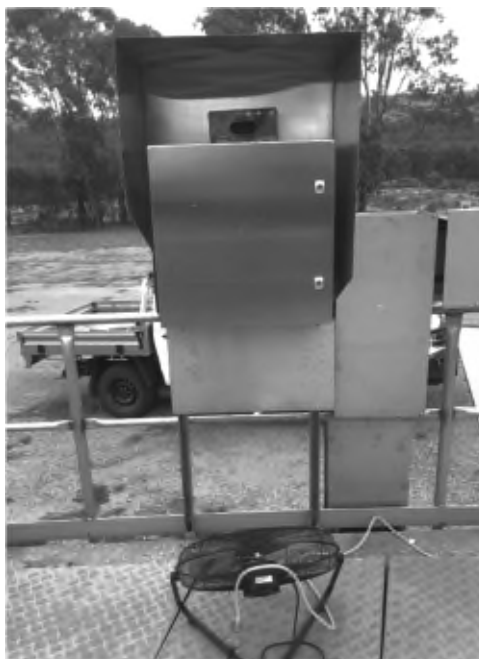
The heating issues at our sewer pump station switch-boards were now under control but they have moved on to our main Wastewater Treatment Plant. One of the clarifier drives decided it was too hot to run and tripped out at 71°C. Luckily, we had spare parts, and this was quickly rectified by our Mechanical and Electrical crew. Recently we had a new band screen installed at the inlet of our wastewater treatment plant. The control panel for this new system is exposed to the elements and didn't cope well with the extreme temperatures even though it already has a radiant heat shade enclosure (Figure 4). We had to install a temporary fan to cool the externals of this control panel. Due to the high hydrogen sulphide levels at the inlet works the option of installing ventilation would pose another risk to the switch board allowing the corrosive gasses to enter. We are still looking into other options for this site for a permanent solution.

Figure 4: *Fan cooling the new band screen control panel*

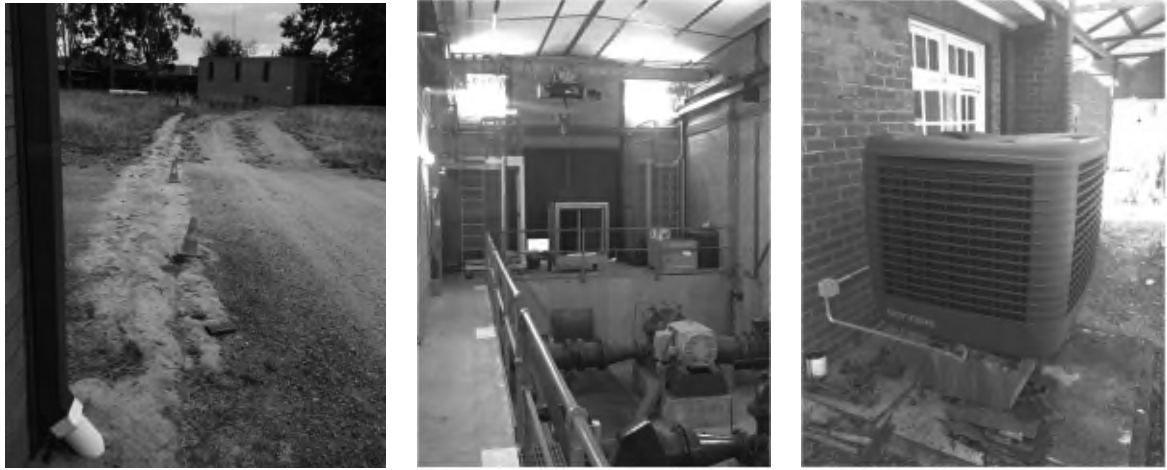
Figure 5: *New temporary water line cut in to supply water to the hired evaporative air-conditions and the new permanent air conditioner installed.*

We then looked into options to purchase portable evaporative air conditioners as funnily enough we were having trouble finding available air conditioners for hire during this period. We did manage to hire two which we ran a temporary water line to, to service the evaporative cooler (Figure 5).

To rectify heating issues at our raw water pump station switchboard, our electrical staff hired a portable industrial evaporative air conditioner and installed a 2500 L water tank as we had no potable water available on site. Our fitters plumbed up a pump so we could run filtered water to the air conditioner for operation, and the tank was refilled with filtered water twice a week.
