44th WIOA QUEENSLAND Water Industry Operations Conference & Exhibition

**FROM WASTEWATER TO COMMUNITY BENEFITS AND
OPPORTUNITIES**

***44th Annual WIOA
Queensland Water Industry Operations Conference and Exhibition
Bundaberg Multiplex Centre, Bundaberg
5 & 6 June, 2019***

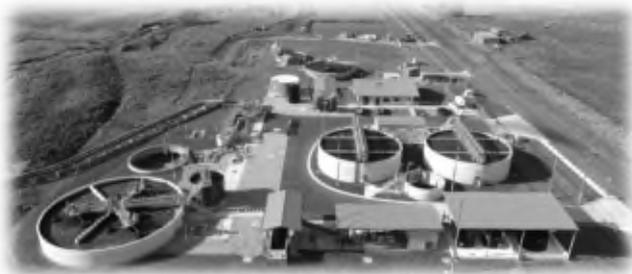
Figure 1: *Kingaroy WWTP 2019*

In mid-2016, Aquatec Maxcon along with Royal HaskoningDHV commissioned Australia's first full-scale Aerobic Granular Sludge (Nereda®) WWTP. The WWTP has the ability to produce Class A+ Recycled Water providing community benefit to the local sporting field, golf course, show grounds and on-site reuse. The secondary effluent from the Nereda® is such quality that after disinfection and detention, it can be applied directly to the South Burnett Regional Council neighbouring 30Ha farm utilising two fixed pivot irrigators to commercialise a resource and further reduce the residual nutrient load that would otherwise end up in the catchment that supplies Kingaroy's water supply. As an operator, driving through town and seeing children playing on the fields that without recycled water would be dust bowls with prickles makes the extra effort in maintaining, monitoring, sampling and verification of the recycled water worth the effort 10 times over.

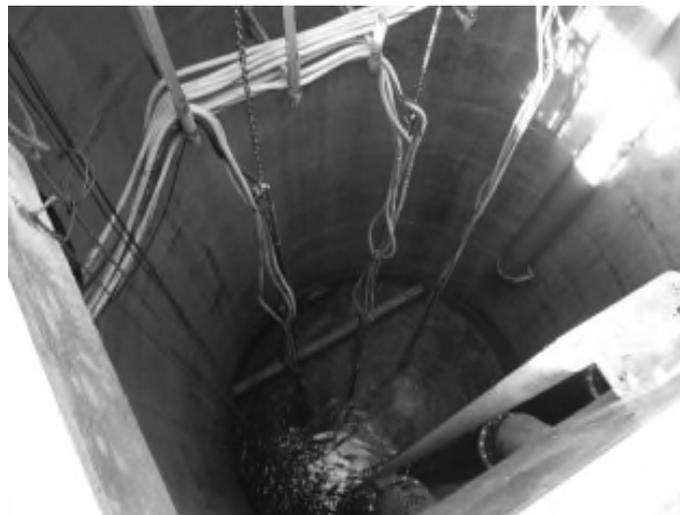
During its engagement, the alliance has been involved in upgrading the Alfred Street wastewater pump station site at Slacks Creek. This is the largest pump station in Logan City. The site contains two separate pump stations: the original SPS02 pump station and the newer SPS69 pump station. The SPS69 pump station (the focus of this paper) is a submersible pump-type station with an 8.5m diameter, 22m deep wet well (refer Figure 1).

Figure 1: *Looking down into the SPS69 wet well*

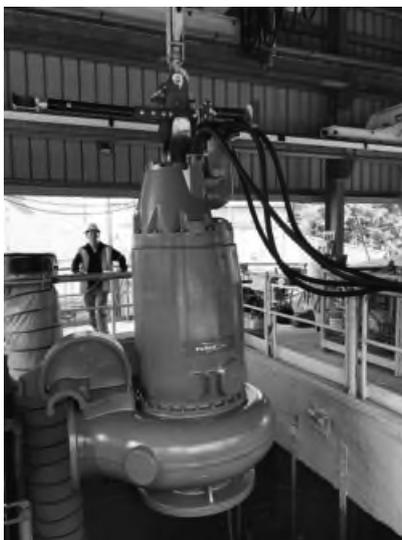
The station is fitted with three 375 kW submersible pumps, each with a capacity of approximately 1,000L/s. The pumps weigh approximately five tonnes each and are over 3m in height (refer Figure 2).

Figure 2: Existing SPS69 pumps weigh approx 5 tonnes and are over 3m in height

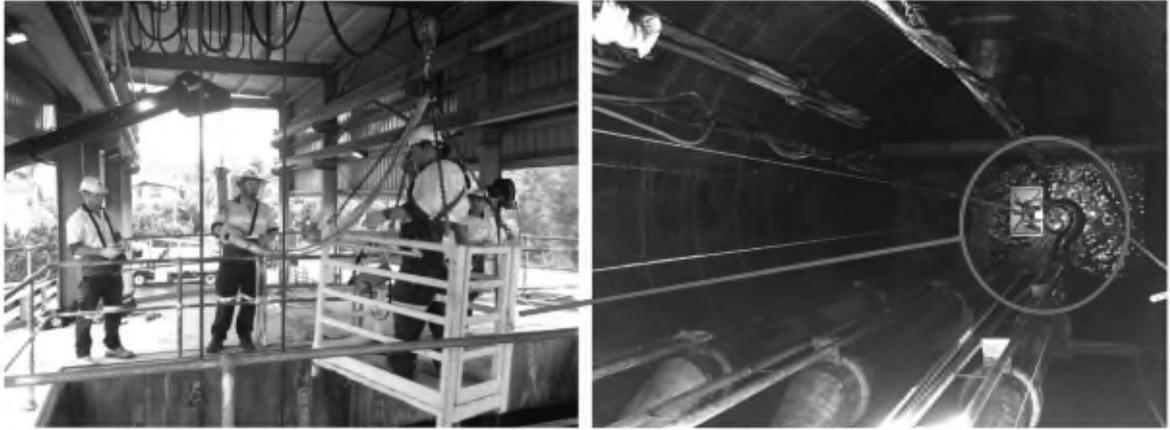
Figures 3 & 4: *The long-standing methodology for removing pumps relied on two bridge cranes and confined space entry into the wet well to shackle the pump (left). Looking down into the wet well when the pump was being shackled to enable its removal (right)*

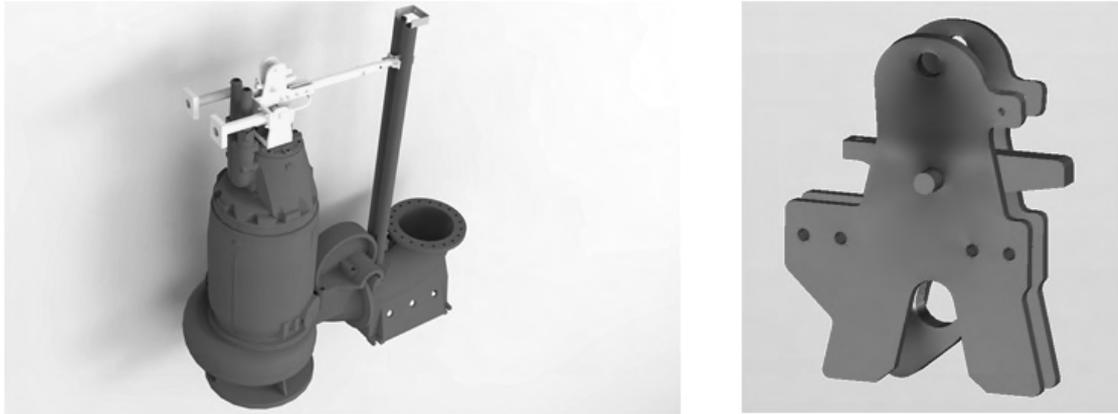
The counter weight at the opposite end of the guide mechanism helps to balance the lifting device when used without the pump. The lifting device was designed and manufactured in accordance with Australian Standards; with AS 4991-2004 Lifting Devices and AS 3990-1993 Mechanical Equipment - Steelwork being the key standards applied. The lifting device was rated with a Working Load Limit (WLL) of 6.5 tonnes. Three dimensional and finite element modelling were used to design key components of the lifting equipment and predict the behaviour of the product in real life conditions (refer Figures 5 & 6).

Figures 5 & 6: *3D modelling (left) and finite element modelling (right) were used during the design of the pump lifter*

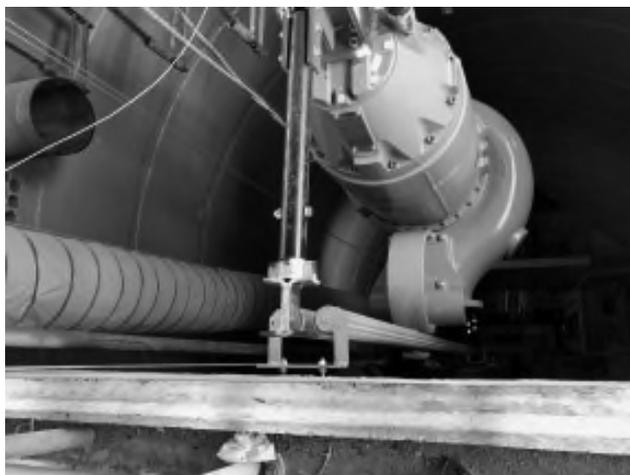
Figure 7: *The pump being lowered into position by the lifter via the existing guide rails*

Once manufactured, various in-house trials of the lifting device were completed. The device and the lifting point were then proof load tested to twice the Working Load Limit (WLL) as per AS 4991 2004 requirements. The lifting equipment and the new lift point were trialled on site. The trial was completed successfully by engaging with key stakeholders from LoganWIA, Council and project partners. The solution has now been proven as an ideal application for this, and potentially other, deep wet well lifting applications (refer Figures 7, and 8).

The 10-tonne crane hook is engaged on the lifter and is lowered down onto the pump's guide rails (as demonstrated in Figure 7). The hook of the lifter has a spring-loaded mechanism that automatically engages when it finds the lifting bail located on the pump. Once the 10-tonne crane cable shows sign of slack, this indicates that the lifter has been engaged onto the pump and indicates to the operator that the crane is able to lift the pump. As an additional visual aid, the crane operator has a load display available on the crane which enables the operator to determine what load is being seen by the crane. Figure 9 shows the lifter removing the pump from the wet well.

The 10-tonne crane hook is engaged to the lifter and is lowered down onto the pumps guide-rails (refer Figure 7). The hook of the lifter has a spring-loaded mechanism that automatically engages when it finds the lifting bail located on the pump. Once the 10-tonne crane cable shows sign of slack, this indicates that the lifter has been engaged on the pump and indicates to the operator that the crane is able to lift the pump. As an additional visual aid, the crane operator has a load display on the crane which enables the operator to determine what load is being 'seen' by the crane.

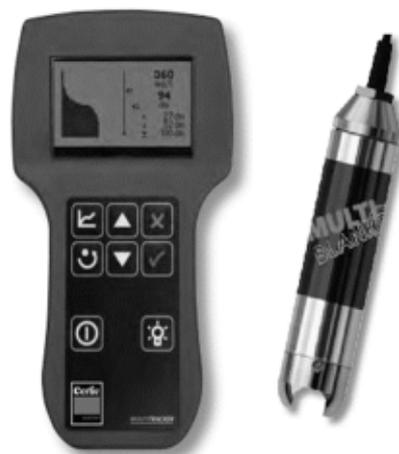
The ‘sensor-based technology’ in question was the Cerlic’s Multitracker and Blanko, which comprised of a control unit and a suspended solids sensor, respectively (Figure 1).

Figure 1: *Cerlic’s Multitracker and Blanko Sensor*

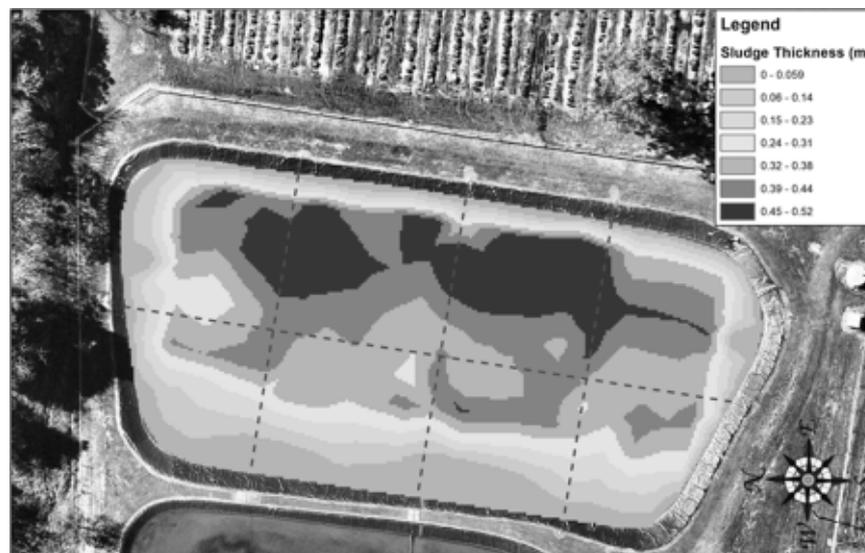
The total volume of sludge in the pond was estimated using two different methods. The first method was by using ‘ArcGIS’ and geographically referencing the survey locations against the baffle curtain anchors. This, in effect, gives all the surveyed locations positions that are geographically correct. By doing so, it was then possible to extrapolate across the entire surface of the lagoon to estimate sludge depth at any given point. Results were then converted into a ‘heat map’ as displayed in Figure 4. Knowing the depth at all points and the surface area, ‘ArcGIS’ was then used to estimate the *in-situ* sludge volume in the maturation pond.

Figure 4: *Heat map of sludge accumulation*

These methods resulted in two different sludge volumes, 1,600 m³ from ‘ArcGIS’ and 1,360 m³ from the ‘Trapezoidal Rule’. The discrepancy between the two is likely because the latter method does not take-into-account extrapolation of data points outside of the survey grid such as pond embankments and its slope, which resulted in the estimated sludge volume being ‘lower’.

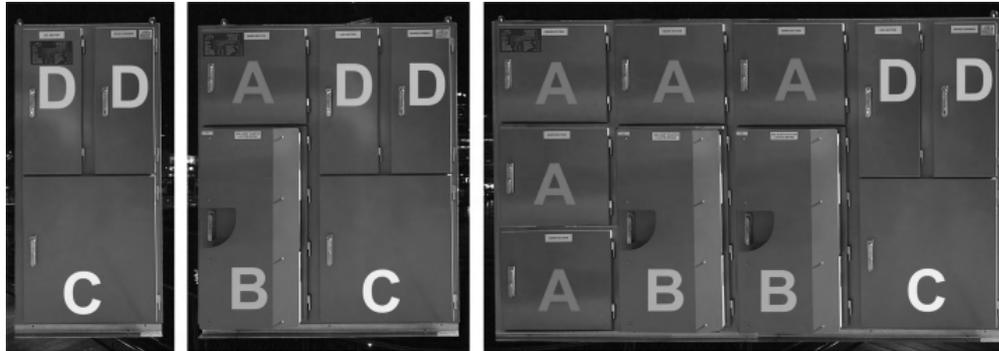
A modular design for the ABCD board was required because it's impossible to test every variant of outdoor switchboard employed by industry and public utilities. To date, four different sized modules, a wide range of functional escutcheons and two variants of exterior doors, have been certified. These represent 95% of all water industry outdoor applications.

Figure 3: *Modular sections required to configure to suit a wide range of applications*

The test unit designs were built and fitted out with VSD and Soft Starter, Distribution section, MCCBs, external button controls, meter enclosures, RTU/PLC sections. This enables PTAS to build a huge variety of switchboards that easily scale up to incorporate combinations of these tested and certified modules.

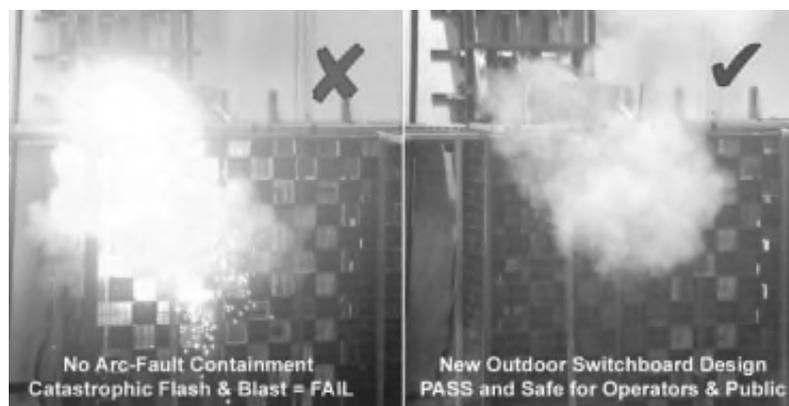
While many switchboard characteristics can be verified by calculation or by extrapolation of an existing design, AS61439.1 requires that some important ones can only certified only by testing; like arc-flash containment.

Figure 4: *Contrasting outcomes demonstrated in testing laboratories*

Tests proved the ABCD switchboard design can endure an arc-fault incident and be returned to service.

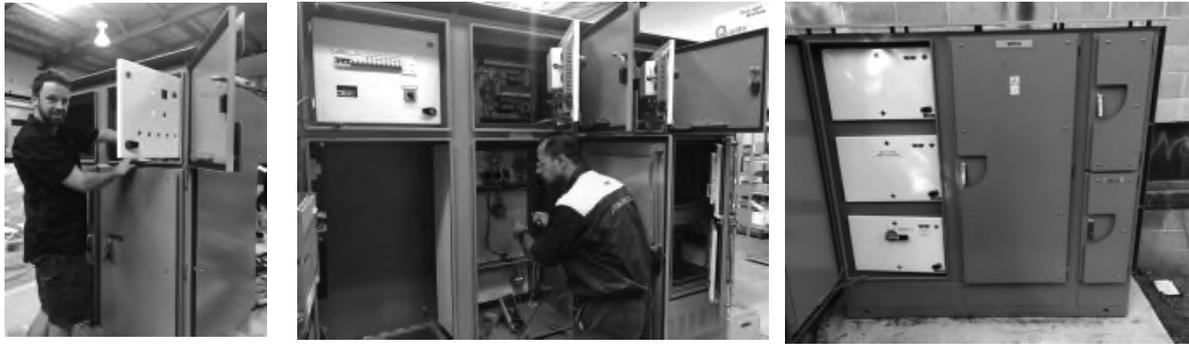
A range of alternate doors and internal fittings have been tested to provide variations for different equipment or applications that require sunshields and ventilation cowlings. The ABCD modular design certification offers customers flexible configurations; units are being be built as double sided, three sided, and longer units for a wide range of equipment.

Figure 5: *Three forms of ABCD modular outdoor board in production and installation*

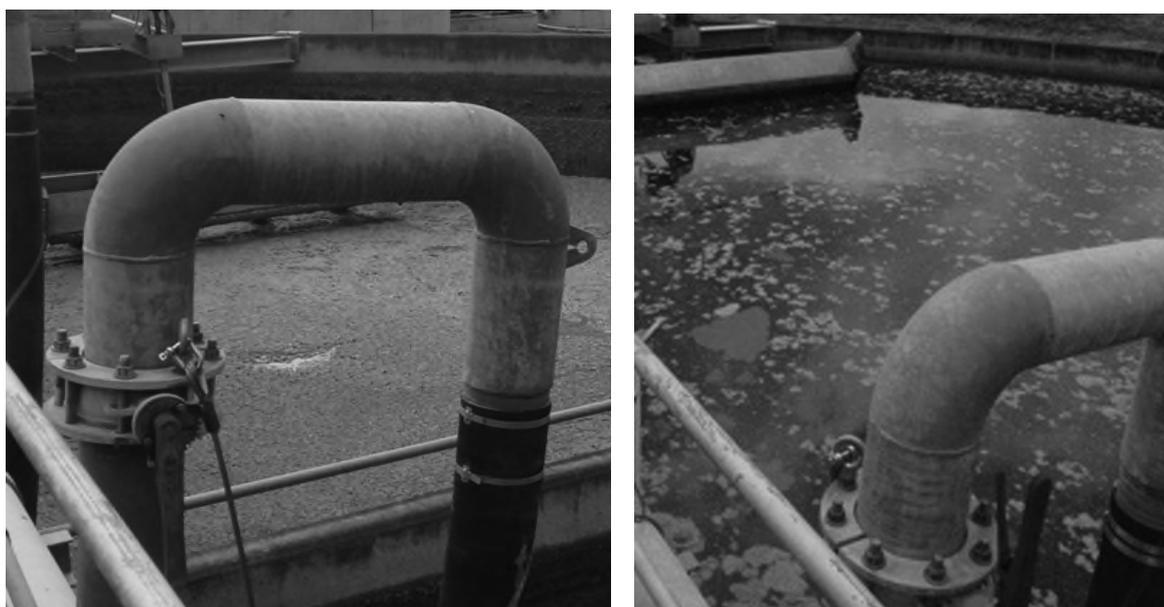
Figure 1: *LEFT: Before Trial Bacterial Foam; RIGHT: During Trial: Reduction in Bacterial Foam*

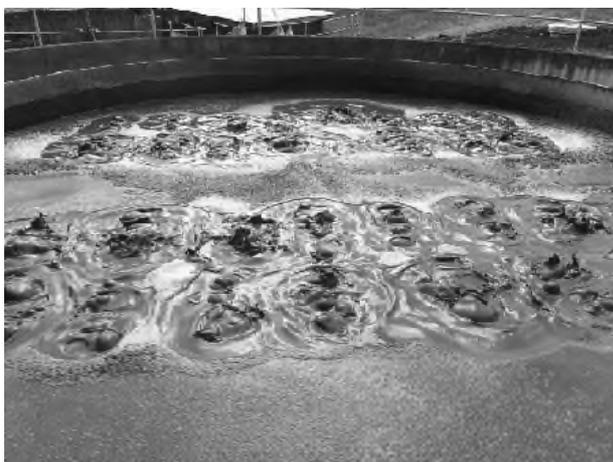
This treatment was observed to have very positive effects on the overall operation of the aerobic digester. Dewatering operation times were reduced from 80 – 90 minutes per day to 45 – 55 minutes per day during treatment period.

Figure 4: Atherton WWTP Aerobic Digester

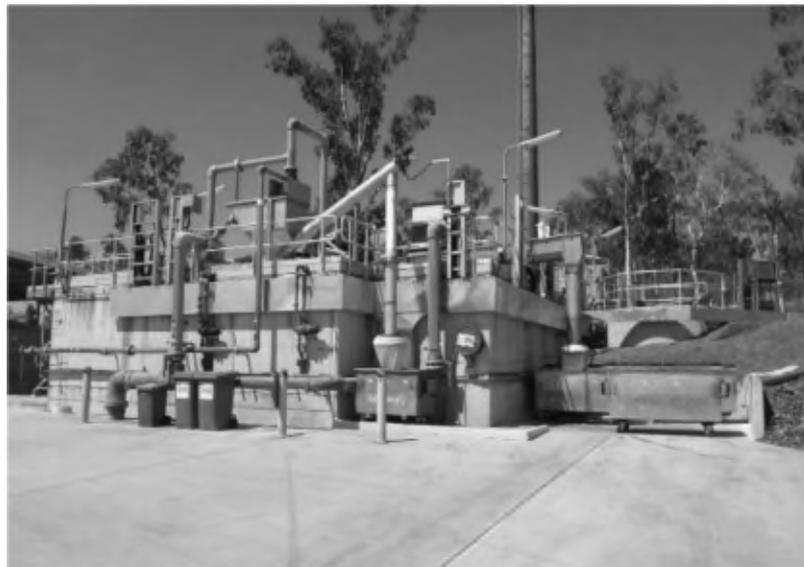
Figure 1: *Overall View of the Cannonvale STP Inlet Works (Looking North-East)*

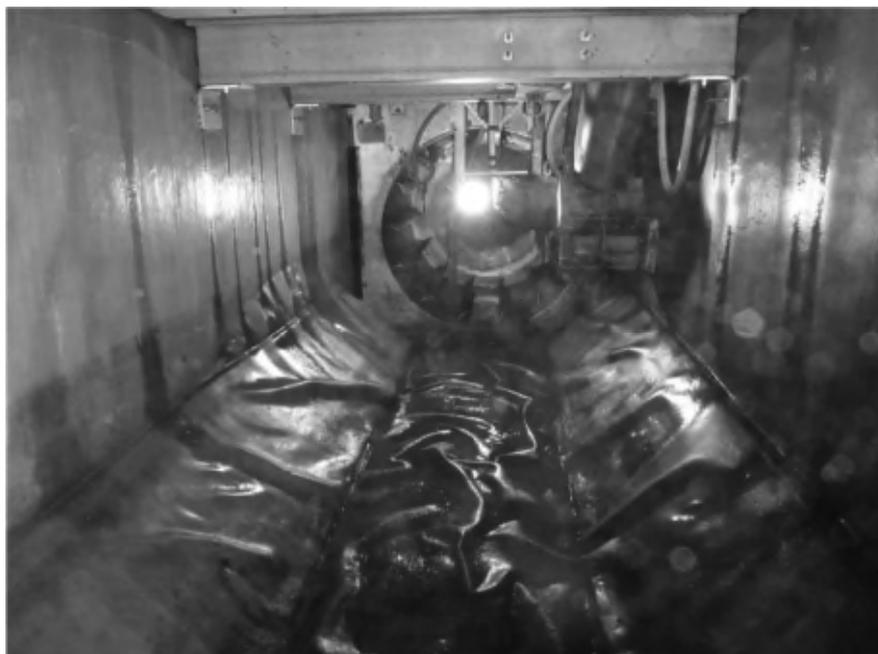
Figure 2: *Delaminated Protective Coating Within Drum Screen Channel at Cannonvale STP*

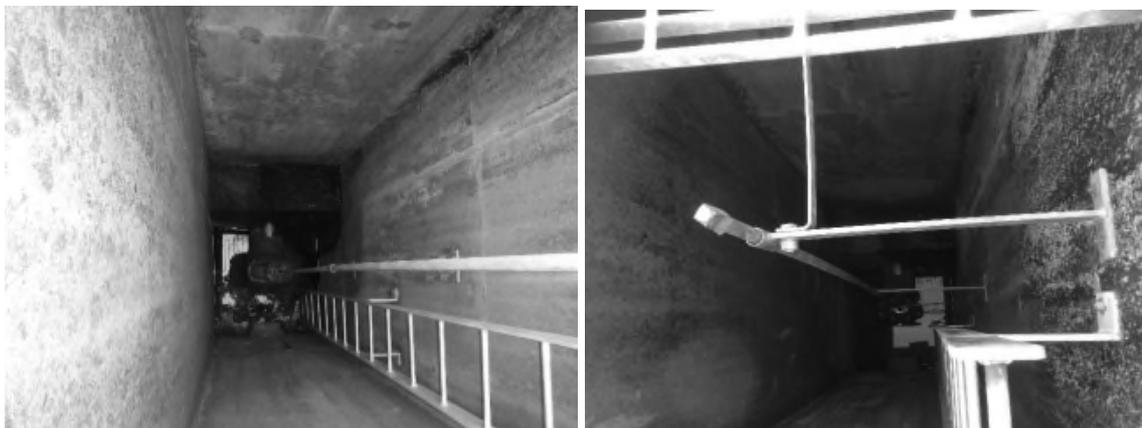
Figure 4: *Scour Pit 3 Valve & ladder*

When operating the discharge valve for treated water balance tank 3, it was found that the valve could not be turned and could not be isolated. To operate the valve, a confined space entry was required, as personnel needed to get into the pit to operate the valve.

The gearbox was removed and was fully reconditioned at the DGH Engineering workshop. Once it was repaired, it was reinstalled. A new pit cover was fabricated and installed along with an extension spindle that could be operated from outside the pit. Upon installation of the reconditioned gearbox and the new extension spindle, the valve is now fully operational and can be operated without entering the pit.

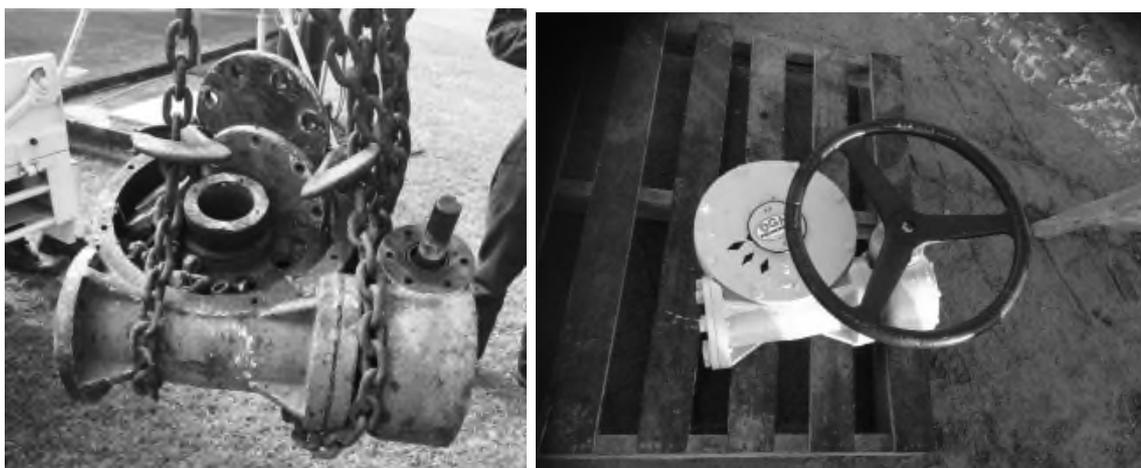
Figure 5: *Balance Tank 3 Discharge Valve Gearbox*

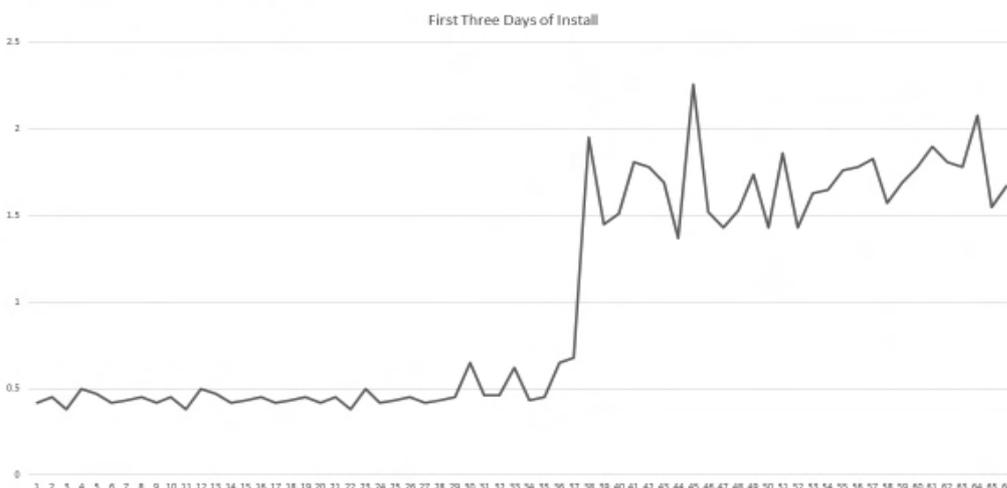
ResMix Vital Analyser Data (20/11/18 – 22/11/18)

Data collected during the trial indicated an overall improvement on chlorine residual in R3 while the mixer was operational. Table 4 demonstrates the comparison of water quality before and after the mixer trial.

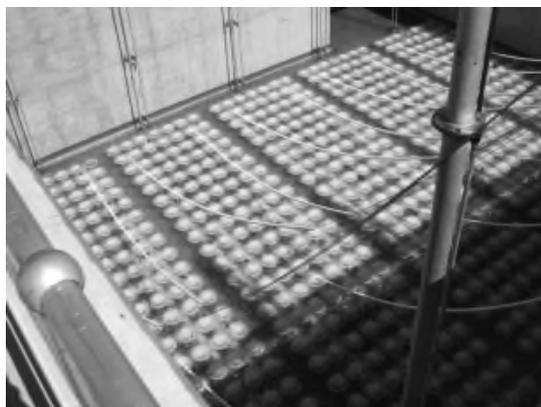
Figure 1: *Original diffuser grids with lifting cables*

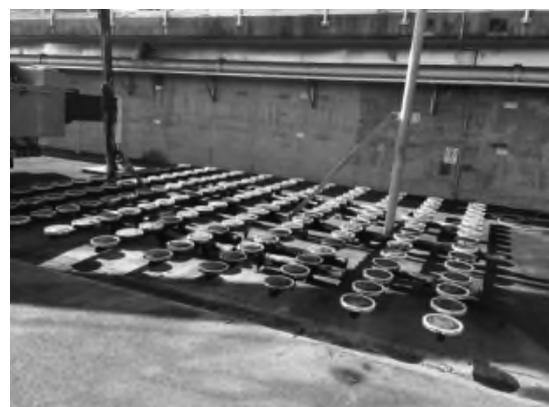
Figure 2: *New stainless steel lifting post*

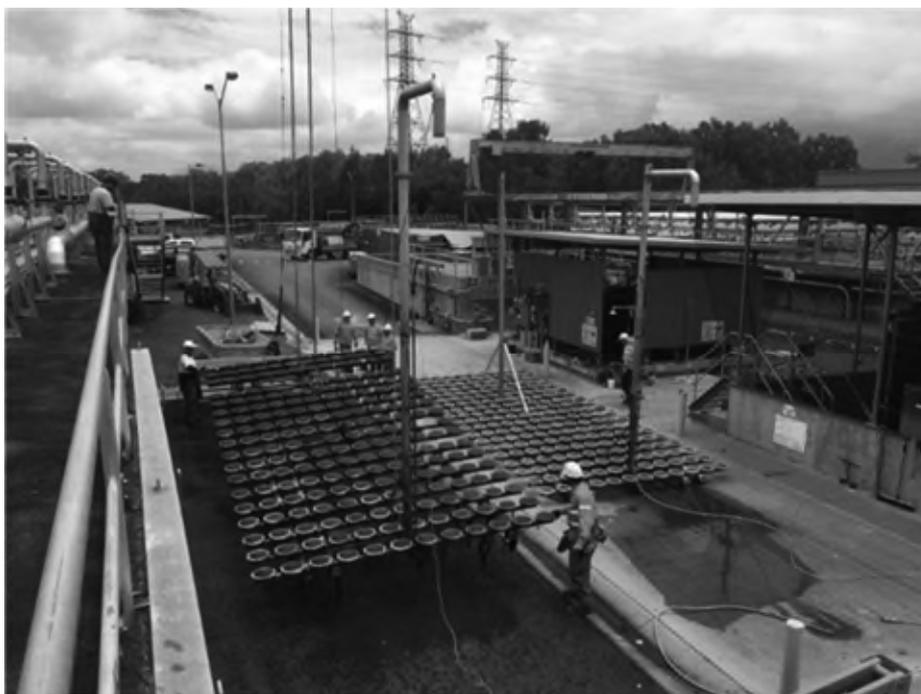
To ensure adequate aeration during the replacement works, a sequence of removal was developed for each respective plant. For Southern WWTP consisting of 25 diffuser grids aligned within the oxidation ditch, the methodology developed was to work within sections and to replace alternating grid before returning to the start. E.g. 1, 3, 5, 2, 7, 4, 9, 6, 10...23, 21, 25 etc.

Figure 3: *Diffuser replacement at Southern WWTP*

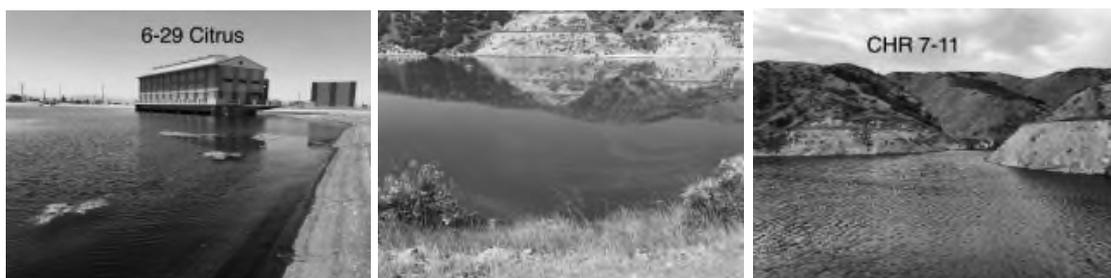
Citrus in California had a major issue with their drinking water storages. The treatment plant reservoir is connected to a “feeder” reservoir via a 16 km pipe (fig. 4). The systems were experiencing an algae bloom that was affecting taste and odour of the treated water.

Figure 4: *Photographs of the two pipeline-connected reservoirs used as the source of municipal water in Citrus, CA*

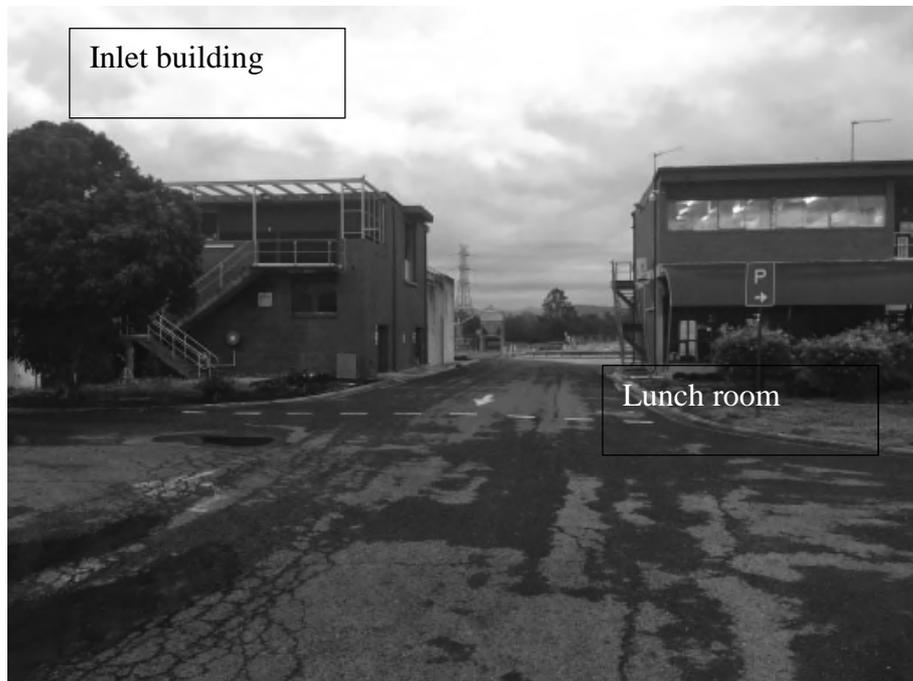
Figure 2: *The inlet works and lunch room locations*

The operators found various trends and high levels of H₂S in the lunch room, laboratory, and around the main building. There were levels of H₂S as high as 200ppm recorded. The majority of the H₂S was coming from the inlet. So a study was done to identify the issues and operations planned to identify ways to reduce the effects of the H₂S and improve the odour control unit reliability. There are many options with dosing ferrous into the network, or look at what can be done at the wastewater treatment plants.

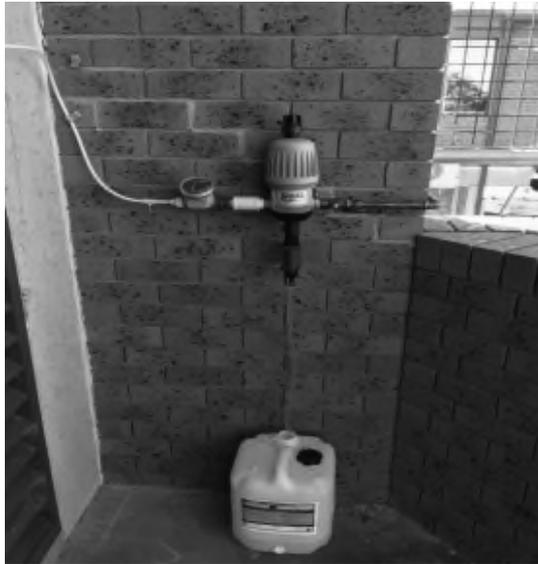
Figure 3: *Misting pump set up*

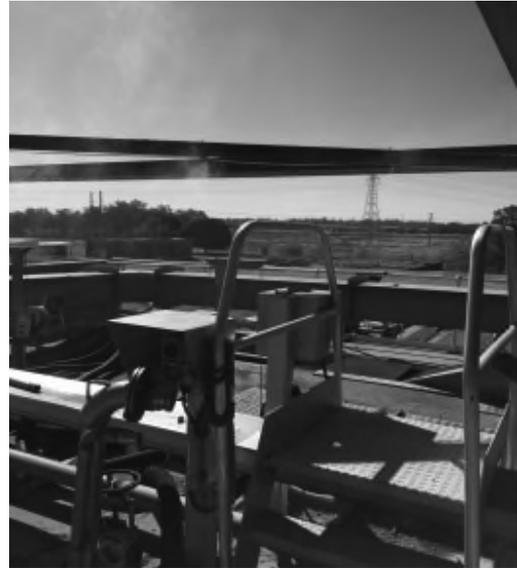
Figure 4: *Fine mist over grit channel*

During the mornings and upon arrival to the treatment plant the lunch room would still have occasional readings of H₂S so we implemented a fine misting system at the inlet which dosed a suppressing agent that reduces the H₂S and also deodorises the work area. This chemical is called Atmosphere and has been found to remove and eliminate some hydrogen sulphide in the atmosphere and results can vary between 98%-99% as found in a study at the Sydney University by Dr Jeffery Shi FRACI C Chemical Manager and Chief Consultant Analytical and Testing Laboratory.

The operators managed to reduce the 90-day exposure average to 0.0125ppm from September 2018 to November 2018 it is recommended that the 90-day exposure limit is 0.014ppm or below. Concerns were still raised that further work is needed to reduce the H₂S and constantly monitor the environment. The ultimate goal was to provide a better work place for our staff.

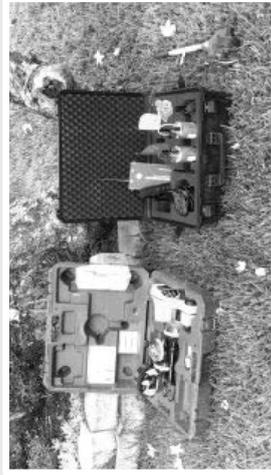
When water pipes leak, the water gushing out under pressure creates a vibration sound. This “hiss” or “whoosh” sound can be detected by leak noise correlators.

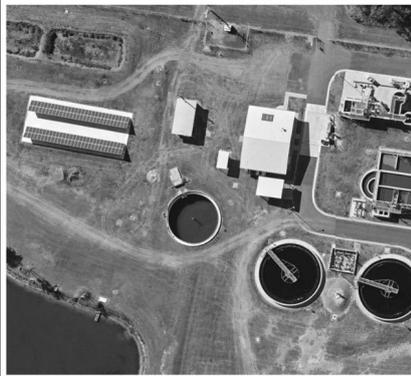
Thabeban WWTP 39.4kW

- Average of 179.6kWh/day
(= 4.6 x DC Rating)
- Billing Reduction of \$668.60/month
- Ground mounted array.
- **\$0.12/kWh**

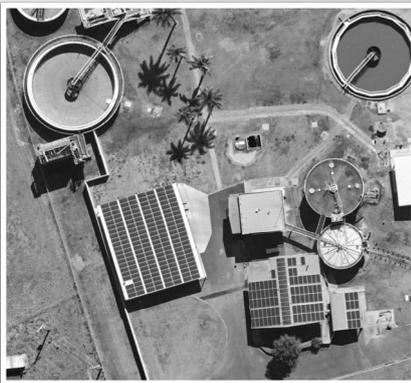
Millbank WWTP 87.7kW

- Average of 450.5kWh/day
(= 5.13 x DC Rating)
- Billing Reduction of \$1675/month.
- LGC income of \$840.00/month.
- Roof mounted array.
- New shed for additional roof space.

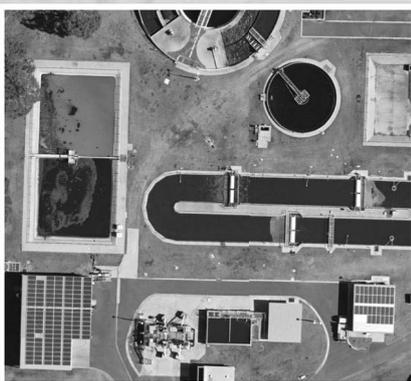
Bargara WWTP 63.24kW

- Average of 290kWh/day
(= 4.6 x DC Rating)
- Billing Reduction of \$1042/month.
- Roof Mounted Array
- **\$0.116/kWh**

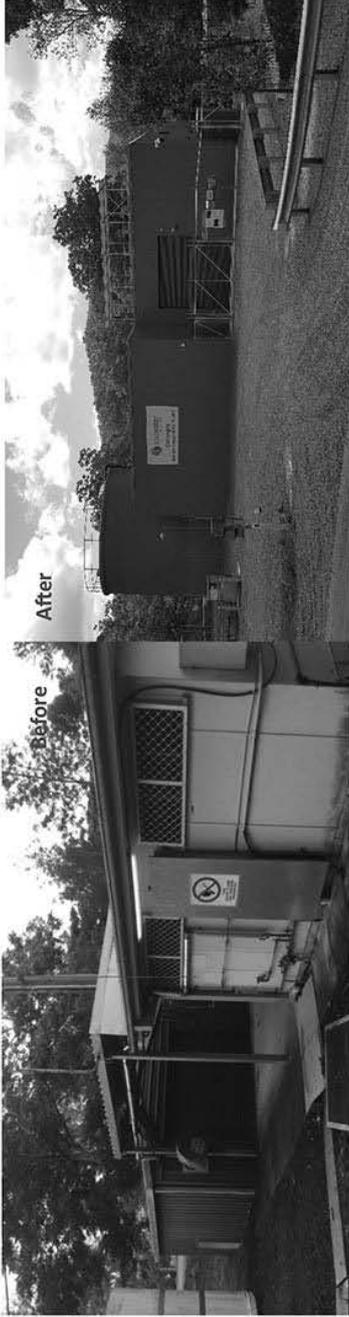
The new Canungra water treatment plant can treat raw water with turbidity up to 1000 NTU at a reduced flow rate. Under "normal" raw water conditions it can treat at 21.3 L/S which equates to 1.53 ML/D with onsite storage of 310KL. That onsite storage alone gives us an increase of 250 KL onsite available for transfer to Appel St reservoir when required. Previously, with limited storage, in times of dirty water from rain events or maintenance issues this could leave us in a precarious position. Having the limited capability to treat a maximum of 5L/s at times it could take days to fill up the Appel St reservoir again if the demand was high.

A brief overview of the treatment process: Screening and pumping at the raw water inlet structure, with 2 submersible pumps that are presently run in a duty/standby arrangement. From there we dose ACH, Aluminium Chlorohydrate; this is a change from the previous coagulant and is recommended with the use of the membrane filtration. The use of ACH also provides other benefits such as giving us a broader dose range which, when treating ever changing creek water, is of a great benefit. The dosed water is pumped into the inlet structure and proceeds through the flocculation and clarification process where a large percentage of the solids, heavy metals and organics are removed prior to filtration with the addition of pre-chlorination after clarification. From this point the fun starts, with ultra-membrane filtration. There are 2 membrane filtration trains, again operated in a duty / standby arrangement, which filter the clarified water. Ancillary systems include backwashing, chemical cleaning and neutralization and membrane testing to verify the integrity of the membranes. After filtration sodium hydroxide is dosed for pH adjustment, sodium hypochlorite for disinfection and sodium fluoride. From there water is pumped from onsite storage to the Appel St reservoir on demand basis determined by the reservoir level.
