WATERWORKS

TECHNICAL PUBLICATION OF THE WATER INDUSTRY OPERATORS ASSOCIATION OF AUSTRALIA

NOVEMBER 2019

SPECIAL FEATURE: TELECOMMUNICATIONS ISSUES ON WATER STORAGES

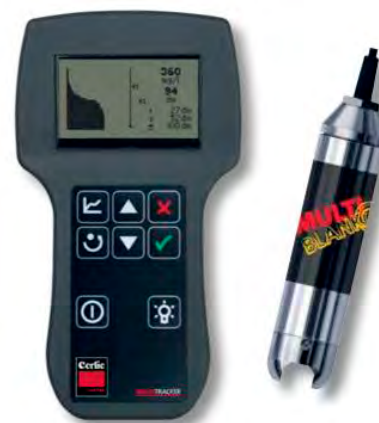
Figure 1. Cerlic's Multitracker and Blanko Sensor.

In an attempt to obtain better data for future management, a sludge survey was undertaken in the maturation pond in October 2018, trialling the Cerlic Multitracker and Blanko Sensor (Figure 1).

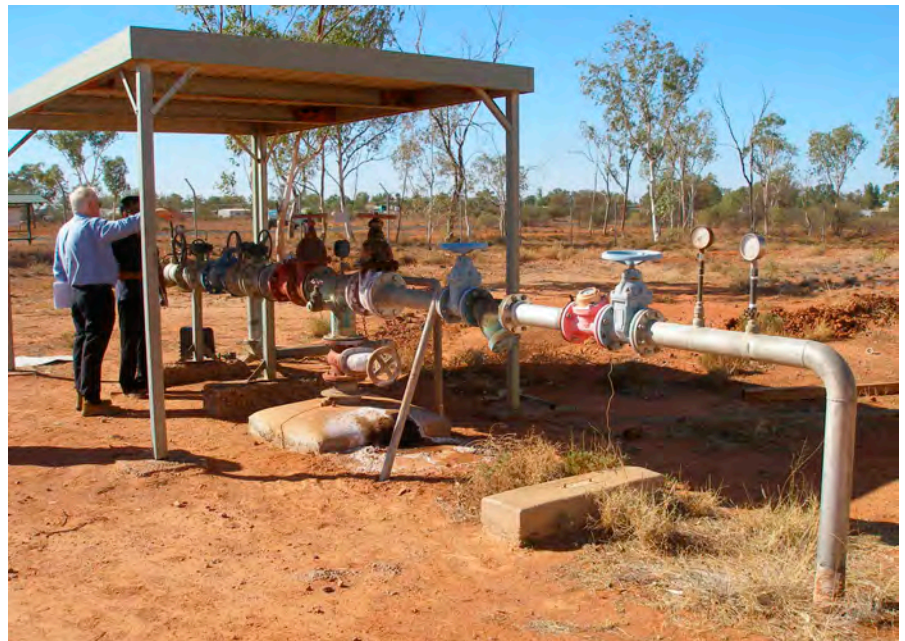
Figure 2. The “Thargo” town bore.

The current bore (Figure 2), constructed in 1999 to a depth of 820 m, supplies the town directly from the Great Artesian Basin, under pressure and without any treatment other than cooling. The water is of a high quality; however, natural fluoride levels of between 1.6 and 1.9 mg/L exceed the

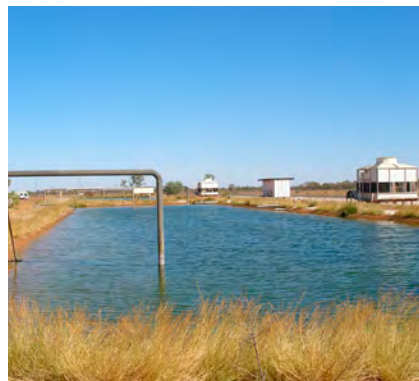
Figure 3. Cooling ponds and one of the cooling towers.

Initially, the residents of the town had sealed rainwater tanks and a pump system that allowed cooler water to be provided to the homes. Following a successful funding application, the Bulloo Shire was able to construct cooling ponds, including cooling towers (Figure 3).

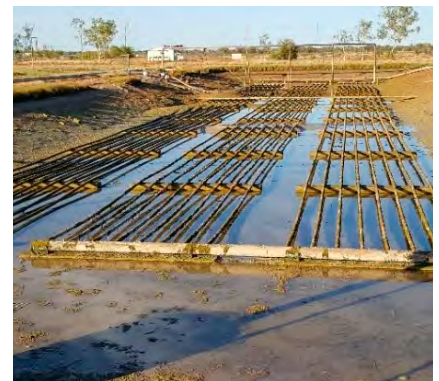
Figure 4. One of the old cooling ponds revealing the original cooling manifold.

Each of the original cooling ponds was approximately 60 m long and 15 m wide. The cooling manifold constructed in the base of each pond consisted of 8 by 50 mm copper tubes connected in a configuration so that the water travelled up, down and then back up to the outlet manifold, prior to connecting into the town reticulation system (Figure 4).

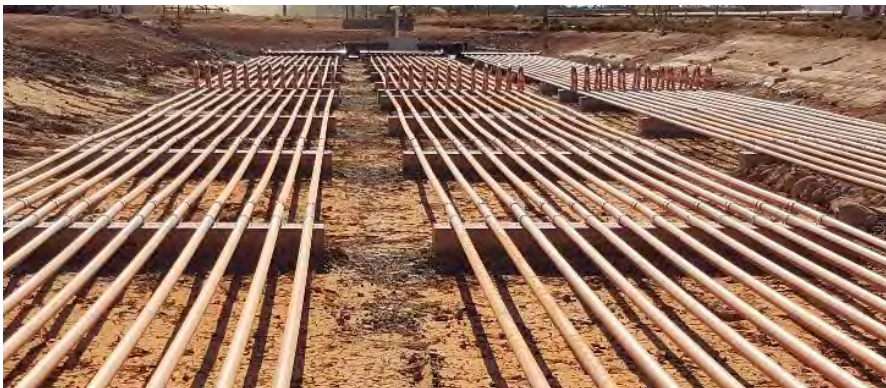
Figure 6. Thargomindah Cooling Manifold.

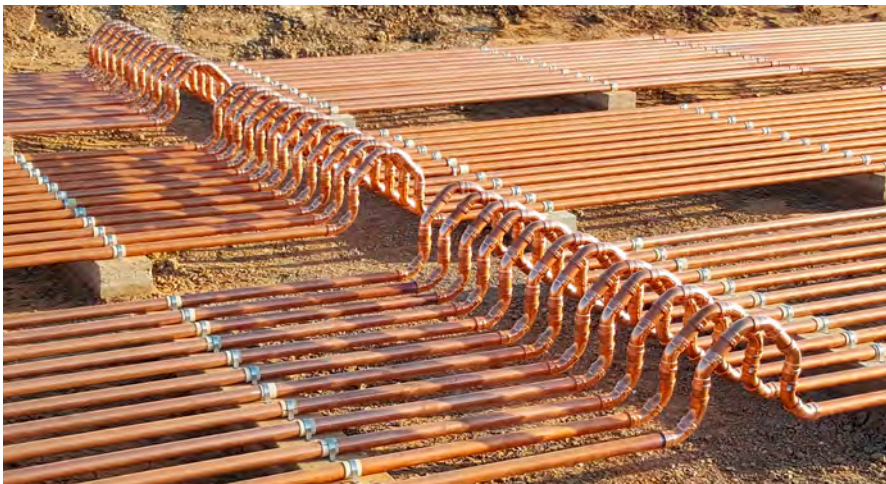
Figure 7. Expansion loops.

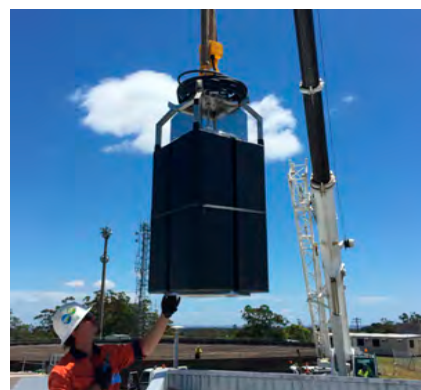
Figure 2a. mixer being lowered.

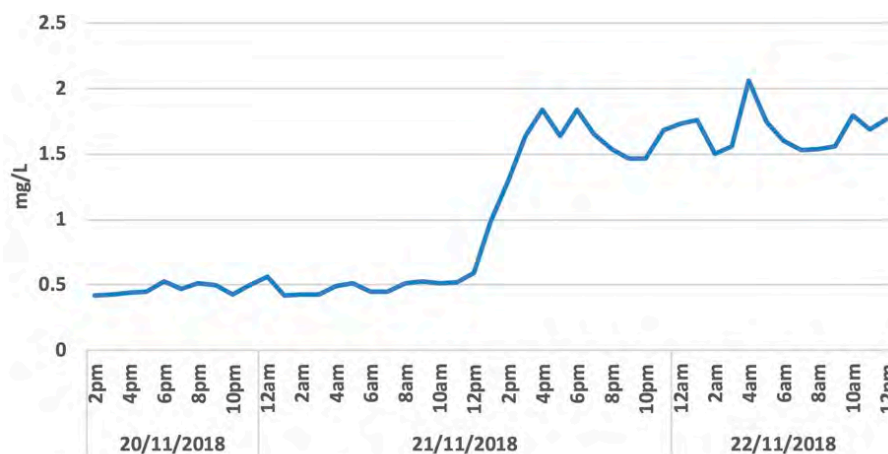
Figure 5. Chlorine residual in Reservoir 3 pre and post mixer over a 3-day period.

At the time of installation of the mixer, chlorine sensing probes were installed and it was an additional 2–3 days until the mixer was operating. Data collected during this period identifies the chlorine residual at a “dead spot” in the reservoir where the sensors were located, after turning the mixer on, instant improvements were observed (Figure 5).

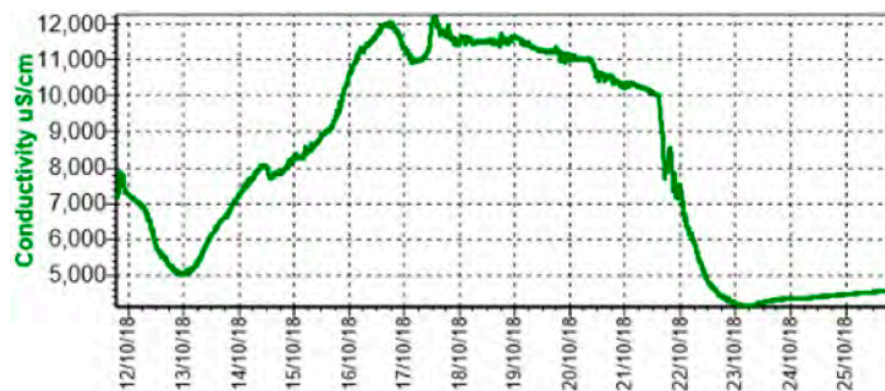
Figure 1. Black Snake Creek salinity measured as conductivity.

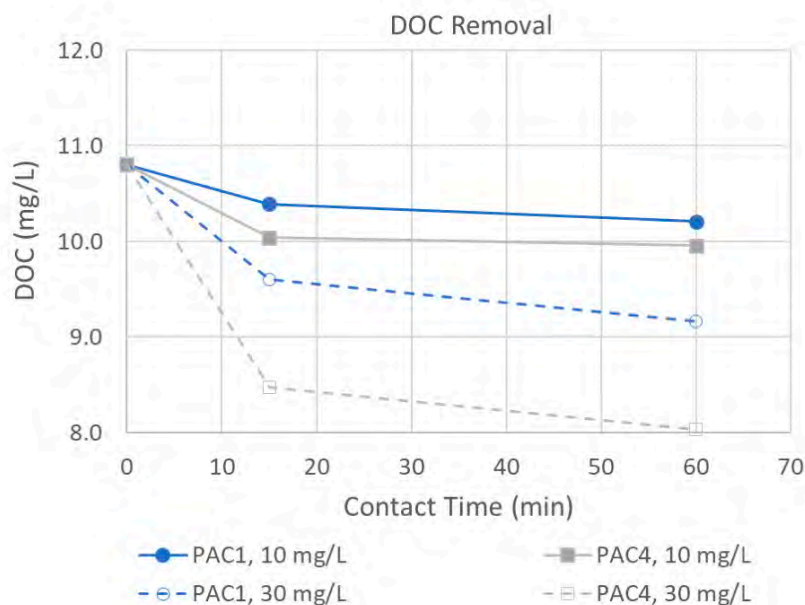
Figure 1. Effect of increasing concentration of PAC on the removal of DOC.

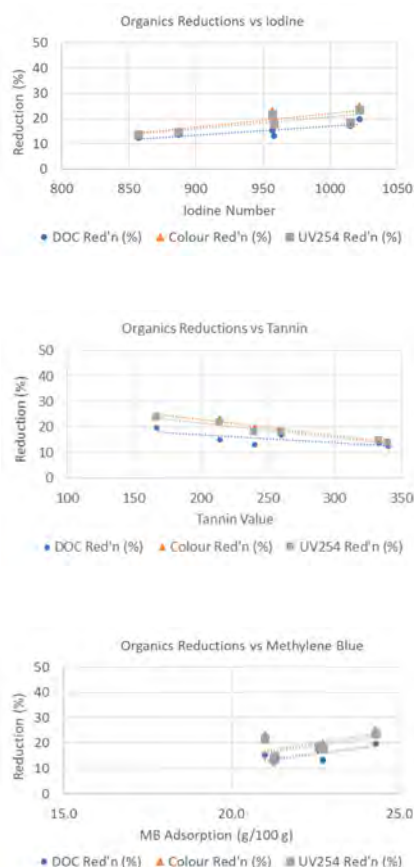
Figure 2. Organics reductions vs adsorptive properties.

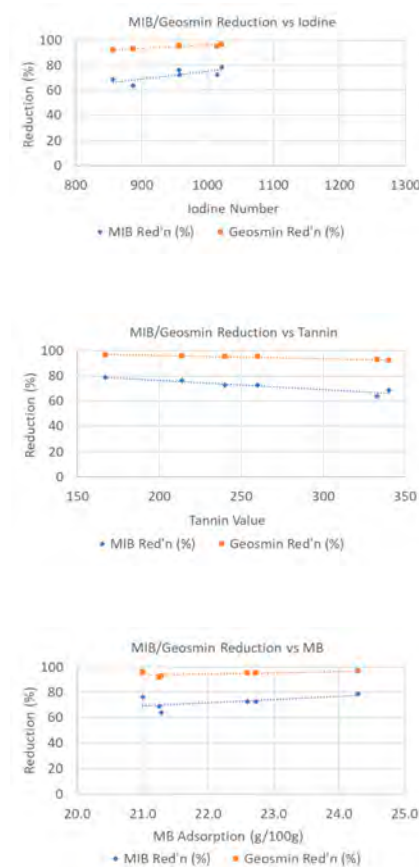
Figure 3. MIB/geosmin reductions vs adsorptive properties.

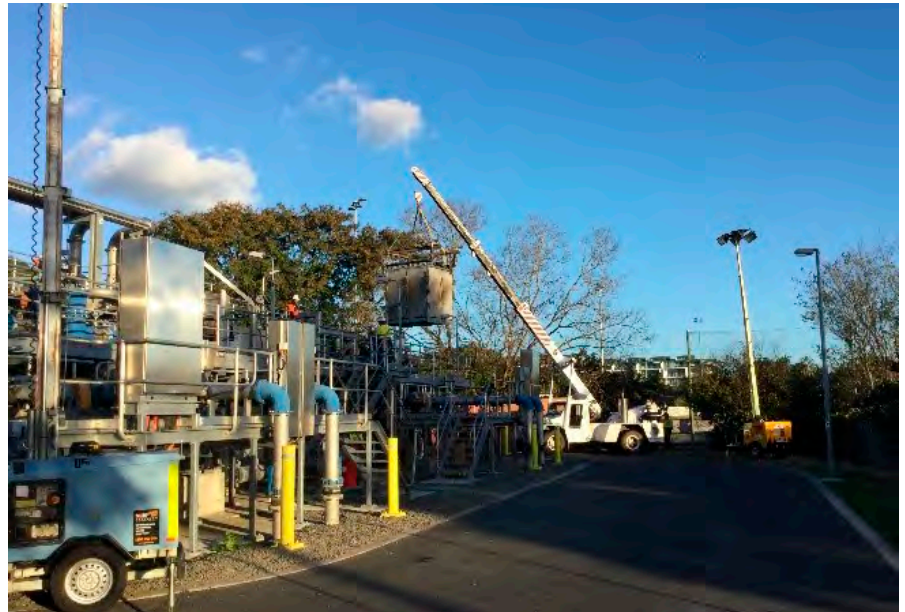
Figure 1. Membrane Cassette removal.

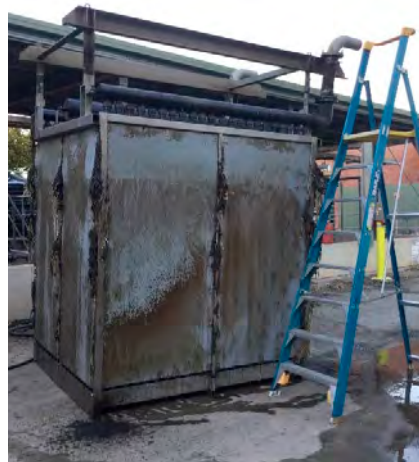
Figure 2. Contaminated Membrane Cassette when first removed from its chamber.

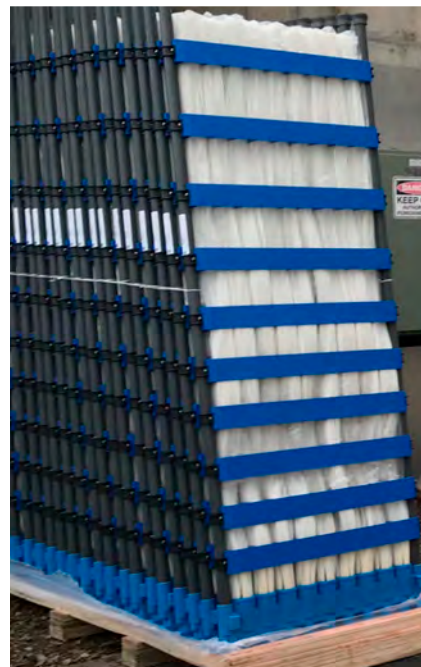
Figure 5. New Membranes prior installation into the Cassette.

The installation of the new membranes (Figure 5) presented some additional challenges. The compaction within the cassettes caused structural cracking of the cassette framework, which added to the refurbishment times.

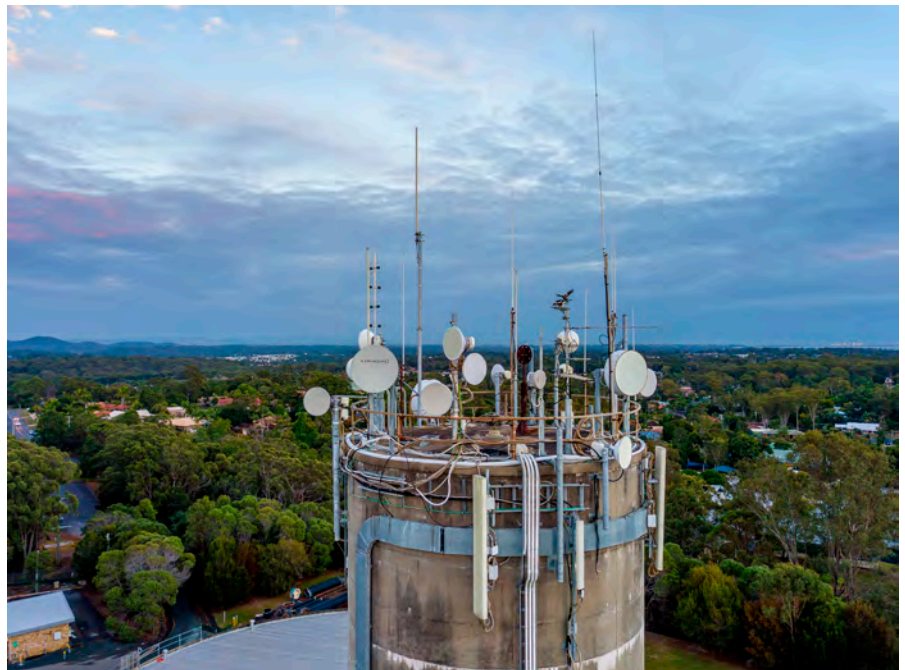
Figure 1. Access to the roof of this storage is all but impossible.

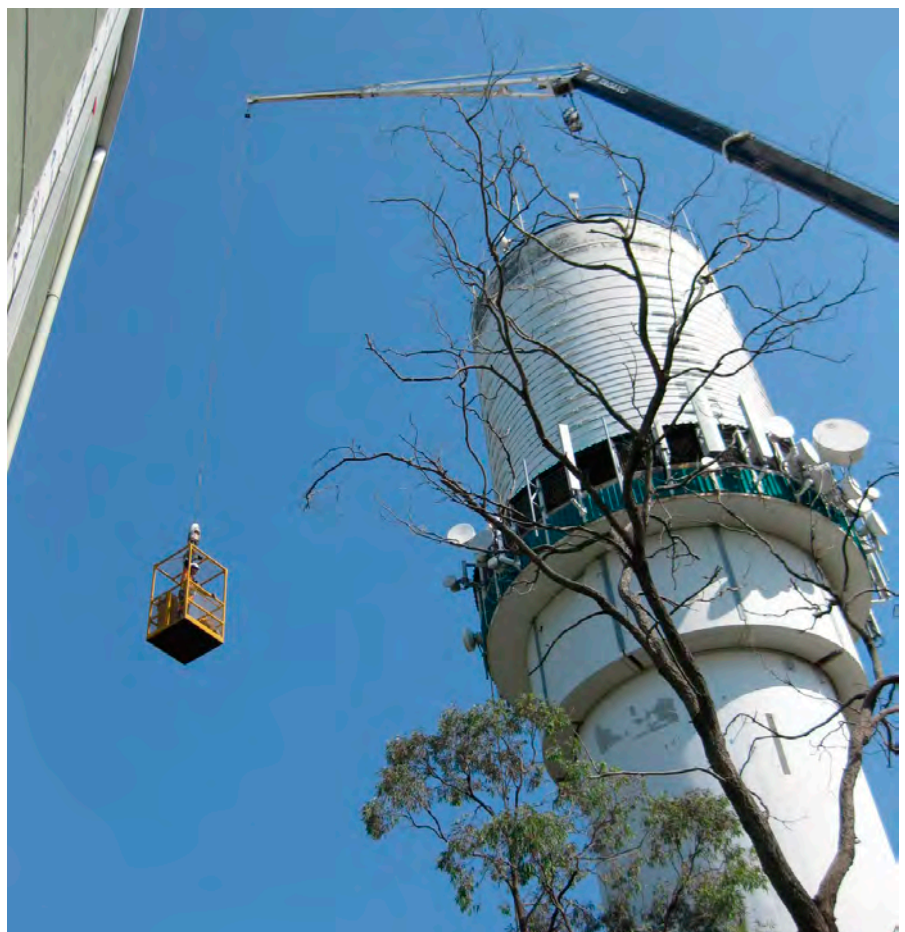
Figure 3. A crane is the only way to access some reservoir due Telco impacts.

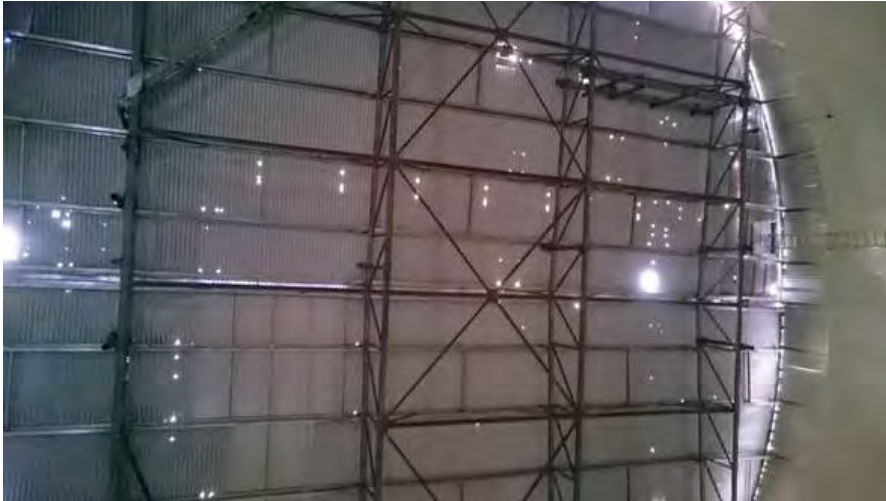
Figure 4. “Swiss Cheese” effect from Telco roof penetrations.

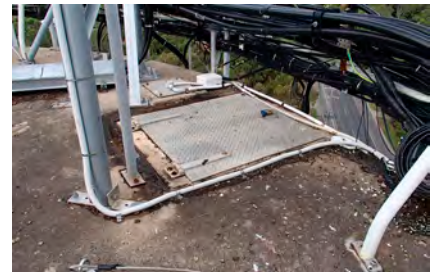
Figure 7. Promotion of bird roosting habitats and blocking roof runoff.

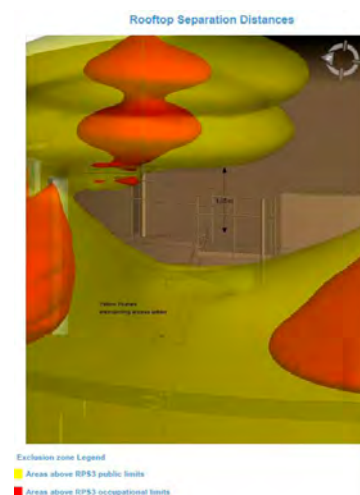
Figure 1. RF emission plume over an access ladder.

Workers and contractors accessing or working near EME fields must be appropriately trained (RADHAZ) and wear appropriate instruments for monitoring EME exposure. This training must be kept up to date.

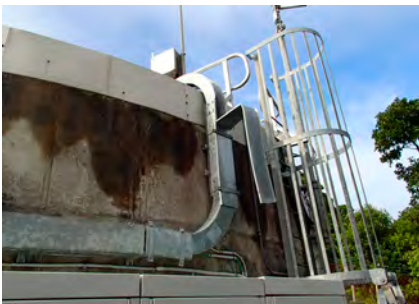
Figure 4. Cable cover defect.

causing trip/slip hazards. Cable tray covers also require ongoing maintenance, and numerous covers have been found unattached on site or in neighbouring areas after being dislodged during a wind event.

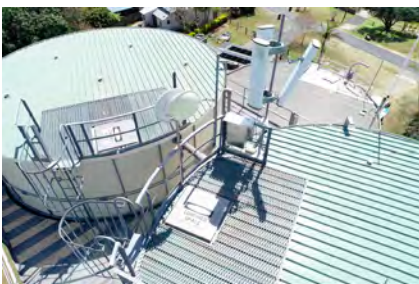
Figure 5. Aerial Intrusion around an operational working space.

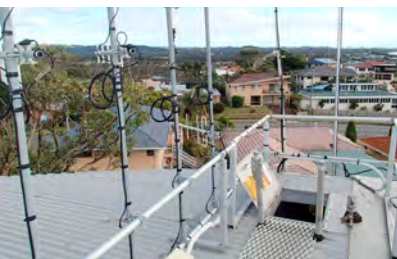
Figure 7. Reservoir entry hatch fully surrounded by aerals.

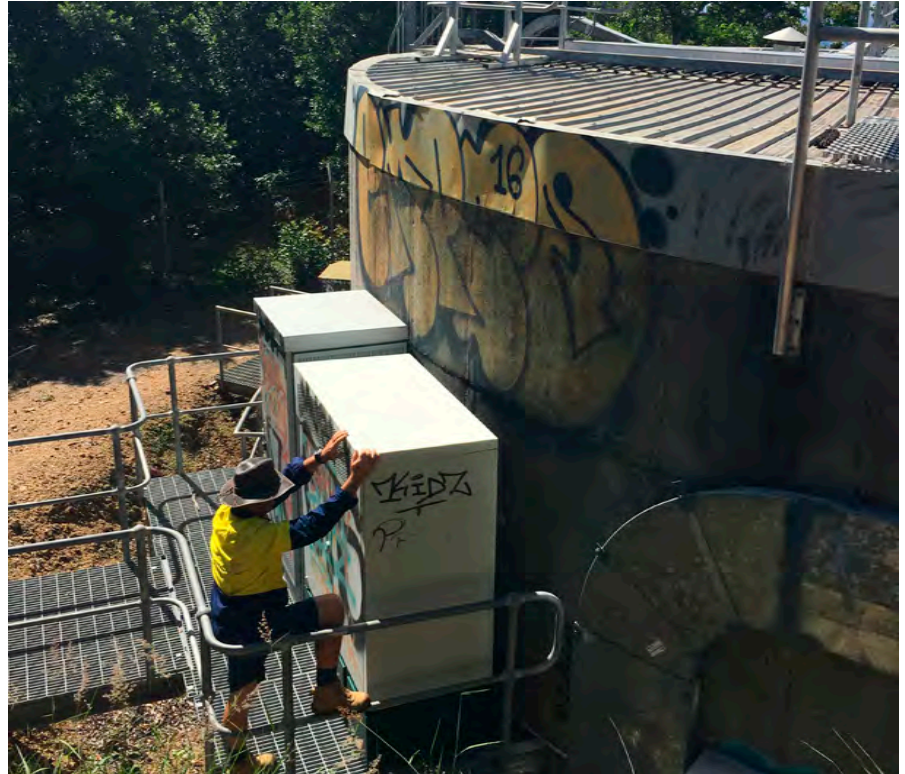
Figure 3. Telco fixtures allowing unauthorised access to tanks.

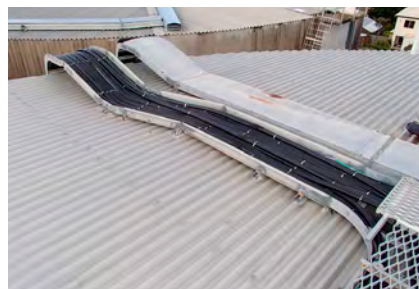
Figure 8. Cable tray cover missing after work on a reservoir roof.

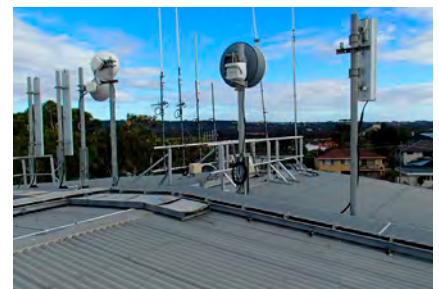
Figure 9. Roof aerals poorly "fixed" directly to roofing materials.
