WATERWORKS

OFFICIAL JOURNAL OF THE WATER INDUSTRY OPERATORS ASSOCIATION OF AUSTRALIA

November 2011

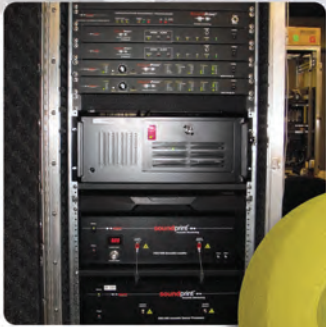
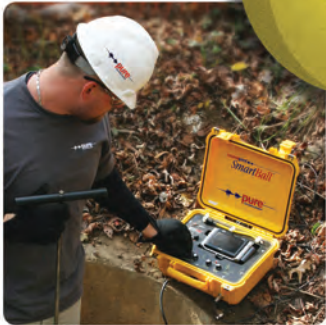
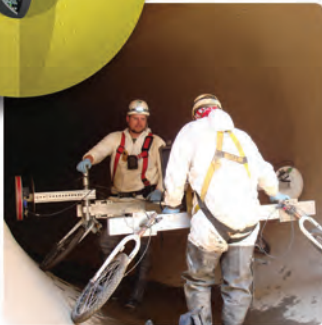
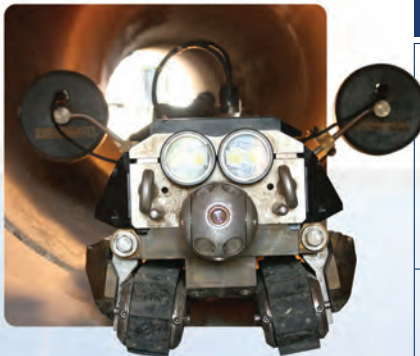
Top: Data Acquisition Unit
Above: Smartball Deployment
Top Right: P-Wave
Right: PureRobotics
Bottom: PipeDiver

SmartBall®	Leak and air pocket detection; Pipe wall assessment
PureRobotics®	Long-range wet or dry pipeline inspection systems
Sahara®	Leak detection, CCTV inspection & wall thickness assessment
PipeDiver™	Evaluation of pipelines; Metallic pipe wall assessment
Magnetic Flux Leakage (MFL)	Inspection of cement lined metallic pipelines

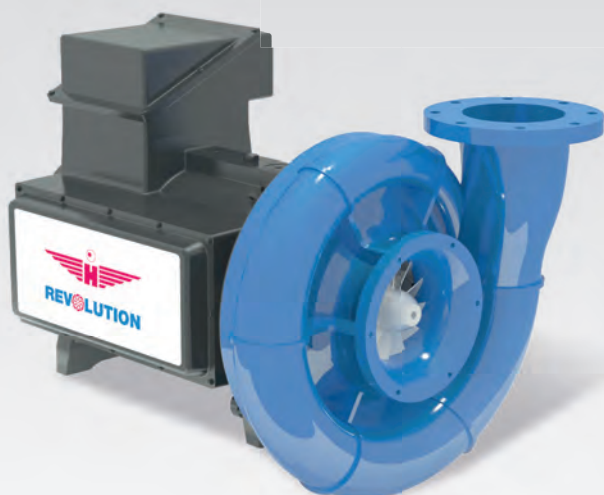
This breakthrough high speed centrifugal blower is driven by a permanent synchronous magnetic motor (PMSM) with a variable frequency drive (VFD) incorporating an infinite life cycle magnetic bearing .

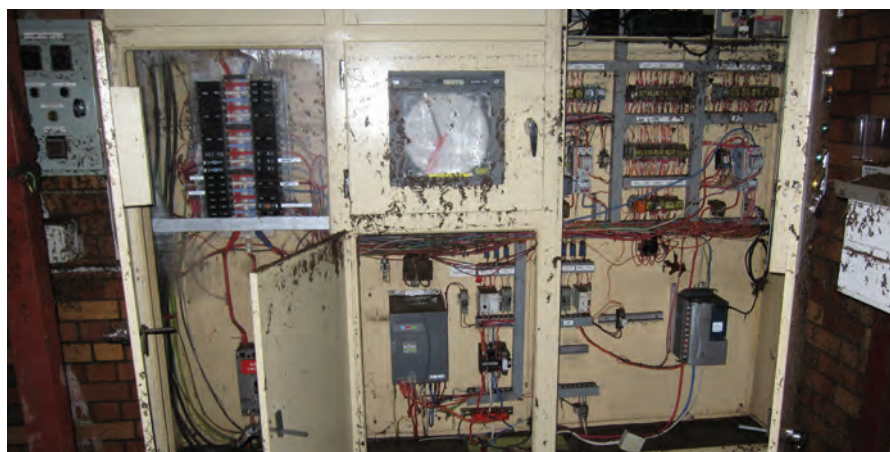
Flood damage to Queens Park Bore switchboard.

- A major wastewater pipeline along the creek broken;
- Flooding of Cressbrook pump station, requiring the baking of two 640kW motors;
- Flooding of several bore switchboards, requiring complete replacement.

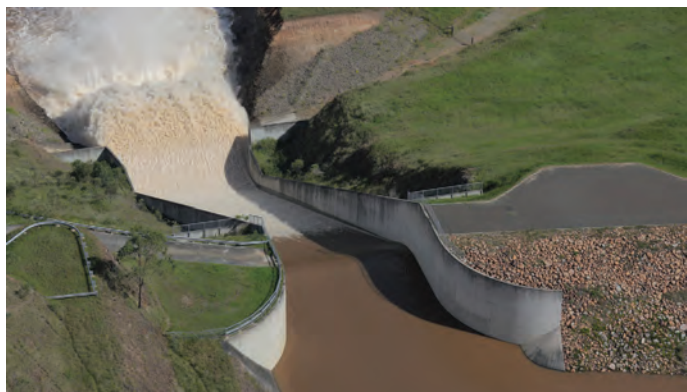
Cressbrook Spillway – approximately 1m over the crest.

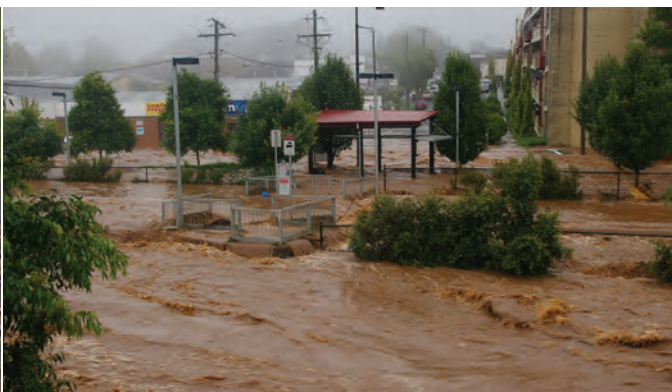
The East Creek pedestrian crossing over the railway line.

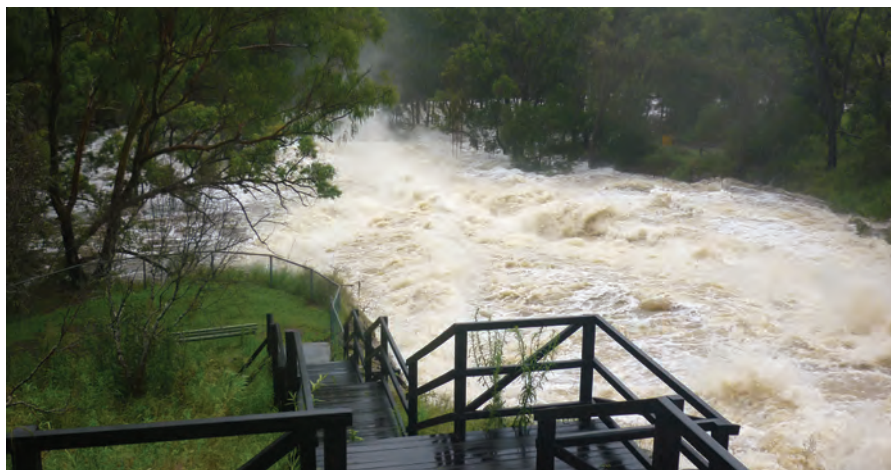
Downstream of Cooby Dam spillway – flows approximately 1.55m over spillway crest.

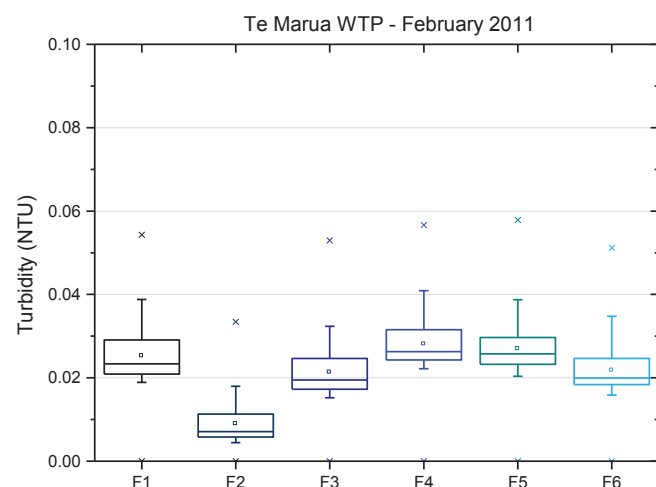
Figure 5. Te Marua WTP Filter Turbidity Box Plot Graph.

A third type of plot is shown in Figure 5. This is a box plot and shows the statistical spread of turbidity data for all the Te Marua filters. The box shows the 25 and 75 percentile values, while the bars show the 5 and 95 percentile values and the crosses show the 1 and 99 percentile values.

These three graph types show that the performance of the filters at the Te Marua WTP met the protozoal compliance requirements for the month of February.

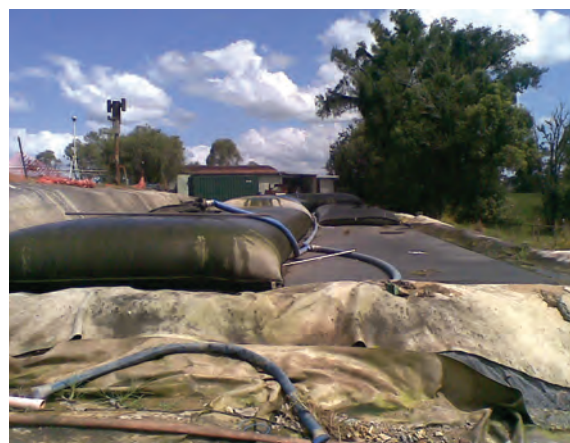
Figure 2. The geotextile bags in place.

The size of the geotextile bags was 15–20m long by 3–4.5m

wide. An area was found that would not interfere with any construction works of the new plant. This area was graded to ensure it was flat across the width, with a very slight slope down the length. The area was bunded and lined with polyethylene sheet. At the low point a pit was constructed, using a 1000L container. This contained a sump pump with float switches. Flexible hose was run back to the digester supernatant pit. The geotextile bags were laid upon porous panels, which improved dewatering. In the final version there were four bags in service, with provision for a fifth. Figure 2 shows the arrangement of the

Site level is very important, particularly across the width of the bags. It was found that even with a very small slope the bags rolled, and it was necessary to stake them. The site had to be level across the width, and only have the slightest fall lengthways.

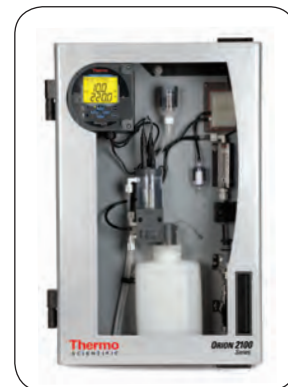
New Thermo Scientific Orion 2109XP Fluoride Monitor.

This easy to use system is designed for stability and responsiveness. The Orion 2109XP offers continuous fluoride detection with security features for your peace of mind.
