# WATERWORKS

TECHNICAL PUBLICATION OF THE WATER INDUSTRY OPERATORS ASSOCIATION OF AUSTRALIA

NOVEMBER 2020

## CONTENTS

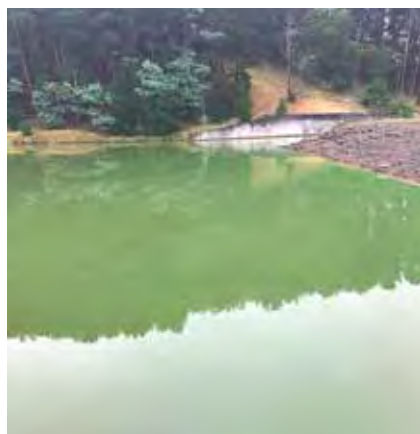
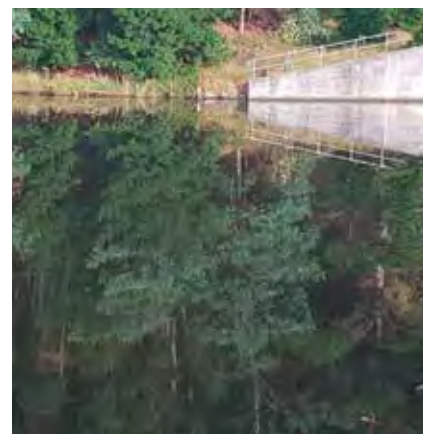
**Figure 1a & b. Leongatha Reservoir No. 4 on the day of treatment (left) and 7 days after treatment (right).**

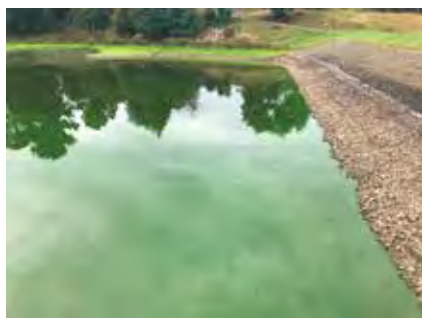
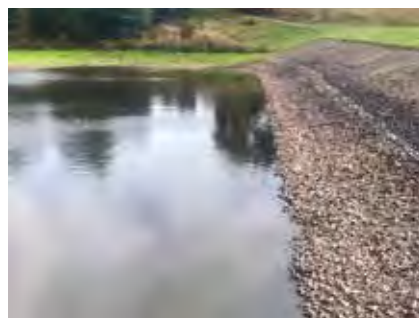
**Figure 2a & b. Little Bass Reservoir on the day of treatment (left) and 7 days after treatment (right).**

in Table 2. A significant reduction in the blue-green algae bio-volumes was observed at Little Bass Reservoir. The majority of the bio-volume reduction took place within the first seven days after treatment.

While a decrease in algae bio volume was evident immediately after the dose, by 5 March, the bio-volume numbers and the geosmin were already increasing again, suggesting that inadequate elemental copper had been applied to overcome the organic demand required to achieve an effective blue-green algae kill.

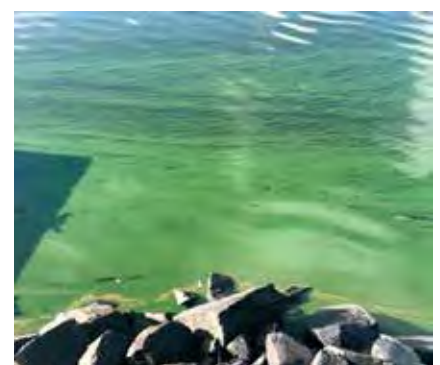
**Figure 3. Lance Creek Reservoir on 24 February prior to treatment with algicide.**

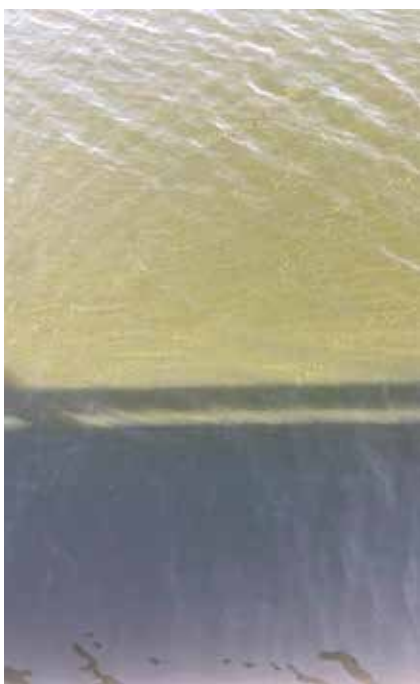
**Figure 4. Lance Creek Reservoir on 16 March 3 days after the second dose.**

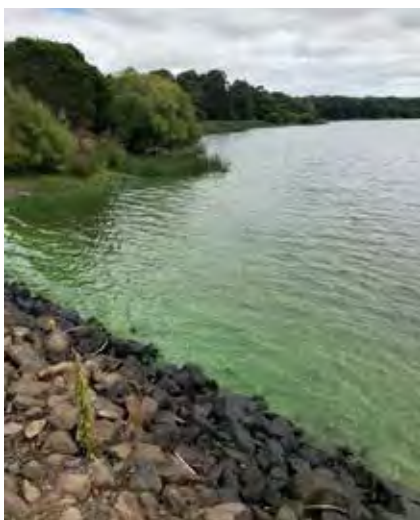
**Figure 5a. Lance Creek Reservoir – 24.3.2020 – Day of application No.3.**

The dose delivered on 24 March was the last dose applied to Lance Creek Reservoir. The post-dosing water quality results for the third application are provided in Table 5. The visual appearance of the reservoir is shown in Figure 5.

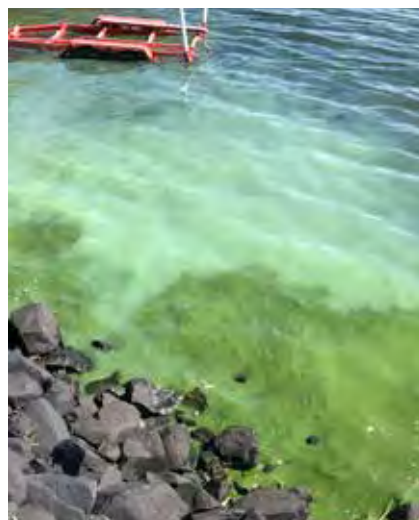
**Figure 5b. Lance Creek Reservoir – 27.3.2020 – 3 days post dose No.3.**

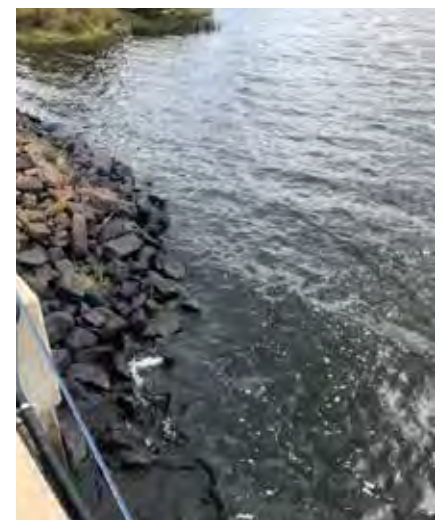
**Figure 5c. Lance Creek 14 April.**

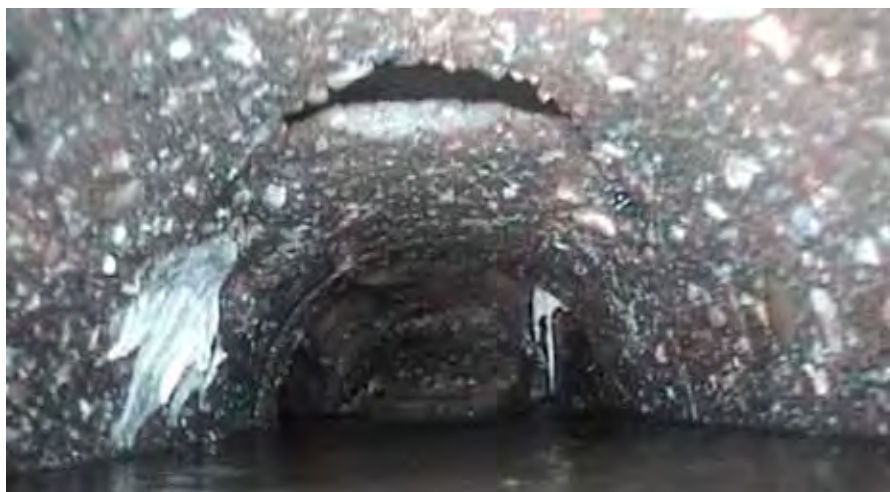
**Figure 1. A typical failure of a concrete sewer main through acid attack.**

Concrete typically fails in the crown of the pipe and exhibits a very brittle exposed aggregate look or significant cavities (Figure 1). Premature ageing of concrete sewer mains results from sulphuric acid attack. Sulphuric acid exists due to the presence of hydrogen sulphide gas which is a by-product of domestic sewage. Deterioration is further exacerbated if the sewer system does not have adequate ventilation (aerobic conditions).

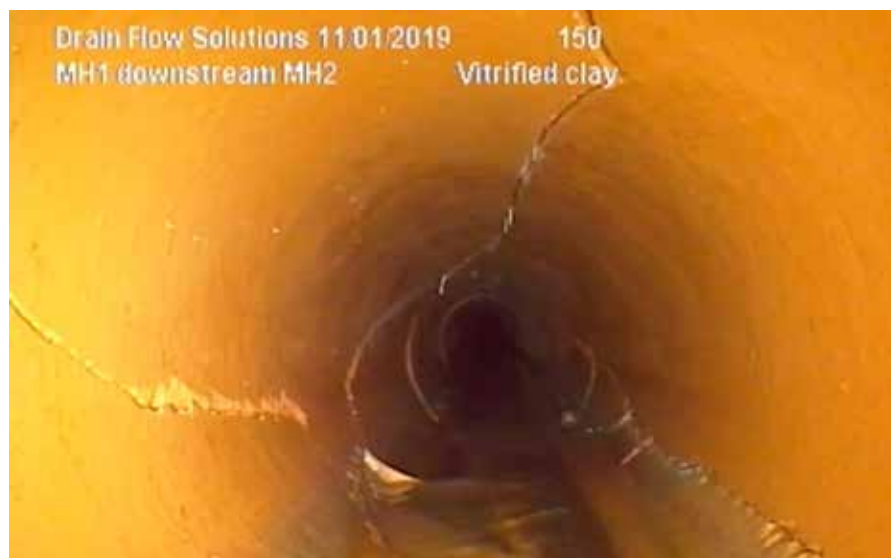
**Figure 2. A typical failure of a vitrified clay sewer main through stress fractures.**

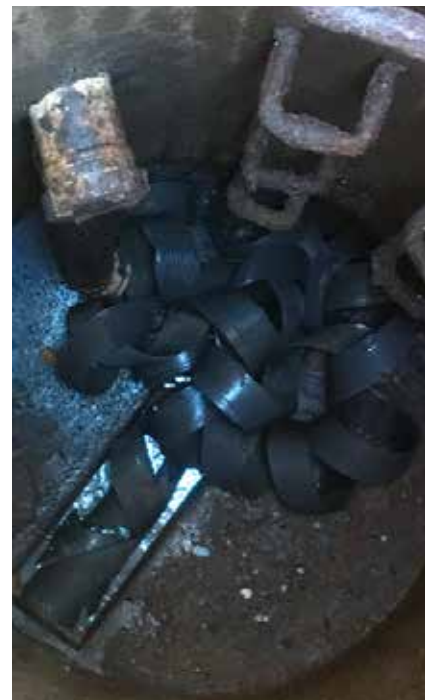
**Figure 3. Pipe failure due to the unravelling of a spiral liner.**

In August 2019, a significant sewer blockage occurred in the Albury CBD due to the failure of a spiral lined trunk main which had been relined in 1986 (Figure 3). The blockage resulted in a disruption to customers due to construction noise and road closures.

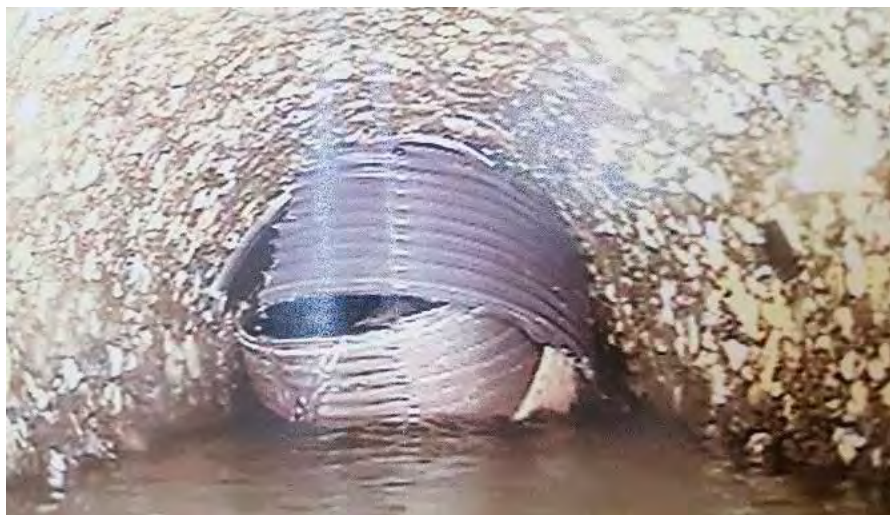
**Figure 4. The unravelled spiral lining blocking the sewer trunk main.**

Initially, downstream manholes were investigated until it was observed that normal flow had resumed. This was discovered five manholes downstream of the blocked cinema manhole. Using CCTV, the cause of the blockage was determined to be due to the failure of a large section of spiral lining (Figures 4 and 5).

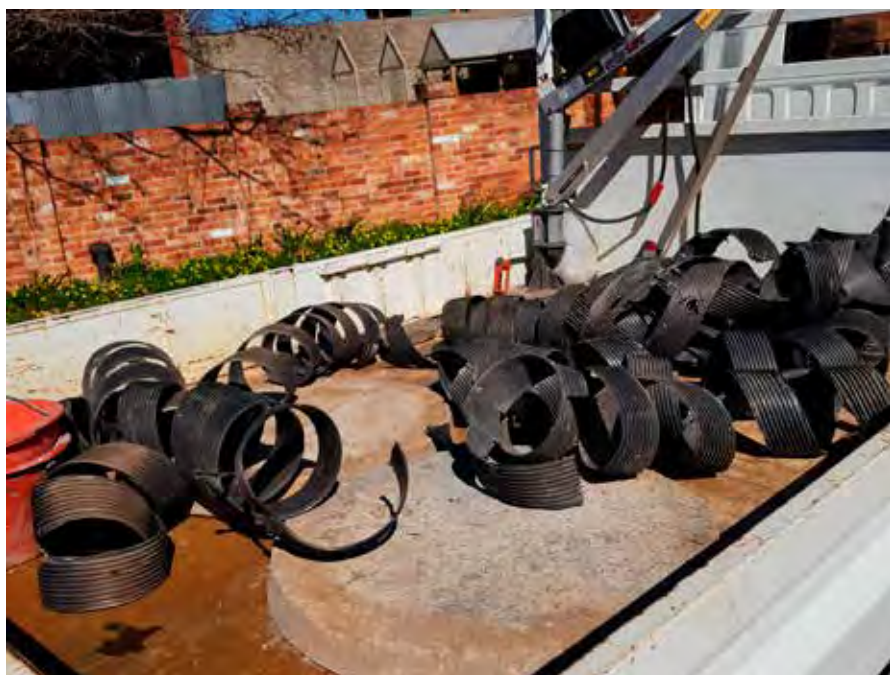
**Figure 5. The spiral lining after removal from the sewer trunk main.**

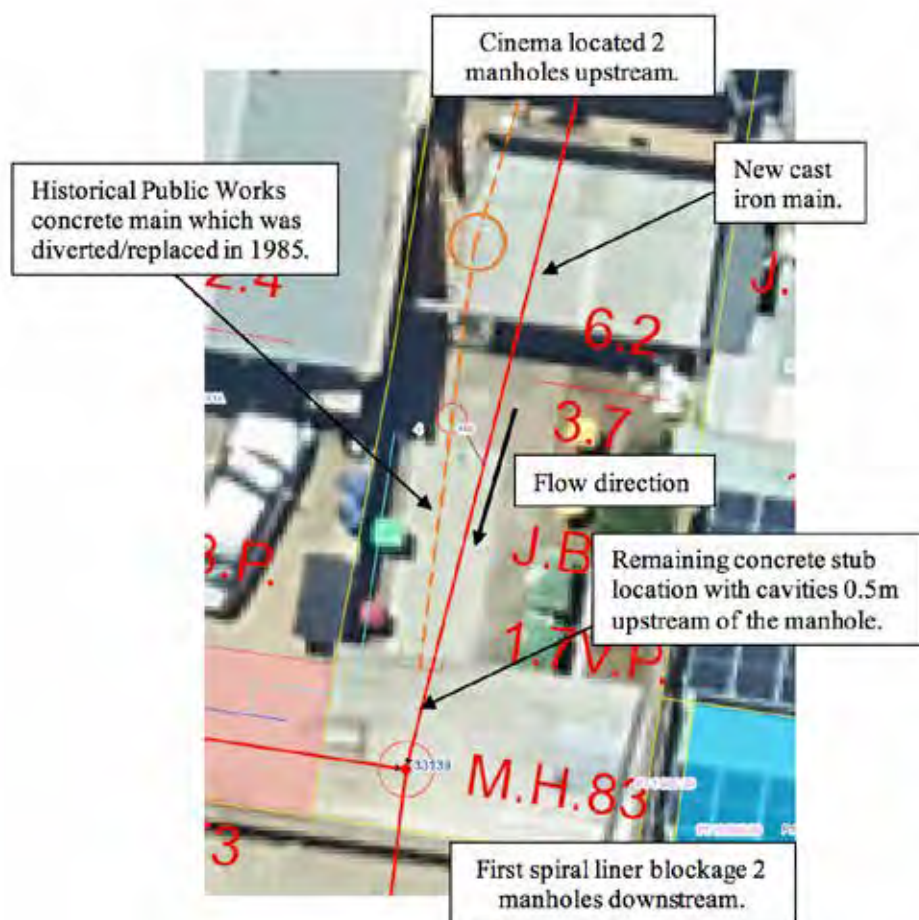
**Figure 6. Sewer main diversion conducted in 1985.**

Council's records showed that this main had been diverted in 1985 and was constructed from cast iron (Figure 6). As cast iron pipes seldom fail, further CCTV investigation was completed revealing that it was a concrete main which had collapsed only 0.5 m upstream of the manhole.

Pipe bursting was again used to rectify this defect, which involved excavating a launch pit directly behind the busy CBD premises. Upon excavation it was discovered that only the first 3 m was concrete, after which it returned to cast iron, as per initially recorded within Council's asset database. It appears that when the diversion was constructed, the existing concrete main was used as a stub to alleviate the need to break into the existing manhole. This remaining section of concrete had subsequently failed as a result of sulphuric acid attack over time (Figure 6).

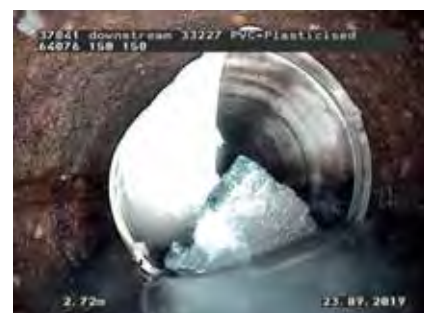
**Figure 7. View of an unravelled spiral junction.**

Two of these mains were able to be rectified through fibreglass patching. This involved installing patches at the start, any intermediate junction and the end of the sewer pipe, followed by recutting of the junctions. The other main had significant unravelling of the spiral lining (Figure 7) that required pipe bursting.

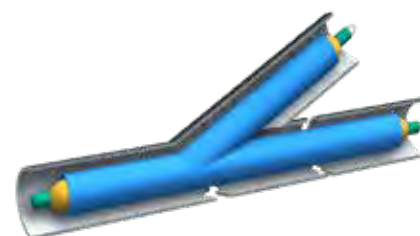
**Figure 8. Typical junction liner (blue) currently being trialled to reinforce poorly cut-out spiral lined junctions. The expanding bladder is shown in yellow. (Diagram taken from SA Pipe Relining (2020), “The alternative solution to repairing your drains”, viewed Tuesday 11 February 2020, <https://sapiporelining.com.au/>)**

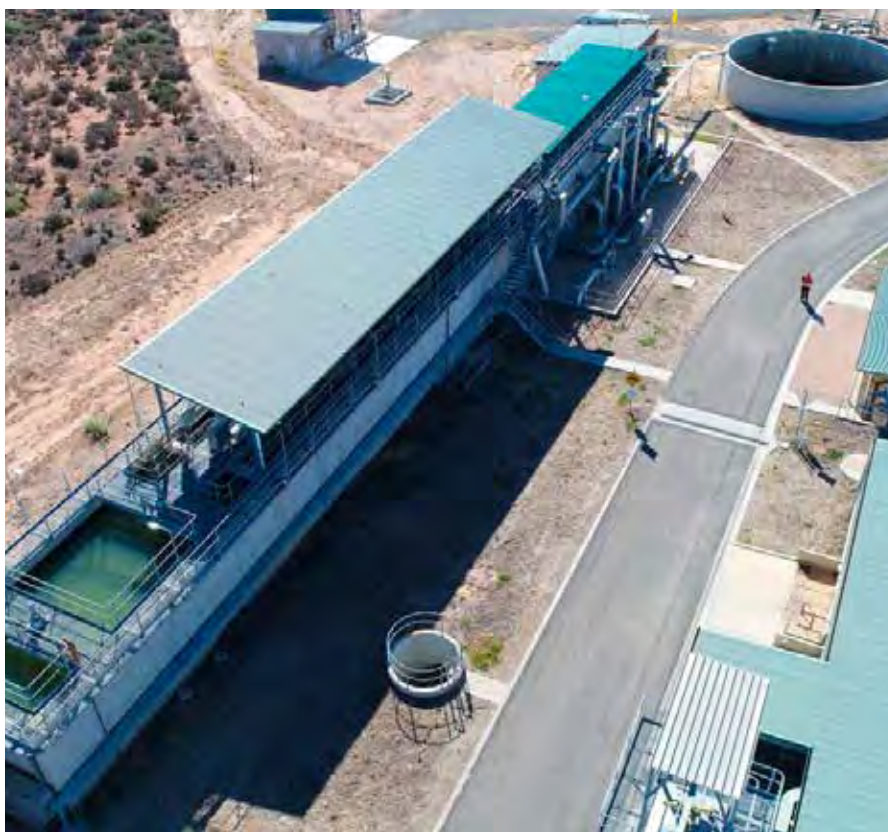
**Figure 1. Mildura West WTP.**

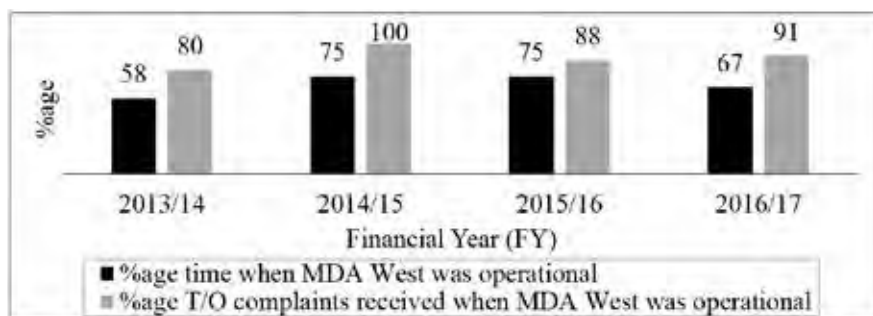
**Figure 2. Comparison of taste and odour complaints received when the two different plants were operating.**

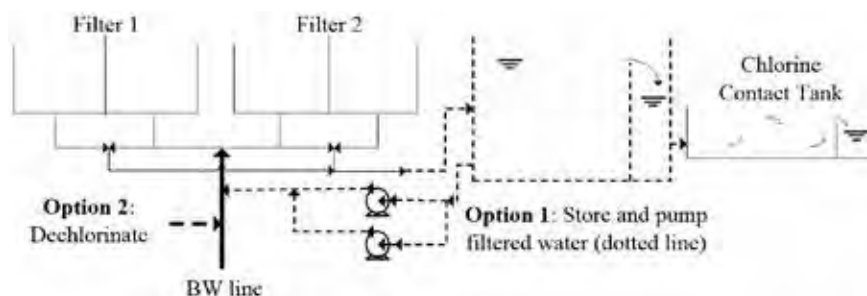
Figure 3. Options for backwashing without a chlorine residual.

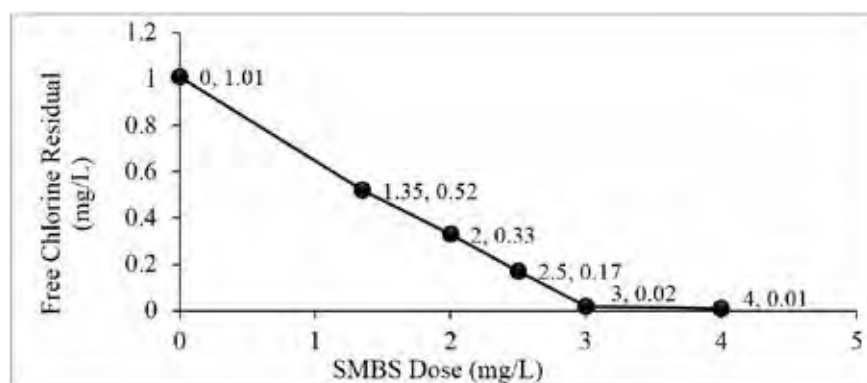
Figure 4. Results of the jar testing showing removal of free chlorine with increasing dose of SMBS.

In August 2017, jar tests were performed to test the effectiveness of sodium metabisulfite (SMBS) for dechlorination. Increasing concentrations of SMBS were added to 1 litre treated water samples containing 1.0 mg/l residual chlorine. After SMBS addition, samples were stirred at 40 rpm for 22 seconds and at 100 rpm for another 6 seconds. The short time was chosen to reflect the conditions of the

backwash water rinse. There is a very short contact time available between the dosing point to be used and the filter plenum entry point. In theory, 1.34 mg of sodium metabisulfite will remove 1.0 mg of free chlorine. In practice however, 3.0 mg of sodium metabisulfite is normally required to remove 1.0 mg of chlorine, which is exactly what was found in the jar tests. The reason for the higher than theoretical dose could be the short contact time or the presence of other chemicals in the water.

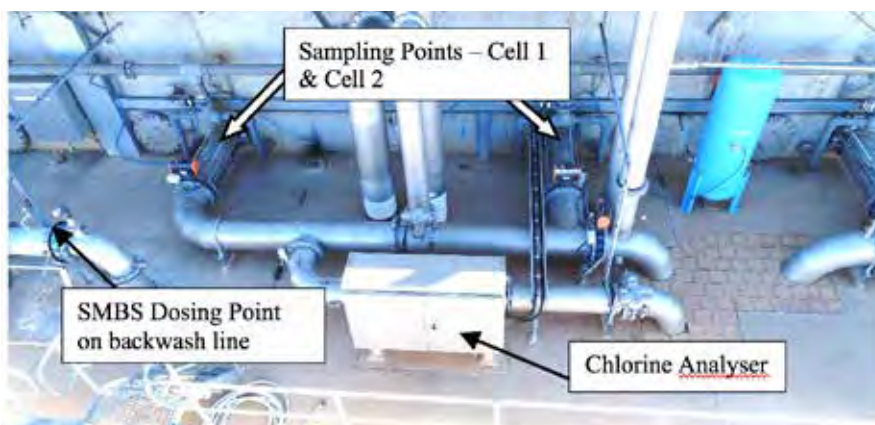
Figure 5. The trial dosing set-up for filter 1.

Mildura West WTP was originally designed with the capability of dosing sulphuric acid for the treatment of saxitoxins but this system has never been required. It was decided to use the existing sulphuric acid area and dosing pump pipework which ran past the filter gallery for dosing SMBS. An unused urea dosing system at one of the wastewater treatment plants, which had a hopper and a batching tank, was disassembled and reassembled in position in the sulphuric acid dosing area. A spare chlorine analyser from another WTP was installed in the existing cabinet, dosing pumps were purchased new and the pipework was built from the suction point to the existing delivery point. The dosing setup is shown in Figure 5.

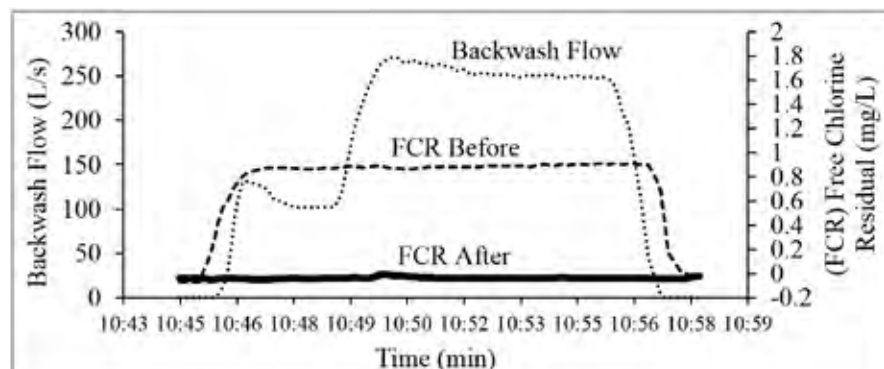
**Figure 6. A typical backwash profile before and after dechlorination.**

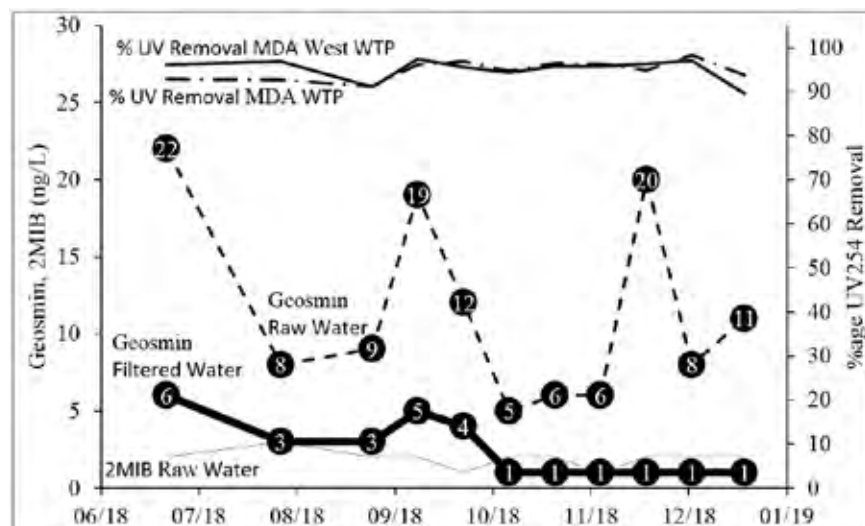
**Figure 7. Geosmin removal without PAC dosing. Continuous SMBS dosing commenced on 1 September.**

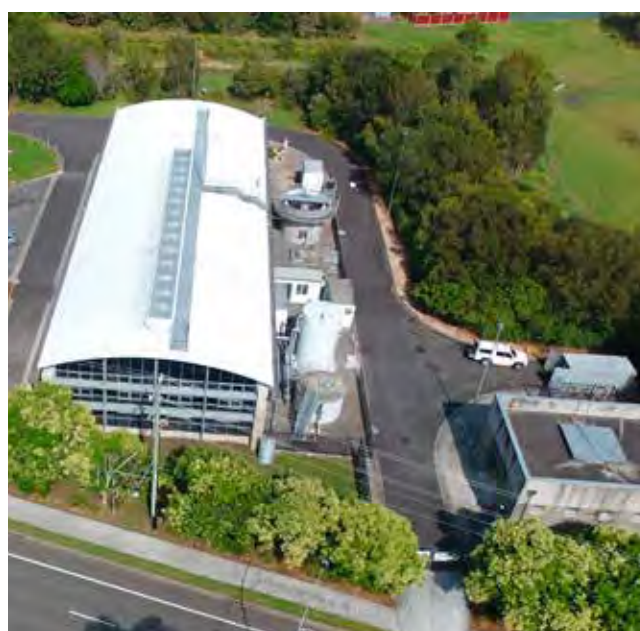
Figure 2. The PMHC recycled water treatment plant.

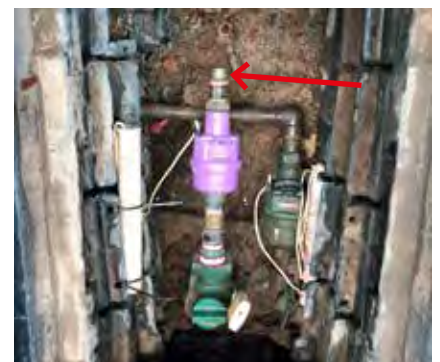
**Figure 4. An underground meter box showing the connection point.**

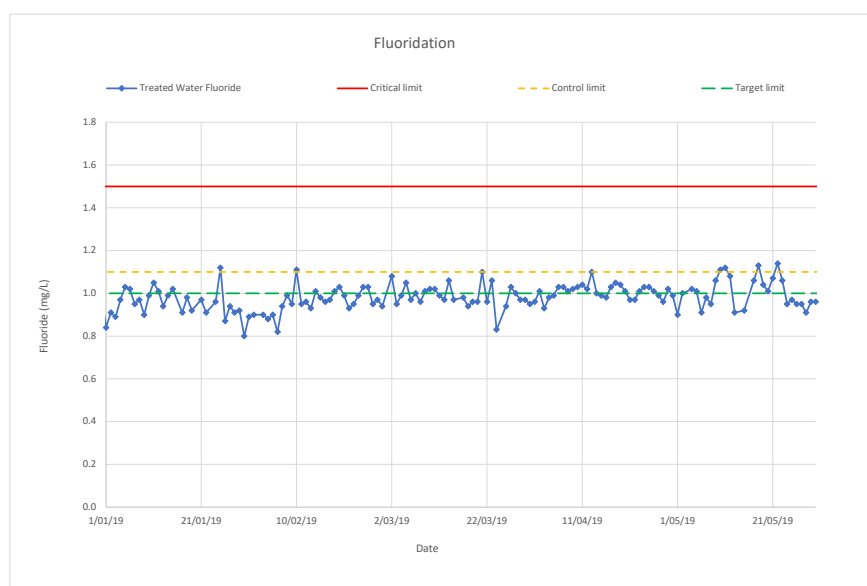
**Figure 1. A typical water quality control chart. (Note that the same coloured lines for the critical limit and control limit are used in the following graphs as well.)**

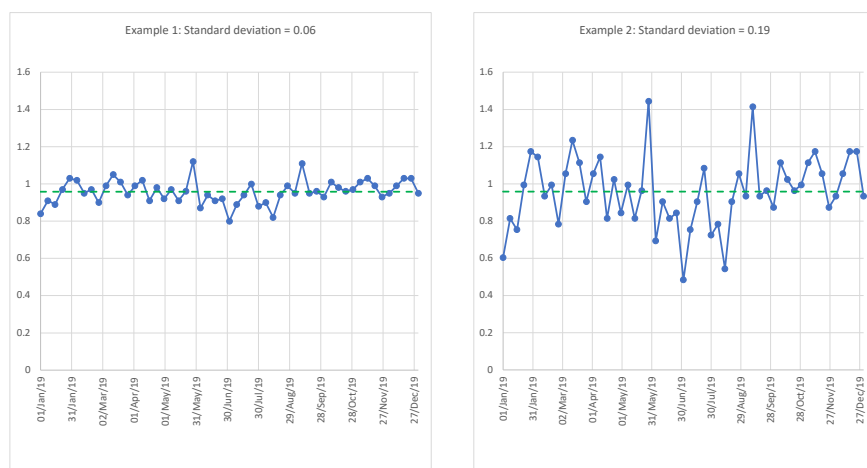
**Figure 2. Examples of the standard deviation for data sets with the same mean but with different variability as shown by the standard deviation of 0.06 for Example 1 and 0.19 for Example 2.**

The standard deviation is simply a number that relates to how much variation there is in the parameter that is being measured. It is therefore a measure of how “in control” the parameter is. If the standard deviation is low, all the data is in control. If the standard deviation is higher, the data is less in control. Figure 2 shows the standard deviation for 2 sets of data with the same mean but with Example 2 less in control than Example 1.

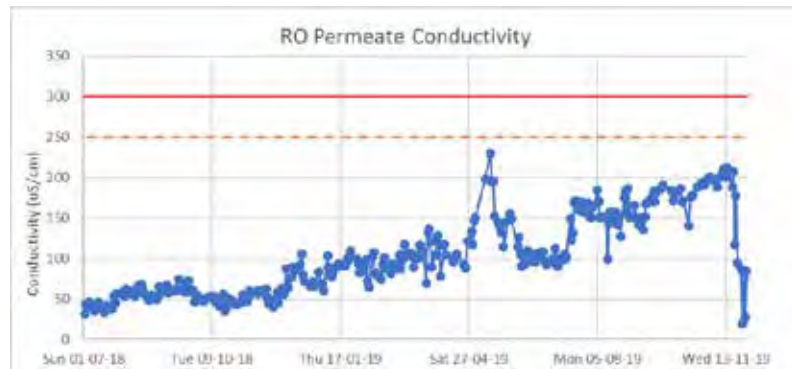
**Figure 3. Example of a control chart with the control limits too wide. The orange dashed line is the control limit and the red line the critical limit.**

An example of data from a recycled water plant where the reverse osmosis (RO) electrical conductivity continued to rise to 4 times the average without reaching the upper control limit is shown in Figure 3. Once the operators noticed the trend, the membranes were replaced and the conductivity returned to normal.

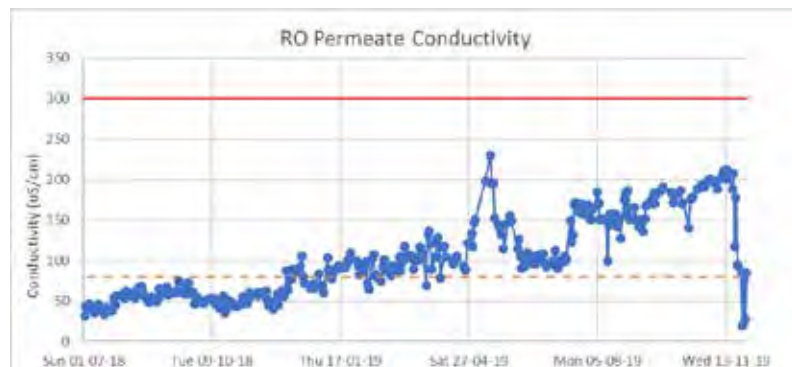
**Figure 4. The same control chart as Figure 3 with the control limit adjusted to three standard deviations from mean. The orange dashed line is the control limit and the red line the critical limit.**

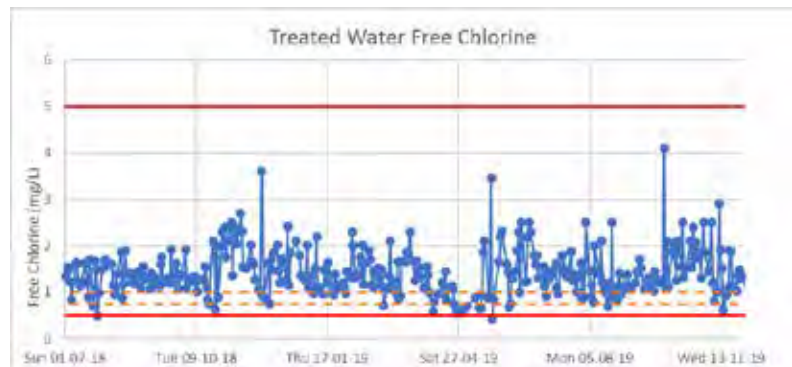
**Figure 5. An example of a control chart with the control limit set too narrow. The orange dashed lines are the upper and lower control limit and the red lines the upper and lower critical limits.**

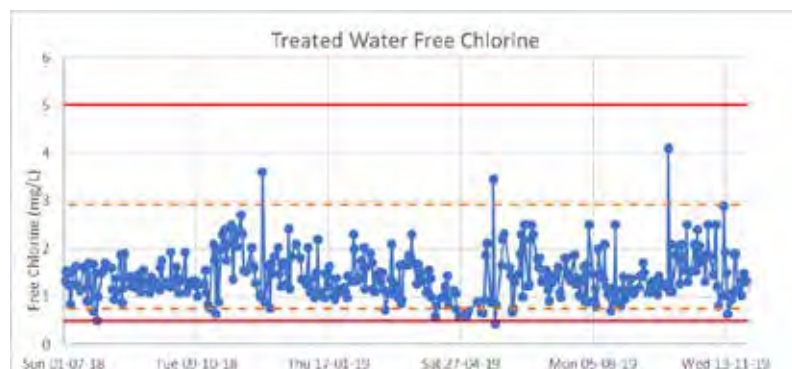
**Figure 6. The same data in Figure 5 with the upper control limit adjusted to three standard deviations above the mean. Orange dashed lines are the upper and lower control limit and red lines the upper and lower critical limits.**

The same data shown in Figure 5, with the upper limit adjusted to 3 standard deviations above the mean is shown in Figure 6.

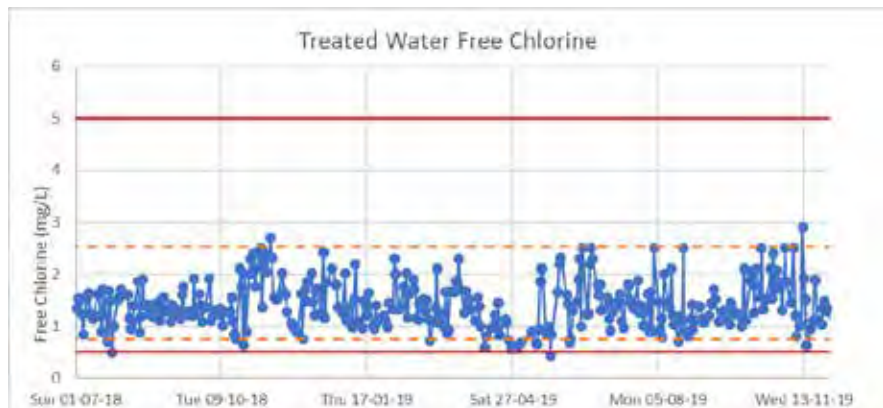
**Figure 7. Automatic lowering of upper control limit as the high (spike) values are removed. The orange dashed lines are the upper and lower control limit and the red lines the upper and lower critical limits.**

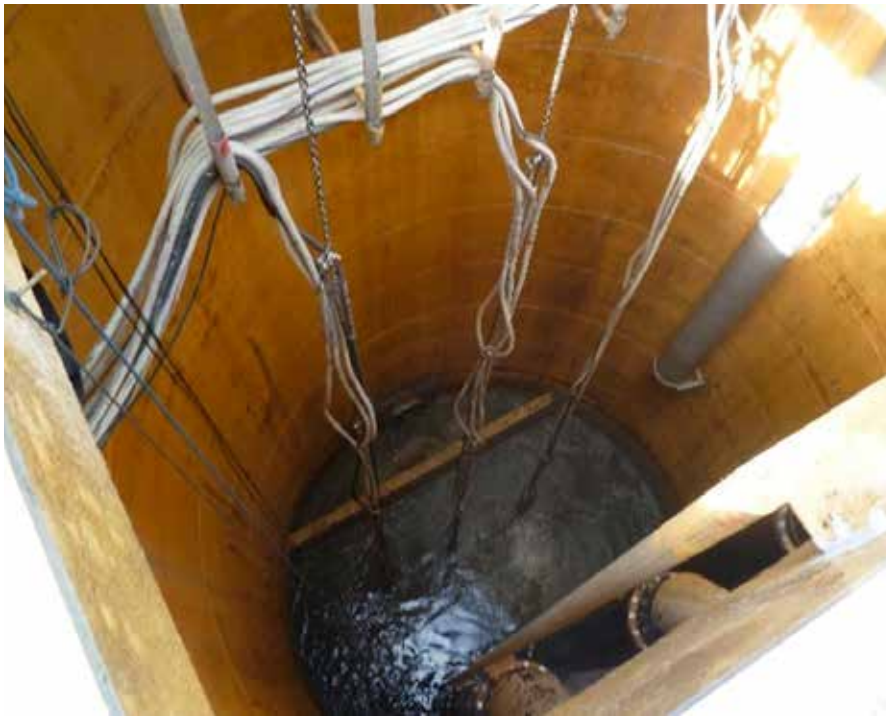
**Figure 1. Looking down into the SPS69 wet well.**

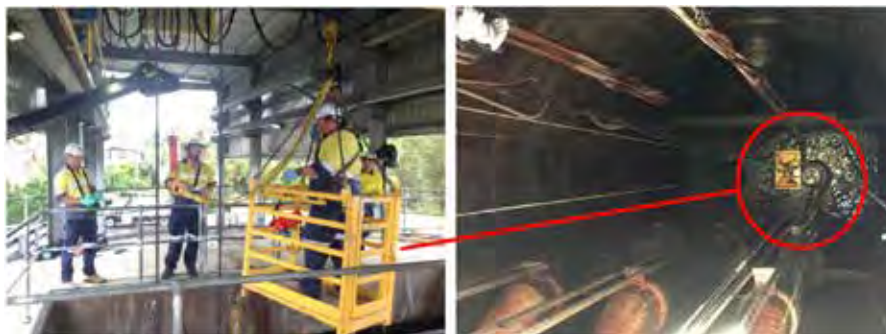
**Figure 3. The longstanding procedure for removing pumps relied on two bridge cranes, a man cage (left) and confined space entry into the wet well to shackle the pump. The right photograph is taken looking down into the wet well when the pump was being shackled.**

These requirements were a major issue for operations and maintenance staff. Maintenance personnel were lowered into the wet well via a “man cage” using the 2-tonne crane. The 10-tonne crane hook was lowered to the person in the well to manually engage the lifting point on the top of the pump (Figure 3).

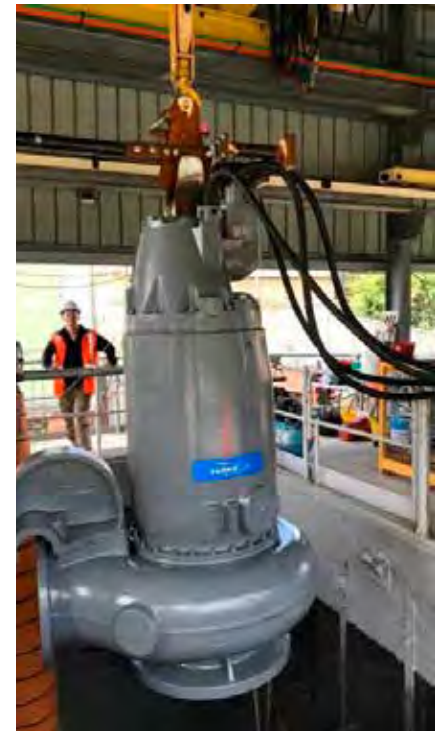
**Figure 2. The existing SPS69 pumps weigh approximately 5 tonnes and are over 3 metres high.**

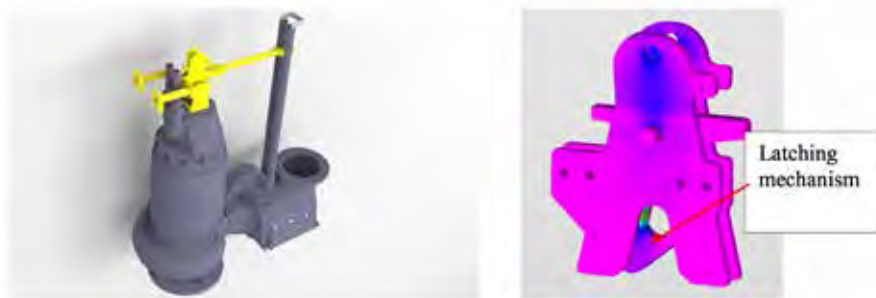
**Figure 4. 3D modelling (left) and finite element modelling (right) were used during the design of the pump lifter.**

Prior to construction, three-dimensional and finite element modelling were used to design key components of the lifting equipment and predict the behaviour of the product in real-life conditions (Figure 4).

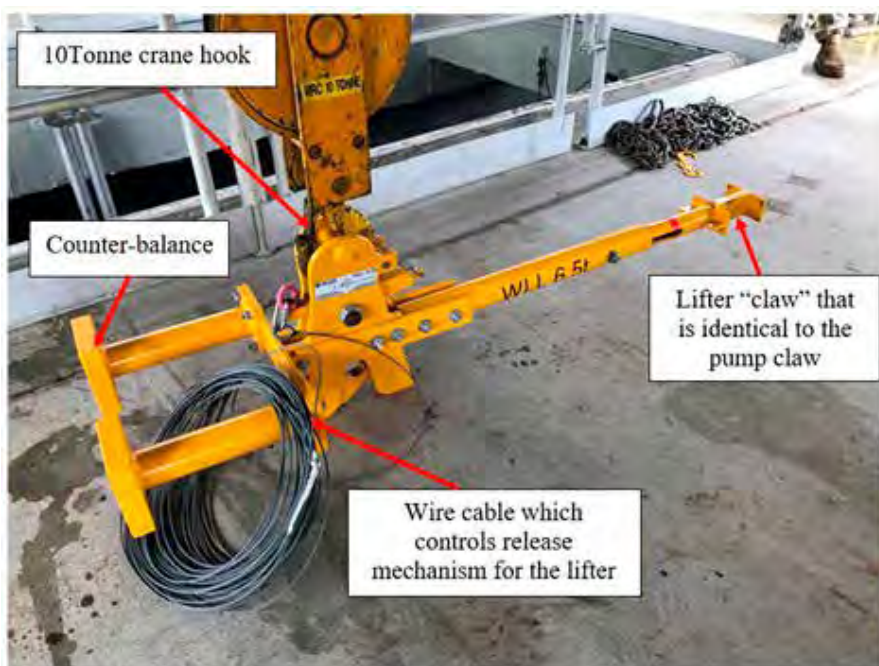
**Figure 5. Components of the lifter.**

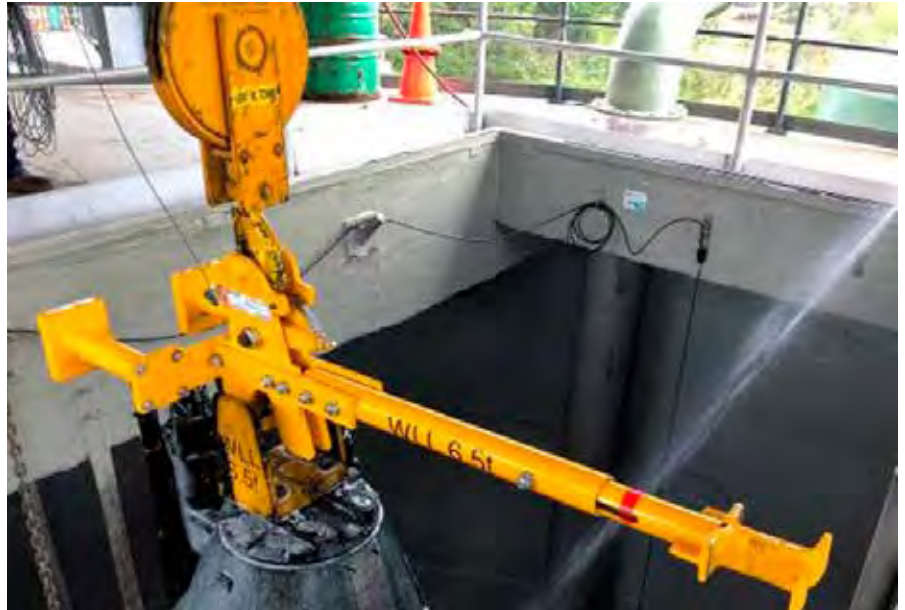
**Figure 6. Close-up view showing how the lifter engages onto the pump.**

Pulling on the wire cable which opens up the latching mechanism disengages the lifter away from the pump. The lifter can then be removed. As an additional visual aid, the crane operator has a load display available on the crane which enables the operator to determine what load is being seen by the crane.

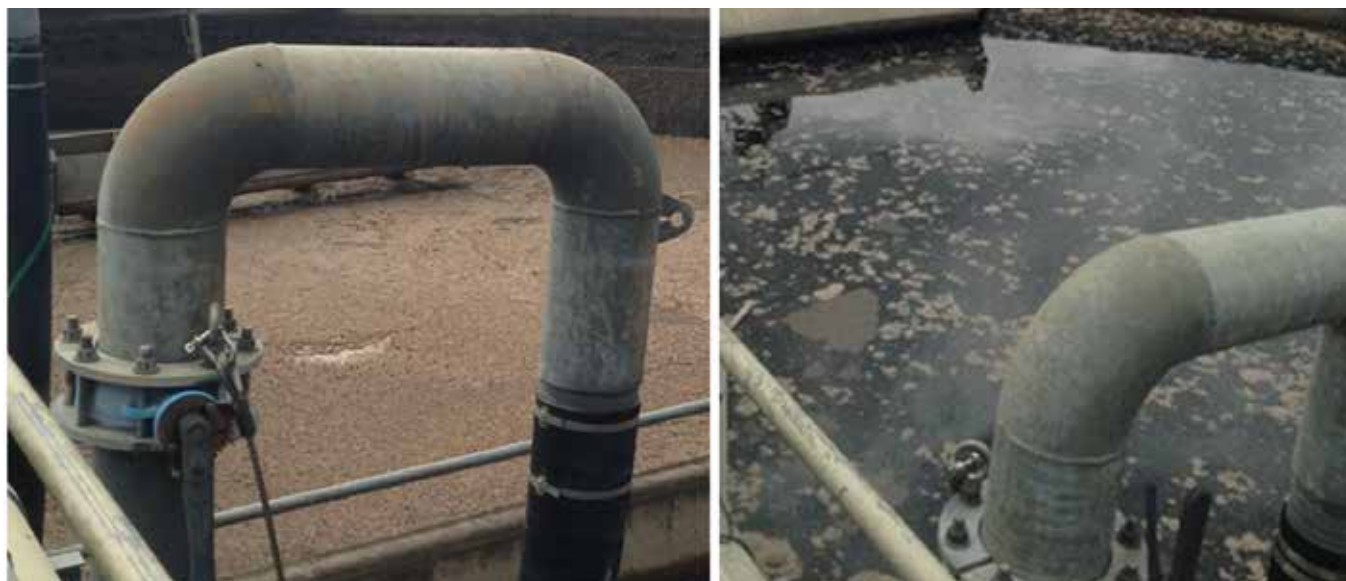
**Figure 1. The surface of one of the reactors prior to the trial (left) and during the trial (right). The reduction in foaming is obvious.**

The surface of one of the bioreactors before and after the start of the first trial is shown in Figure 1. Prior to dosing, there were several centimetres of thick foam covering the surface throughout the year. Once the dosing was started, the foam began to reduce and by the second week a very clear improvement was noted (Figure 1).

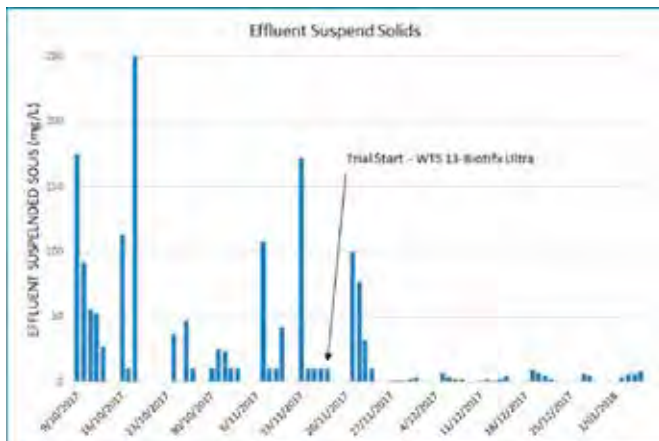
**Figure 2. Effluent suspended solids before and after the start of the trial.**

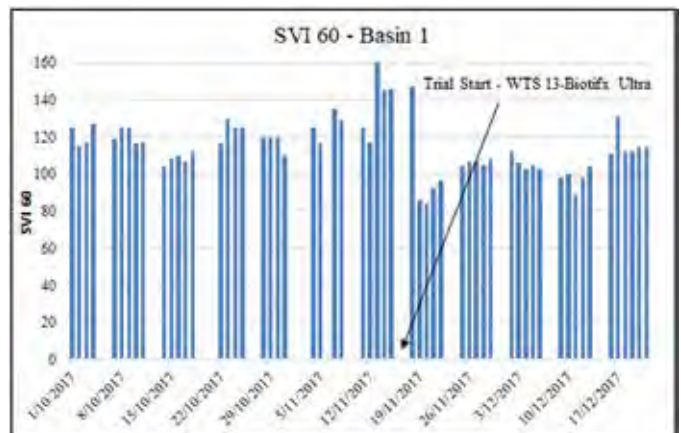
**Figure 3. SVI 60 results before and after commencement of the trial.**

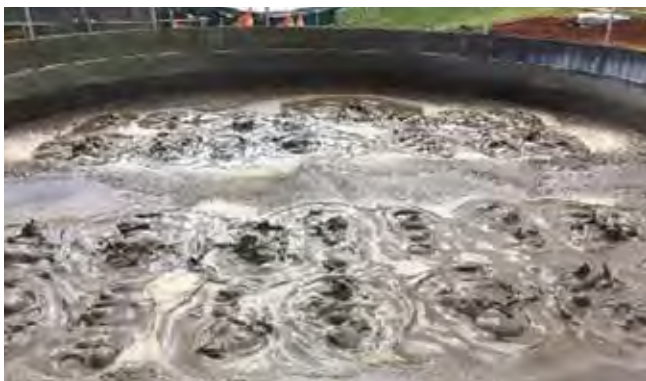
**Figure 4. The Atherton WWTP aerobic digester.**

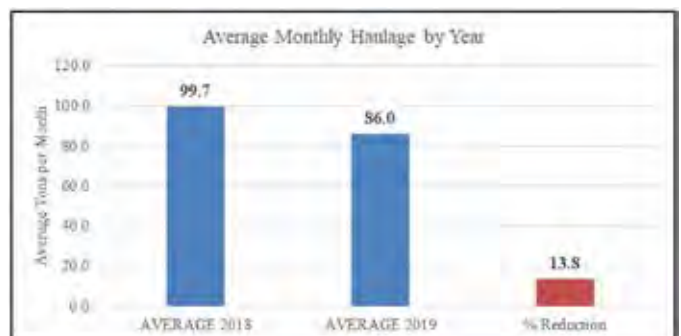
**Figure 5. Average monthly haulage of bio-solids for 2018 (untreated) vs 2019 (treated).**
