# WATERWORKS

TECHNICAL PUBLICATION OF THE WATER INDUSTRY OPERATORS ASSOCIATION OF AUSTRALIA

MAY 2022

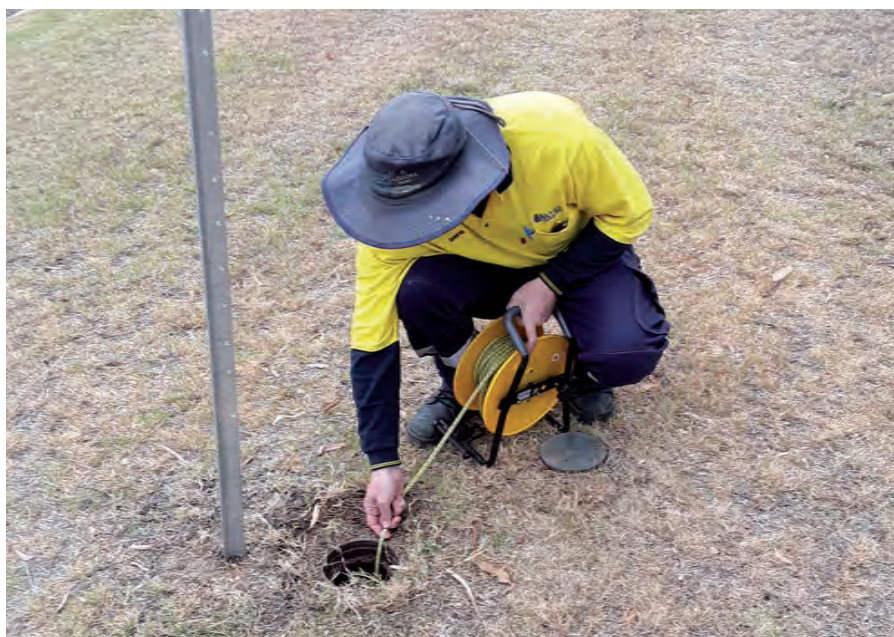
**Figure 1. An operator taking a tape gauge bore water level measurement during an online assessment.**

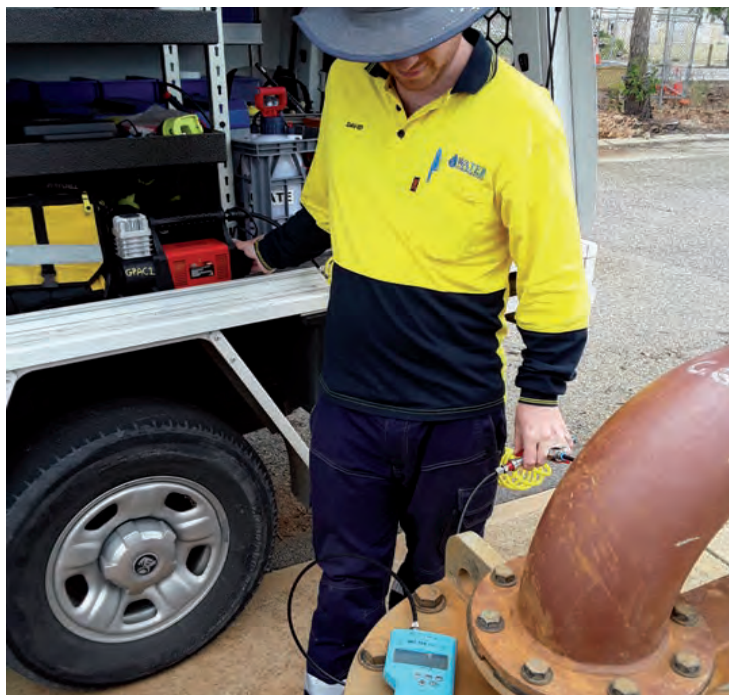
**Figure 2. An operator taking an airline bore water level measurement during an online assessment.**

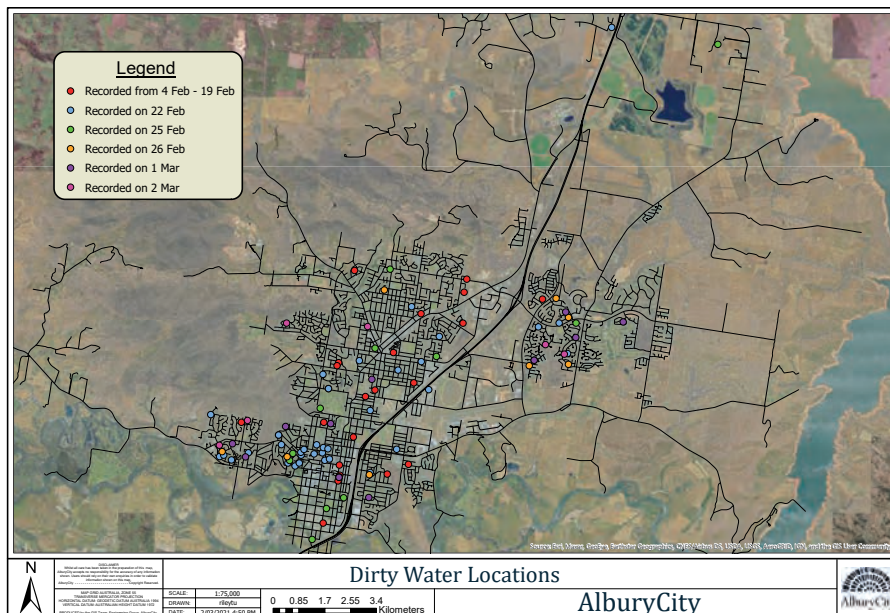
**Figure 1. Location of the customer complaints of discoloured water.**

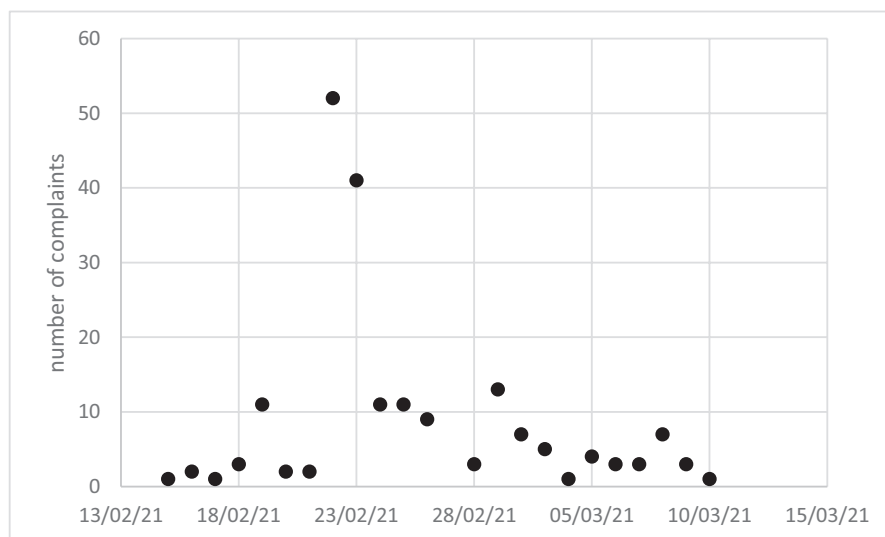
**Figure 2. Graph showing the number of customer complaints of discoloured water received by AlburyCity.**

The number of complaints continued to rise throughout the weekend, peaking at 52 on Monday the 22nd of February (Figure 2).

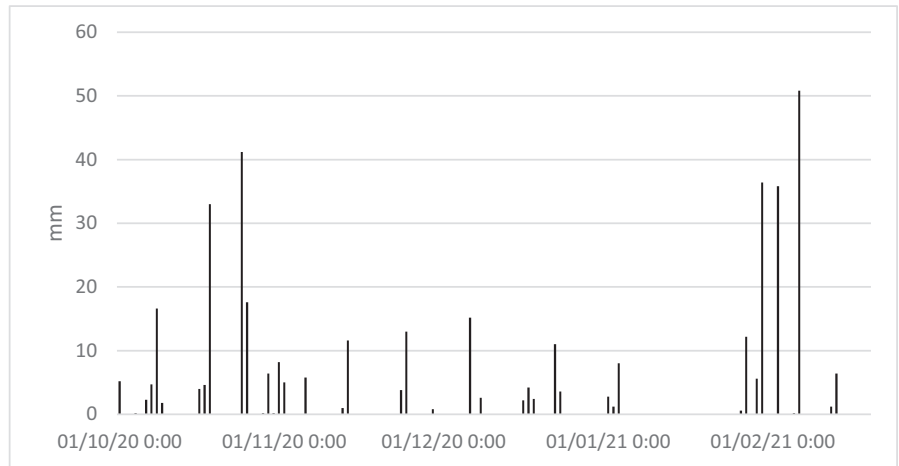
Figure 3. Daily rainfall totals at Jingellic.

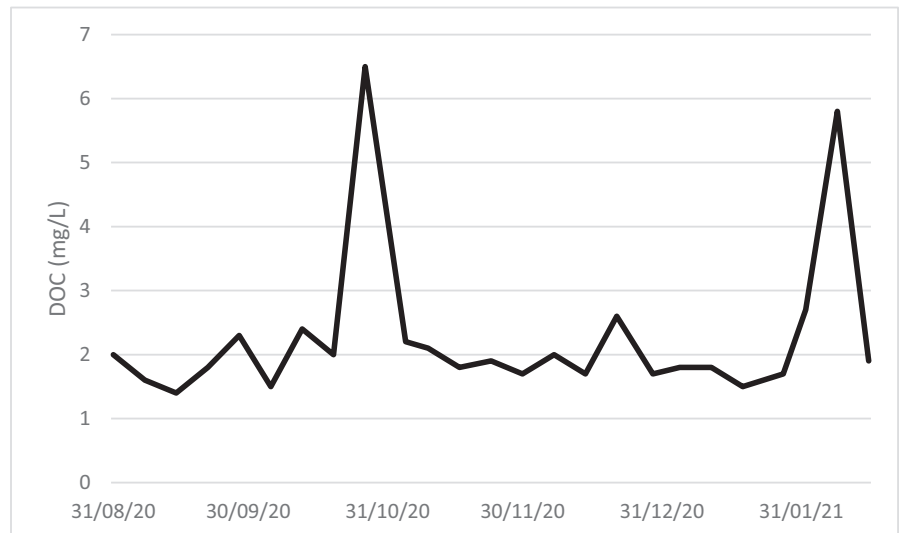
Figure 4. Dissolved organic carbon (DOC) concentrations at Jingellic.

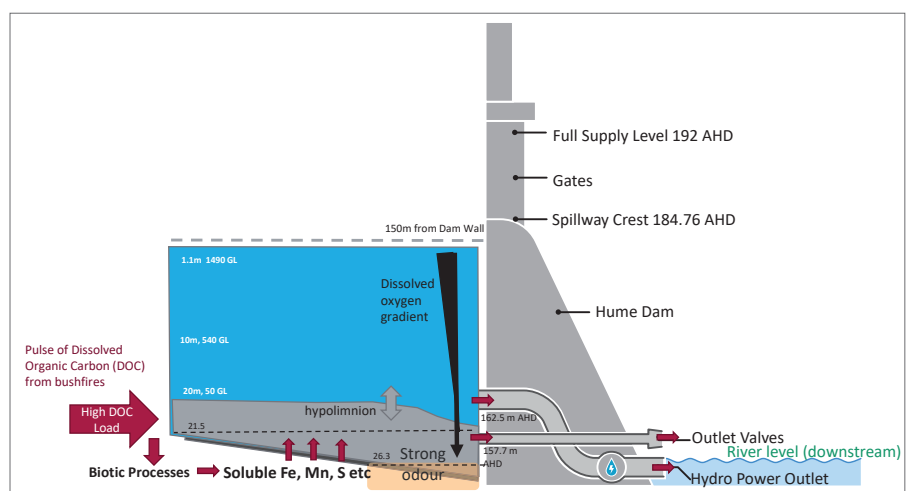
Figure 5. Cross section of Hume Dam showing the possible processes that occurred after fire and rain. (Diagram provided with permission by MDBA)

It is worth noting that the outlet valve sits above the hypolimnion zone with the hydro outlet below. This results in varying quality of the water being discharged, typically dependant on two variables. The ratio of water being discharged between the outlet and hydro plant and the water quality in the hypolimnion zone. During the event described here, water in the hypolimnion had significantly high concentrations of dissolved manganese and iron.

There are three ways in which water can be discharged from Hume Dam. Through the gates at the top, through the outlet valve and through the hydro plant outlet. Typically, unless the dam is spilling, the latter two are used. The mixture between the two varies dependant on what discharge is required for downstream users.

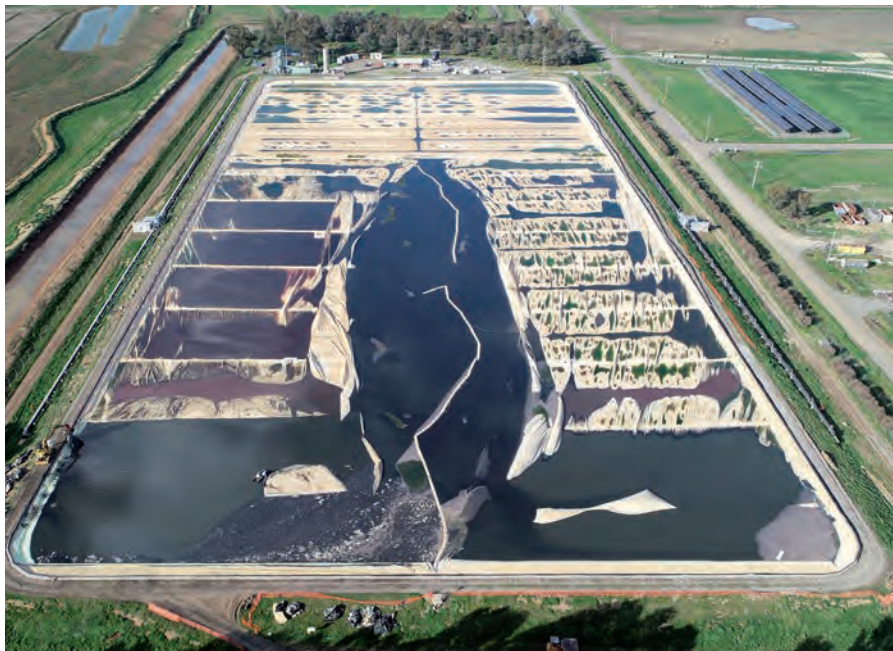
**Figure 2. The old HRAL cover with a very large tear in it.**

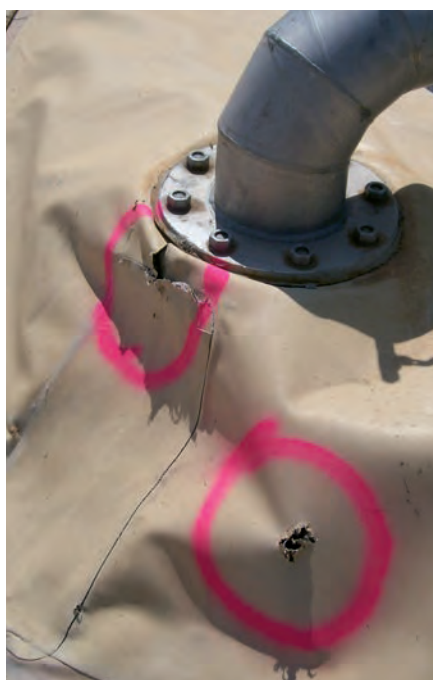
**Figure 1. Damage caused to the old cover by corellas.**

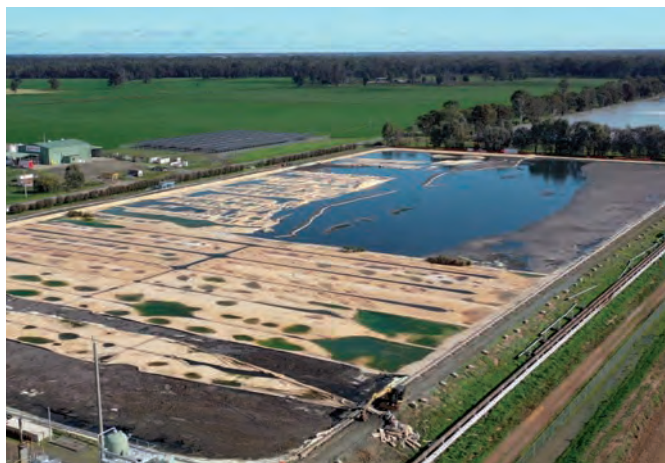
**Figure 3. 25% removal of the old cover.**

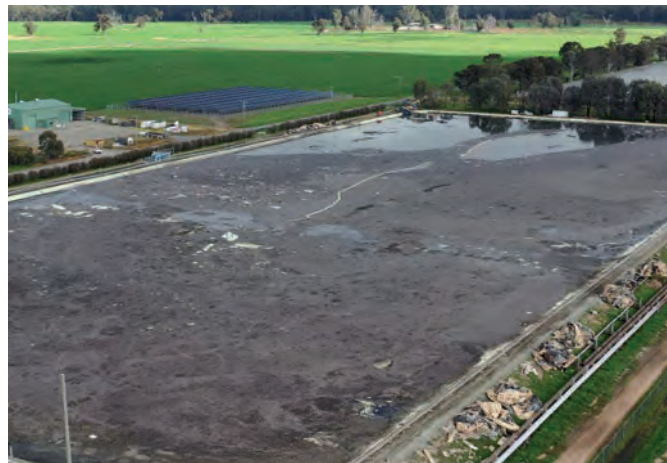
**Figure 4. The old cover fully removed and the lagoon ready for desludging.**

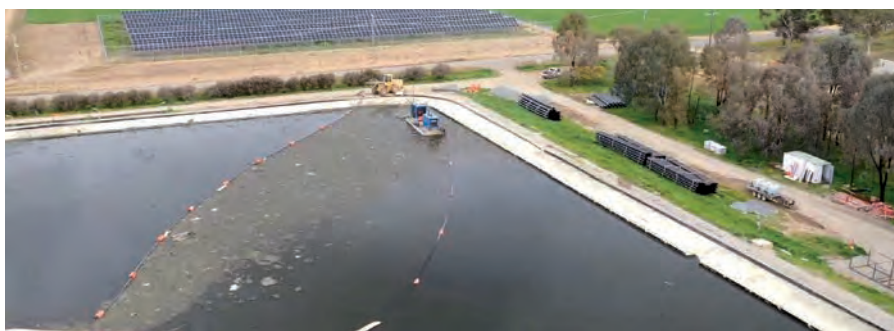
**Figure 5. Lagoon desludging underway.**

During September a new ring beam was installed and a sludge survey undertaken. Some 1,200 tonnes of sludge were removed by a floating dredge in October (Figure 5) and dried in an adjacent paddock (Figure 6). Recirculation draw-off pipework was also checked and repaired or replaced as required.

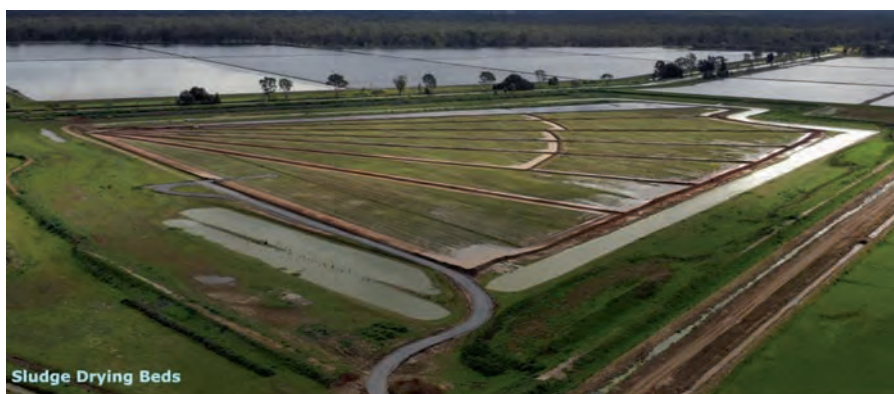
**Figure 6. Sludge drying bays.**

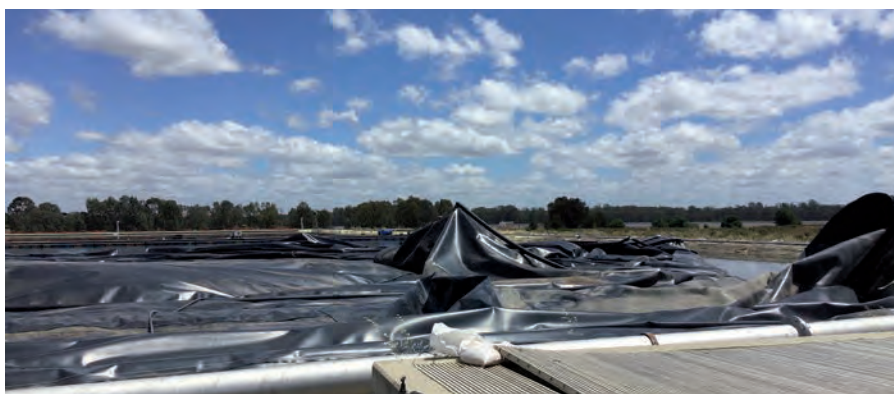
**Figure 7. The new cover was damaged by windstorms during installation.**

Late October 2020 saw a 12m wide works barge constructed and installed on the lagoon. The barge assembly spanned the full width of the lagoon (see Figure 8 below). By the end of October, the new cover installation had commenced and the contractor was now in the full swing of installing the cover. By mid-November, the reaction zone of the lagoon was almost covered when a windstorm, struck blowing the cover off (Figure 7).

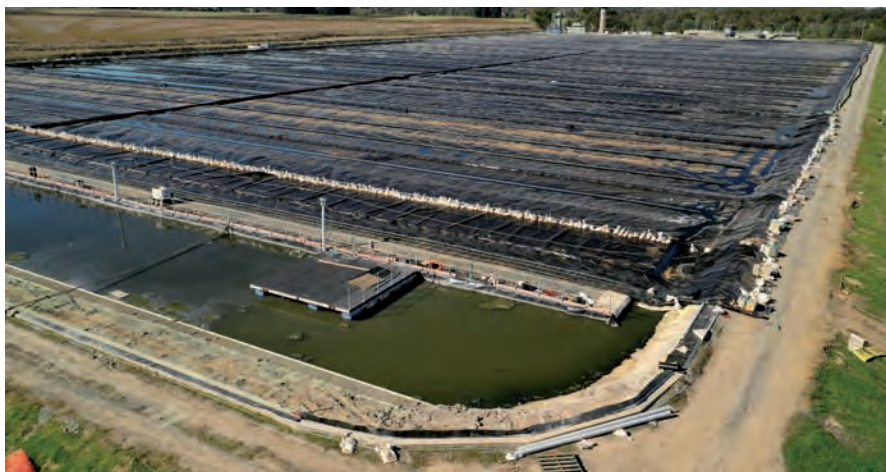
**Figure 8. The new cover almost complete. Note the assembly barge where the new installation work was carried out.**

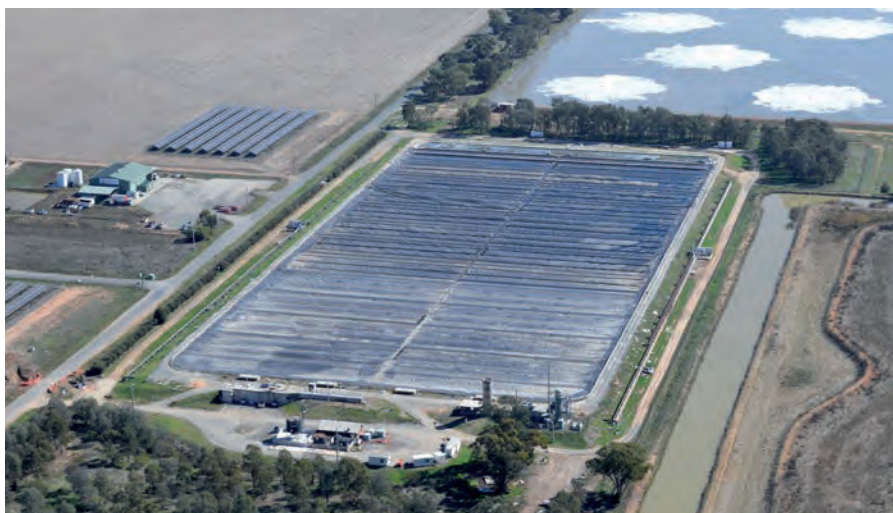
**Figure 9. Cover installation complete.**

Whilst the repairs were completed by mid-December, it would not be until the end of January 2021 that the reaction zone cover would be fully sealed and secured in place. By the end of December 2021, the reaction zone was covered, sealed and the gas flare recommissioned. Works then commenced on covering the settling zone – the remaining 2/3 of the lagoon (Figure 8). By mid-April the works barge was removed from the lagoon as the cover was almost complete and by the end of April the lagoon was fully covered (Figure 9).

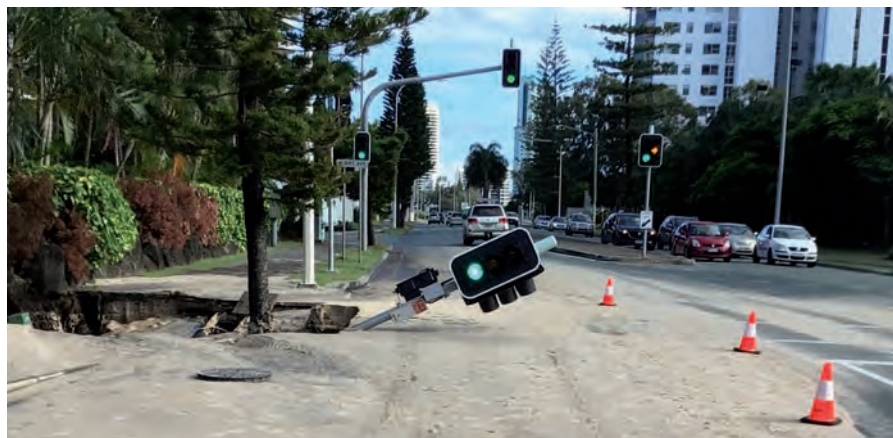
**Figure 1. The traffic light is an early casualty of the subsidence.**

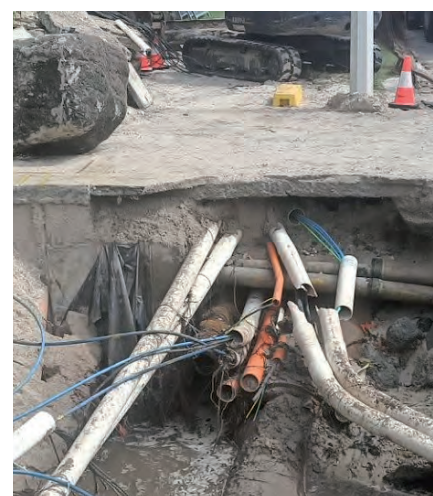
**Figure 2. The extent of the massive subsidence became clear.**

The cause of the subsidence was the roots from a large Norfolk pine tree nearby, combined with lots of rain one week and lots of wind the next week whilst the ground was soft.

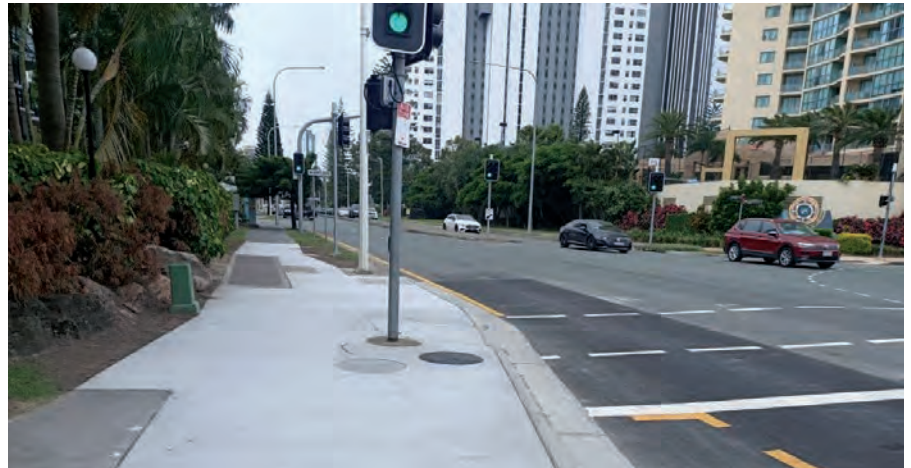
Figure 3. The completed restoration.

The task of rebuilding started over the next few days. The works had to be paused each night to minimise noise and disruptions to residents and visitors staying in the surrounding tourist accommodation. Our maintenance and construction crews repaired the affected water main and laid a

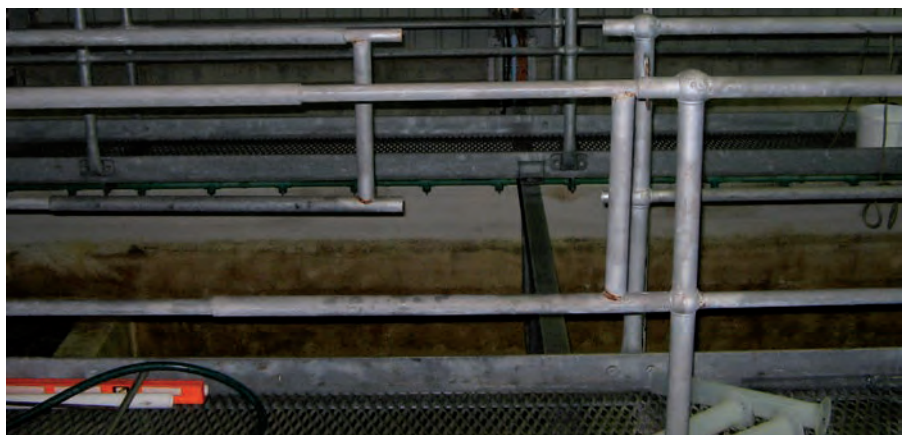
Figure 1. A “trombone slide” entry point.

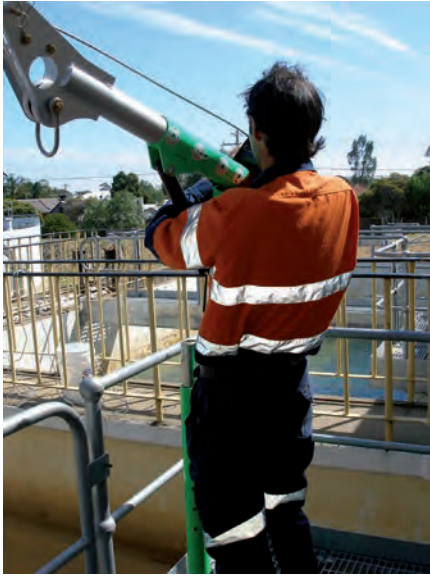
**Figure 2. Positioning the fall arrest gantry. Note the curve in the lower back under load. Not visible in this photo is the fact that the person was on tip toes to make the connection, further destabilising the body.**

- Simply securing the fix point is often very unsafe. At one site recently, an operator had to stand at the top of a long ladder, balancing the shackle and retraction system to allow attachment to a roof purlin. This definitely wasn't safe and presented a very real risk of falling, which in itself, using the same logic as the filter entry, would have required fall arrest!

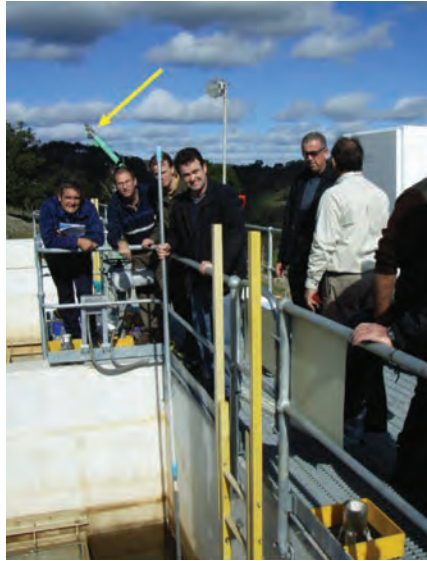
**Figure 3. The failed brand-new winch system in the background (yellow arrow).**

Figure 3 shows one such winch failure where the winch jammed while operators were coming out of the filter. The end result was we just had to climb the vertical ladder and as you can see in the figure, a bad slip or fall would have resulted in a body very possibly hitting the corner of the launder, probably resulting in injury.

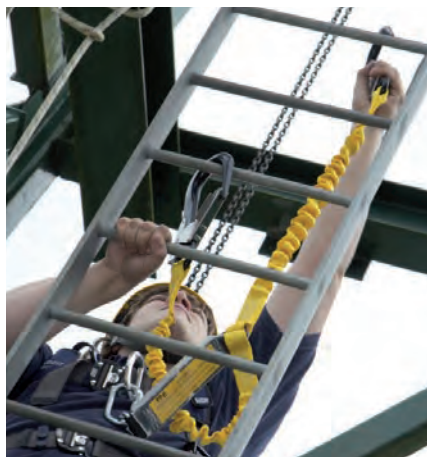
**Figure 4. Entry and exit from a filter using a lanyard and scaffhooks.**

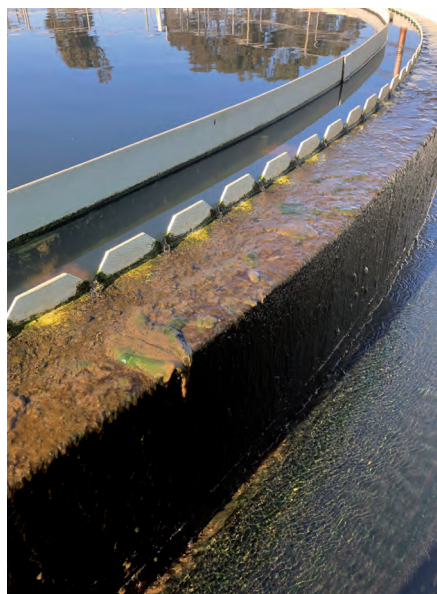
**Figure 2. An example of the fouling of the V notch weirs and overflow wall.**

One of the main operational challenges at the plant is the routine cleaning of solids built up on the 'V' notch weirs (Figure 2) and in the outlet channel. Depending on the amount of build-up, the cleaning required could range from a hose down with potable water, to entering the outlet channel and manually scrubbing it out.

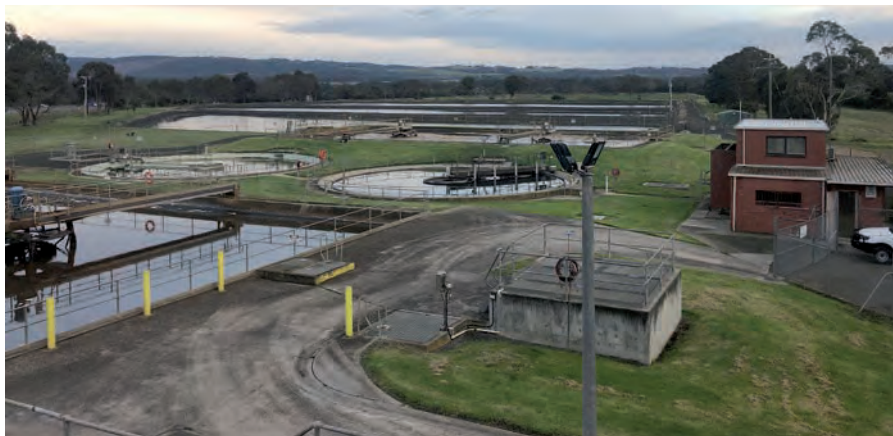
**Figure 1. The Morwell WWTP showing the two clarifiers.**

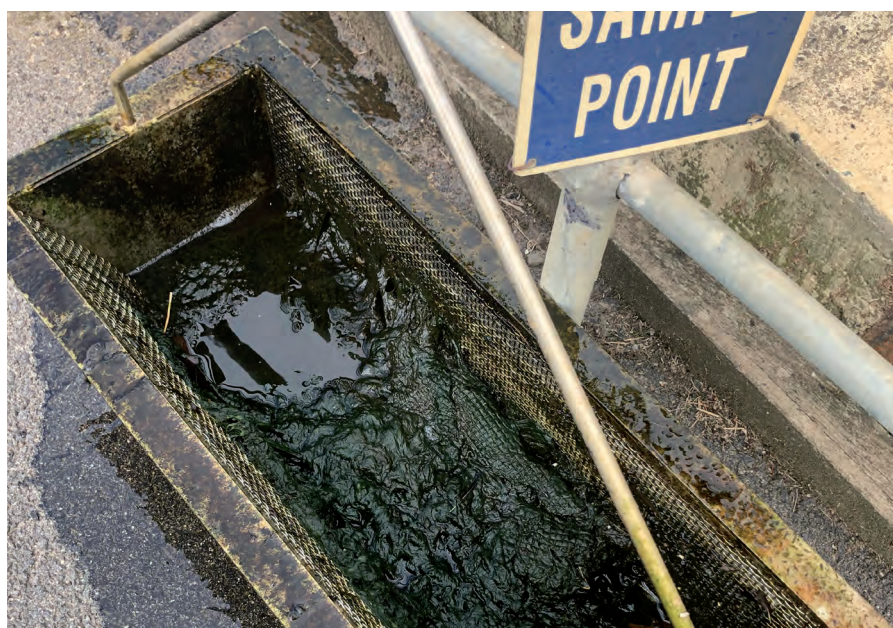
**Figure 3. The blocked clarifier outlet filter basket.**

The solids build-up on the weirs and outlet channel, as well as looking unpleasant, would eventually slough off in large clumps and block the clarifier outlet filter basket (Figure 3). These large clumps could also be carried through to the UV disinfection system and reduce the effectiveness of the disinfection process.

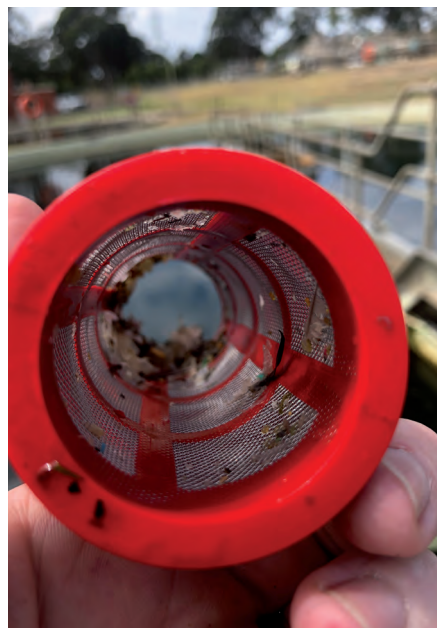
**Figure 4. The inline filter during weekly inspection.**

The pump is mounted under the walkway of the clarifier scraper bridge. This allows for all the pipework and cables to be run out of the way whilst still allowing access to the spray system while the scraper bridge is still running. The hose from the pump to the spray manifold has a camlock fitting and all sections of the manifold are screw fit allowing for easy removal for cleaning or maintenance. An inline filter (Figure 4)

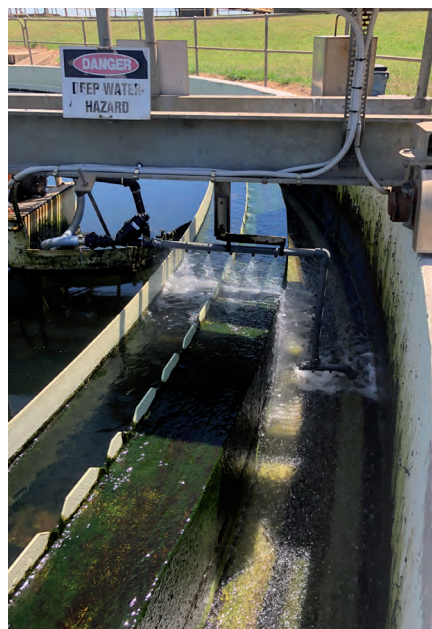
**Figure 5. The spray system in operation. Note the clean clarifier outlet channel.**

With the spray system up and running (Figure 5), cleaning by the operator is almost no longer required. Routine visual inspections are carried out daily, and the filter is checked and cleaned twice a week.

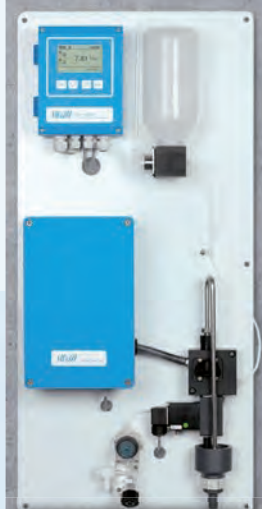
AMI SAC254

- Measurement of UV absorption at 254nm for monitoring of organic contamination.
- Ideal for UVT measurement.
- Insensitive to fouling.

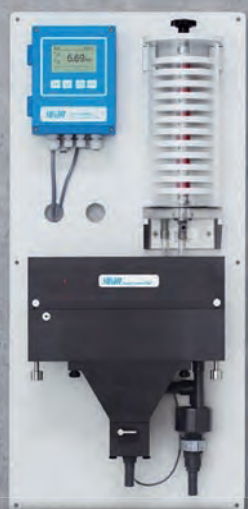
AMI Turbiwell

- Contact-free turbidity measurement.
- No consumables and no follow-up costs.
- Automatic measurement chamber flushing.
- Fast and easy verification.

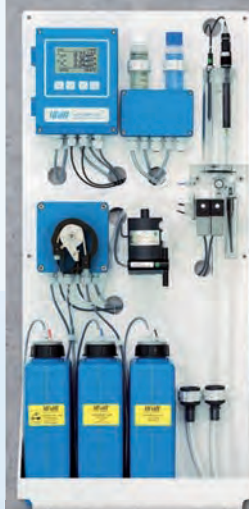
AMI Codes-II CC

- Differentiated photometric determination of chlorine.
- Continuous analysis.
- Freely adjustable measuring intervals.
- Fast and easy verification.

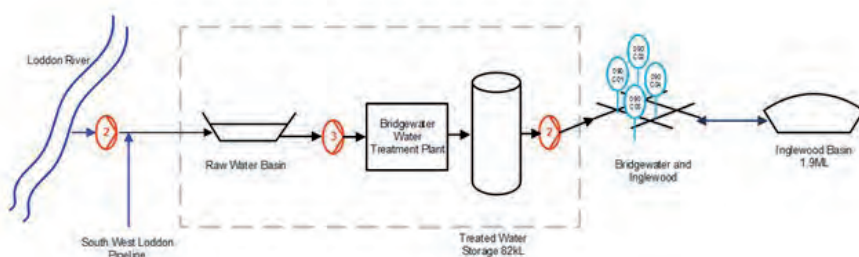
**Figure 1. Schematic of Bridgewater and Inglewood Water Distribution System.**

1. Inability to achieve breakpoint chlorination.
2. Difficulty in controlling the dose. The dosing system consisted of chlorine tablets placed in canisters where the treated water was pumped from the TWS, located at the plant, to the Basin.
3. Decay of chlorine in the basin as chlorine was dosed only when the Basin was filling.

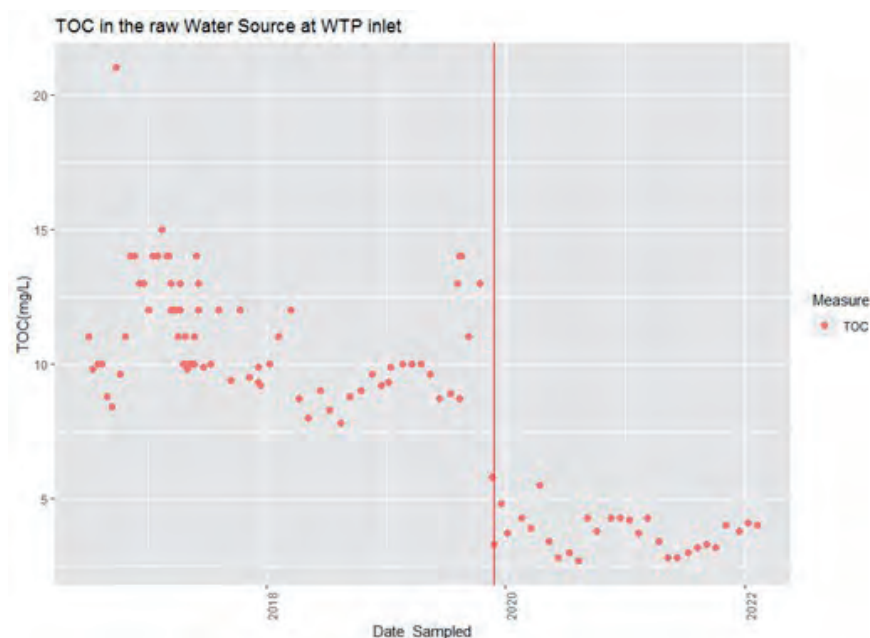
**Figure 2. TOC in the raw water entering the Bridgewater WTP before and after the change of source water.**

The higher concentration of TOC in the Loddon River reflects the higher concentration of Natural Organic Matter (NOM) in the water. The presence of a higher concentration of NOM also increases chlorine decay. As a consequence of changing the source, the TOC in the raw water entering the Bridgewater WTP reduced 2 to 3-fold (Figure 2).

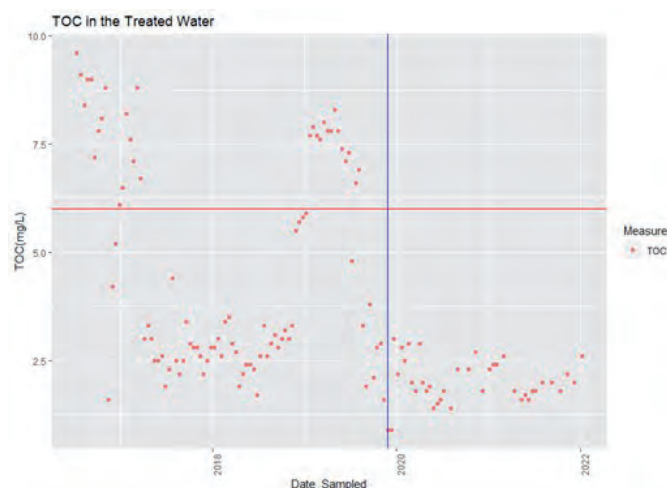
**Figure 3. TOC in the treated water from the Bridgewater WTP before and after the change in source water. (The red line is TOC concentration of 6 mg/L and the blue line the changeover date.)**

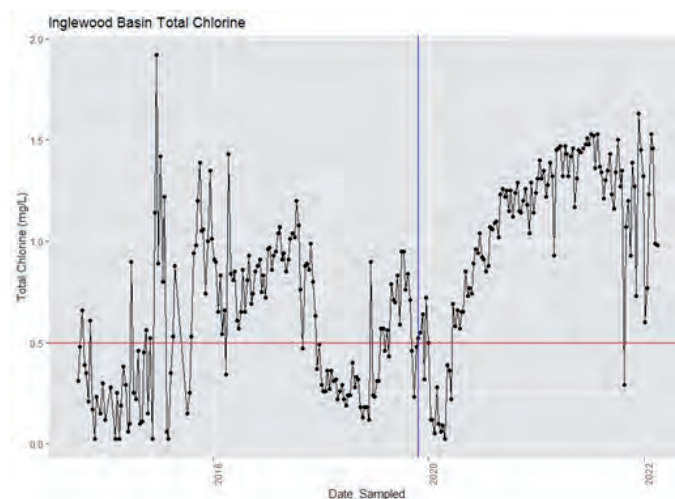
**Figure 4. Total chlorine in the Inglewood Basin. (The red line is a chlorine residual of 0.5 mg/L and the blue line is the changeover date.)**

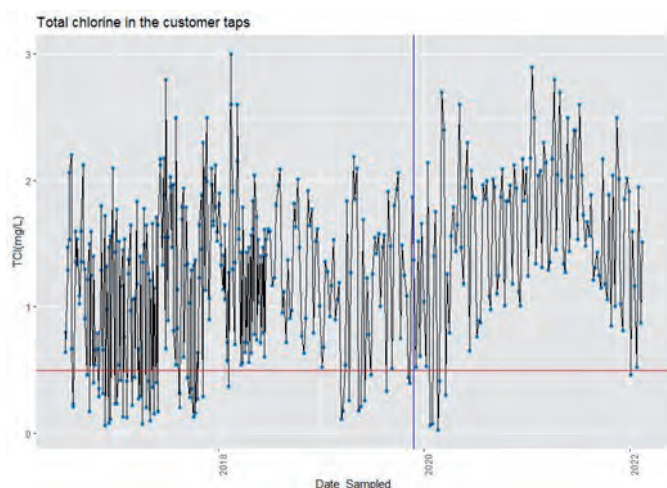
**Figure 5: Total chlorine at customer tap sites. (The red line is a chlorine residual of 0.5 mg/L and the blue line is the changeover date)**

Figure 5 shows the total chlorine measured at Bridgewater and Inglewood customer taps. The samples were taken and tested weekly in either Bridgewater or Inglewood. The total chlorine results have been consistently above 0.5 mg/L since April 2020. Note that the fluctuation between high and low total chlorine results was mainly due to samples being either taken when the treated water was pumping from the TWS at the plant into the distribution system, or when it was being back-fed from the Inglewood Basin.

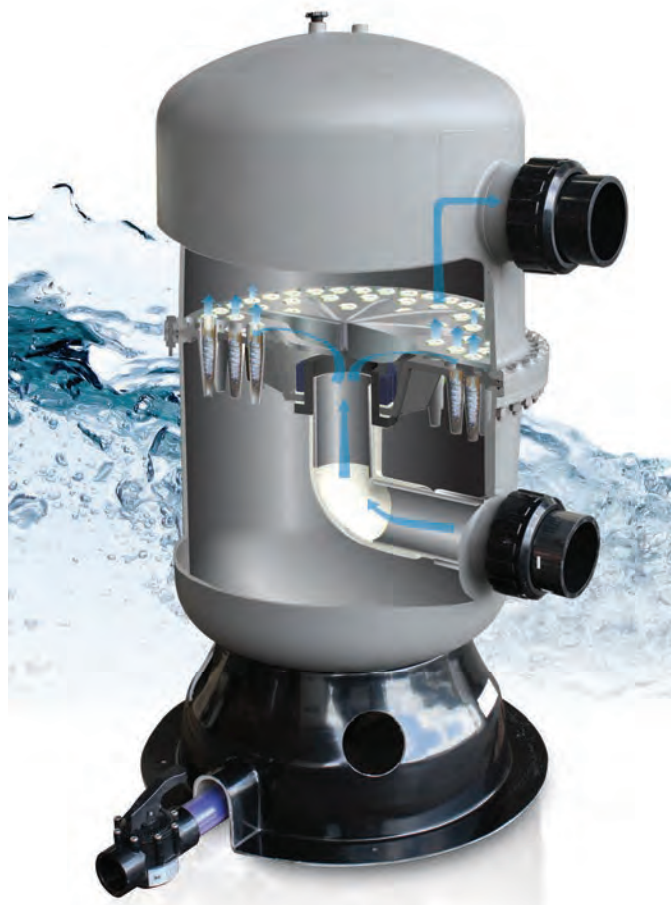
## MULTI CYCLONE 70XL

MultiCyclone 70XL works on the basis of centrifugal water filtration and is designed with no moving parts and no filter media to clean or replace.

- ① Minimises filter maintenance and saves water
- ① No filter media to clean or replace
- ① Maximum flow rate of 90m<sup>3</sup> / hr
- ① Compact size and ease of installation
