THE FUTURE IS TRENCHLESS – REHABILITATION OF PRESSURE INFRASTRUCTURE WITH UV-CURED FIBERGLASS REINFORCED PIPE LINER

Katharina Helming, Business Development Manager, SAERTEX multiCom GmbH

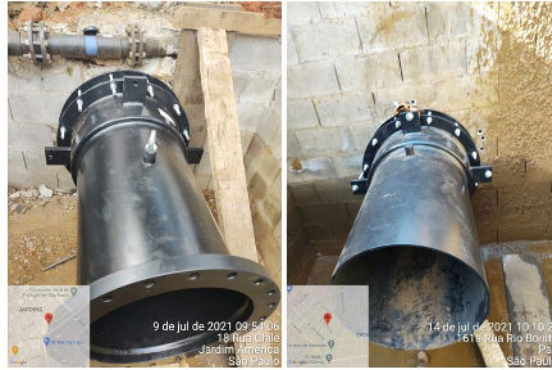
Generally, everything starts with creating the excavation pits for the rehabilitation. As the team had already created the temporary pits for cleaning and CCTV inspections, these could also be used for the installation of the liner. In general, it is necessary to cut out a piece of the host pipe to gain access to the network. Additionally, a new piece of pipe must be mounted on the host pipe as a preparation of the ends of the liner. Various methods can be employed to achieve this such as welding on a new piece of pipe, connect it with a coupling or utilising a product called CIP JOINT from the company NovaSiria®. This step is necessary to ensure a proper end connection of the liner with the existing network to ensure a leak tight system after installation. For this project a CIP JOINT of NovaSiria® was the preferred solution for the end connection which is shown in Picture 2. This is a combination of a coupling and a new piece of pipe either with or without flange, which will be slipped over the host pipe and secured with the coupling.

Picture 5. CIP JOINTS

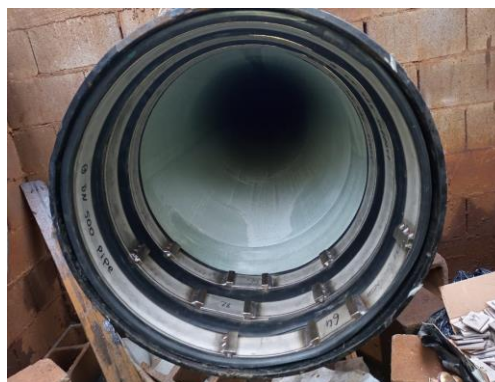
After the installation of the liner, it is necessary to install liner end seals for full connection to the network and to prevent groundwater from penetrating the cut edges of the composite material. These liner end seals consist of an EPDM rubber band including steel bands. The cured liner is cut back approximately 10 cm from the end of the pipe to fit the rubber on the cutting edge of the liner. Following this step, the steel bands are installed on the rubber to fixate the system. The installed seal is shown in Picture 3. Given the scale of the project with its large section, the installations often extended into the early morning hours with the final step being the installation of the end seal.

Picture 3. Installed Liner End Seal
