RELINING A SECTION OF THE MT COLE PIPELINE – INNOVATIVE SOLUTION TO A CHALLENGING PROJECT

Chris Baker, *Senior Project Engineer*, GWMWater

ABSTRACT

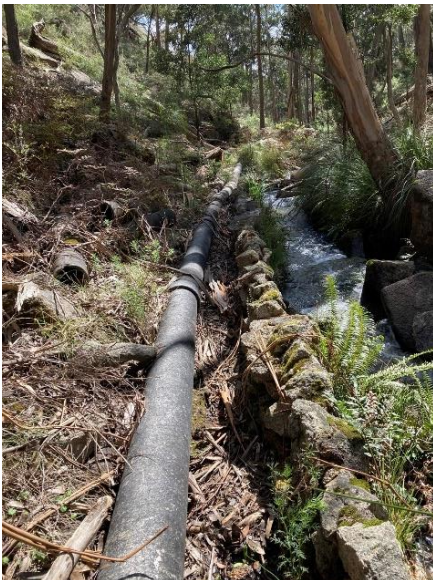
Figure 1: *Mt Cole Pipeline - DN250 AC (Asbestos Cement) Section*

CH 0m – 400m DN250 AC (Asbestos Cement) Pipeline (circa 1973)

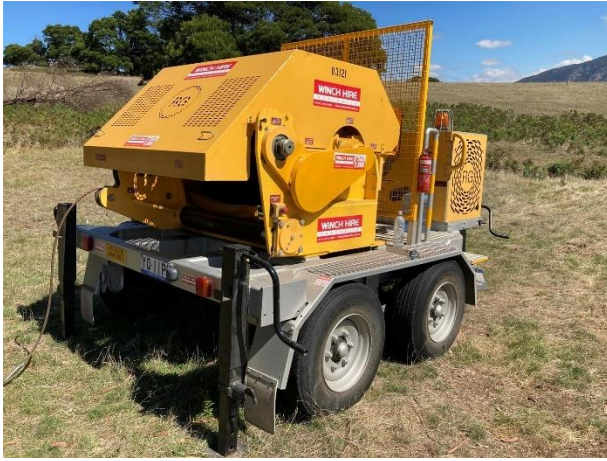
Figure 2: *Cable Winching Trailer located at Downstream End (9t Rating)*

The first step in the construction methodology for the Primus Liner installation was the installation of a pull cable for the entire length. A 10mm Stainless Steel Cable was utilised, with a parachute arrangement connected to it to enable the pull through of the cable utilising the water flow to successfully pull it through the pipeline.

The first main challenge found was that when winching upstream (uphill) with a pipeline foam swab (pig), that the cable kept snapping. The solution was to source and attach a second 2 km 10mm diameter stainless steel cable onto the first cable and only clean (pig) in the downstream (downhill) direction. The cable was coiled at the bottom onto a drum, disconnected and transported to the top and reconnected to the start of the other cable. This methodology worked, however resulted in taking a longer time to clean the pipeline that originally allowed for.

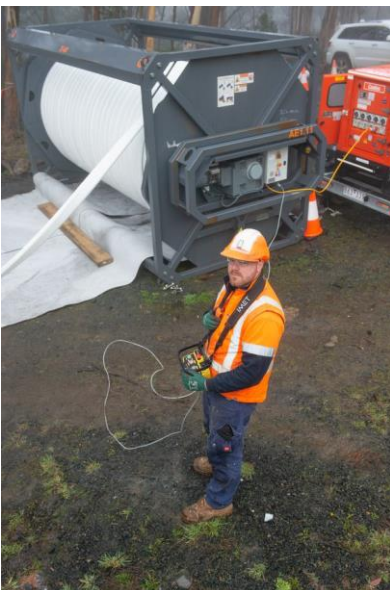
Figure 3: *Unwinding DN200 Primus Liner from Transport Drum at Upstream End (Length: 1.4km)*

Due to the high risk activity of pulling the Primus Liner through, a new 16mm diameter stainless steel 'pull' cable was retrofitted to the system. The pulling though of the 1.4km liner taken one (1) working day to complete. Lubricant was sprayed onto the outside of the Primus Liner to aid installation.

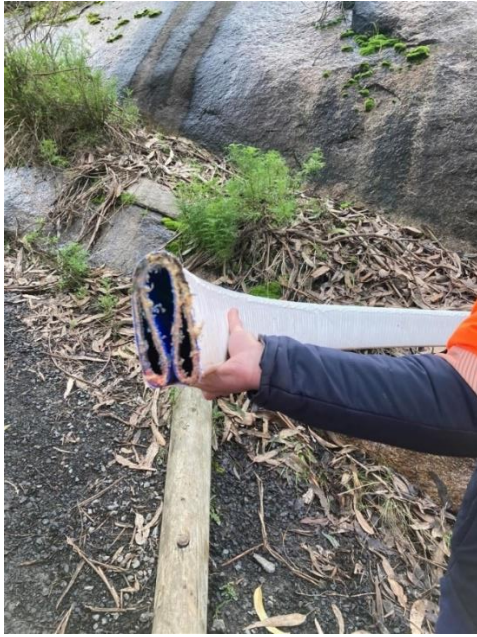
Figure 4: *Primus Line in a compressed 'C' shape for installation*

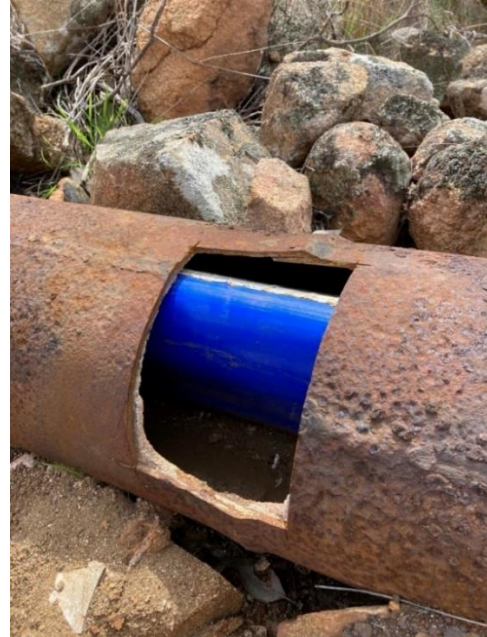
Figure 5: *DN200 Primus Line installed inside host pipe (DN250 MSCL) ready for pressure testing*

Compressed Air was initially utilised for Pressure Testing for the continuous liner (~1.4km) before the valve stations were cut in to prove the success of the liner install.

After successful liner Pressure Testing with air, the valve station sites were installed and the system was then pressure tested utilising water.

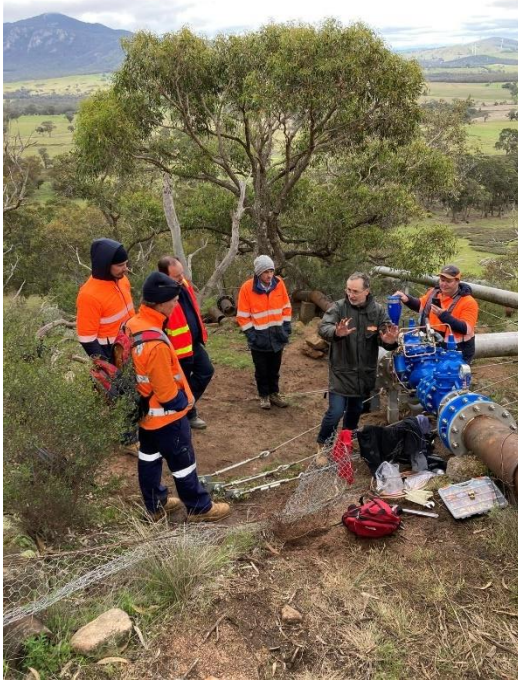
Figure 6: *Combined Pipeline Commissioning and Operator Training. Photo of Pressure Sustaining Valve site - located at the downstream end of the relined section. (CH 1,400m)*

The commissioning process involved flowing water through the pipeline from 0 L/sec up to the maximum design flowrate of 37 L/sec, with the Pressure Sustaining Valve (at the end of the relined section) being utilised to create a suitable back pressure to ensure that the hydraulic grade line is higher than the entire relined pipeline length to create a fully inflated (round) liner at all times.
