HIGH PRESSURE WATER JETTER INCIDENT CAUSING SERIOUS INJURY

Fred Sadler, *Branch Manager Maintenance, Wannon Water*
Mick Mahoney, *Manager Civil Maintenance, Wannon Water*

ABSTRACT

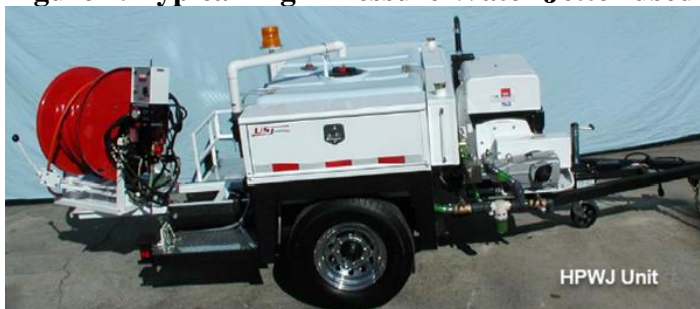
Figure 1. Typical High Pressure Water Jetter used for drain cleaning

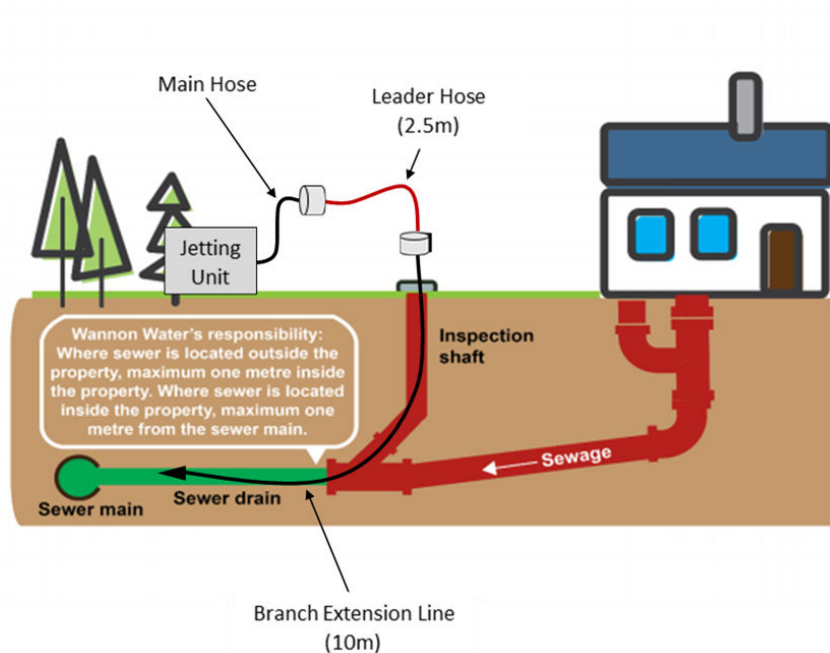
During the drain cleaning process, the hose connection from the Leader hose to the Branch extension line separated allowing the unrestrained end of the Leader hose to suddenly strike

the operator in the head.

Figure 2. House connection branch drain cleaning arrangement.

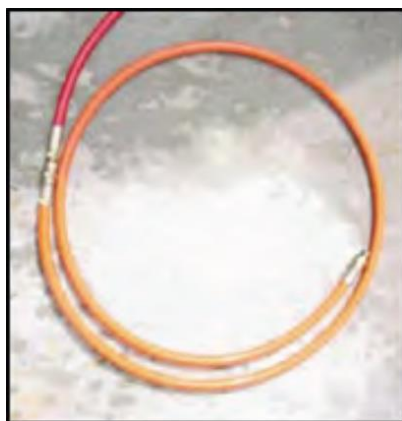
Figure 3. Leader Hose connected to the Main Hose

- Leader hoses are typically 3m in length of the same or greater pressure class as the main hose.
- Leader hoses act as a safety indicator by providing a different colour to contrast with the Main hose, to warn the operator that the jetter nozzle is approaching the pipe opening.
- Leader hoses also provide a sacrificial length of hose that is more susceptible to wear in close proximity to the cutting jet, to protect the life of the main hose.

The use of Leader hoses was suspended for all other drain cleaning HPWJ units pending review of the safe systems of work to eliminate the risk of hose connection separation.

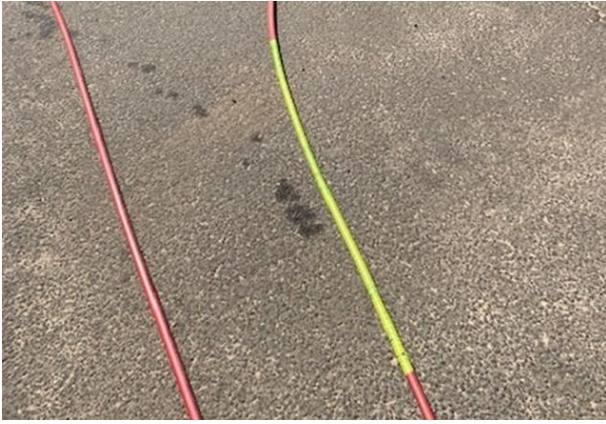
Figure 4. Application of contrasting tape to main hose

(in lieu of leader hose)

An effective safety indicator was created using PVC electrical earthing tape, which is easily installed & maintained, while providing good contrast.

In lieu of the use of Leader hoses, a visible contrasting tape marking system of 1 metre in length was applied at approximately 3 to 5 metres from the end of main hose as an alternative safety indicator.

Add a contrasting marking system to the main hose to provide a safety indicator in lieu of the use of leader hoses. Remove the use of branch extension lines and substitute with hose reels to eliminate connections directly the main hose without a hose restraint system.

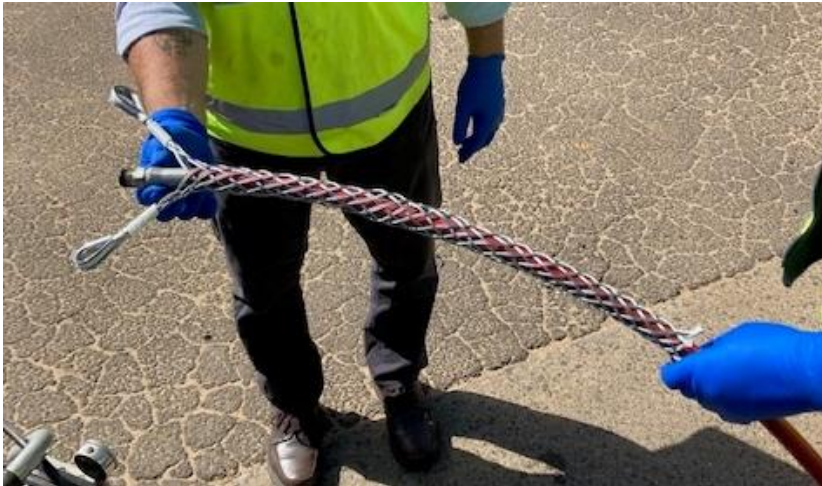
Figure 5. Typical braided hose restraint fitted to a HPWJ main hose

The Australian standard AS4233.1:2013 High pressure water jetting systems, provides guidance on the application of hose restraints, such as braided stockings or other suitable means to restrict hose movement, hose separation, or end failure. The standard also clarifies that Whip checks shall not be used as hose restraints for HPWJ systems.

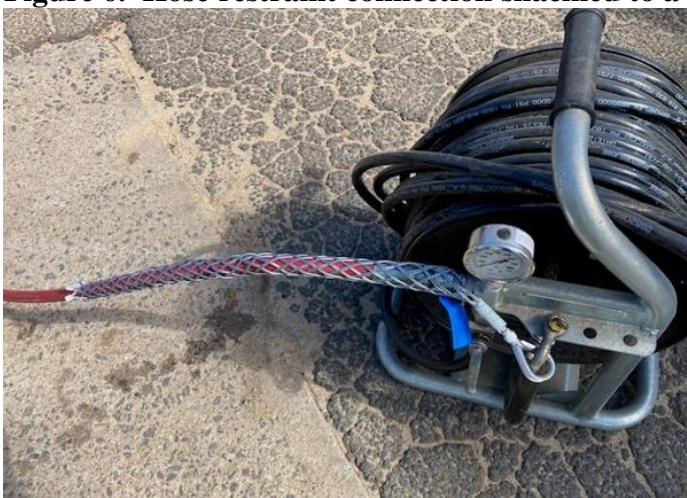
Figure 6. Hose restraint connection shackled to a HCB hose reel

- Hose reel with HPWJ rated hose to suit House Connection Branch (HCB) cleaning.
- The hose is of smaller diameter and more flexible to suit HCB cleaning.

Restrain any hose connections that could separate and cause injury, such as at the House Connection Branch hose reels, with the use of braided hose restraints connecting the main hose to the reel.

Braided hose restraint systems are required to secure the main hose to the house connection branch hose reel and other connections where applicable.
