# SUPPLYING RELIABLE SAFE WATER IN A FLOOD

**Elise O’Keefe**, *District Manager – Central Operations and Maintenance*, Goulburn Valley Water

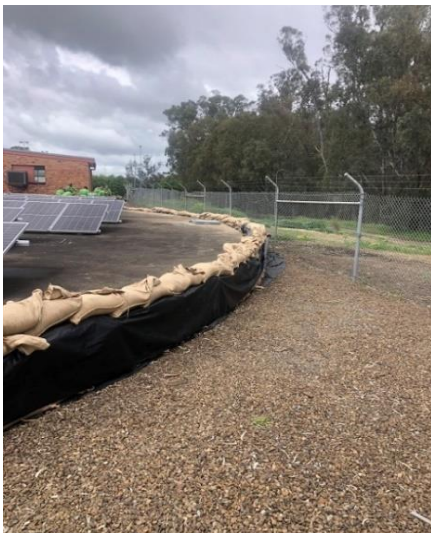
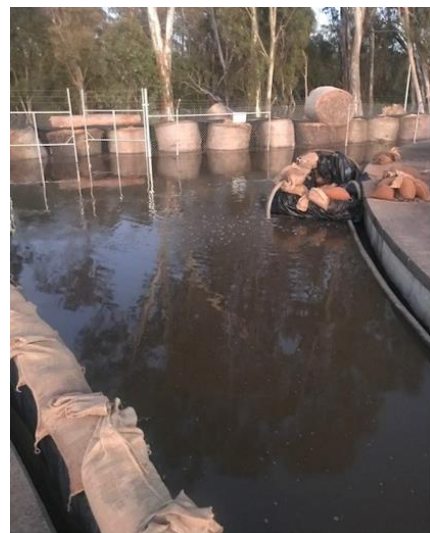
Figure 1. The treated water storages before (left), and during the flood peak (right). The photos above were shared on GVW social media so that the community would have confidence in the town water supply. Misinformation was a common occurrence but the communications team quickly corrected rumours on social media that the town water supply was about to be cut off.

Protection of the Shepparton WTP and underground treated water storages was high priority. The storages have a small above ground clearance and there was uncertainty around whether the flood peak would be above the level of these storage but it was known that it would come very close. Due to the level of risk, should the treated water storages be compromised, the direction was given from the IMT to sandbag these storages early. The photos below show the before and after condition of the storages, no technical language required here – it came really, really, close!
