Best Practise Drinking Water Sampling for Microbial Testing

Ehsan Farno, *Water Quality Engineer*, South East Water

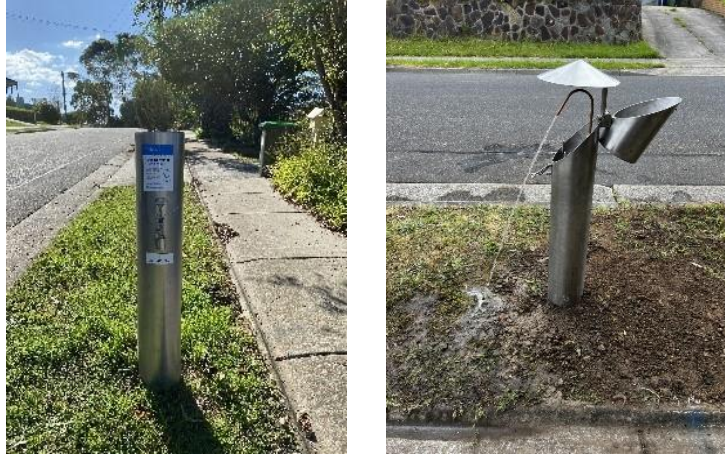
The design of the new tap encompasses several essential features aimed at fortifying its functionality and reliability. Notably, it boasts a 1-meter-tall lockable stainless-steel bollard cover, serving as protection against potential animal interference, overgrown

grasses, or shrubs. This protective cover also acts as a deterrent against unauthorized usage, enhancing security measures.

Additionally, the tap design incorporates a rain cover or rain hat, safeguarding the sampling process from rain droplets during inclement weather conditions, thereby ensuring the integrity of the collected samples. Moreover, the inclusion of a fixed gooseneck simplifies and enhances the sampling procedure, facilitating easier and more reliable flaming by samplers before collecting samples (refer to Figures 1). Crucially, this tap installation strategy focuses on situating the tap on a service pipe within the nature strip outside the customer's property, effectively circumventing potential access issues.

Figure 1: *New bollard sample taps.*

Upon rigorous testing, particularly on a rainy day, the results yielded no evidence of *E. coli* contamination in the sampled water (refer to Table 1). Furthermore, an assessment of the water retained in the tap over a period showed no alterations in the metal content of the sample, confirming the absence of water contamination attributable to the tap design (see Table 2). Notably, a total of 10 taps of this nature have been strategically installed and utilized within our network, consistently yielding negative microbial results and garnering no customer complaints.
