# a PASS

Problem Accepted - Solution Supplied

# Contents

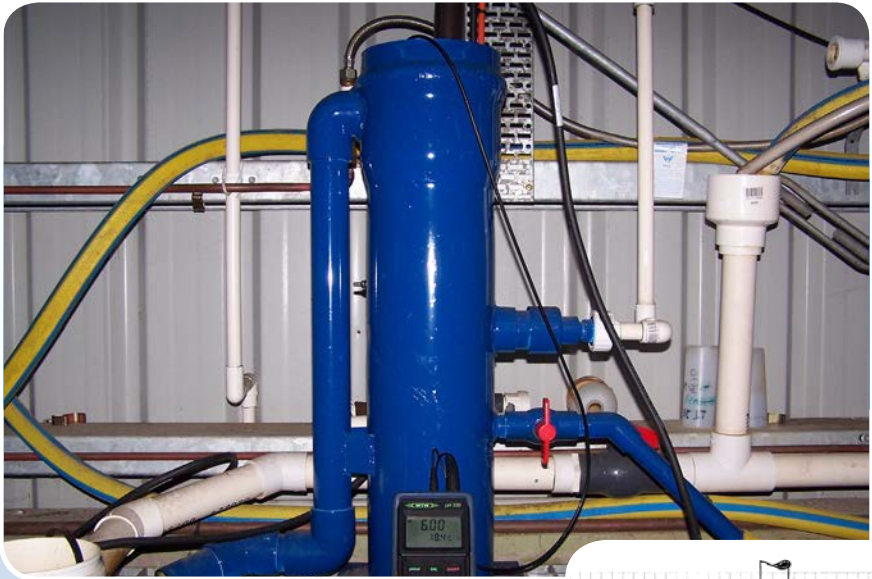
The solution was to be able to keep up a high volume flow with a low velocity around the pH probe.

I checked the pH using the portable pH meter which indicated a pH of 5.3 compared to the online unit at 6.00 +/- 0.2. I decided to check it again using my old comparator using Bromo Cresol Purple reagent tablets. The tablets are getting old but still indicated a pH in the region of 5.3. Maintenance personal were brought in to recalibrate the online meter, after which the same tests were carried out with the same result. Another maintenance Technician was consulted and following another full calibration and checking his thoughts were that the flow rate through the online fitting was too fast. Therein lay the problem as a high volume of water through the meter was required to keep the loop delay times for dosing to a minimum. To prove this I removed the probe from the online fitting and put it into a small bucket that the drainage flow from the supply to the unit ran into. In a very short time the online meter was reading near enough the same as the portable meter. I put the maintenance Techs, that we need a vessel to be able to get a high volume low velocity flow.

The two maintenance technicians who carried out the cleans and calibrations of the meter and probe and also verified the results that I was obtaining. Maintenance fitter Duane Kelly and I set about designing and building the vessel which is currently in place and keeping the coag pH on track due to reliable accurate readings.

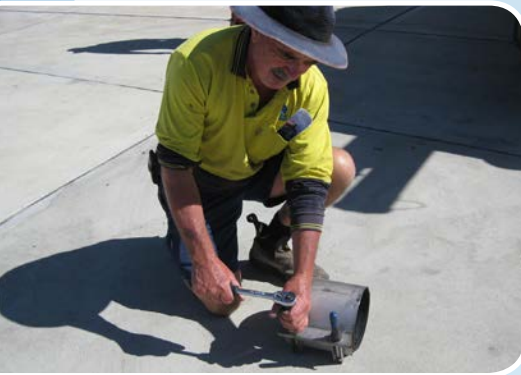
Traditional method of tightening nuts.

Whilst doing up the stainless steel band on repair jobs, we are often bending over, down in the mud, and ditches. There was a safety issue with being in this position and the work was dirty, and your hand movements were often restricted, and hands would slip whilst trying to fully tighten the nuts.

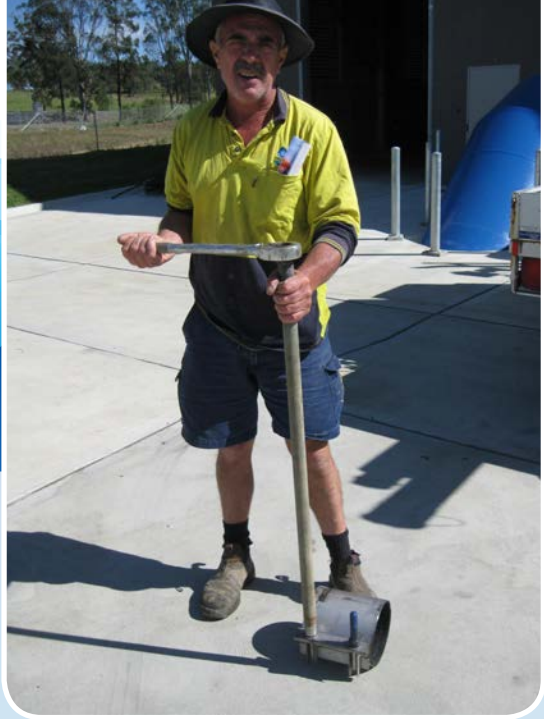
SS Band Fastener

I welded a socket of the correct size (matching the SS band nuts) onto the end of a gal pipe. To the other end was welded a 25mm male attachment which fits into the female end of a 18 inch ratchet spanner.

We did try and use stillsons instead of a ratchet, but with the force needed to tighten the bolts, we ended up bugging the end!! So a ratchet spanner was bought, and has worked perfectly since.

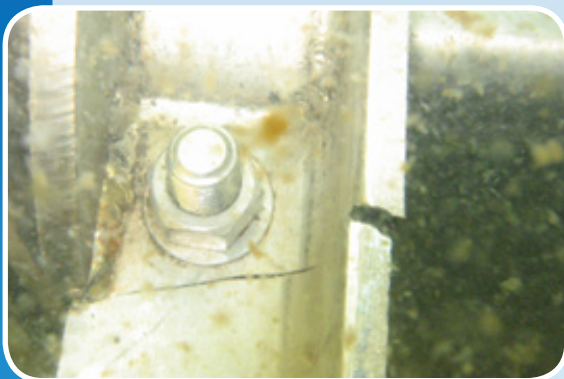
Stress crack on paddle support hub

The Water treatment plant Floc paddle arms were cracking and breaking at welds close to the main hub area, due to the flexing of the paddles. With the arms being made from Stainless Steel, stress cracking is a common problem and not something that can be fixed by adding more welds to the already defective sections.

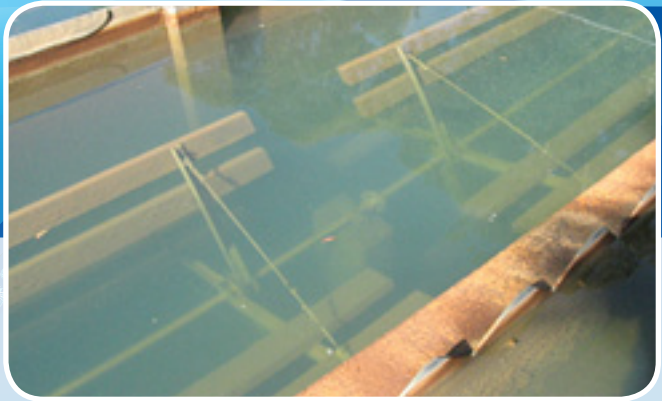
Floc paddles

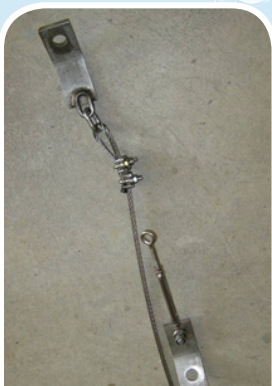
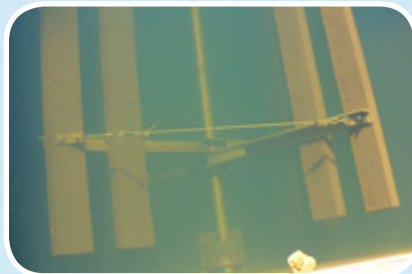
Stainless steel fixtures

Strengthening brackets

A SS angled bracket was connected via 10mm SS cable, and tensioned using a SS turnbuckle to the floc paddles. The SS cable was then secured using a wire rope clip. These fittings allow the tension in the cable to be adjusted, and allows adjustment of the length and fit for different sized paddles.

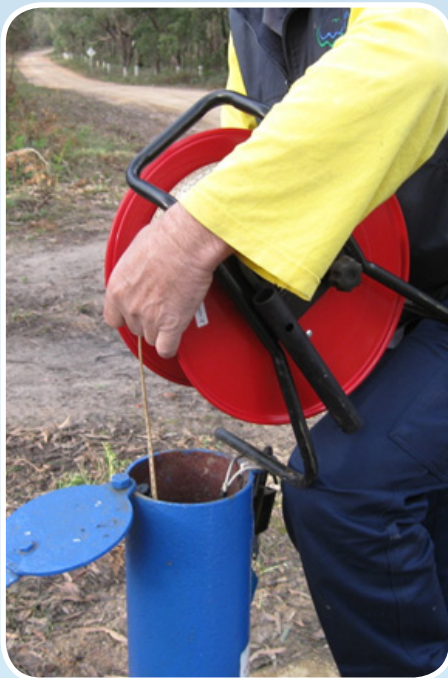
The frame was designed to fit the top of the observation bores, and then the measuring device sits on top, into locating lugs. The tape is fed down the bore through a guide pulley so as not to damage the measuring tape.

The frame is fine the way it is. A small electric winch could be fitted; however this would add more weight which could cause more problems with manual handling.

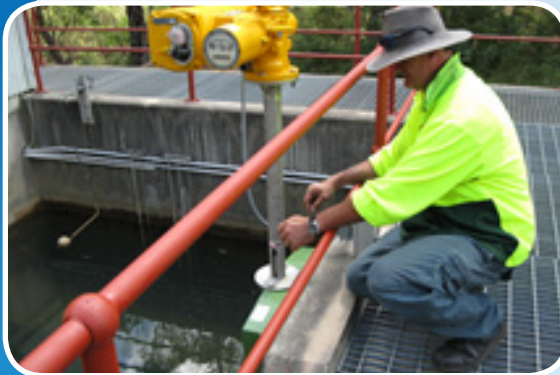
The original working position for the actuators

To manipulate the Water Treatment Plant filter penstock actuators, we had to bend down low, and reach around handrails etc, to access the controls. This was an OH&S risk for back injuries.

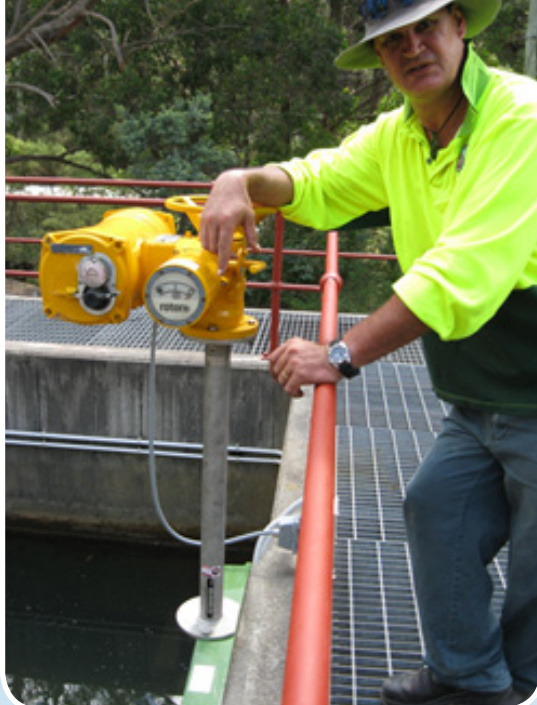
The penstock extension

The actuator was mounted on top of a 1m high bollard type pedestal. Inside the bollard is an extended drive shaft to control the penstock. The actuator was fitted with a 'plug and play' disconnection fitting, allowing easy isolation. There are 4 securing bolts at the top of the bollard which allows easy rotation and fixing of the actuator during maintenance time, as the actuator can be swung over the walk way area, rather than over the filter area.

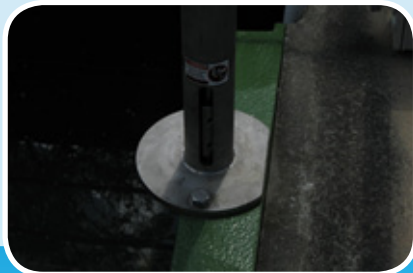
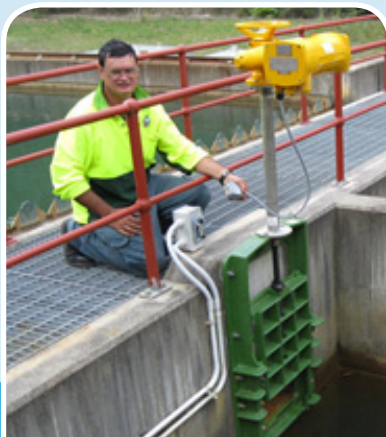
Pedestal internal drive shaft

The 'plug and play' connection

We can easily manipulate the controls on the actuator from a standing position. The 'plug and play' fitting means that we don't need to call an electrician to isolate or perform maintenance.

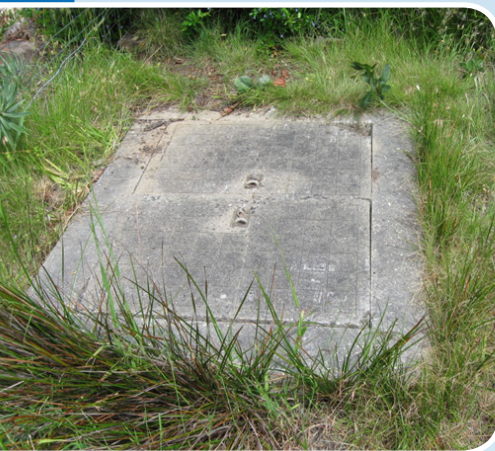
Two panel concrete lid

In some areas there are sewer manhole lids that are rectangular/square and are made entirely of concrete with either singular or twin components.

The rectangular concrete lids are difficult to lift/reinstall and generally poor fitting. This creates manual handling issues for operators. The poor fitting allows runoff water to enter the sewerage system which contributes to excessive hydraulic loadings of the gravity sewer. In some cases the lifting lugs/points on lids are either nonexistent or rusted so they cannot be used for lifting thus contributing to the manhole not being easily accessible when required. Due to their poor design there have been some cases where the concrete lid has been damaged due to traffic loadings which has caused disruptions/blockages to the gravity system.

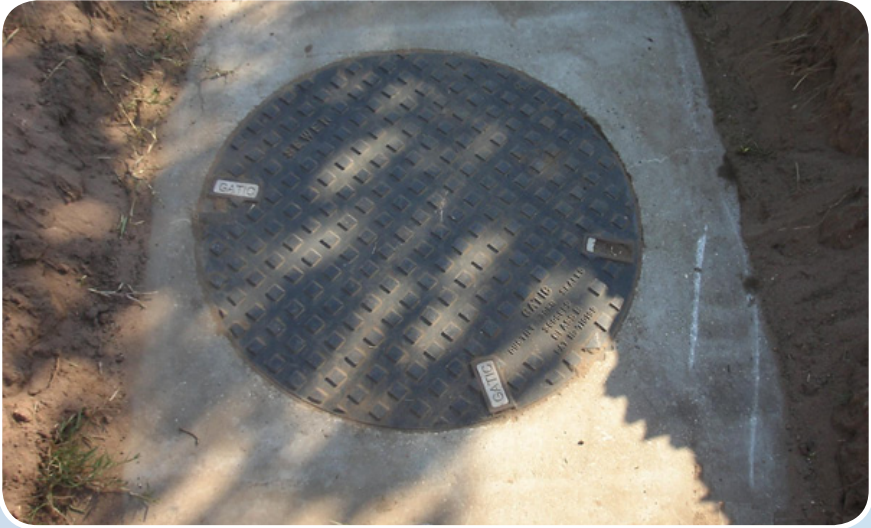
Lid after conversion

Construction of a frame that allowed converting the rectangular opening so that a cast iron round lid could be incorporated into the frame. The frames are designed to suit individual sites as there appears to be no uniform opening size in the different areas administered by Barwon Water. Frames are also designed to suit the different load carrying criteria, e.g. trafficable loads – class D type. The frame is installed so that it becomes completely sealed against any infiltration.
