a PASS

Problem Accepted - Solution Supplied

2022 Winner - Pump Sump Claw
Matt Holz, TasWater

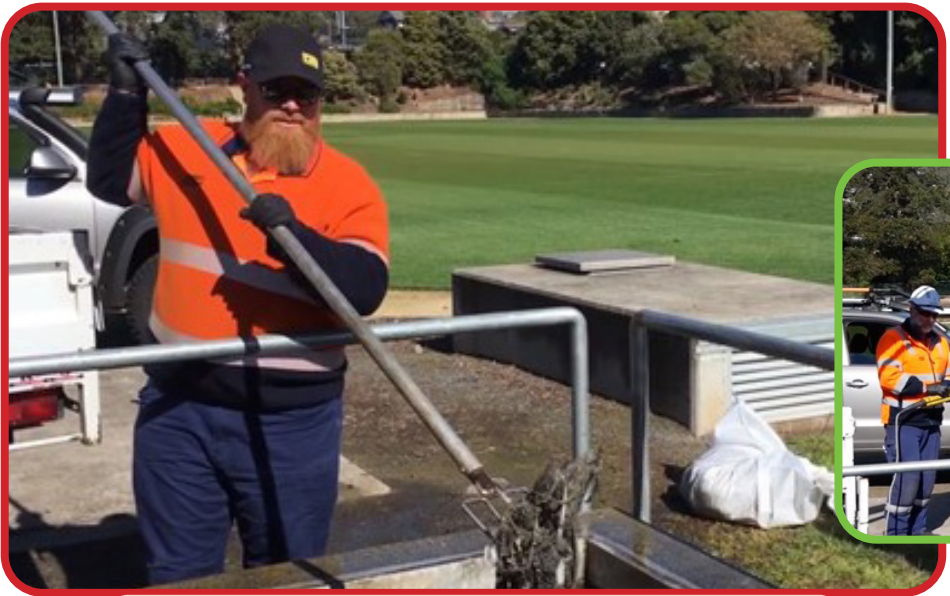
Manual removal of rag from sewage pump stations.

Manual removal of rag from sewage pump stations using rakes in combination with a jet hose to cut up the rag was a very slow, physically demanding and high risk activity which would often result in rag and debris being transferred to the treatment plant and potentially cause problems there.

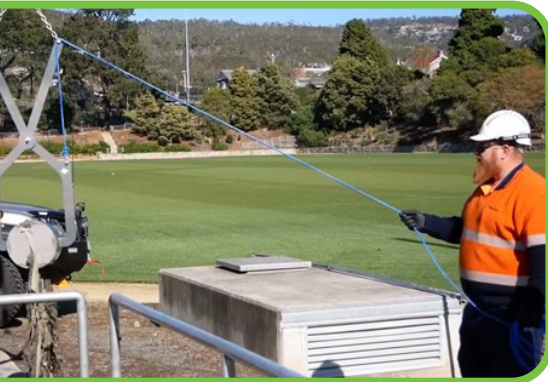
“The Claw” in action.

The Claw. The claw has clamps that grab the rag without cutting or breaking it, and as the claw is lifted up, the scissor action causes the clamp to grab tighter as the weight is taken up. This way, the rag is lifted as a large wad. The claw can be operated on the lift arm of service utes or larger trucks.

One operator holds a rope that opens the jaws - a later design has a holding mechanism that can be pulled to releases the jaws to close rather than the operator holding them open. The jaws also enable the collection of smaller debris and gravel that was impossible to capture previously. The original rake or a pole can be used to push the claw under ledges and position it on a rag ball. Rag that is torn off very large rag balls is captured and held fast in the jaws, unlike with the rake.

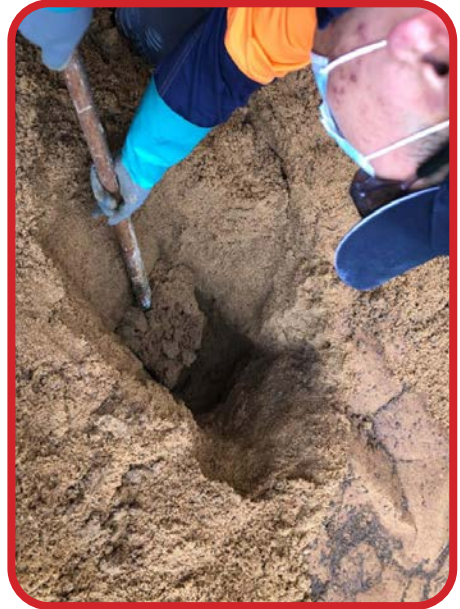
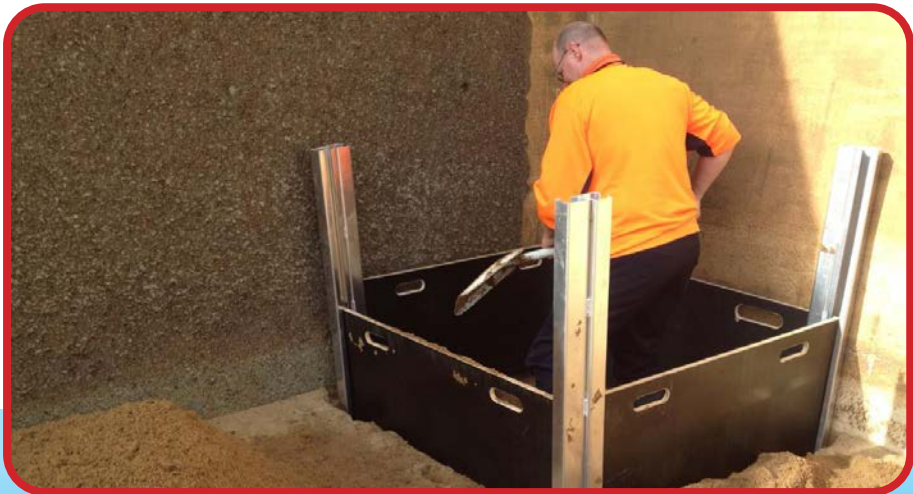
The Winneke Plant has been in operation since 1980, so any previous media sample extraction over the past 42 years has required the use of a shovel to dig down to the appropriate depth.

The overall length of the tool is also limited to ensure it cannot be screwed in too far, to prevent potential damage to the filter nozzles.

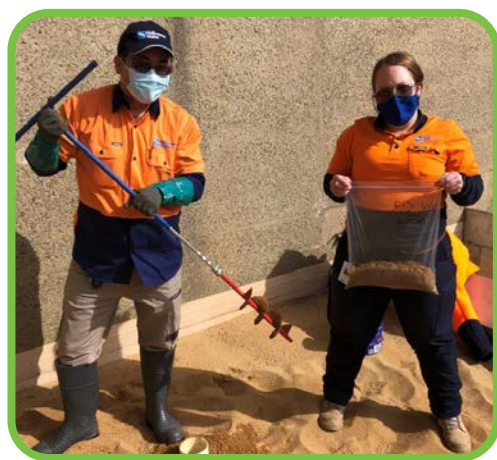
The media extraction tool is quite simple and consists of a 1 metre section of 90mm PVC pipe with a cutting edge on one end and a separate 1 metre long auger which fits neatly inside the PVC pipe. The PVC pipe is first twisted down into the media until the supporting gravel layer is reached. The auger is then placed inside the PVC pipe and twisted down into the media to the required sample depth. The auger can then simply be lifted out of the pipe to extract the media sample. Once the sample is extracted, The PVC pipe can be removed and the hole backfilled.

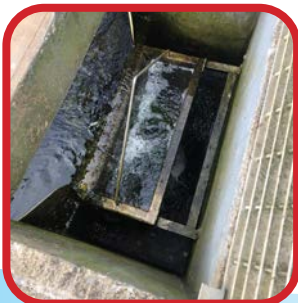
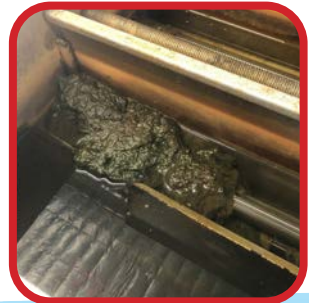
Clarifier outlet filter baskets and UV system blocked up by solids build

The solids build-up on the weirs and outlet channel, as well as looking unpleasant, would eventually slough off in large clumps and block the clarifier outlet filter basket. These large clumps would also have the opportunity to be carried through to the UV system and reduce the effectiveness of the disinfection process.

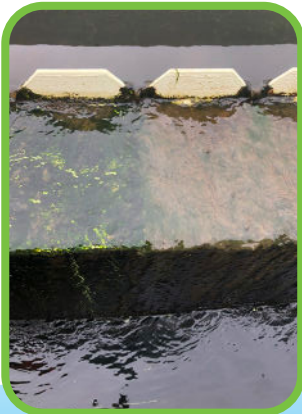
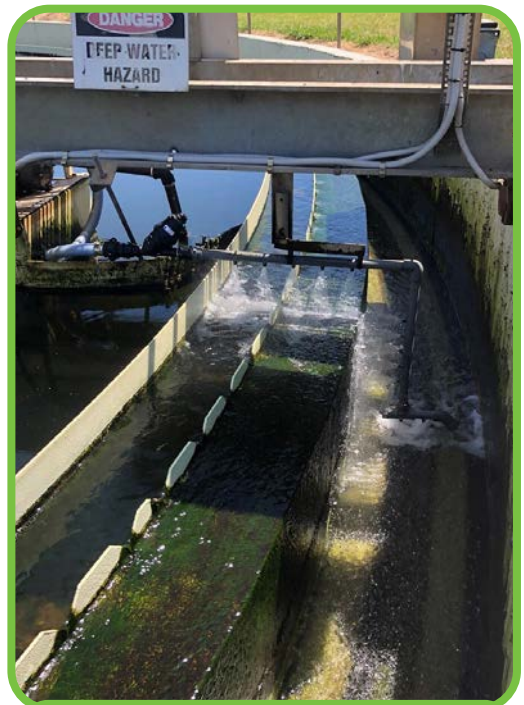
Spray system and clean clarifier outlet channel

The solution was a spray system that is efficient and requires little routine maintenance. The pump is mounted under the walkway of the clarifier scraper bridge. This allows for all the pipework and cables to be run out of the way whilst still allowing access to the spray system while the scraper bridge is still running. The hose from the pump to the spray manifold has a camlock fitting and all sections of the manifold are screw fit allowing for easy removal for cleaning or maintenance. An inline filter prevents any solids picked up by the pump from blocking the spray nozzles and can easily be accessed for cleaning.

The spray system has been set up on an individual circuit breaker with built in timer, this allows for the system to be turned off separate to the scraper, and also allows for the operator to select on and off times to optimise and reduce power usage when not required. All items are off the shelf and can easily be replaced for same day repair.

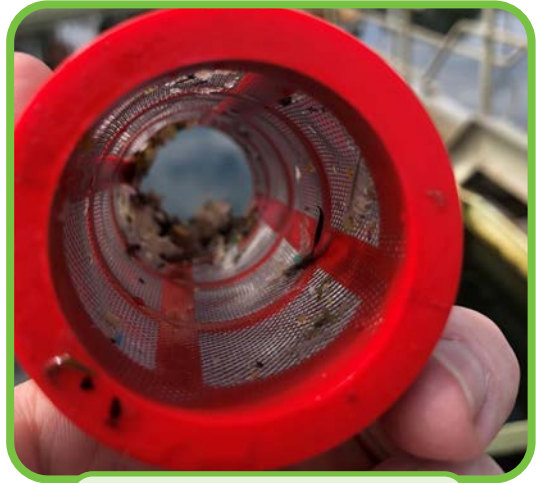
Inline filter during weekly inspection

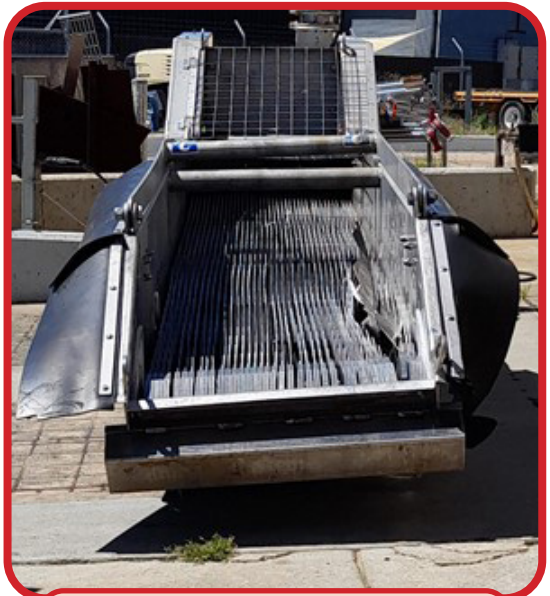
Damage to the existing step screen

January 2022 was a particularly wet month for Albury. In that one month Albury received three 1 in 100 year rainfall events. Due to the widespread damage the flooding caused, a Natural Disaster declaration was issued. These events caused large rocks and other debris to move through the city's sewer system. When this debris entered the Kremur Street Wastewater Treatment Plant (WWTP) it caused irreparable damage to the single inlet step screen at the treatment plant. The screen plays a crucial role in the protection of downstream assets.

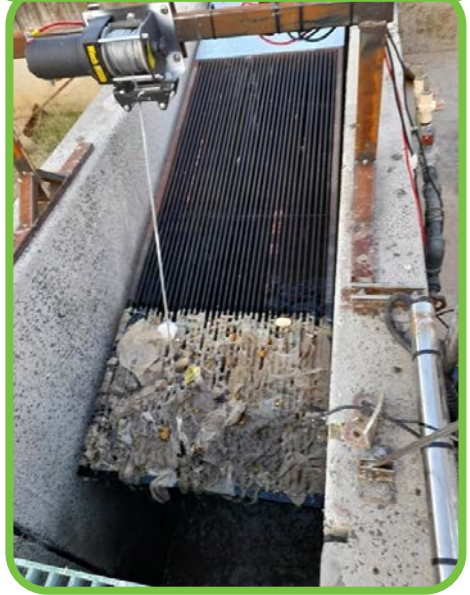
The new screen being raised for cleaning

The screen was fabricated to size and installed into the inlet channel. A battery operated winch was fitted to the screen. This was used by the operators to raise and lower the screen easily and safely before and after cleaning it. At the opposite end to the winch cable, a pivot point was installed which allowed the screen to pivot from its intended angle of use to horizontal for manual cleaning. The screen had to be cleaned three times a day. Therefore, the cleaning process needed to be simple and easy to complete.

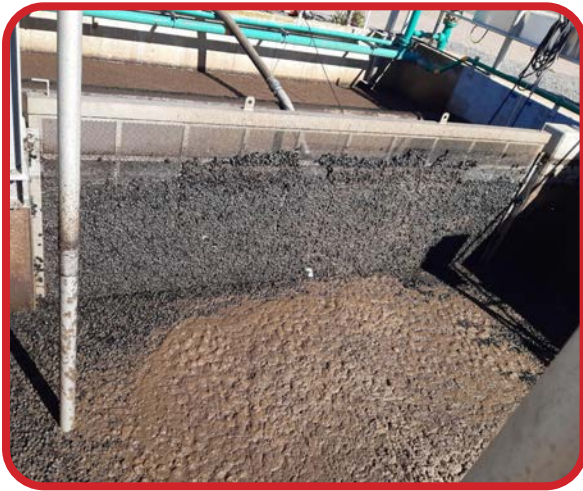
Integrated Fixed Film Activated Sludge (IFAS) media is used in two bioreactors at Glenelg WWTP in South Australia to increase the nitrifying capacity of activated sludge. The media is aging and therefore starting to break apart. This has been exacerbated by capital works to replace the diffusers which has resulted in the overloading of media in the basins. The construction of tube screens is also thought to have had an impact. The broken media gets caught in the screen mesh wire that is located at the end of a zone in the tank, preventing the treated wastewater from passing through to the next zone. Some of the broken media also passes through the mesh and enters the next zone where it should not be.
