a PASS

Problem Accepted - Solution Supplied

Providing opportunity for water industry operational staff to share their in-the-field innovations & fixes to problems so that others in the water industry can benefit.

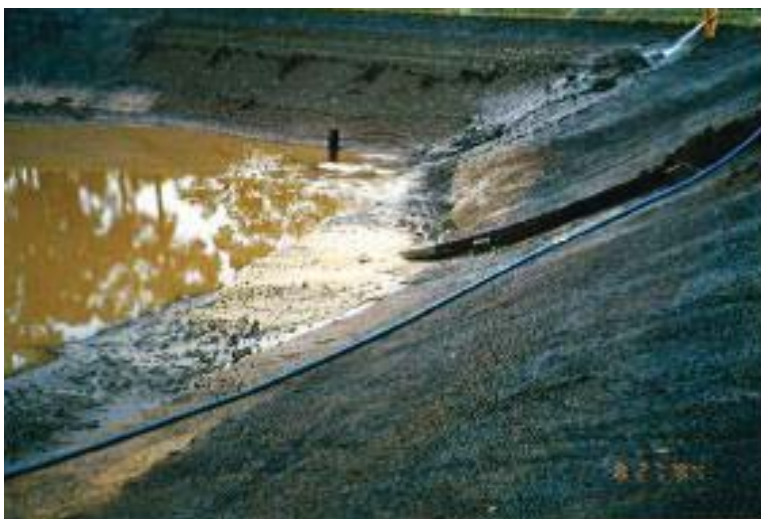
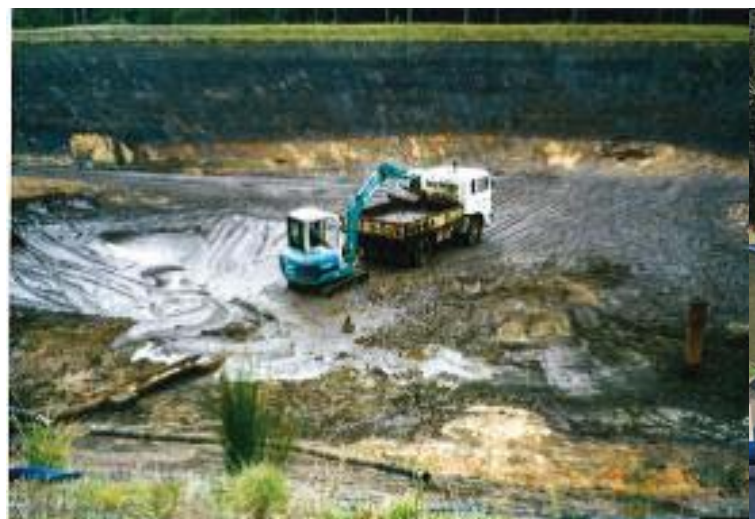
We harvest raw water from a small stream which is subject to high levels of sand and silt, particularly during periods of high rainfall.

This has been an issue for a long period of time. There have been several attempts to address the problem with the most recent being the introduction of a stainless steel wedge wire cylinder screen. This screen was fitted to the weir outlet and was effective in removing larger debris, including sticks and leaves. However, the fine sand and silt still passed through to the basin.

▼ The problem.

The raw water enters the sand trap which has a baffle plate directing the flow down towards the base of the vessel. The sand and silt is heavy enough to settle on the bottom and accumulate, while the water level rises, spilling over the bell mouth outlet and entering the basin.

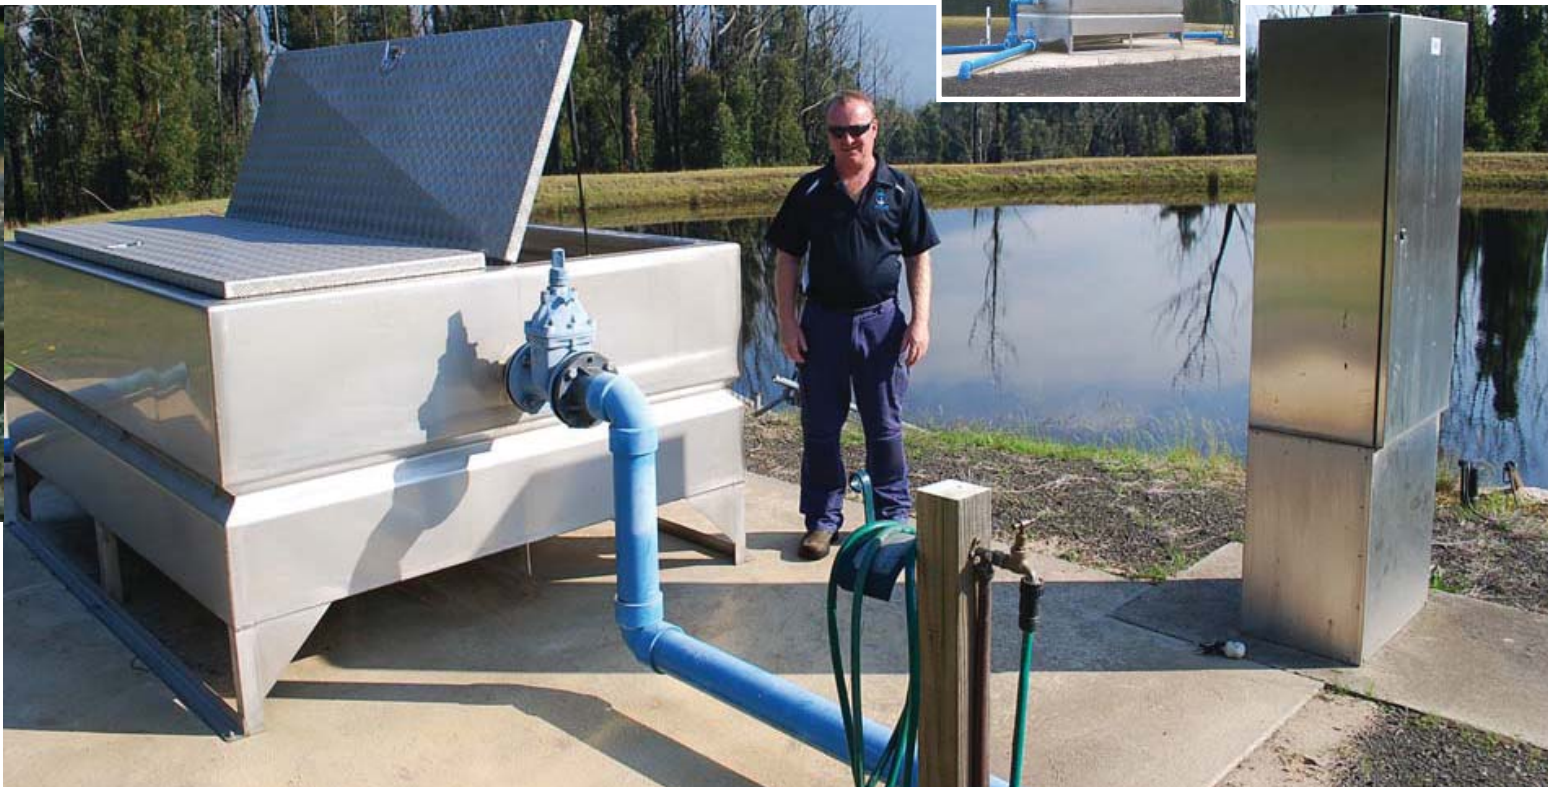
The sand trap needs to be cleaned out approximately every couple of weeks, which is a very user friendly exercise. As the trap has a hopper style base that slopes toward the scour, all we have to do is reduce the inlet to approximately 2L/s and it basically cleans itself out.

The solution. ▼

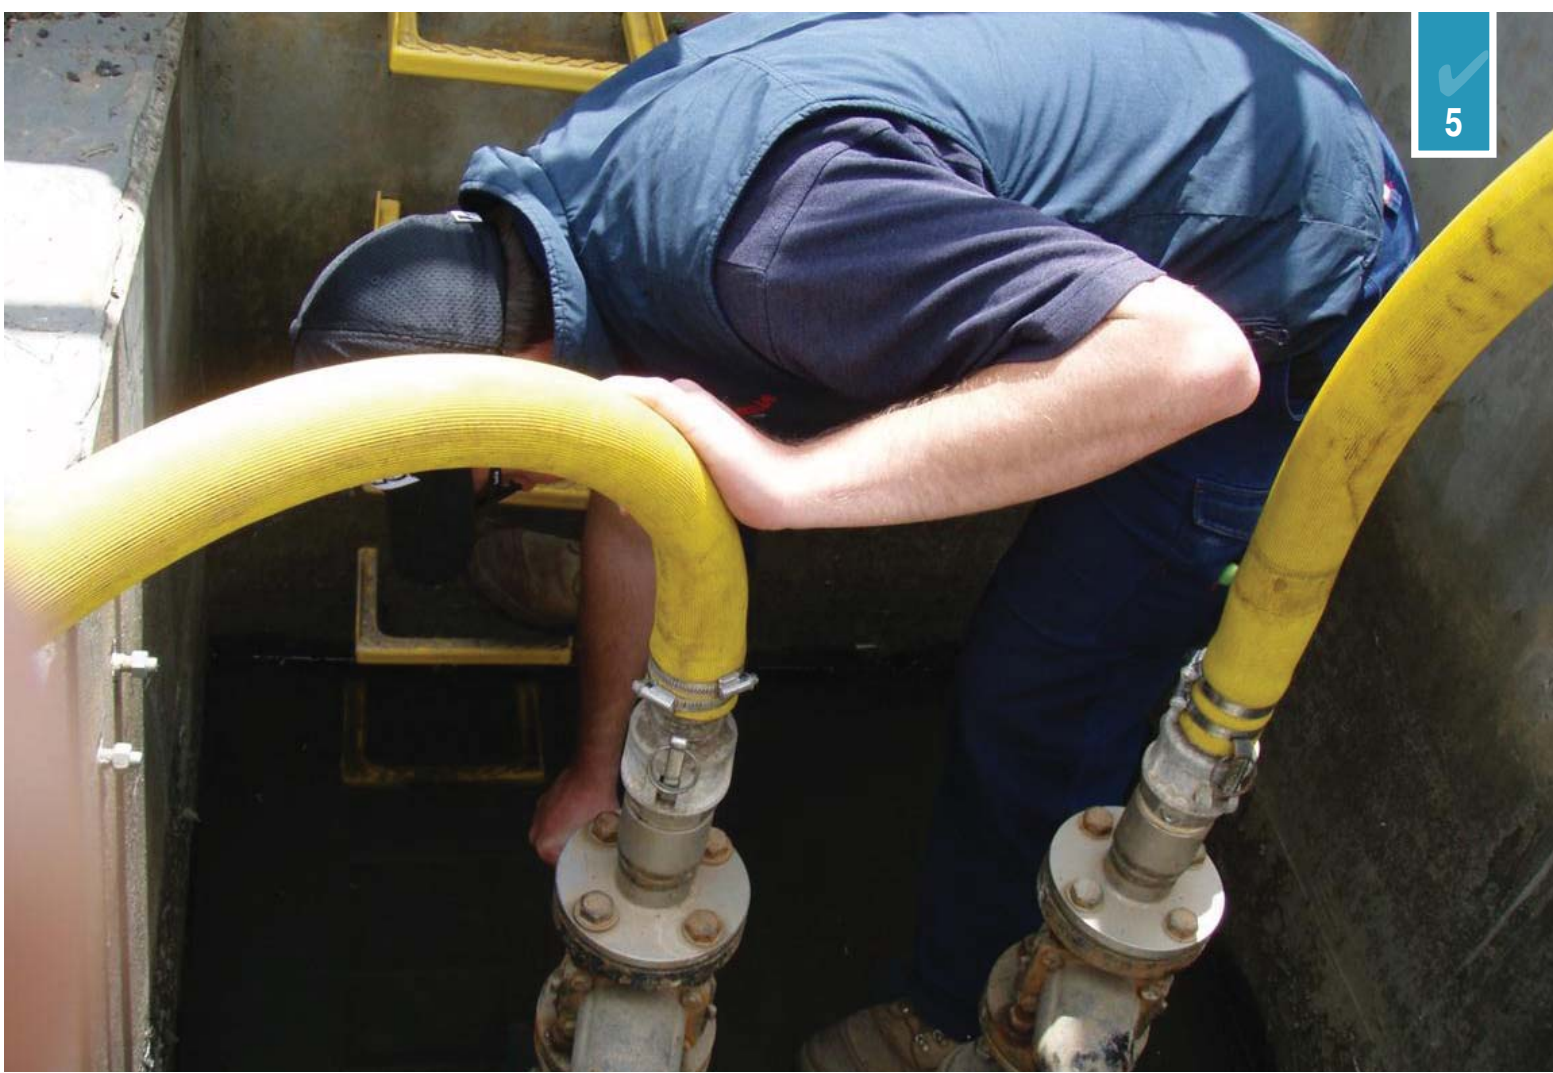
Due to the size and location of the lime dosing spears, the task of removing the spears was identified as a manual handling issue, in that they were difficult to remove from their sleeve, requiring force and awkward posture (see photo of the problem).

▲ *The problem.*

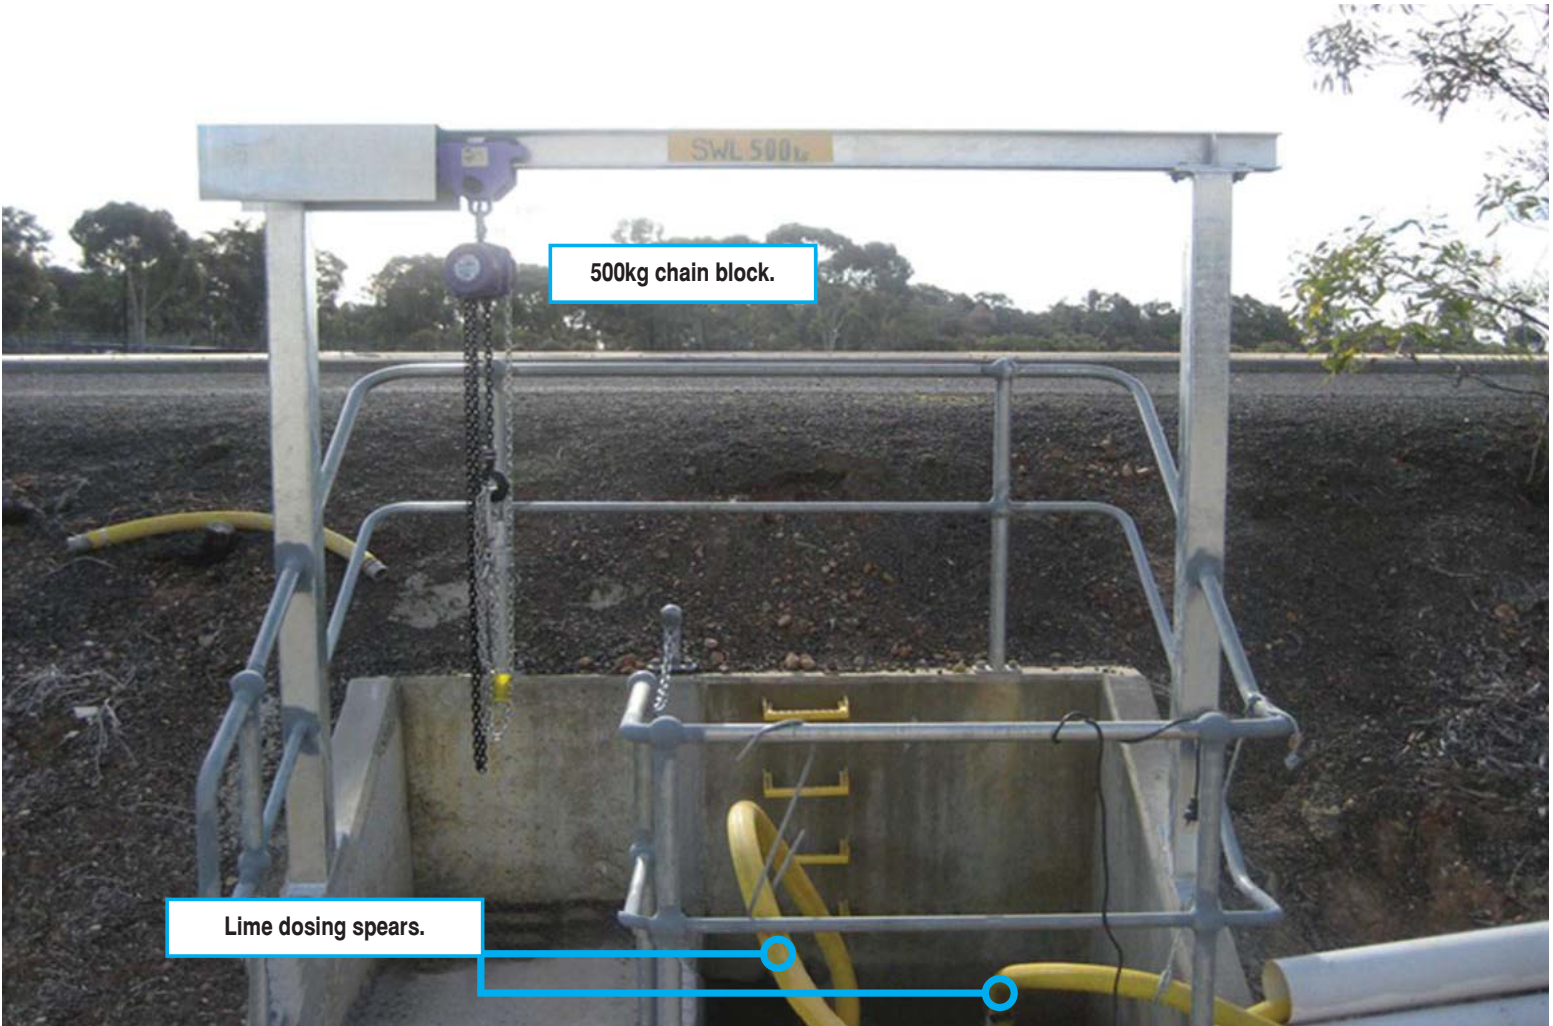
A gantry was designed and mounted to the surrounding structure so the lime spears could now be removed using a chain block. This greatly reduced the risk of manual handling and eliminated the hazards involved with mobile plant. The operators can now easily attach the chain block without physical force or the need to work in awkward positions. Removing the lime spears and easily sliding the spear along the gantry to an accessible area to be cleaned then simply lowered back into position.

The solution. ▼

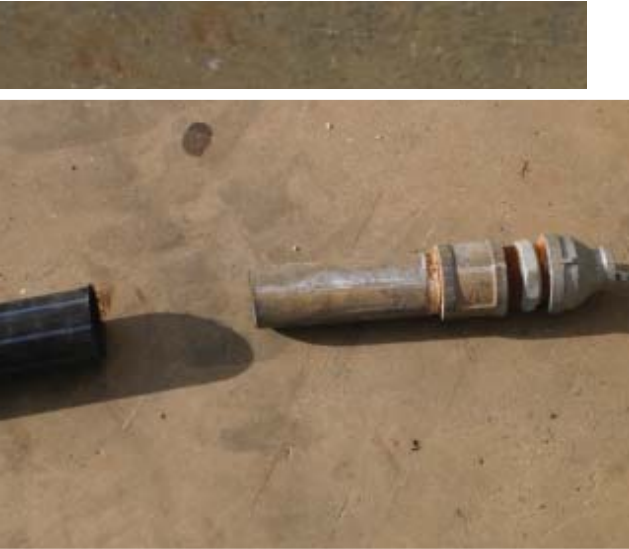
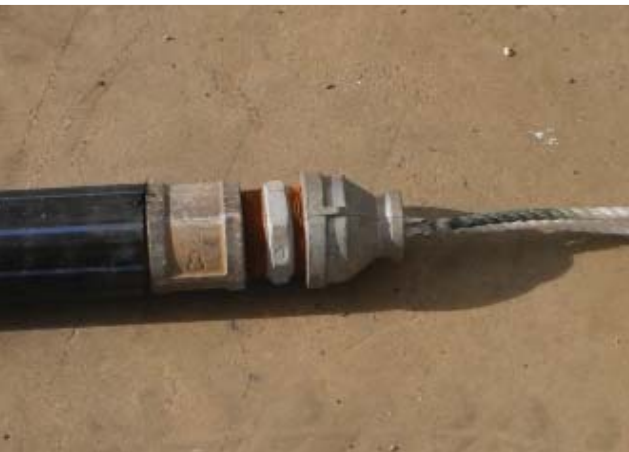
▲ Re-sleeving lead end - version one.

Working on approximately 90m lengths at a time, a jet cleaner was used to blast a draw line through the AC pipe to pull through a winching rope to be connected to a winching system. On the 'lead end' of the poly pipe that was to be re-sleeved into the existing AC pipe, a 200 mm length of gal pipe (Version One) was inserted into the poly pipe containing a screw end (for protection) and a welded bar across the internal section of the gal pipe as a fixing point for the draw line. The poly line was then carefully winched through the rising main.

Unfortunately due to bends and dips, this system became stuck and had to be dug up and retrieved. It was then decided that the 'lead end' of the poly pipe needed to be modified to fit around bends etc. A 70 mm length of gal pipe (Version two) with a bar welded (once again for securing the draw line), was placed some 300mm down inside the poly line. 'V sections' were cut in the end of the poly line so the poly pipe could be closed into a cone shape and secured with duct tape. This modified head of the poly pipe made the pipe more flexible and was able to be drawn through the AC pipe, even around bends and through depressions without becoming stuck.

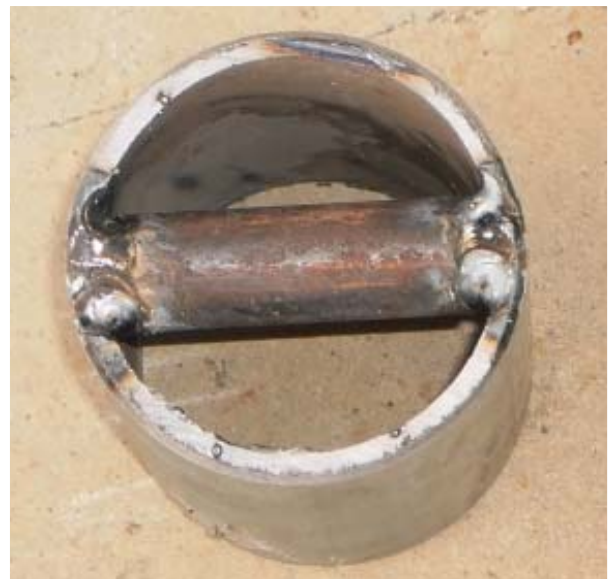
Re-sleeving lead end - version two. ►

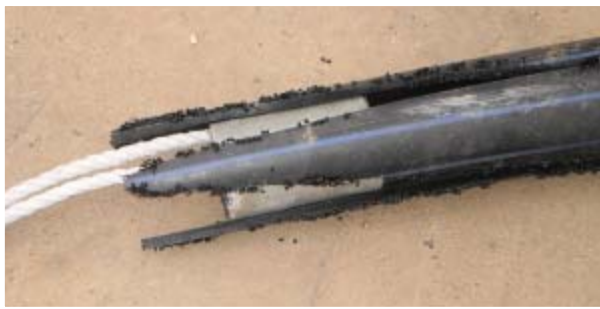
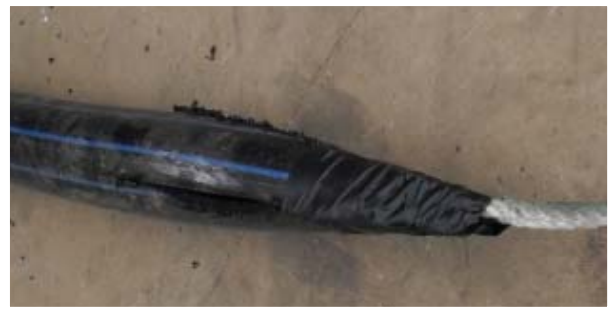
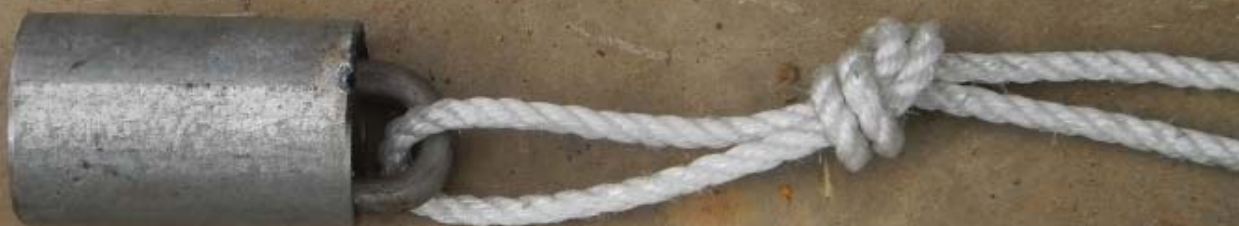
We were able to re-line the rising main at a minimal cost, and with no disruption to the towns water supply. There have been no further occurrences of leaks in the newly re-lined main, and a noticeable improvement in water quality.

An old low volume 100mm AC rising main in a small town kept breaking and leaking. This rising main was laid in the ground right next to the town supply main so extreme care was required when repairing any leaks.

To replace the main, this would have been a major job as the customer services often crossed the rising main. Other alternative techniques involve 'punching out' the old main was possible, but due to its close proximity to the treated water main, this was deemed too risky.

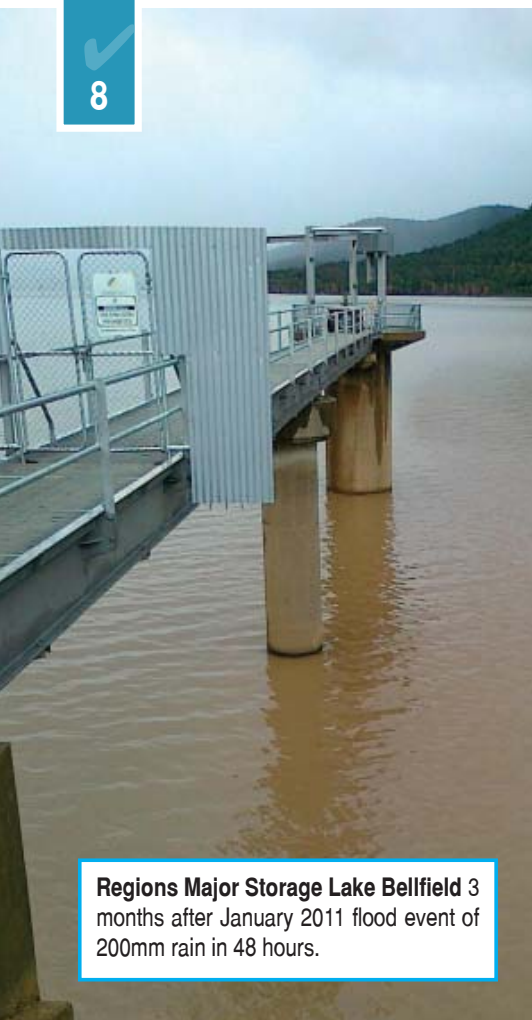
Regions Major Storage Lake Bellfield 3 months after January 2011 flood event of 200mm rain in 48 hours.

GMMWater's major raw water storage –Lake Bellfield, was severely impacted by sediment washed in by the January 2011 floods. After the flood, turbidity reached 580 NTU and colour 180 HU. The lake is the raw water source 15 towns in the region all with disinfection only systems and no filtration. The poor raw water quality impacted thousands of customers. Lab studies determined the turbidity was mainly fine clay and it could take several years to settle.

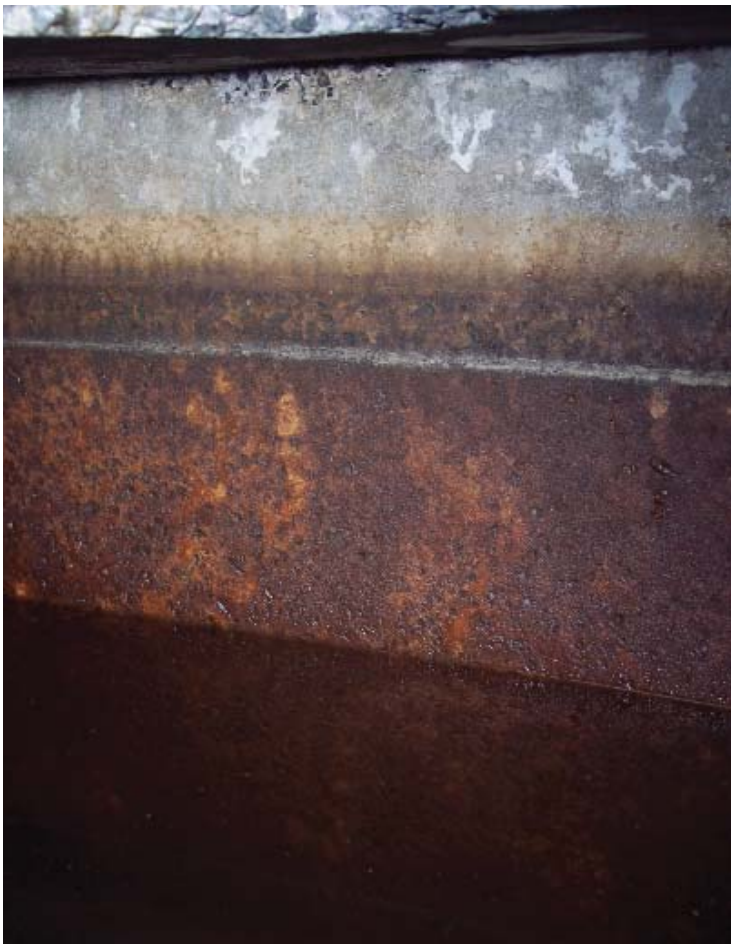
Throughout the summer months, manganese residuals in the raw water rise to levels that the treatment plant process cannot remove. Once the filtered water was dosed with sodium hypochlorite, the manganese would oxidise and become insoluble in the clear water storage tanks. This causes dirty water, staining of assets and monitoring equipment and dirty water complaints from customers.

▼ *The problem - staining of water storage tank walls.*

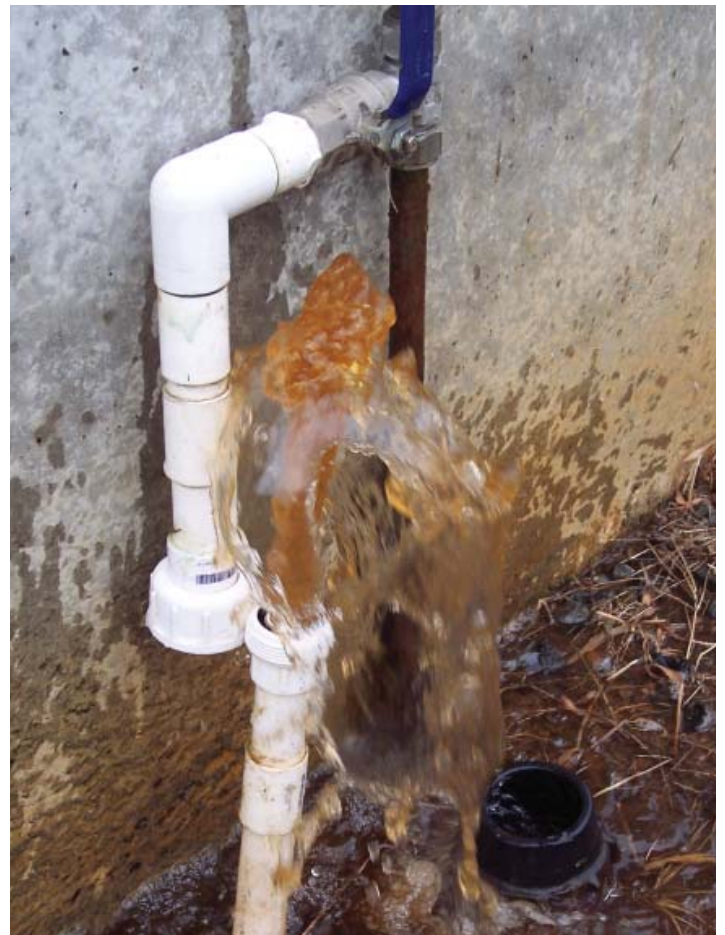
The problem meant constant cleaning of sample lines and monitoring equipment to try and maintain accurate readings. The chlorine demand in the water was really high due to the manganese consuming the chlorine; also the plant was running less efficiently. The problem sometimes meant water needed to be carted to the clear water storage by tanker from other treatment plants.

▼ *Flushing dirty water sample lines.*

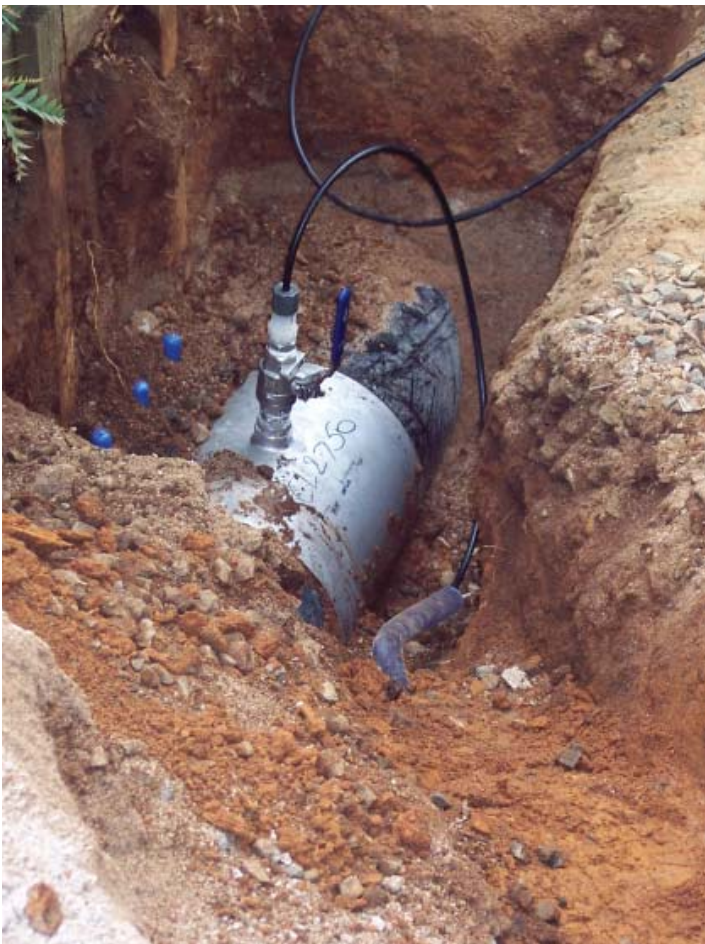
▼ *The solution - new ph correction dosing point.*

After jar testing many different dosages and contact times, raw water pH correction was introduced. A new dosing point was installed on the raw water main for this; also another power point run from the PLC was required to power the extra dosing pump. The raw water pH was raised to 8.5 with soda ash and correct dose of potassium permanganate (which was already available in the process but had no affect) was added a few seconds later. We utilised a booster pump (already part of the process) to mix the chemicals thoroughly. Then with the standard coagulation/flocculation, sedimentation and filtration the manganese was effectively oxidised and removed from the treated water.

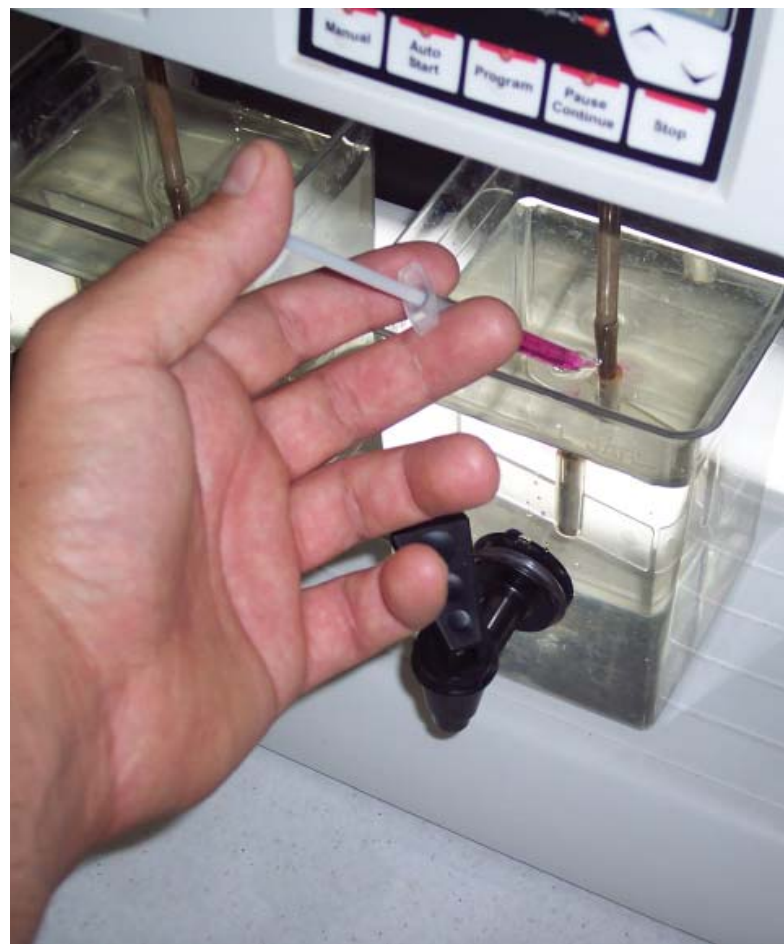
▼ *Jar testing Potassium Permanganate doses.*
