a PASS

An award providing opportunity for water industry operational staff to share their in the field innovations & fixes to problems so that others in the water industry can benefit.

Using an air diffuser system to clean a major pump station wet well.

Chlorine dosing skid modification.

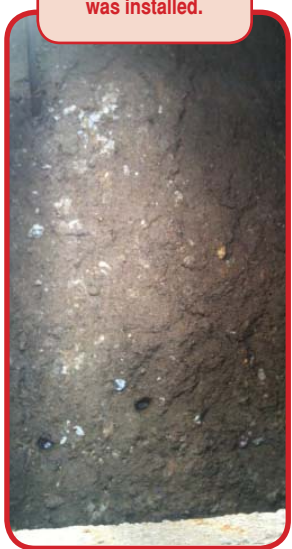
A major sewer pump station south of Hobart suffered from a continual build-up of rag, fat and other foreign material in the wet well. This caused continuing pump blockages, and also required a monthly clean out of the wet well. The flow from the PS is around 1.0 to 1.5ML/day.

Scum in the wet well before the diffuser was installed.

There was an old, unused blower at one of our treatment plants that was formerly used to aerate the primary sludge in the sedimentation tank. All we had to do was relocate and install it at the pump station, fabricate a diffuser to suit the wet well and electrically wire it in. By aerating the wet well, this would keep the scum / rag to a minimum and reduce odour, not to mention removing the dangerous aspect of entry by staff.

Senior fitters installed the diffuser in the wet well with air outlets about 400mm/500mm under the water level. The blower was located inside the dry well of the pump station. A flexible pipeline was installed from the blower, through the concrete wall into the wet well to the diffuser inlet. Electricians wired the blower in and Clear Water Controls configured it into our SCADA system so that it could run on a time sequence, changeable by the operator. Initially we had some concerns with the air entering the pumps from the diffuser causing the pumps to cavitate but after running for some time there was no evidence of this. Overall the project works well and after a couple of years of operation it has provided a very pleasing result at a reasonably small cost of less than \$7,000, given that we already had the blower.

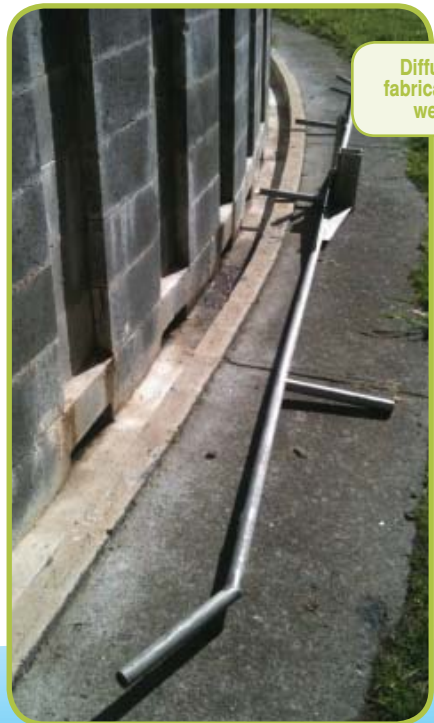
Diffuser S/S fabricate to suit wet well.

Look at improving the design of the diffuser as there have been some issues of rag tangling around the diffuser off-takes. This has to be removed on occasions and there is still some need to use vacuum trucks once per year to remove rag build-up.

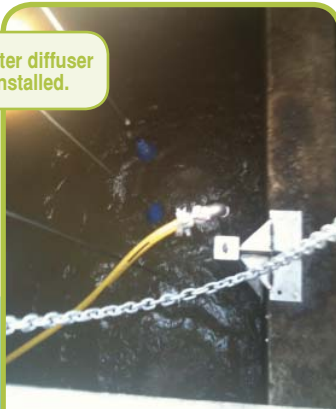
Wet well after diffuser was installed.

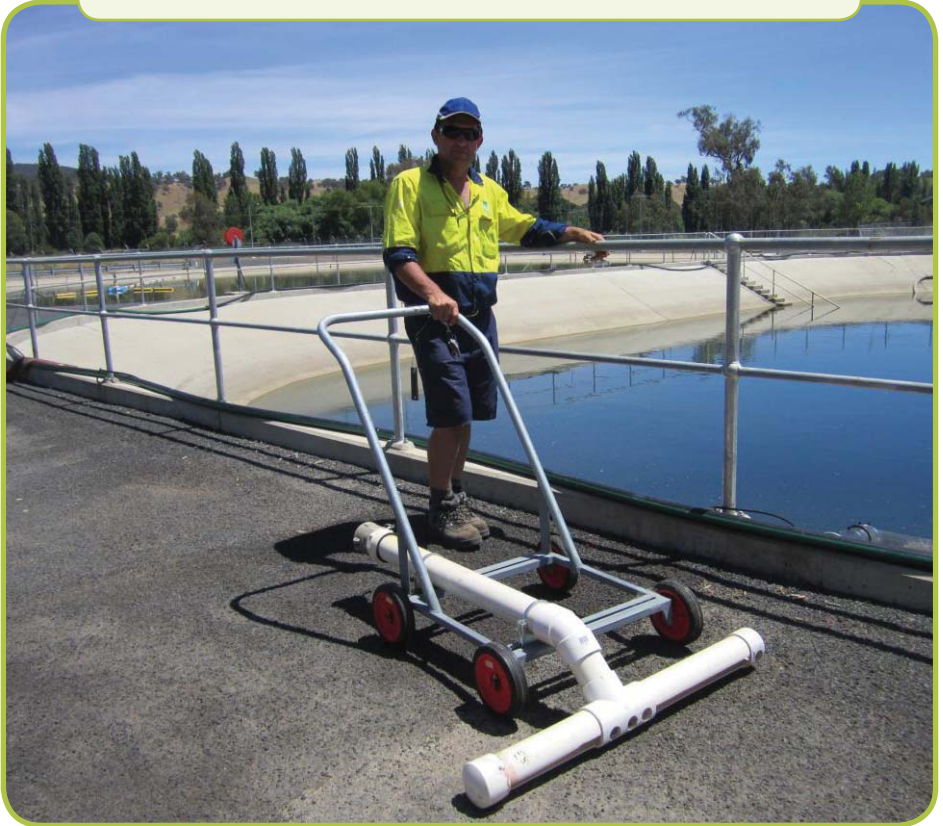
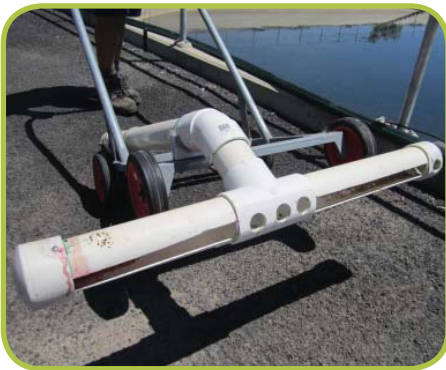
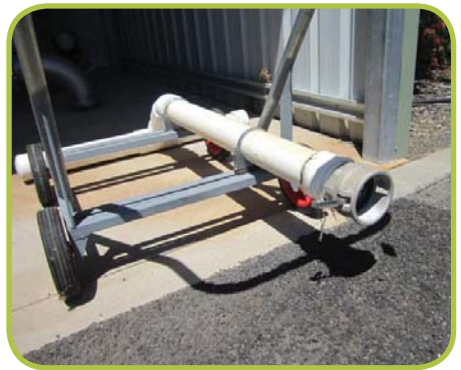
Desludging Trolley with Catch Pond in background

A trolley was designed with 4 wheels that had nylon bushes rather than bearings for movement in water. Adjustable frame to support the vacuum head.

The vacuum head is made of 80mm PVC pipe with a slot and end caps all connected with a T piece to a suction hose cam lock fitting. A 4 inch self priming pump is connected to the trolley and discharged to the sludge lagoon.

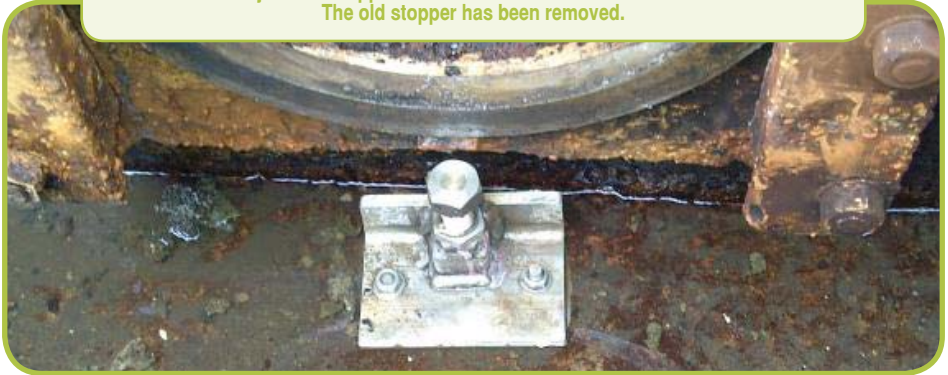
New adjustable stopper installed fixed to filter inlet channel floor.
The old stopper has been removed.

The solution involved organising a plant shut down to inspect all filter inlet valves. We brainstormed a solution and set to work on a prototype to test and ensure the design would work. We manufactured the prototype in our workshop that comprised of a mounting plate and an adjustable thread with a stopper that could be set to height then locked into position with a lock nut. The prototype was installed and worked successfully eliminating valve failure in the closed position. Following this we set to work to produce another seven stoppers.

The three of us inspected the faulty valves and we considered a few options for repair involving removing each valve and re-welding stoppers in the workshop. This would have taken considerable time and required a heavy crane to get the reach required to remove the valves. Eventually we came up with the solution to cut the old stopper from the valve casting and fix a new adjustable stainless steel stopper to the inlet channel floor. It was important the new stoppers were adjustable as the concrete floor had a variance of approximately 25mm along the filter inlet channel.

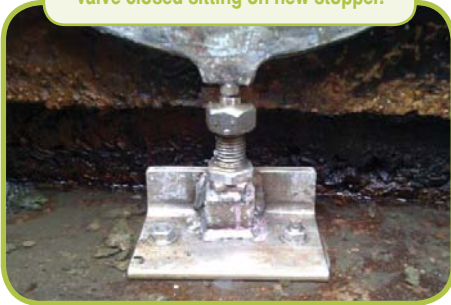
Valve closed sitting on new stopper.

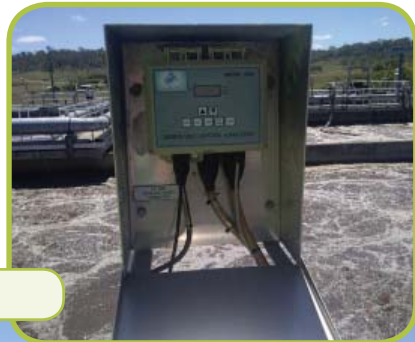
Cover fitted and in the open position

Initially I came up with a cover made from sheet stainless steel recovered from the scrap pile. I folded the steel into shape and fitted it to the sun cover, protecting the analyser from the sunlight. At first the cover hinged from the top of the shade cover however this proved to be unsuccessful as the cover was required to be held open while viewing or maintaining the unit. I refitted the hinge point to the bottom of the sunshade and allowed gravity to hold the cover open. This made it easy to view and maintain when required.

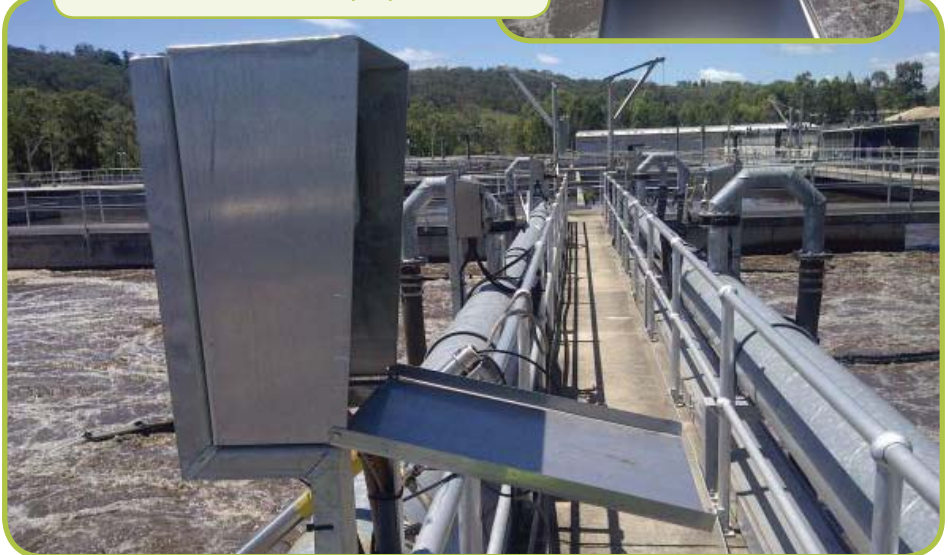
Cover closed and operating safely out of the sun and U.V light.

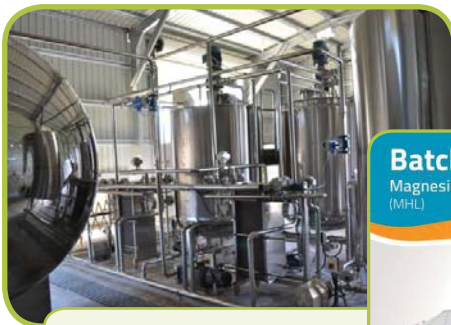
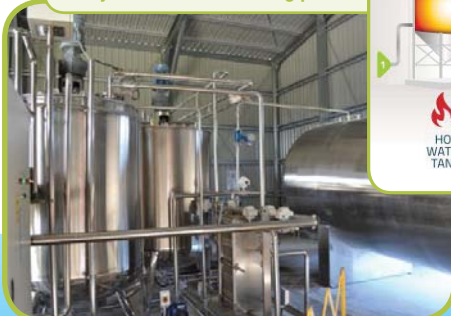
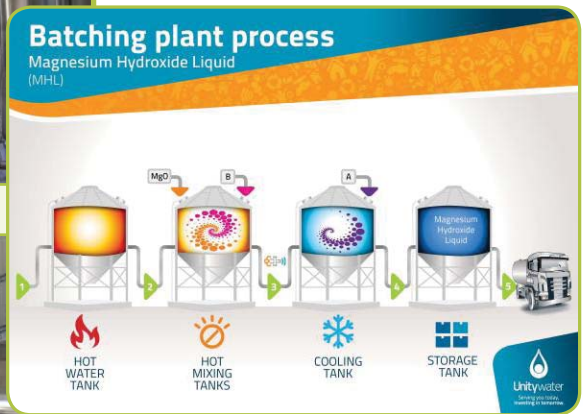
Unitywater's MHL batching plant.

Unitywater worked with Wise Waste Solutions to develop a micro-batching plant for the production and supply of MHL. Built at Unitywater's Maroochydore Sewage Treatment Plant, the batching plant currently produces 1.5 million litres of MHL a year. It employs a new patented formula and production process and uses water recycled from the sewage treatment plant.

The process we developed has been very successful because it found a way of keeping the magnesium in suspension in its liquid. The MHL micro-batching plant is fulfilling its intended role very well and has ample capacity for Unitywater foreseeable needs.
