# a PASS

Problem Accepted - Solution Supplied

2016  
WINNER

An award providing opportunity for water industry operational staff to share their in the field innovations & fixes to problems so that others in the water industry can benefit.

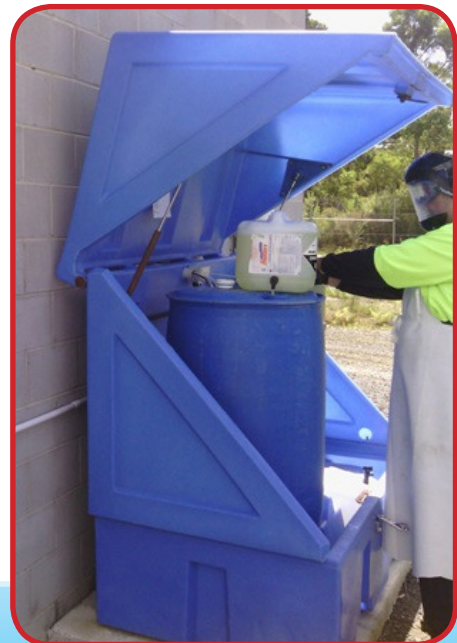
We made a stand which holds a drum pump that slides up and down into the 15L containers, transferring the Sodium Hypochlorite through a hose fixed to the chemical tank. This means there is no need to hold any part of the drum pump, hose or container whilst transferring and there is no handling of opened containers of Sodium Hypochlorite.

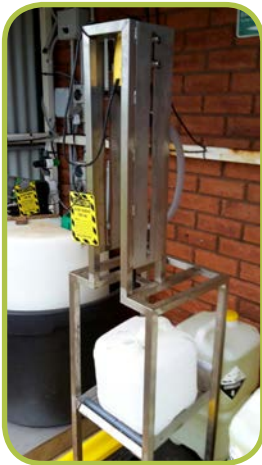
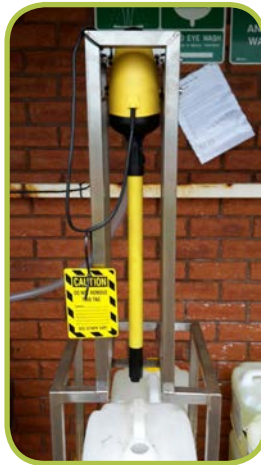
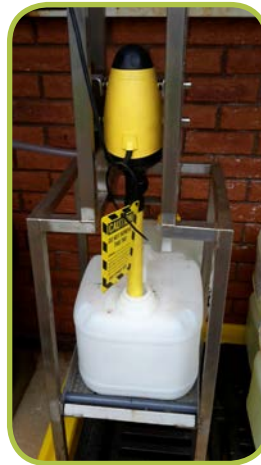
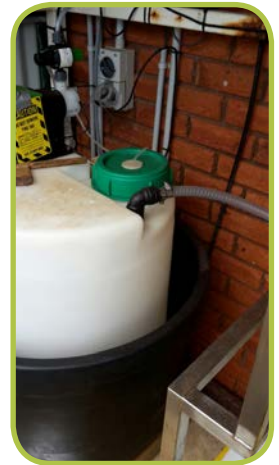
We needed a device that was portable and easy to install on any elevated structure handrail, where goods had to be lifted up to the roof area. A pipe clamp, yacht capstan and pulley were mounted onto a length of aluminium square tube. The unit clamps onto round or square handrails and then has a safety rope clipped around the rail as a backup. When hauling up, you can stand directly behind the unit, or off to one side if the working area is limited. When lowering things down to the ground, you simply take a turn around the capstan, so that it acts as a brake (it can only rotate in one direction). A few more wraps of the rope around the capstan locks off the rope and allows you to take your hands off it completely, when manoeuvring an object up and over the edge.

Lifting application

Lowering with rope wrapped as a brake

Device in locked off position

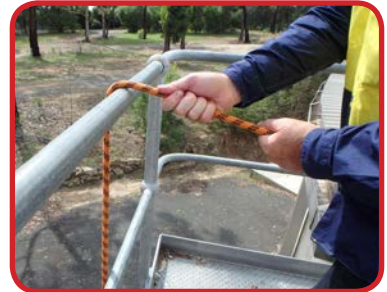
When lifting gear up, it was just hanging the rope over the handrail and hauling up. The heavier the object, the more friction on the rope. Some objects such as 20L chlorine containers can be difficult to lift over the edge of the handrails, when you cannot 'lock off' the rope.

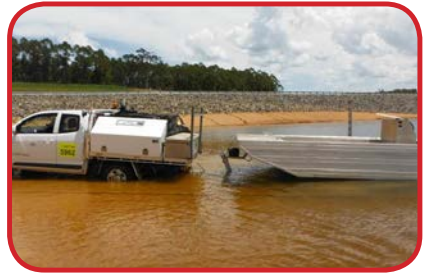
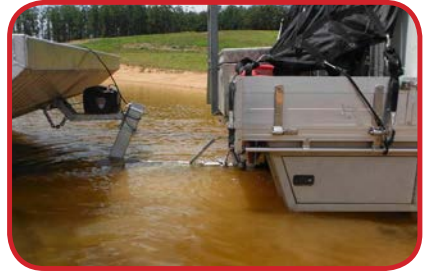
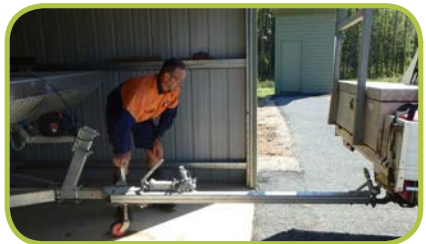
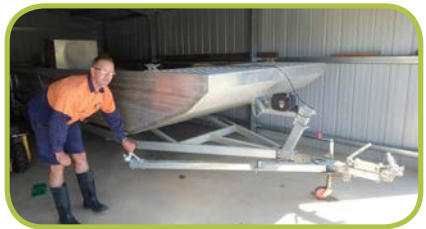
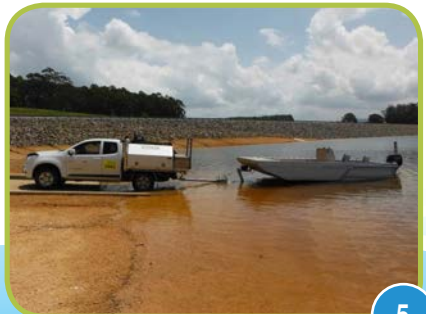
By fabricating a temporary extension section to the trailer tow hitch we can effectively launch the boat while the tow vehicle wheels remain dry. This hitch is folded back and stored against the trailer frame for normal towing situations and when parking the boat within the storage shed.

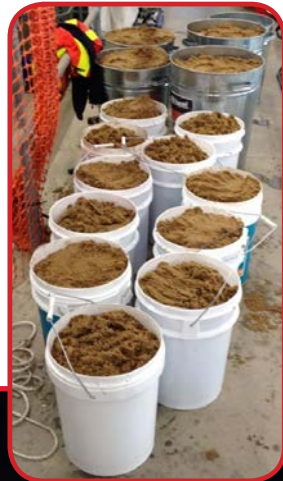
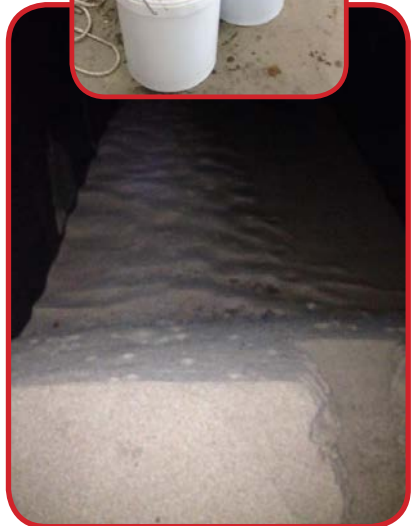
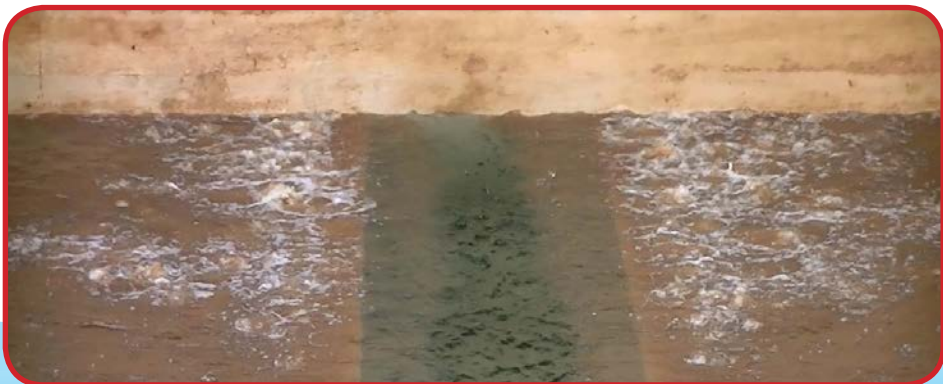
The plant has had an inherent problem with excess air in the plenum chamber after backwash for several years. Several improvement options have been implemented in the past with limited success and there was still evidence of this issue observed by operators during routine filter backwashes

This issue was highlighted during our recent filter inspection program where a backwash improvement project was initiated to address several improvement options. I had trialled this solution during several backwashes which appeared to show a marked reduction in boiling during the washwater cycle of the backwash.

Further trials were conducted with the aid of our process support team with video evidence collected. We also monitored the sand volume presenting in the washwater system and noted a significant reduction. Each of the filter plenums were also cleaned out with the aim to quantify the sand reduction during the next scheduled inspections.

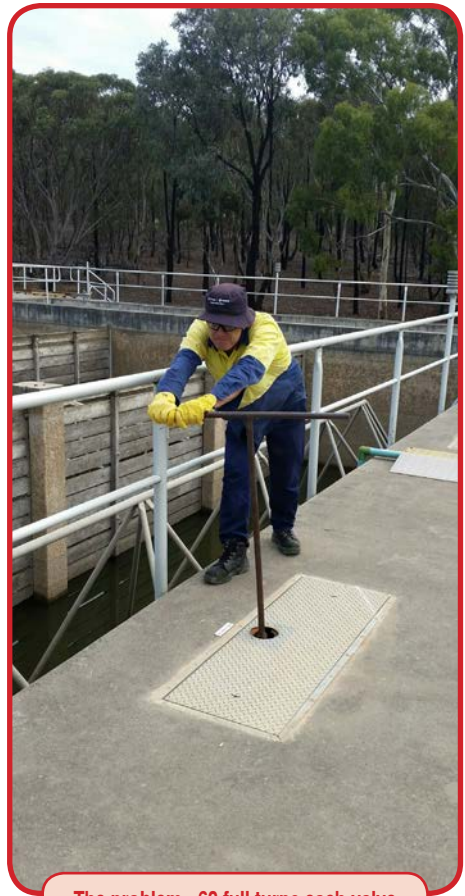
The problem - 60 full turns each valve

Opening the sedimentation inlet penstock valves requires at least 60 full turns to open each valve, with 5 valves for each sedimentation tank. The plant has 4 sedimentation tanks, and these are in 2 pairs of 2 tanks, with a total of 20 inlet penstock valves. Opening and closing each valve requires 2 people due to the number of turns and the tightness of the valves as they are operated usually about 4 times a year on average. Operating the valves (with the excessive tightness of the valves) required a considerable amount of manual labour and the risk for potential injury was very high.

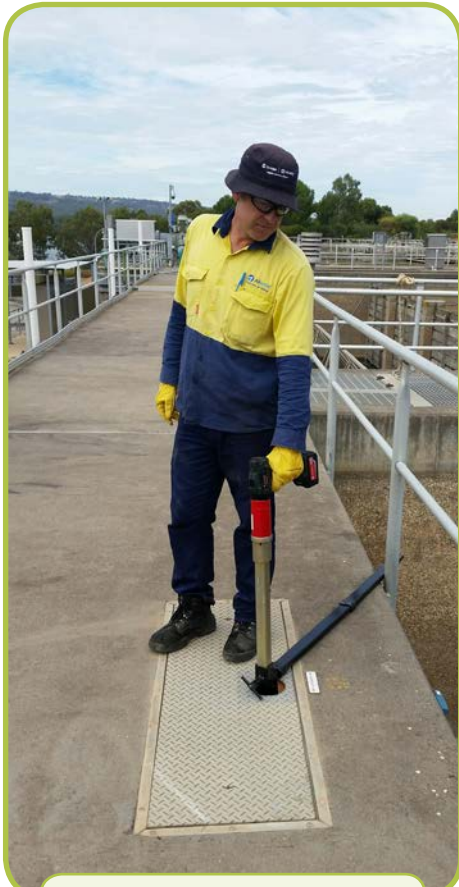
Electrically operated valve key opener

The solution was to use an electrically operated valve key opener that incorporated a torque limiter to reduce the potential to break the valve if torque became excessive. Use of small battery packs enables the valve opener to open or close 2 valves in a short time when compared to manual operation.

A detachable reaction arm is used against a solid structure to prevent rotation of the valve opener when attached to the valve and to maximise safe operation of the valve key opener.

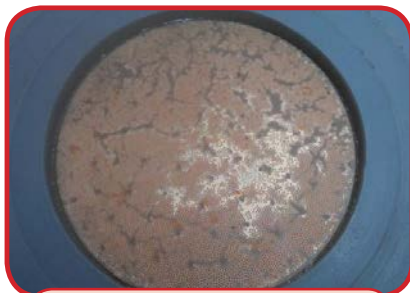
Membranes in test rig  
- false flow due to air ingress

The draining of the water from the membranes while on the racks allowed air to ingress into the membranes. This air ingress made it difficult to identify the individual strands that required a pinning repair as there was very little water left to create reasonable sized bubbles.

When the membranes were placed in the test rig and low pressure air was applied the lack of water in the membranes caused false positives at the membrane ends.

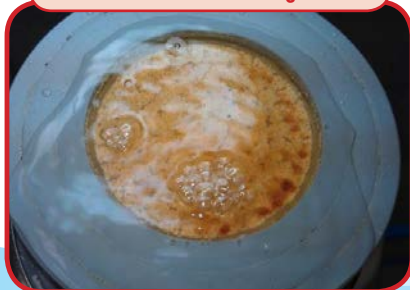
Saturator Unit

The membranes are removed from the racks one clover (4 membranes) at a time and placed into the saturator. The membranes are left in the saturator for a few minutes to saturate. They are then removed one at a time and placed immediately into the test rig and low pressure air applied. The strands requiring attention are easily identified and pinning repair is quickly completed. After repair, the membranes are placed back into the racks and another clover is removed for repair.

- Stainless steel pipes
- Valves to fill and drain
- Inlet valves to fill
- Tilt Trolley mount

The membranes are hosed down while standing on the racks to keep them from drying out. We knew that the hosing down kept the membranes moist but did not saturate them. We decided that it would be easier to identify the leaking/broken strands if the membrane modules remained saturated.

Our saturator has made our pinning repairs easier, less tedious, less time consuming and more effective.

This simple device took very little time to put together, was inexpensive and solved our problem so we could get on and do our repairs more efficiently and effectively.

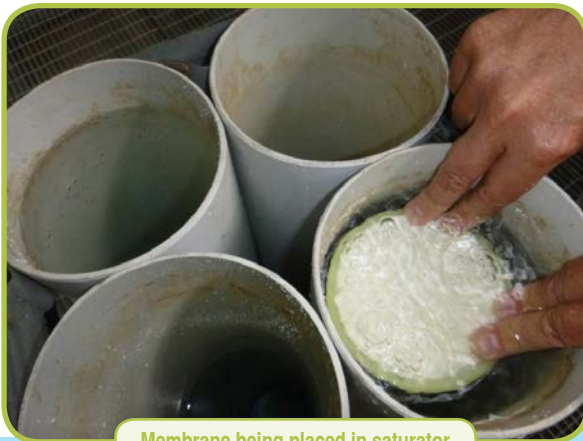
Membrane being placed in saturator

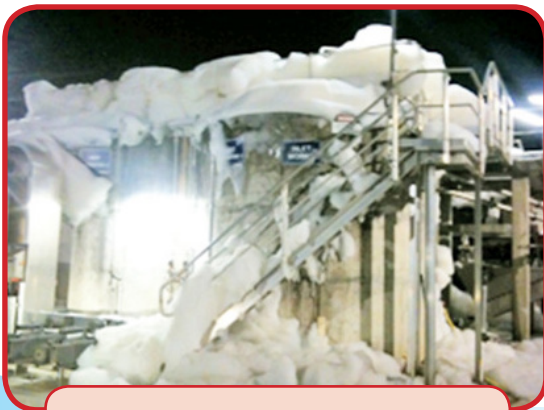
Trade waste shock causing foaming at Burpengary East STP

Unitywater's Burpengary East activated sludge Sewage Treatment Plant (STP), receives wastewater from domestic and industrial sources. Occasionally, substances in the influent temporarily affect process performance but don't usually cause an environmental compliance issue. In 2013 the plant received an influent trade waste shock load which became apparent to operators when significant foaming was observed at the inlet works.

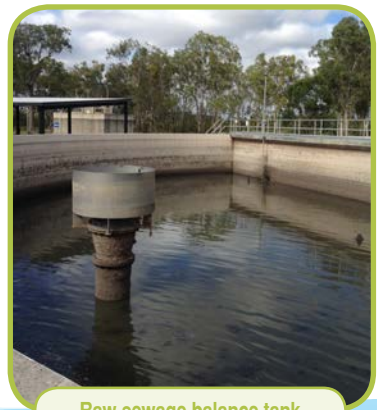
Raw sewage balance tank with wet weather bypass bellmouth

Unitywater chose to upgrade the plant with operations staff having a very high level of input into process design. Operators lobbied to ensure that the largest capacity possible Raw Sewage Balance Tank (RSBT) was included and a four ML RSBT was approved.
