Bloomsbury Bore: Remote supply challenges, one bore with Iron & Manganese

Mark Vairy, *Team Leader Water Treatment*, Mackay Regional Council

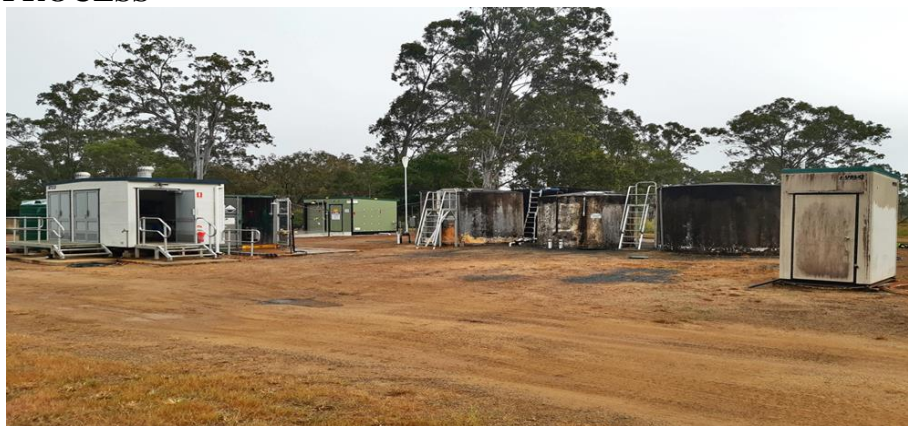
Figure 2: Bloomsbury WTP

Bloomsbury sources its raw water from a single bore associated with O'Connell River. The raw water is pumped from the bore at the riverbed and into a raw water dosing tank before being dosed with Sodium Hypochlorite to a level above 1.4ppm. This level is monitored by a dedicated chlorine analyser for the polishing process stage. The bore water after being chlorinated will now oxidise the iron and manganese whilst also creating a chlorine residual high enough to maintain disinfection after treatment.

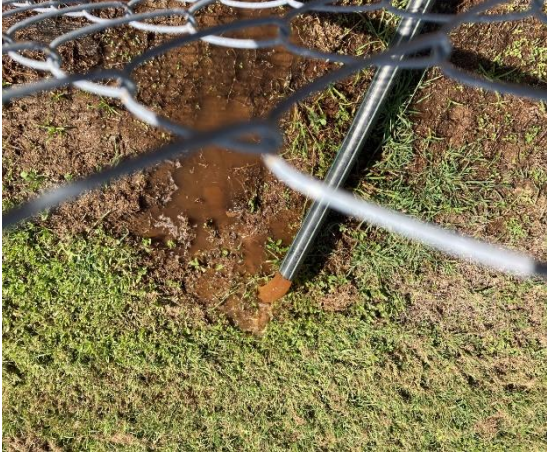
Figure 4: Flushed bore water

With recent years of dry conditions demonstrated by data collected over may years of routine testing, the levels of iron and manganese in ground water had elevated along with reduced recharge of the water table from the years of drier than average years.

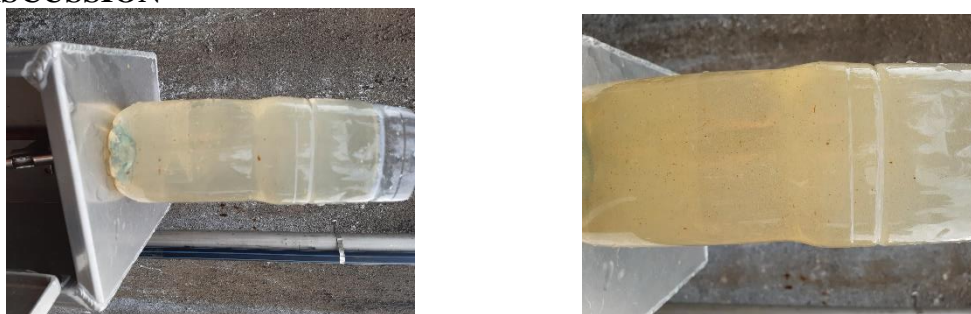
Figure 6: Compromised water quality

With the towns bore water supply being compromised the plan was to continue to cart water from the township of Marian, almost an hour away although with road works in place at times this could be an hour and a half at times.

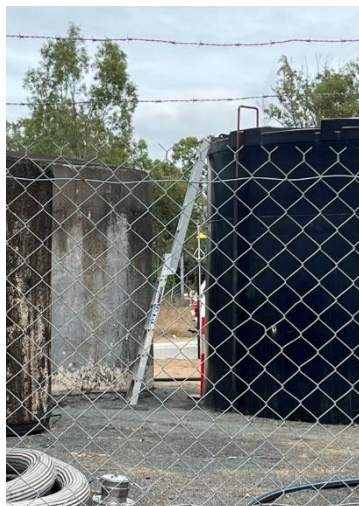
Figure 7: temporary tank connections

Simple solution to this would be more storage! Also, a little bit costly, but luckily, we had some suitable poly tanks that had just been used as temporary storage for a reservoir repair job, so with the assistance of our maintenance team we redeployed two additional 20 kL black poly tanks which would now give us a total of 80kL storage and 56kL of usable storage.

After some plumbing and valving to balance these tanks, we were then better able to schedule and coordinate routine site deliveries to maintain the water supply.

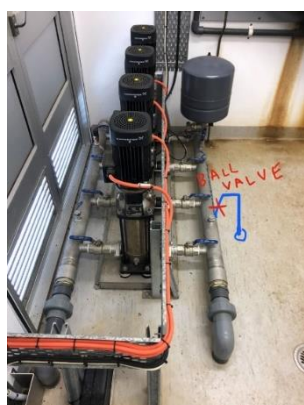
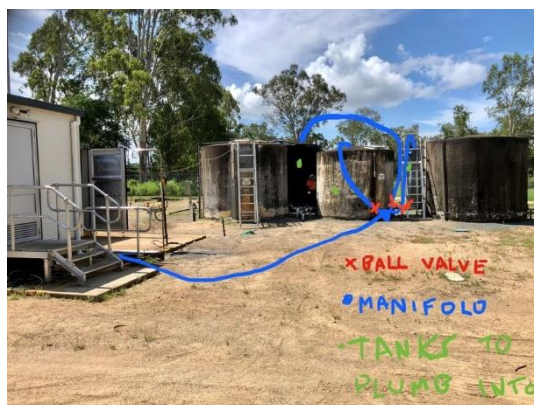
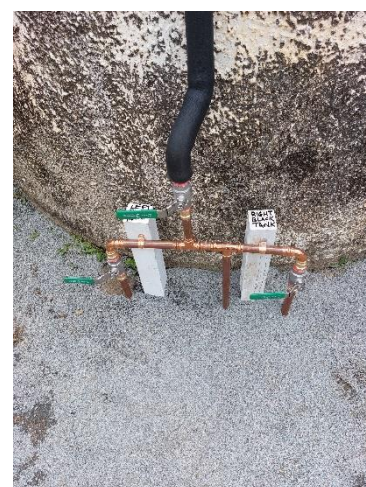
Figure 8: Modified recirculation system

We added a recirculation system using the existing booster pumps and needing nothing more than

some extra piping and valves. Tapping into the outlet side of the booster pumps and utilising a small percentage of the pressurized water heading to town diverting and splitting it between the tanks to create a constant water flow loop. This loop helped create an even distribution of chlorine levels by this added mixing. With a simple ball valve installed we were able increase or decrease the total amount of mixing required as well as valves on a common manifold giving operators further control over the process by adjusting individual flows to each tank depending on the requirement for increased or decreased mixing.

Furthermore, we also created a table as a guide utilising data we captured during the initial manual dosing trials testing chlorine residuals of each of the 4 four reservoir tanks prior to adding water from the delivery water tanker / chlorine residual of the tanker water itself / Volume of chlorine added and final residuals in each tank 30mins after manual dosing and mixing using the modified mixing system using the booster pumps.

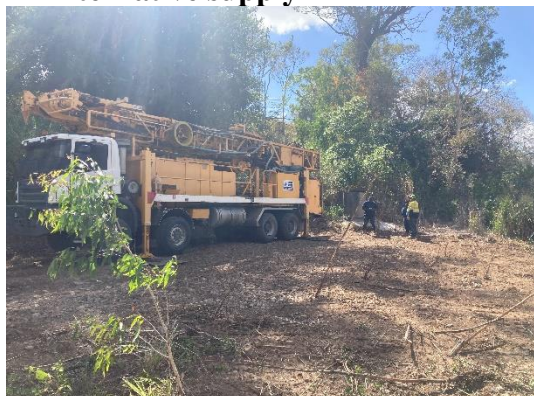
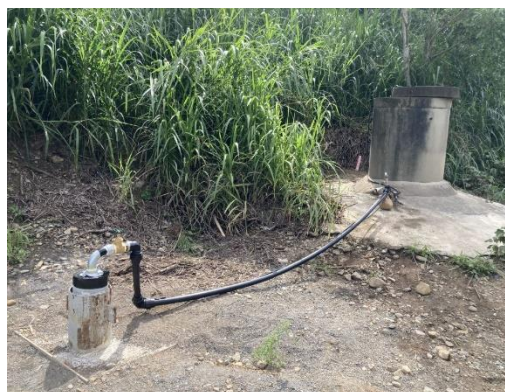
Figure 9: Alternative Bore Drilling

We looked if we could drill a second bore onsite at the WTP itself. After having to drill down quite some distance, testing was carried out and unfortunately, we discovered the water quality in this bore tested unsuitable with existing elevated levels of chloride.

We then decided to drill a 2nd bore near to the original bore on a 45-degree angle beneath the riverbed. This drill did not come without challenges hitting bedrock during the job but was completed and now we are awaiting test results. The thinking is that drilling closer to the surface water that being a shallower bore then the supply should have picked up less minerals. We are still pursuing this, unfortunately due to issues with the contractor, there are no records from the company of the drilling logs, so they are coming back to redrill down by the riverbed.

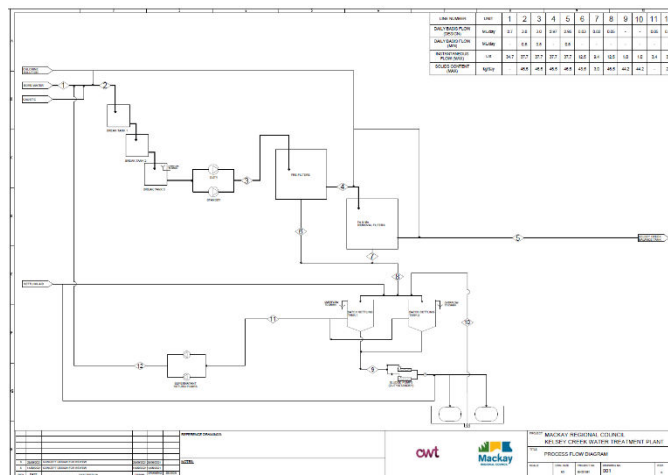
Figure 10: Kelsey Creek

Also, we are working with our planning and capital team on a long-term solution. There is an upgrade due to commence on a nearby scheme at the township Kelsey Creek and commissioned by the end of the calendar year. This upgrade is to also resolve iron and manganese issues by implementing a water treatment plant solution that includes dedicated dosing, filtration, and a residual handling. The scheme delivers water via a pipeline which includes supply to the residents of Midge point. Council is developing a design to extend this pipeline 12 km away to the Bloomsbury scheme which would then potentially see Bloomsbury as a storage and chlorination booster site.
