PROACTIVE WATER SERVICE CONNECTION REPLACEMENT PILOT PROJECT

Roxie Luo, *Asset Project Officer*, City of Gold Coast

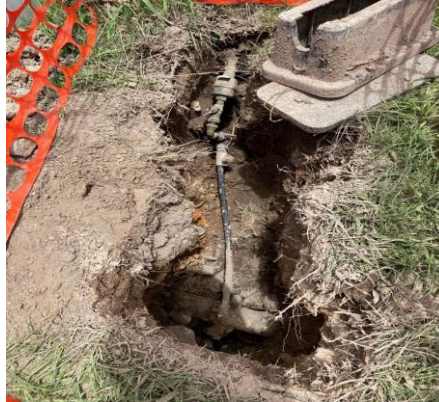
Based on our site investigation, the previous repair strategy can also be attributed to causing repeated leakages from the same WSC. For instance, figure 1 is shown a typical example of a leaking water service that contains three different types of PE pipes and has more than one joint or clamp. This evidence indicates that several repairs had been undertaken in the past years without triggering renewal works. With the increased number of joints and clamps, the risk of water leaking is also escalated.

Figure 1 – Identified repeated leaking water service

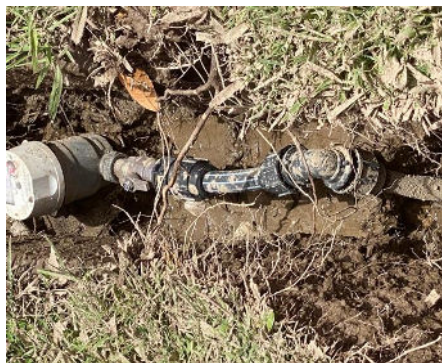
Although the maintenance teams are responsible for operating the whole WSC asset (including tapings, service pipes and meters), the metering asset is recognised as an individual asset and a different branch and contractor manage its annual meter replacement works. The metering replacements are conducted across the city, driven by its 15 years of useful life. However, the city metering contractor replaces the existing meters with a new meter and a section of new PE pipe and joints (example shown in Figure 2 below), consequently it creates more potential leaking points.

Figure 2 – Metering replacement

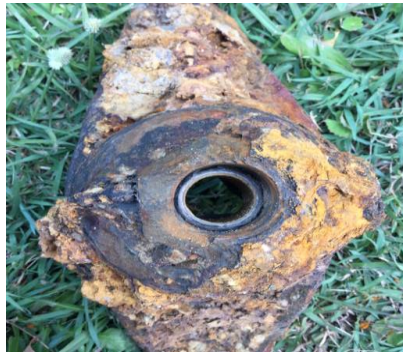
A commonly known reason causing metallic fittings failure is the corrosion issue. Figure 3 as an example is shown that the previous steel (cast iron) tapping band is experiencing severe corrosion issues. In contrast the brass tapping band remained in excellent condition after 30 years of installation. However, replacing the saddle tapping band is challenging on a reactive basis as the work requires a water main shutdown. The proactive replacements of the poor condition saddle tapping band can reduce the number of emergency water shutdowns and the impact of service interruption.

Figure 3 – Corrosion issue on steel tapping band

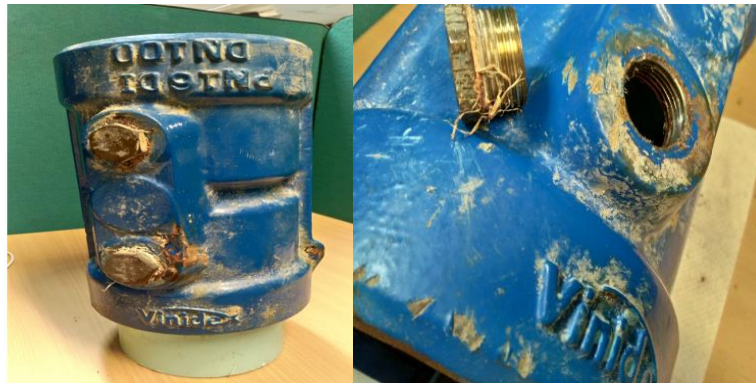
Another major failure was found in ‘ReadyTap’ fitting (an alternative saddle tapping product), distributed mainly in the new development areas. This ductile tapping failure is due to internal corrosion after service pipe replacements. Since many failures had been identified, W&W had reported quality issues back to the manufacturers and waited for the product re-design to eliminate the corrosion issues.

Figure 4 – Internal corrosion from the ReadyTap fitting

The material issues, especially for newly developed products, from both pipes and associated fittings should be addressed through the following process: 1) collect data or samples from the repair works; 2) report to standards engineer; 3) review design issues; 4) suspended the poor-quality products; 5) engage lab testing and design improvement; 6) review and approve the new design.

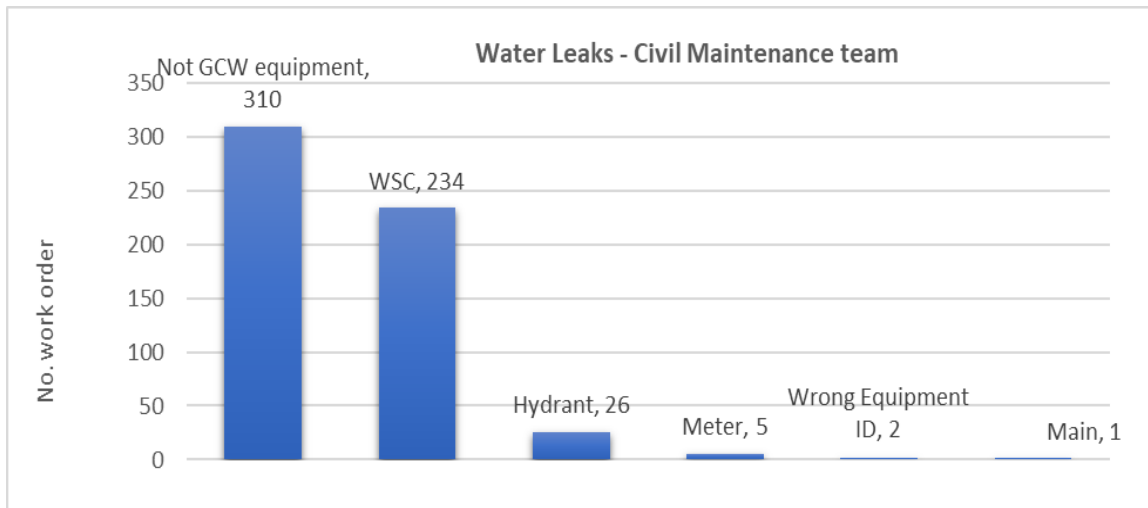
This risk was recognised at the project imitation stage and effective communication of improving the maintenance records has been widely engaged. As a result, the recent leakage report (figure 5) has been significantly improved. It is shown that more than half of the maintenance activities are related to the ‘Not GWC equipment’ that are the jobs investigating private internal leaks, groundwater saturation and pressure / odour complaints.

Figure 5 – Water leaks report on WSCs

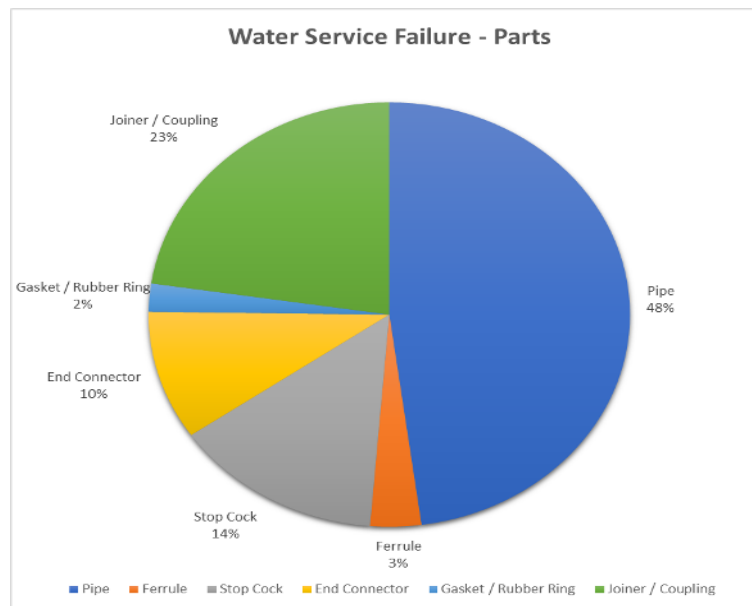
A further analysis (shown in figure 6) for the failed WSC parts is indicated that almost half of the leaks are due to the poor condition fittings (joints & couplings, end connectors, and stop cocks), particularly on the meter side.

Figure 6 – Water service failure - parts analysis

With the continuous improvement of the data availability and accuracy, W&W will be able to develop a more targeted replacement program for leaking service pipes and tapings. At the same time, it is also recommended to initiate a customer engagement / education program and enhance the regular communication with the metering team to address the issues apart from the WSC asset failures.
