# Cedar Grove Commissioning from An Operators Point of View

**William Smith**, *Supervisor Treatment Operation*, Logan city Council

**Michael Gow**, *Process Engineer*, Logan City Council

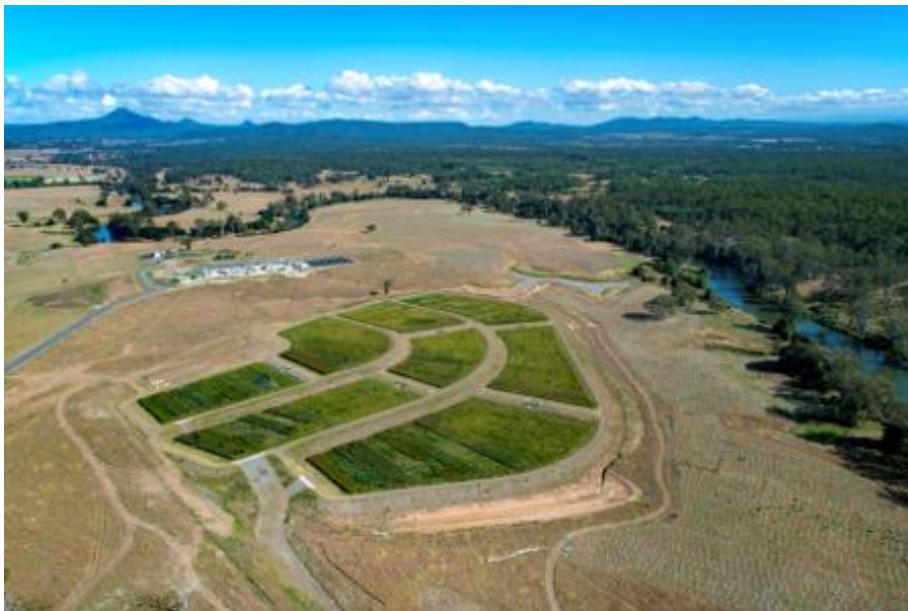
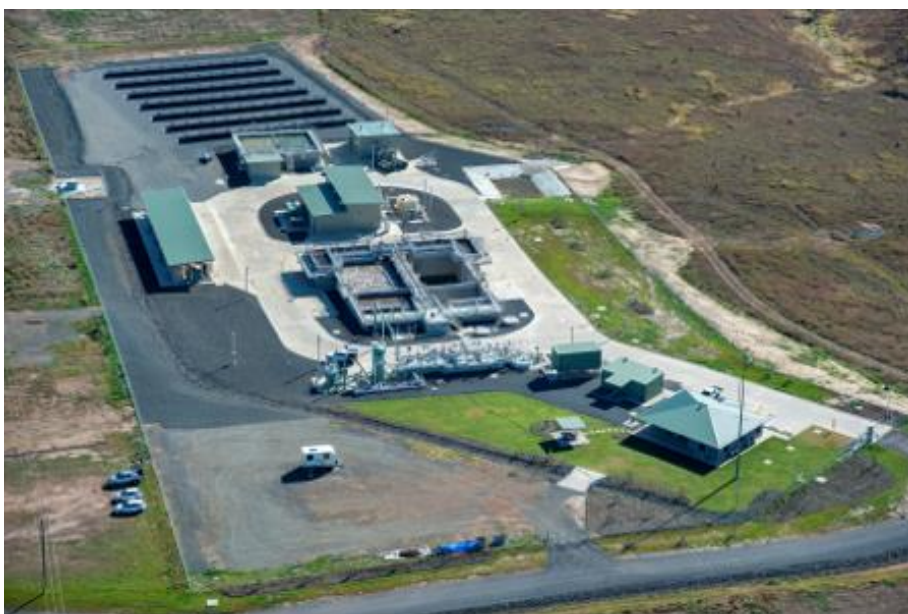
The Cedar Grove WWTP is located along Cedar Grove Road in Cedar Grove, beside the Logan river. The total area is approximately of 203.9 hectares (ha)

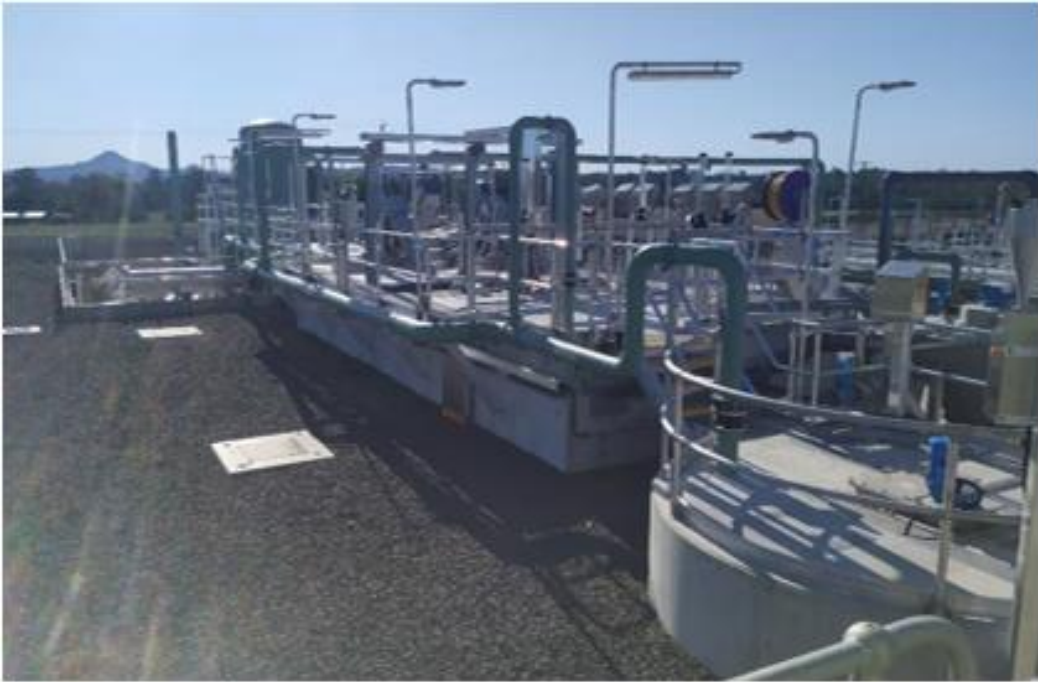
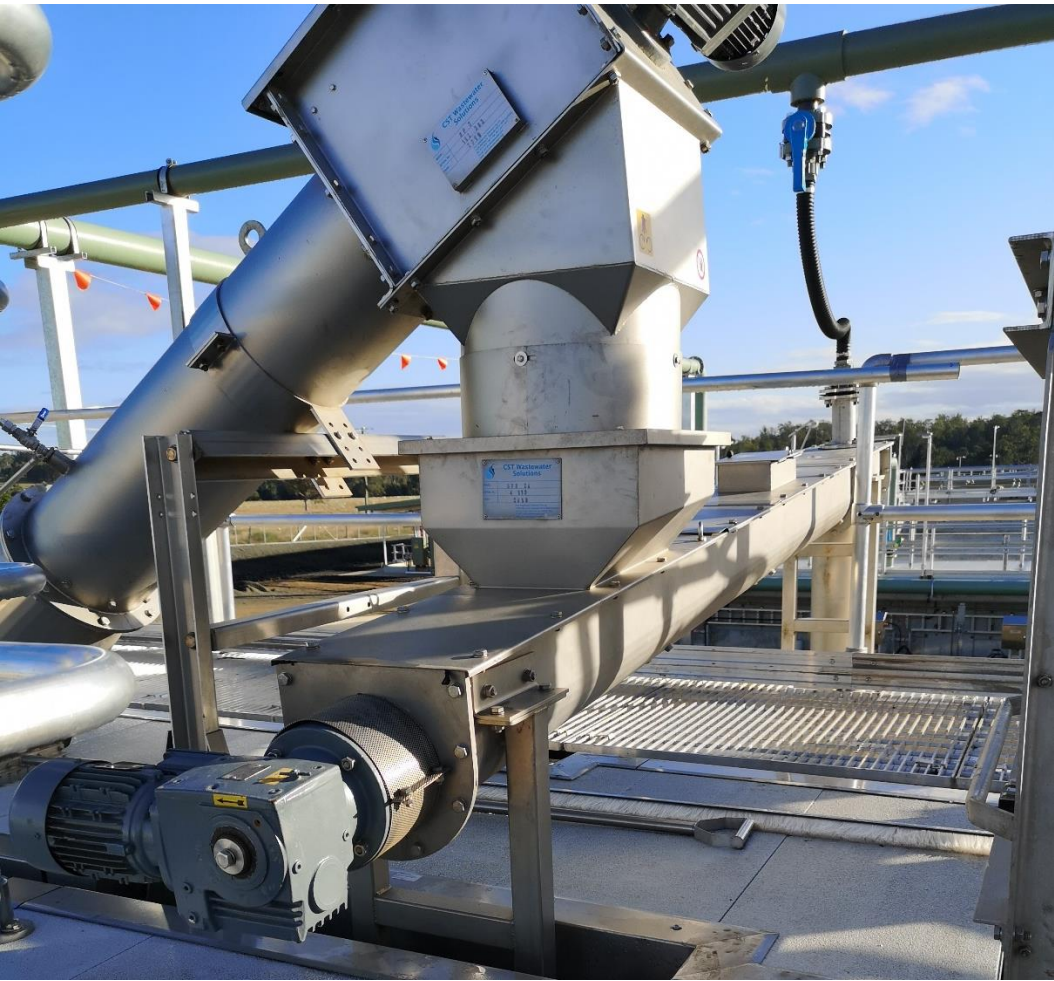
The issue we found in this area are some of the auger motors was impacting the maintenance capability where they are located.

Inlet Work	Access	There is not much room for accessing and inspecting through the man holes on the trickling filter
		Cannot open the hatch covers of the bar screen from the outside of the hand rail
	Maintenance	The oil drainage plugs of the gear box of the fine screen augers is located below the deck. The drained oil can pass into the waste water flow
		The brush opening for the drop boards can be a trip hazard
	Walkways	There are gaps in between walkways and other area of the top floor of the inlet. It leads to trip hazard
		The 90 degree bend joints used to join the handrail are not secured
		The Aluminium kick plates are joined with SS connectors at some places and Galvanized connector at other places. It is not consistent & different material joint can lead to galvanizing action and corrosion
	Main Screens	Service water lines to the water spray at some places are not braced properly
		There is a gap in between the fine screen chute and the screw conveyer. Something can drop into the conveyer mistakenly

Manual Screen	the gap around the davit bases. It leads to trip hazard
		The lifting handles of the hatch covers are sitting on the top of the covers. It leads to trip hazard

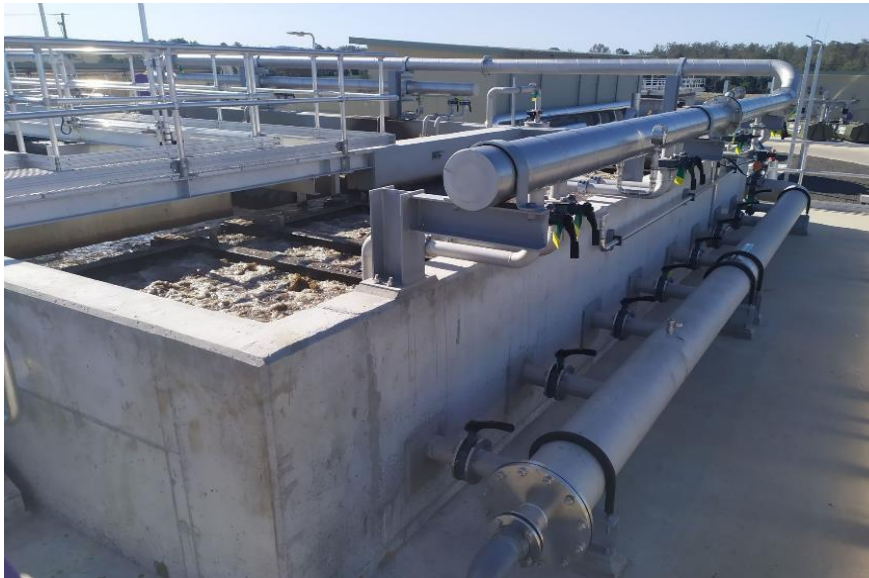
The plant consists of two parallel bioreactors linked to four independent membrane tanks. The bioreactors provide biological treatment of the screened and de-gritted sewage for BOD, TSS, nitrogen and phosphorus removal and consist of four key reaction zones:

- The Bio-selector zone
- The Anaerobic zone
- The Anoxic/swing zone
- The Aerobic zone.
- 4 Membrane chambers

To provide dissolved oxygen and mixing for biological treatment blowers push air through grids of diffusers on the bottom of the Aerobic zones, as well as the Anoxic/swing zone if required, which produces fine bubble aeration with high oxygen transfer. Mixers are also located within the Anoxic/swing tanks which operate when no aeration is provided. Air is provided intermittently on a timer basis to the bio-selectors to assist with scum removal on the surface. A scum harvester is also installed on the side of the membrane feed tank. A Return Activated Sludge (RAS) flow is pumped from the Recycle Chamber and split and returned to the Anoxic/swing zones, bio-selectors, and mixed with the raw sewage flow at the inlet works.

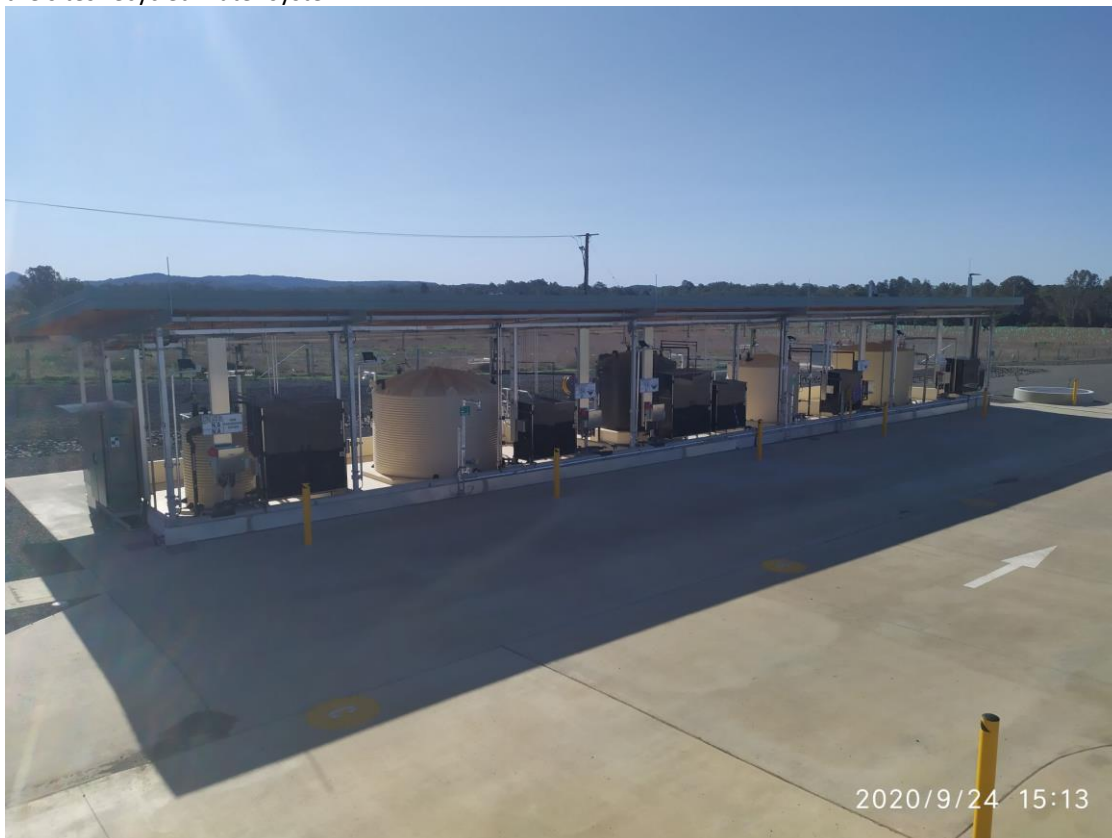
Sodium hydroxide solution dosing to the exit chamber of the inlet works can facilitate the adjustment of process alkalinity levels. The caustic is supplied to counter the effects of chemical coagulant dosing (alum) and net alkalinity consumption through nitrification.

Sodium hypochlorite and citric acid are kept onsite for membrane cleans. Sodium Hypochlorite is also dosed into the sites recycled water system

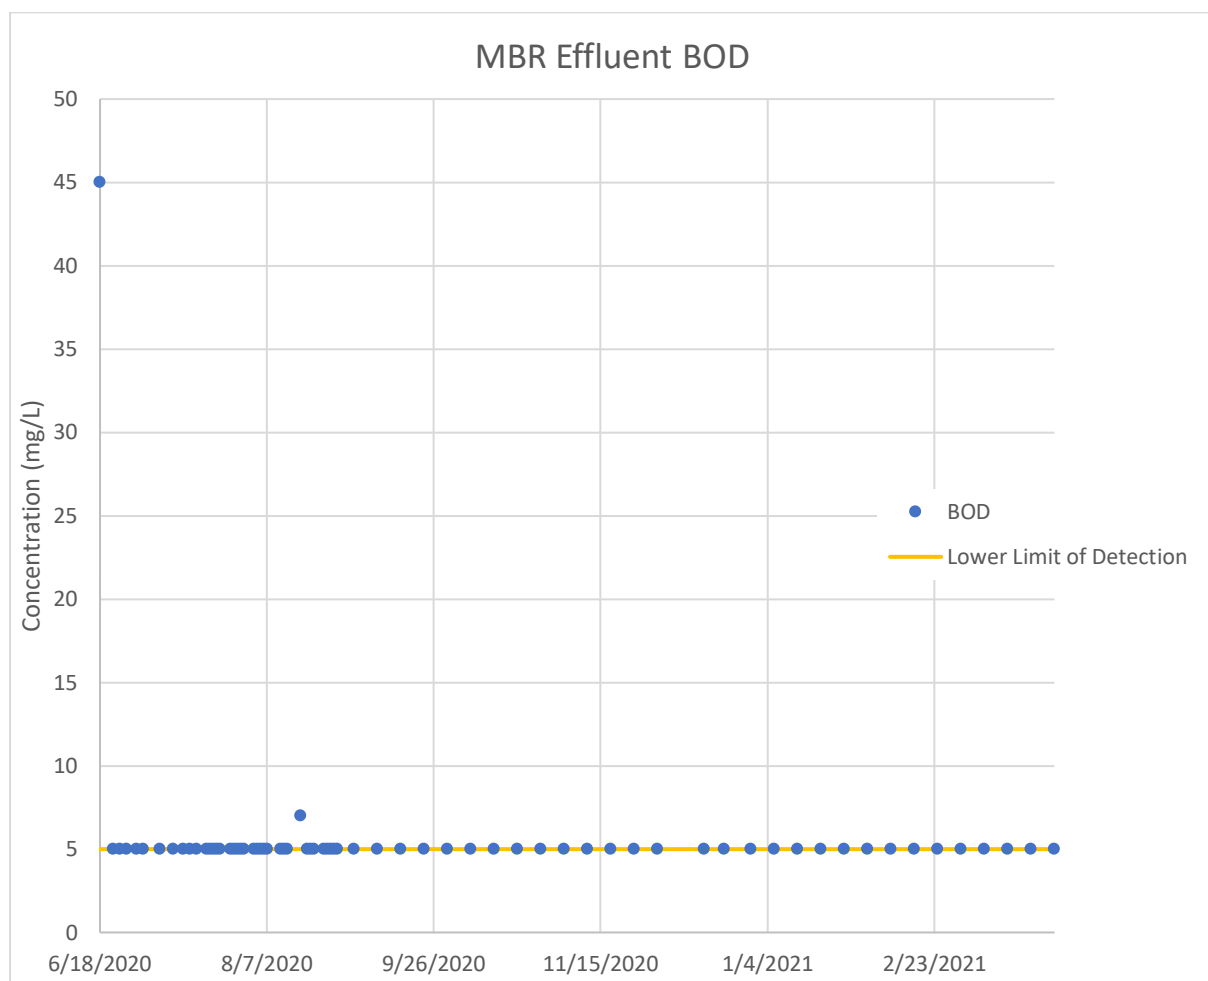
Figure 2: MBR Effluent BOD. During the initial commissioning there was BOD breakthrough due to low solids volume, however within several days there was sufficient solids to resolve this. Current MLSS is 4500mg/L which is working well while the plant is underloaded

The MLSS levels were checked the next day, and were found to be low, but adequate for the low plant load at this time. No sludge was wasted for a period while the biomass built up, and liquid sugar was added to help the rate of solids build up and improve nutrient removal.

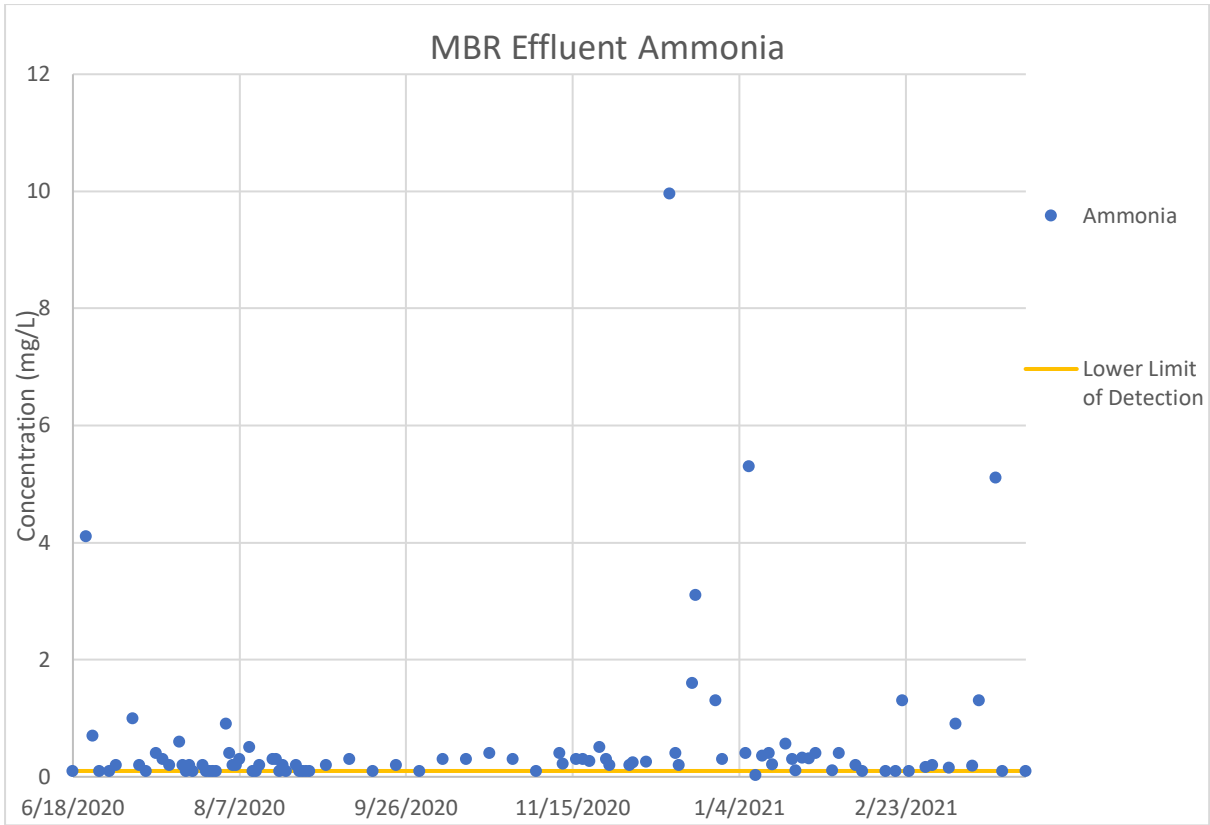
Figure 3: MBR effluent ammonia. This parameter is heavily influenced by wet weather. Dry weather performance has been good, and a wet weather aeration mode has recently been implemented to improve wet weather performance.

This process works well most of the time. During wet weather, we found that the ammonia levels would start to increase during the event. When investigating this issue we found that due to the length of rising mains leading the plant, at the start of wet weather event, a large slug of raw sewage would be pushed through at wet weather flow rates, which overwhelmed the aeration systems. To fix this we came up with a semi automated wet weather procedure. There were a couple key factors considered in developing this procedure:

1. Trigger point to engage the wet weather mode. We settled on a two point trigger flow, or ammonia, or both.
2. The balance of additional aeration and denitrification capacity. We settled on erring on the side of additional aeration as the wetlands system is better able to treat nitrate and nitrite loading than ammonia.

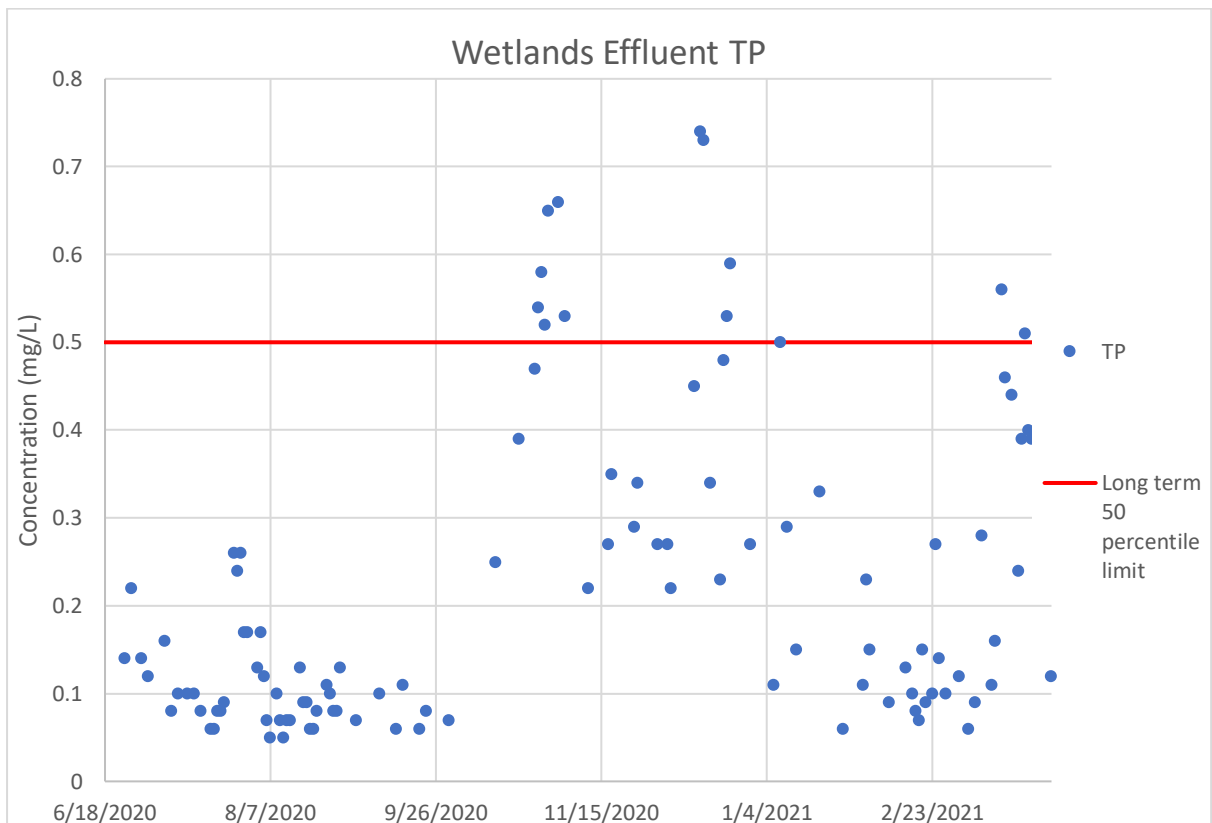
Figure 11: Wetlands total phosphorous. This parameter is affected by wet weather due to erosion of the batters and stirring up of sediment in the cells. Due to extremely good TP removal in the MBR there is no compliance issue with TP however.
