RECOVERING BRISBANE'S SECOND LARGEST WASTEWATER TREATMENT PLANT AFTER THE 2022 FLOODS

Cait Pauling, *Graduate Engineer*, Urban Utilities

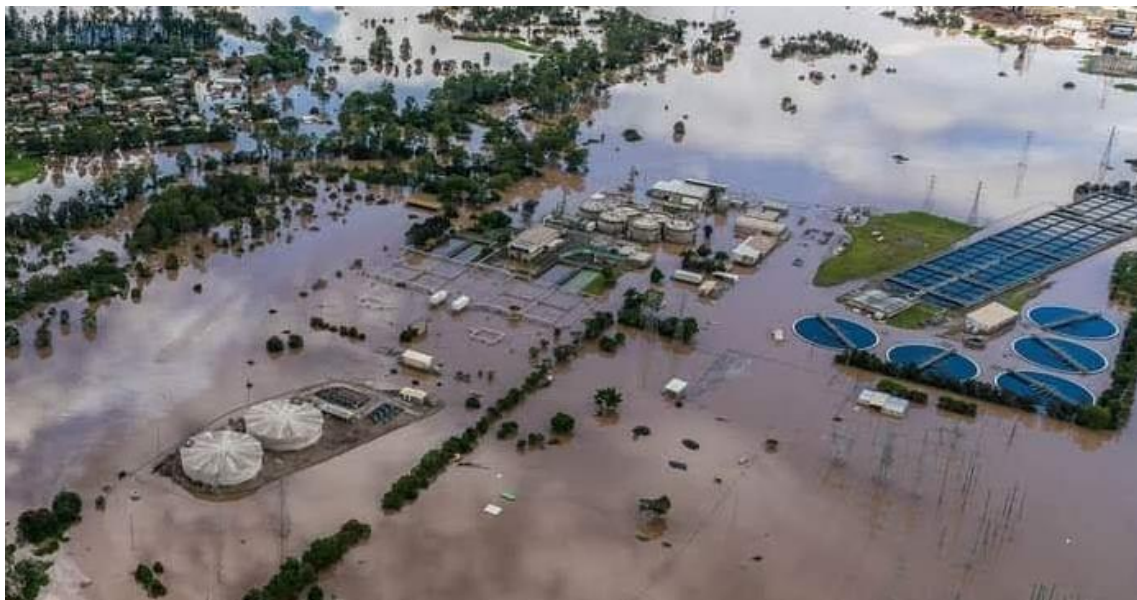
Oxley Creek RRC is located in a low-lying, flood-prone location and during the 2022 floods the water level rose quickly, with two operators needing to be rescued from site by the SES. Some parts of the plant avoided significant inundation, however, some treatment trains were completely flooded (Figure 1). The on-site inlet works pump station was flooded, along with the admin office, which is a hub for our process engineering team, trade waste officers and other site staff, such as project managers and maintenance engineers. Crucially, our biosolids processing area was severely flooded. In fact, some parts of the site reached more than 2 metres of inundation. As a result of the floods, more than 85 pump sets, motors, gearboxes, compressors or other assets were replaced – this number doesn't include replaced instrumentation or any pumps that were refurbished instead of replaced. Overall, Urban Utilities spent more than \$3 million in 6 months during the recovery of Oxley RRC.

Figure 1: *Aerial view of the flooded treatment plant and surrounding area*

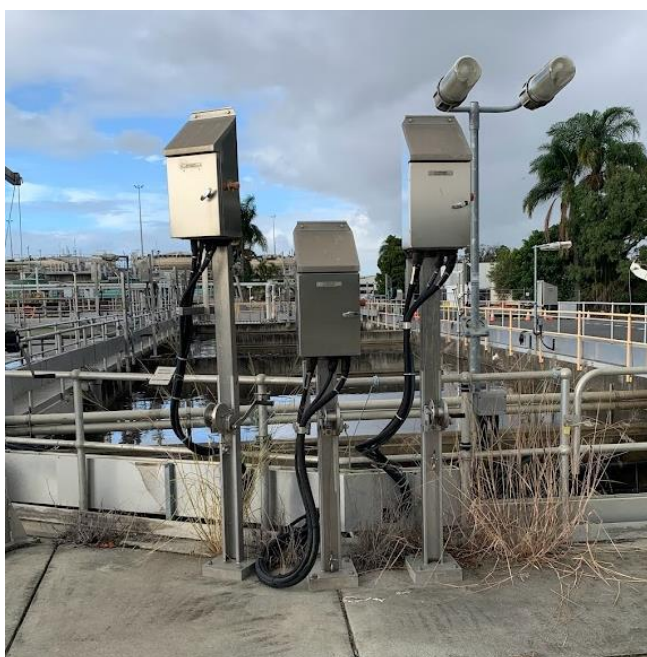
After the 2011 floods, Urban Utilities did a lot of work to improve the resilience of the site. Some of the resilience projects included raising switch rooms and blower rooms above the flood height plus 300mm, and installing wind-up control panels, distribution boards and junction boxes (Figure 2). Overall, we invested \$15M after the 2011 floods to improve flood resilience at Oxley. This expedited the flood recovery effort in 2022, as in 2011 it took us 6 weeks to recover **preliminary treatment**, compared to 6 days in 2022. Additionally, in 2011 the cost to recover the plant post-flood was approximately \$25.7M compared to an estimated \$8M to recover the plant from the 2022 flood.

Figure 2: *Example of the wind-up control panels installed after the 2011 flood*

In 2011, the critical bottleneck faced was recovering and rebuilding the MCCs, which is why all of the electrical control rooms were raised. It's also why there's such a big difference in time taken to recover the preliminary treatment, as well as the recovery costs. However, in 2022, the critical bottleneck faced was supply chain issues and long lead times for asset replacements.

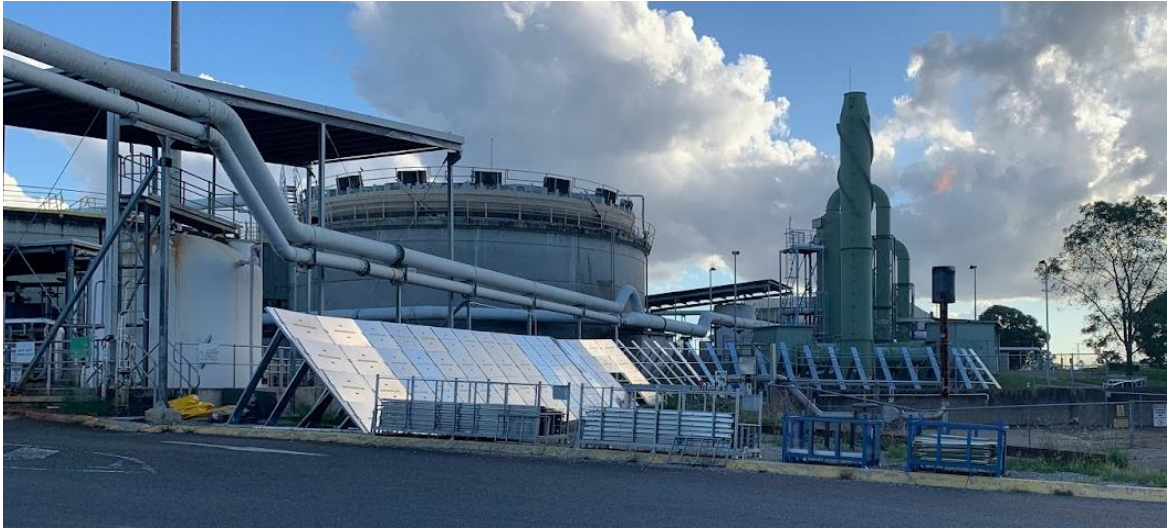
Figure 3: *Flood barrier during assembly at Oxley RRC*

After the flood, Urban Utilities considered what the best option for protecting Oxley treatment plant from future flood events was. Different options were considered, such as raising critical sludge processing assets, like the CAMBI. Ultimately, the preferred solution was found to be a flood barrier, which would surround the sludge processing facility and protect the site from inundation (Figure 3). The barrier was partially deployed on site at the beginning of this year, and we plan to leave it partially assembled during wet seasons for rapid deployment if needed.
