AUTOMATED DREDGING- A SAFER WAY TO CLEAN OUR WASTEWATER BASINS

Charndeeep Chahal, *Ops Readiness Technical Advisor (Wastewater)*, SA Water

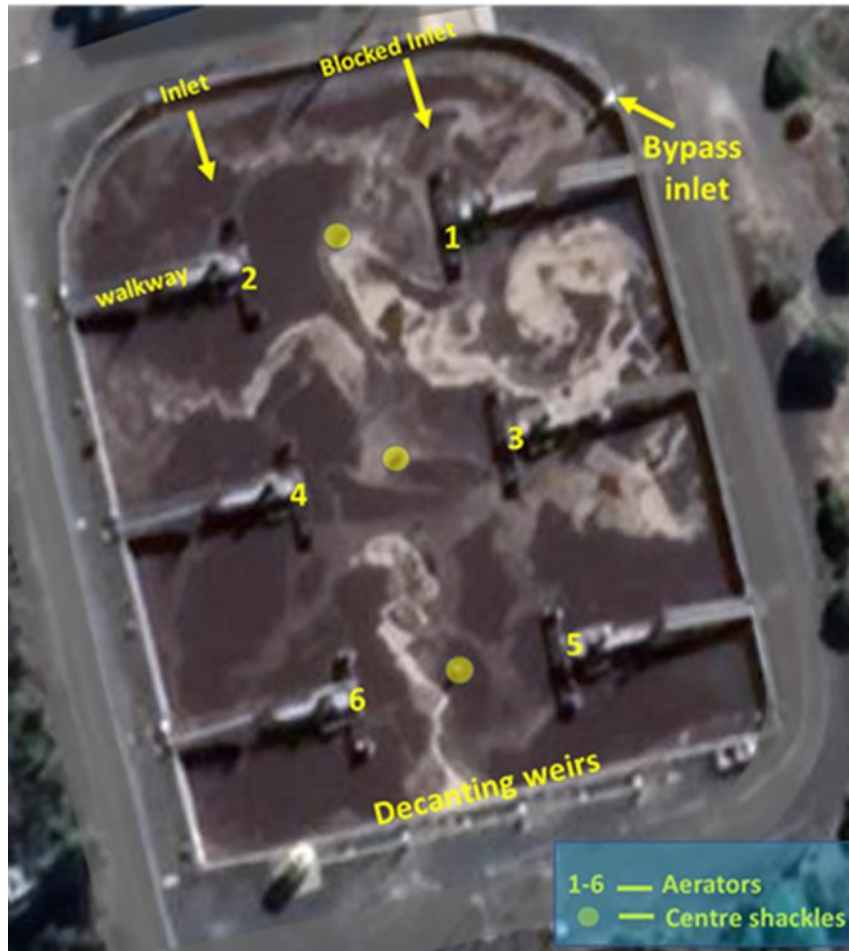
The IDEA basin is 5.3 m deep with a total volume of 11.5 ML. It has 6 floating aerators (Figure 1) which are held in position by cables connected to the side of the basin and fixed shackles in the middle of the basin. Each aerator has a dedicated walkway which is not connected to the aerator during normal operation and has automated swing gates to access the aerators when required. The basin has two inlets for screened influent, as well as a bypass from the inlet screen, sludge supernatant return lines and three decanting weirs at the opposite end to the inlets. Waste activated sludge (WAS) is removed periodically from the basin and transferred to one of the four sludge drying lagoons which are fitted with underdrains. Partially dried sludge (8-10% dry solids) is then excavated onto a dedicated hardstand area for further drying and stabilisation. Two mixed liquor return (MLR) pumps recirculate mixed liquor from the basin to the head of the plant to create a plug flow selector by mixing incoming sewage with return activated sludge. They are currently not in use due to ongoing ragging issues.

Figure 1: *The IDEA Basin at Finger Point WWTP*

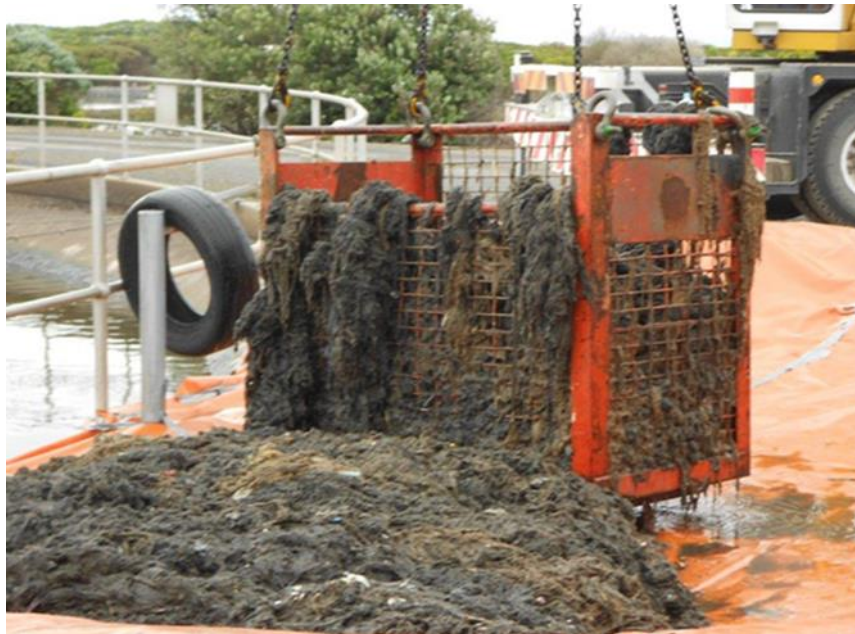
The basin was last cleaned in 2013 using divers and cages where the divers shovelled rag at the bottom of the basin and cages full of rag were lifted out and emptied on tarps on site (Figure 2). The rags were then left to dry and taken to landfill. This approach had safety, operational and environmental risks and so alternative options were investigated. There were numerous constraints to safely conducting another clean, including identifying a suitable approach and managing the treatment process given the IDEA basin could not be taken offline for the cleaning.

Figure 2: *Material lifted out of the basin in 2013*

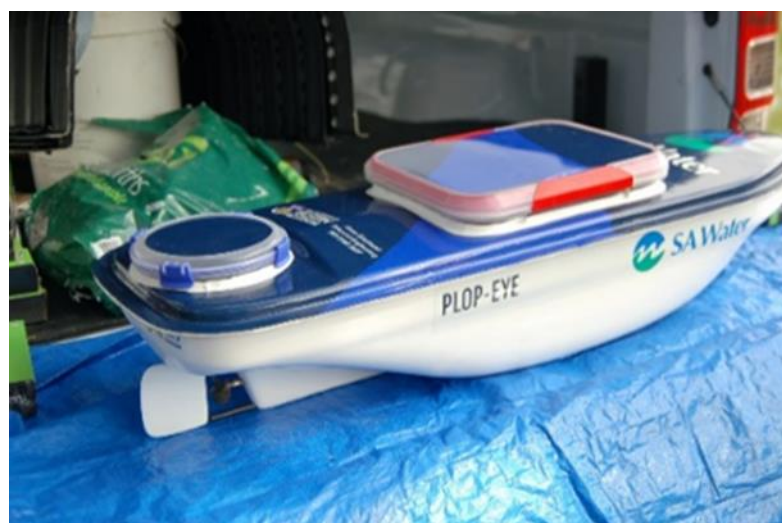
The issue was clearly identified and documented via multiple process reviews and during options assessment for other upgrades. The first step was to estimate the amount of rag present within the basin. A sludge profiling survey was undertaken using a sonar equipped sludge profiling boat (Figure 3). The survey was unable to identify differences between organic and inorganic material but provided a settled sludge profile (Figure 4) and identified potential areas of piles within the basin. The survey measured 0.5 to 0.7 m of sludge at the bottom of the basin which equated to 2.7 ML of solids, based on the dimensions of the basin. The survey also identified that the western top corner of the basin (near the bypass inlet) had a significantly higher amount of sludge compared with the rest of the basin. This also correlated with the flow pattern observed within the basin during an earlier study to identify detention times, flow patterns and any short circuiting within the basin. This was done by mixing a fluorescent dye in the influent to determine the transit time from inlet through to the basin at different flow rates.

Figure 3: *Sludge profiling boat*

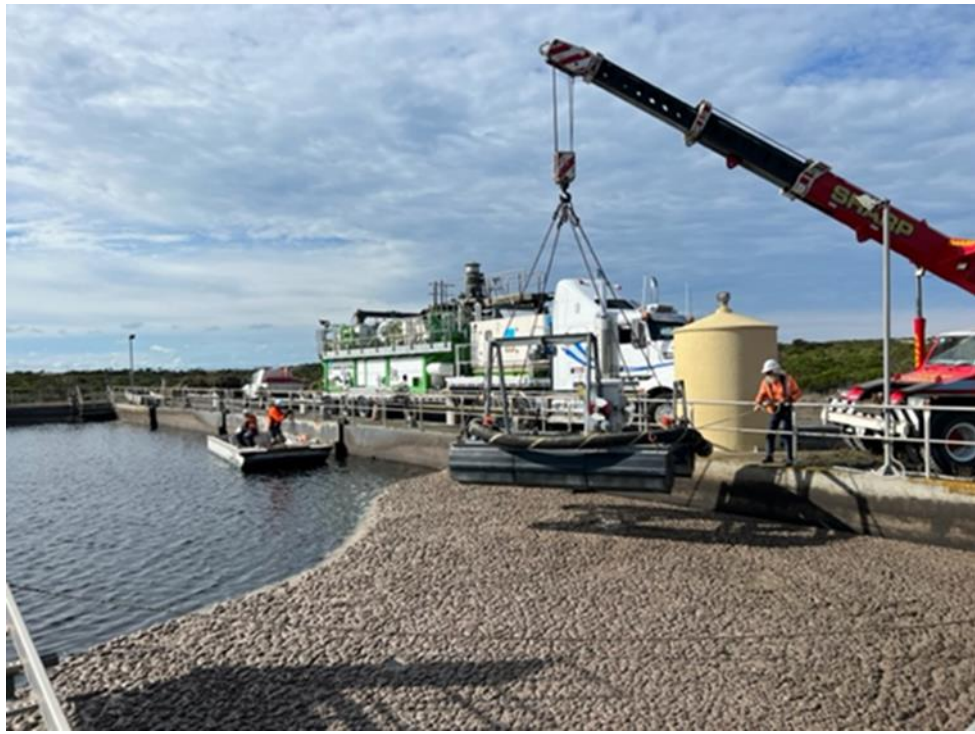
The clean started at the decanter end of the basin with aerator #5 being lifted out and placed on a cradle. All the aerators were electrically isolated, and the operating cycles of the basin were adjusted to provide sufficient run time for the dredge. The remaining the aerators were not lifted out, rather they were moved within the basin to enable dredge movement. As aerator #5 was lifted out of the way, the remote-controlled, robotic dredge was launched into the basin. The dredge, equipped with a macerator pump, lifted out the rags as it moved backwards and forwards on a transverse line controlled by a variable speed winch. The lifted material was fed to the screening unit which separated all the organic material from large inorganic rag and grit. The separated rag and grit were collected in hook lift bins and the liquid biomass was returned to the basin.

Figure 5: *The robotic dredge being launched into the basin*

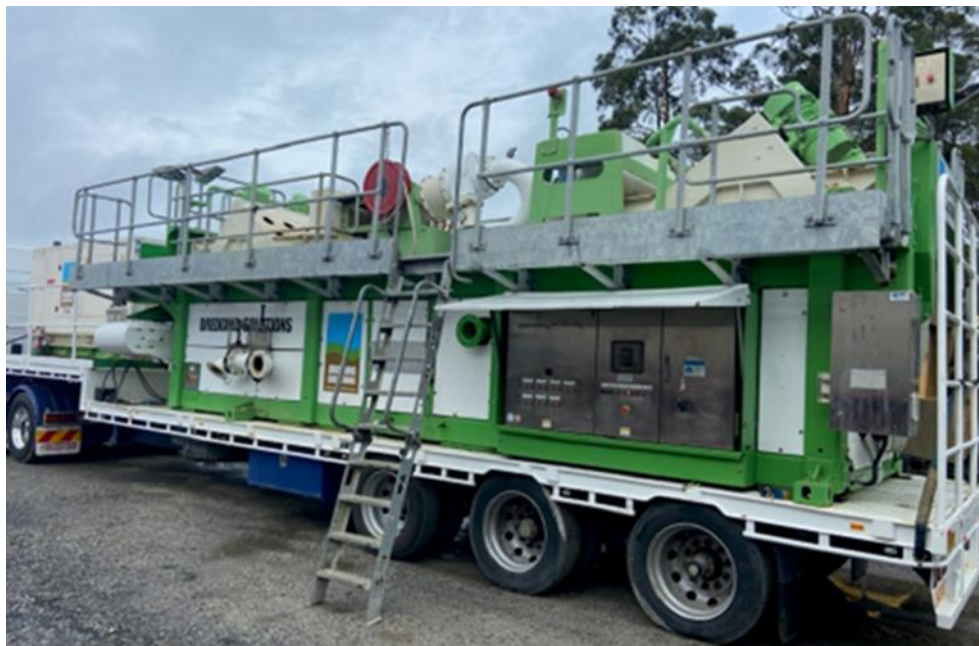
Figure 6: *D:MAX screening unit*

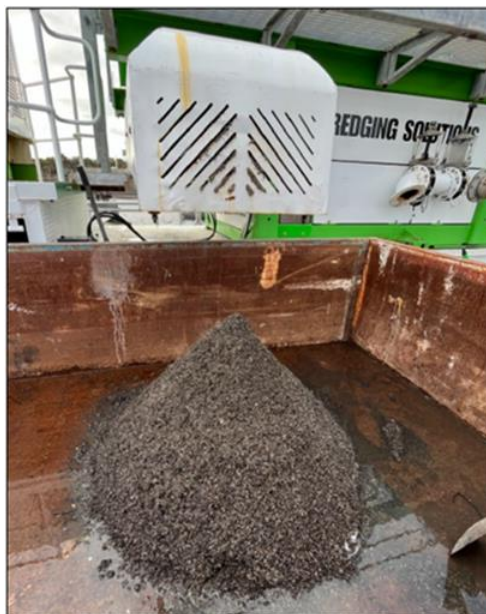
The dredge then continued to run through the basin to pick up all identified material (Figure 7).

Figure 7: *Lifted rag from the basin*

As the dredge started moving through the basin, only minimal material was being lifted. The dredge was repositioned to further scan the basin, but it did not collect any more rag. The pump was lifted out of the basin and checked for any blockages, and the pipework was also checked. Work was paused to understand why less rag was being collected than anticipated, and a dip test undertaken to confirm the efficacy of the dredge. The contractor and operators then went out in a boat to identify any areas of rag. The dip test verified that the basin did not have the expected volume of rag and only a small portion was identified in the western top corner of the basin which correlated with the sludge survey.
