DELIVERING REAL-TIME CCTV FOOTAGE TO ENABLE BETTER ASSET DECISIONS AND CUSTOMER OUTCOMES.

James Neeson, *Operations Manager*, ServiceStream

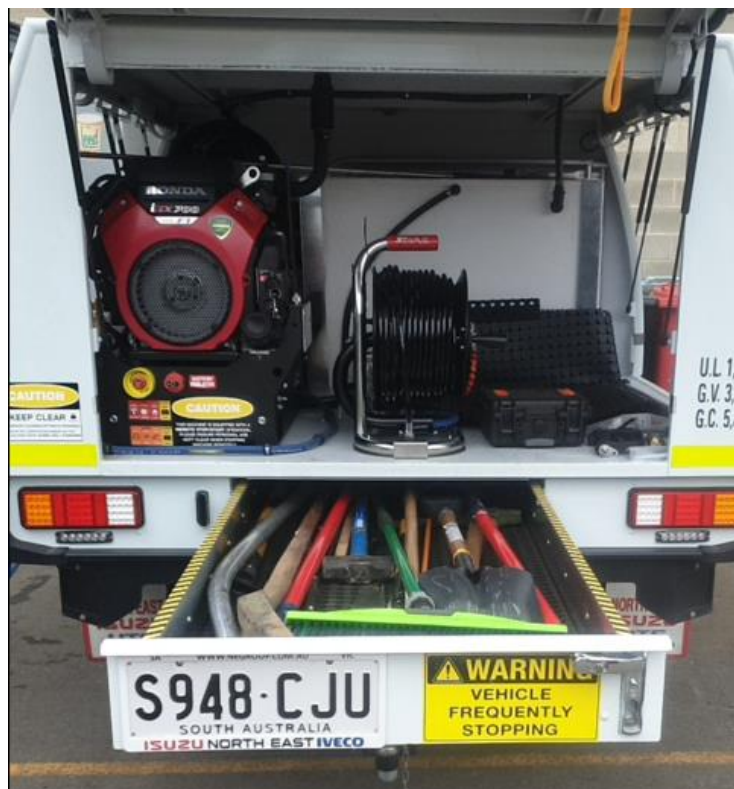
Figure 1: Wastewater field response unit

With a fleet of twenty-two (22) wastewater field response units all fitted with new equipment that included: Jetwave Scorpion - 4350psi @ 26lpm HONDA GX690, multiple hose reel configurations including low pressure hose reel equipped with mini reel, extension hosing foot pedals and lance; our team were well-equipped to trial the ‘proof of clean’ concept and determine whether the equipment, together with improved processes would result in a corresponding decrease to overflows on customer connections and improve the overall customer experience.

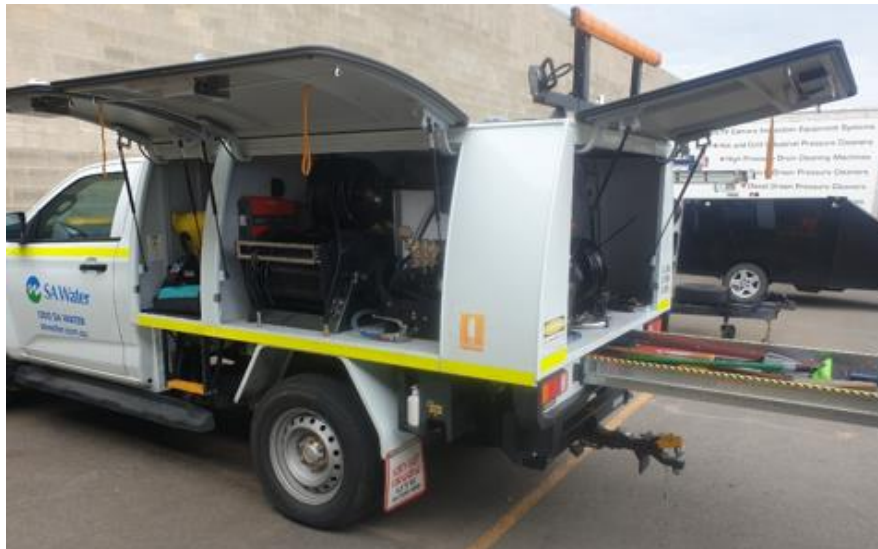
Figure 2: Wastewater field response unit

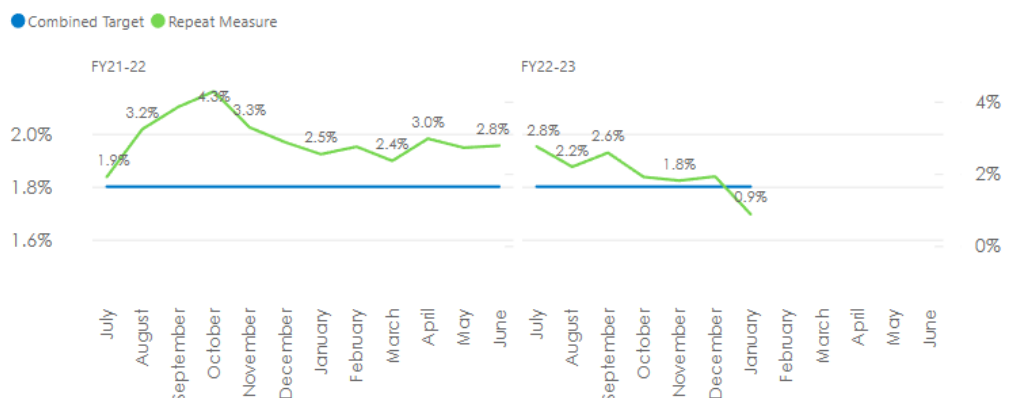
Figure 3: Repeat Sewer Boundary figures July 2021-June 2022

After trialling, this new improved end-to-end solution was rolled out to all field employees by July 2022. Since inception, there has been a decrease in the number of:

- Internal overflows.
- Repeat internal overflows.
- Repeat IP overflows.

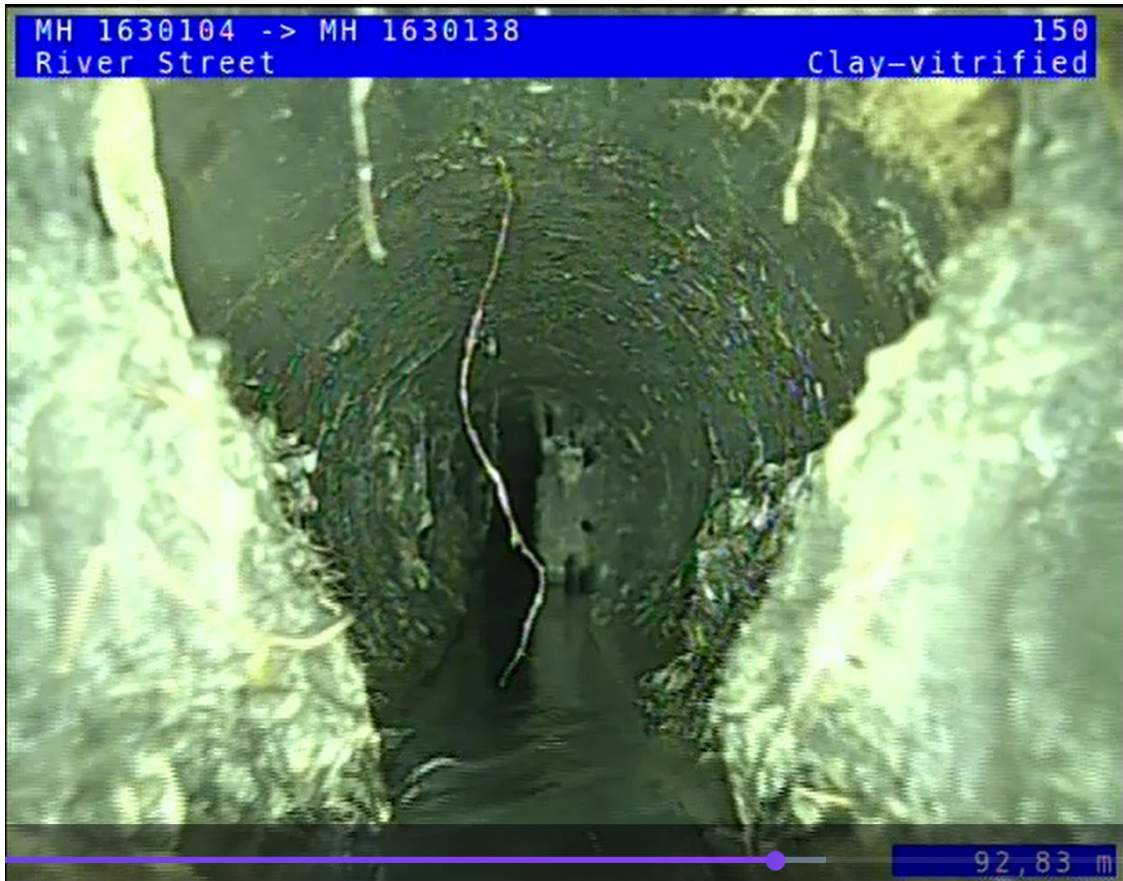
Figure 4: Example of CCTV Footage showing asset prior to cleaning

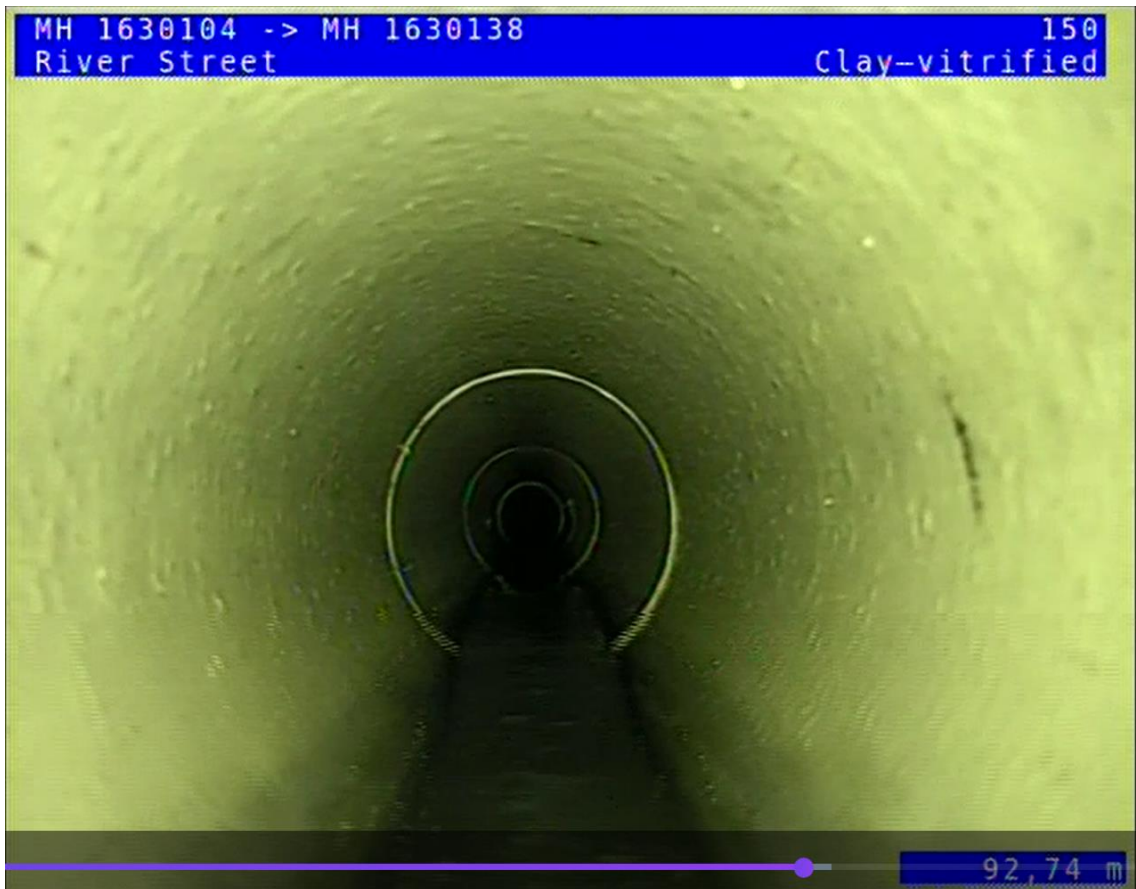
Figure 5: Example of CCTV Footage showing "Proof of clean" on asset

At the start of the partnership, ServiceStream identified the need and value for all sewer employees to have the ability to provide a “Proof of clean” essentially taking out the VMAX MX 2 and RIDGID SEESNAKE to ensure the customer connection was:

- clear of Debris and functioning as designed;
- clear of all blockages; and
- any other defects were identified.
